Radiated Emission Measurement

Condition : FCC\_part 15E RE\_Above 1GHz\_PK

EUT : W6M22409-23739

Test Mode : TX 802.11ax80 CH39

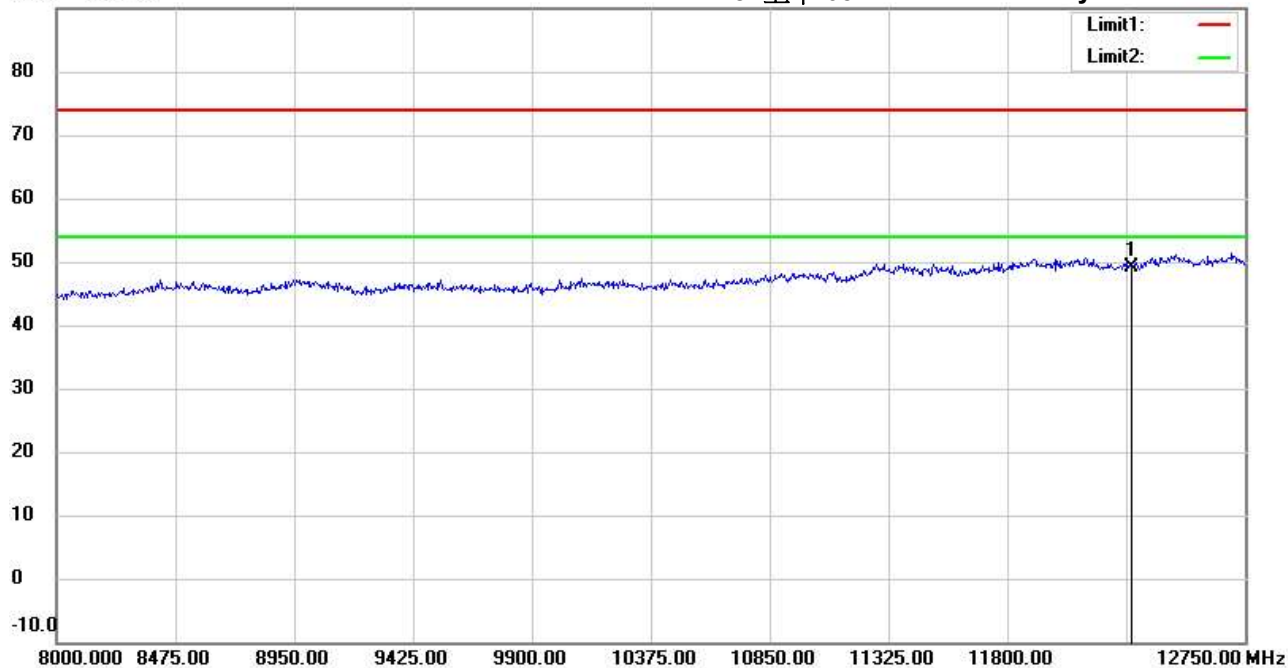
Site : 966A Chamber

Condition : FCC\_part 15E RE\_Above 1GHz\_PK

Test Mode : TX 802.11ax80 CH39

Polarization: **Horizontal**

| Mk. | Frequency (MHz) | Reading (dBuV) | Detector | Corr. factor (dB/m) | Result (dBuV/m) | Limit (dBuV/m) | Ant.Pos (cm) | Tab.Pos (deg.) | Margin (dB) | Comment |
|---|---|---|---|---|---|---|---|---|---|---|
| * | 12290.000 | 32.89 | peak | 16.12 | 49.01 | 74.00 | 150 | 59 | -24.99 | |

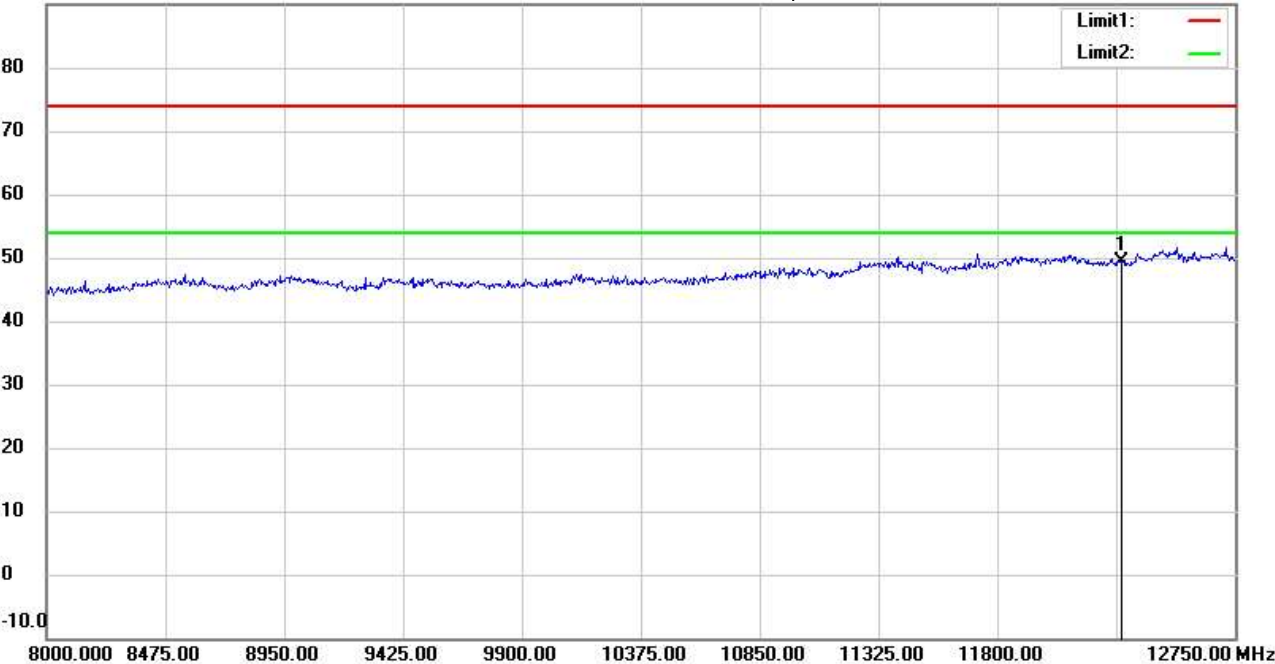
Site : 966A Chamber

Condition : FCC\_part 15E RE\_Above 1GHz\_PK

Test Mode : TX 802.11ax80 CH39

Polarization: Vertical

| Mk. | Frequency (MHz) | Reading (dBuV) | Detector | Corr. factor (dB/m) | Result (dBuV/m) | Limit (dBuV/m) | Ant.Pos (cm) | Tab.Pos (deg.) | Margin (dB) | Comment |
|---|---|---|---|---|---|---|---|---|---|---|
| * | 12290.000 | 33.34 | peak | 16.12 | 49.46 | 74.00 | 150 | 318 | -24.54 | |

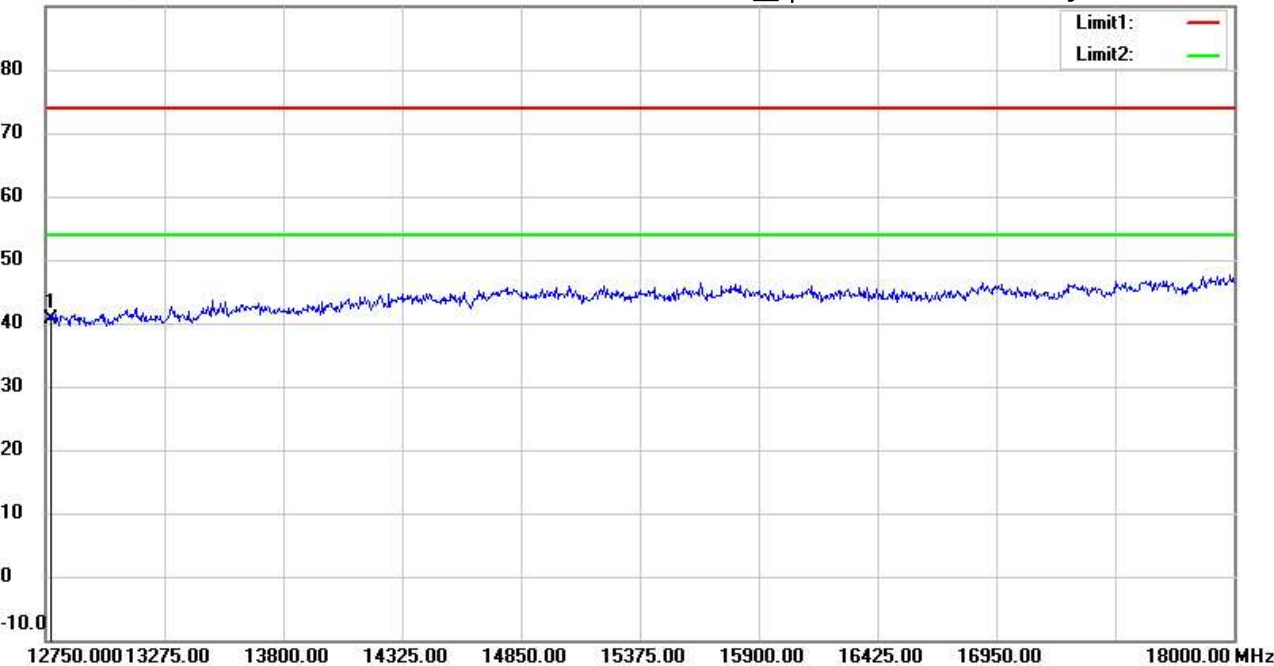
Site : 966A Chamber

Condition : FCC\_part 15E RE\_Above 1GHz\_PK

Test Mode : TX 802.11ax80 CH87

Polarization: **Horizontal**

| Mk. | Frequency (MHz) | Reading (dBuV) | Detector | Corr. factor (dB/m) | Result (dBuV/m) | Limit (dBuV/m) | Ant.Pos (cm) | Tab.Pos (deg.) | Margin (dB) | Comment |
|---|---|---|---|---|---|---|---|---|---|---|
| * | 12770.000 | 23.82 | peak | 16.91 | 40.73 | 74.00 | 150 | 280 | -33.27 | |

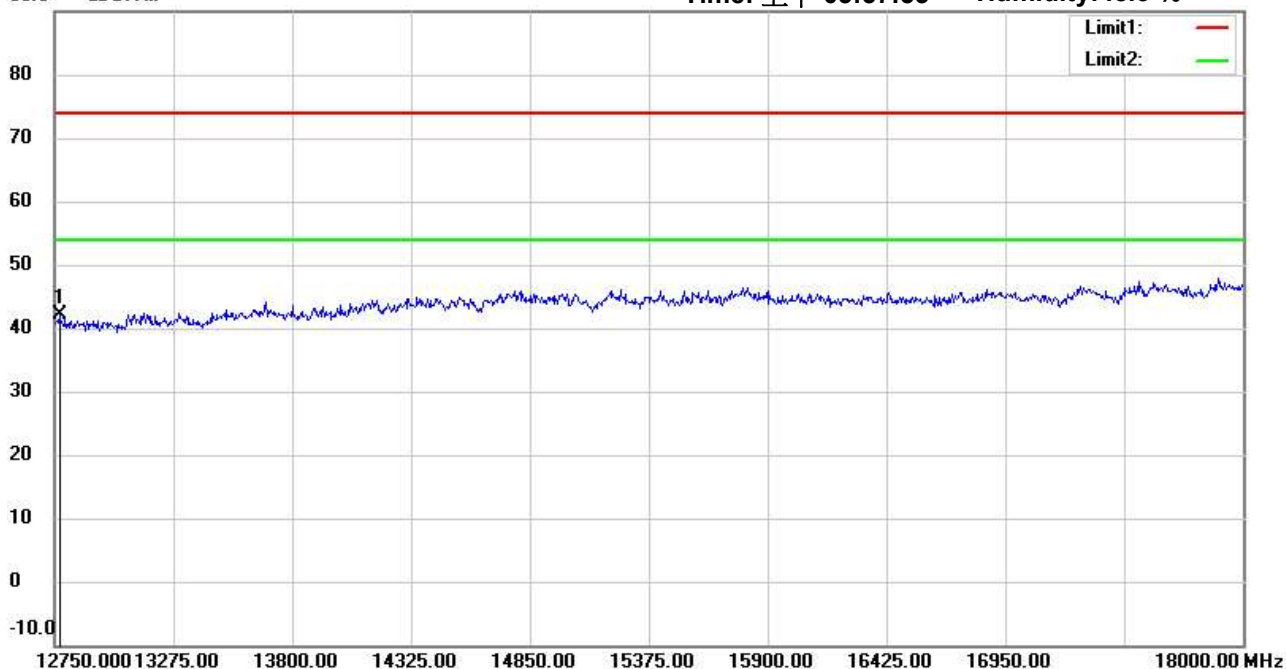
Site : 966A Chamber

Condition : FCC\_part 15E RE\_Above 1GHz\_PK

Test Mode : TX 802.11ax80 CH87

Polarization: Vertical

| Mk. | Frequency (MHz) | Reading (dBuV) | Detector | Corr. factor (dB/m) | Result (dBuV/m) | Limit (dBuV/m) | Ant.Pos (cm) | Tab.Pos (deg.) | Margin (dB) | Comment |
|---|---|---|---|---|---|---|---|---|---|---|
| * | 12770.000 | 25.16 | peak | 16.91 | 42.07 | 74.00 | 150 | 152 | -31.93 | |
