Radiated Emission Measurement

Condition : FCC\_part 15E RE\_Above 1GHz\_PK

EUT : W6M22409-23739

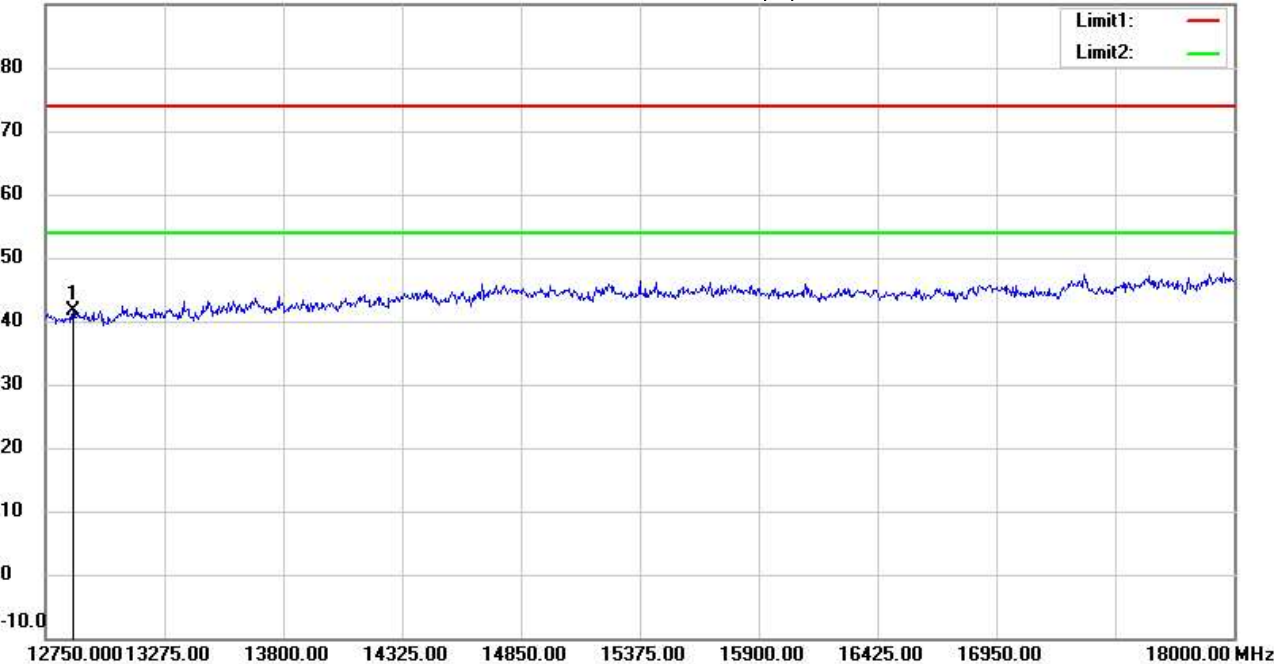
Site : 966A Chamber  
Condition : FCC\_part 15E RE\_Above 1GHz\_PK  
EUT : W6M22409-23739  
M/N:  
Test Mode : TX 802.11a CH97  
Note :

Polarization: *Horizontal*  
Power : 120 Va.c.  
Distance: 3m

| Mk. | Frequency (MHz) | Reading (dBuV) | Detector | Corr. factor (dB/m) | Result (dBuV/m) | Limit (dBuV/m) | Ant.Pos (cm) | Tab.Pos (deg.) | Margin (dB) | Comment |
|---|---|---|---|---|---|---|---|---|---|---|
| * | 12870.000 | 24.22 | peak | 17.37 | 41.59 | 74.00 | 150 | 111 | -32.41 | |

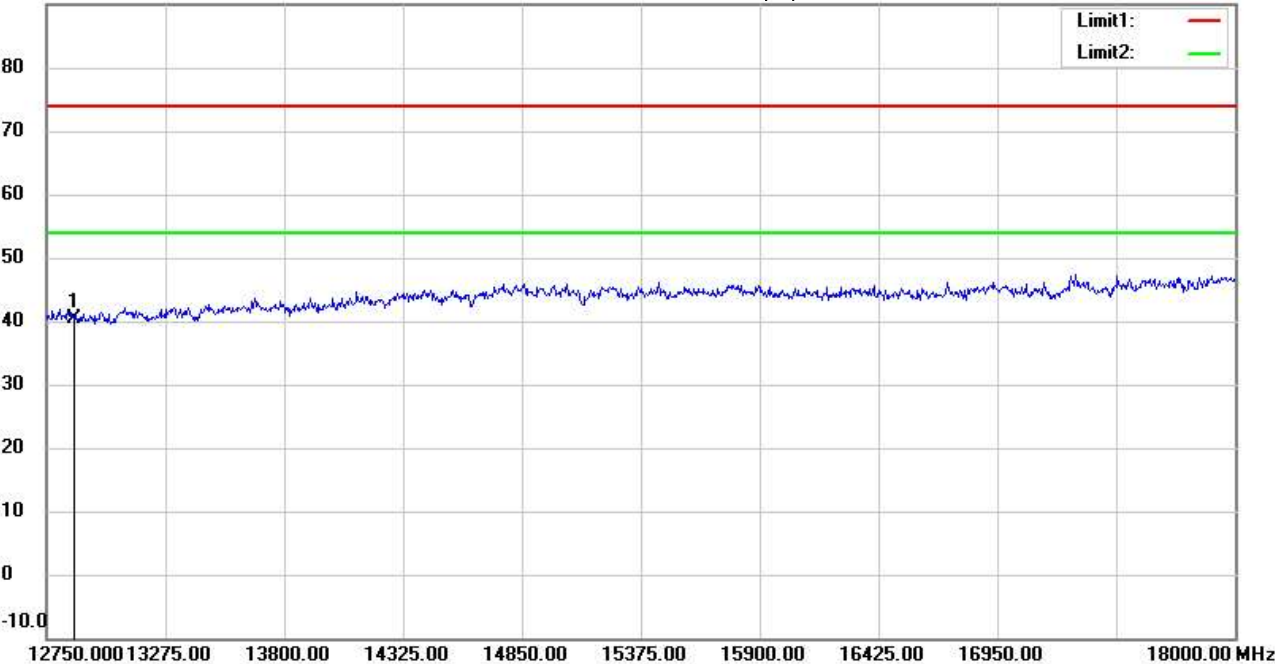
Site : 966A Chamber  
Condition : FCC\_part 15E RE\_Above 1GHz\_PK  
EUT : W6M22409-23739  
M/N:  
Test Mode : TX 802.11a CH97  
Note :

Polarization: Vertical  
Power : 120 Va.c.  
Distance: 3m

| Mk. | Frequency (MHz) | Reading (dBuV) | Detector | Corr. factor (dB/m) | Result (dBuV/m) | Limit (dBuV/m) | Ant.Pos (cm) | Tab.Pos (deg.) | Margin (dB) | Comment |
|---|---|---|---|---|---|---|---|---|---|---|
| * | 12870.000 | 22.91 | peak | 17.37 | 40.28 | 74.00 | 150 | 238 | -33.72 | |

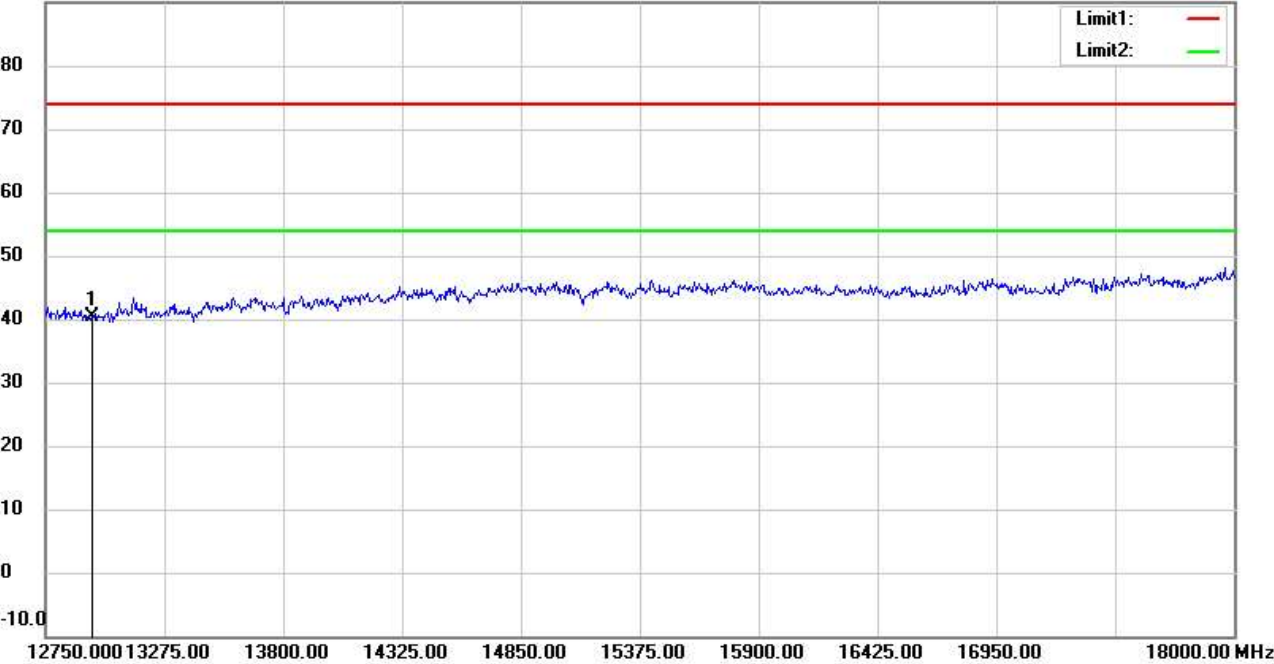
Test Mode : TX 802.11a CH105

Polarization: *Horizontal*

| Mk. | Frequency (MHz) | Reading (dBuV) | Detector | Corr. factor (dB/m) | Result (dBuV/m) | Limit (dBuV/m) | Ant.Pos (cm) | Tab.Pos (deg.) | Margin (dB) | Comment |
|---|---|---|---|---|---|---|---|---|---|---|
| * | 12950.000 | 23.02 | peak | 17.30 | 40.32 | 74.00 | 150 | 355 | -33.68 | |
