Radiated Emission Measurement

Condition : FCC\_part 15E RE\_Above 1GHz\_PK

EUT : W6M22409-23739

Test Mode : TX 802.11a CH105

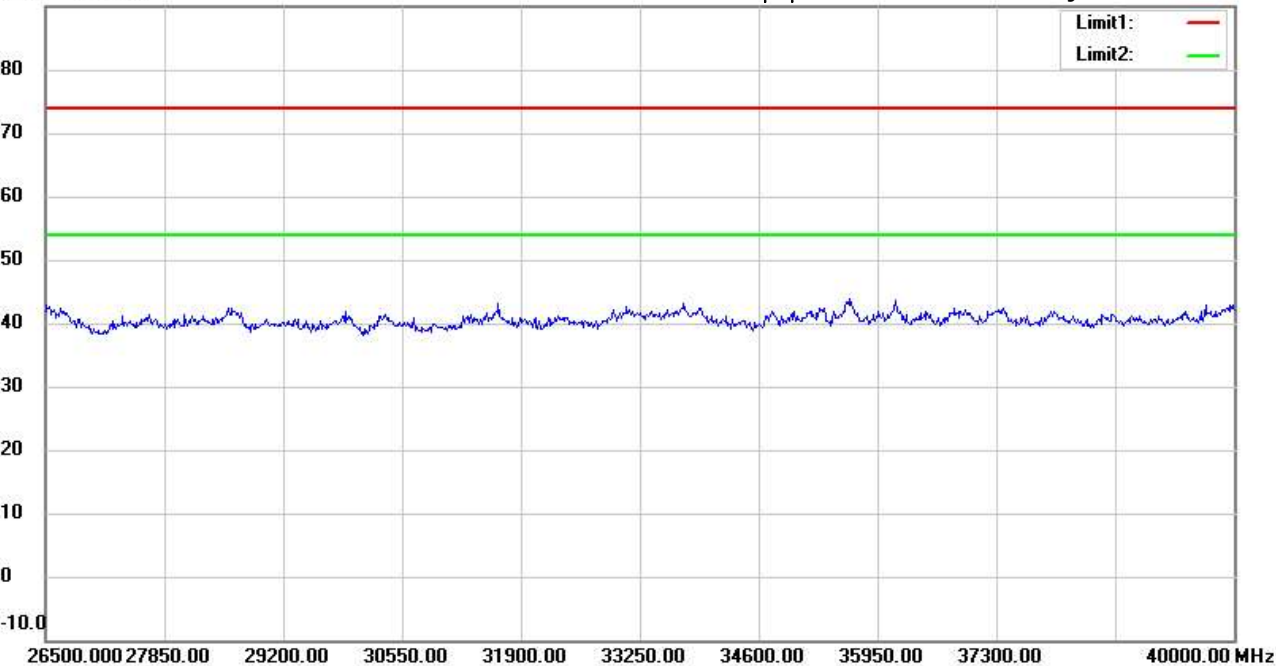
Data :#6

Polarization: *Horizontal*

Distance: 3m

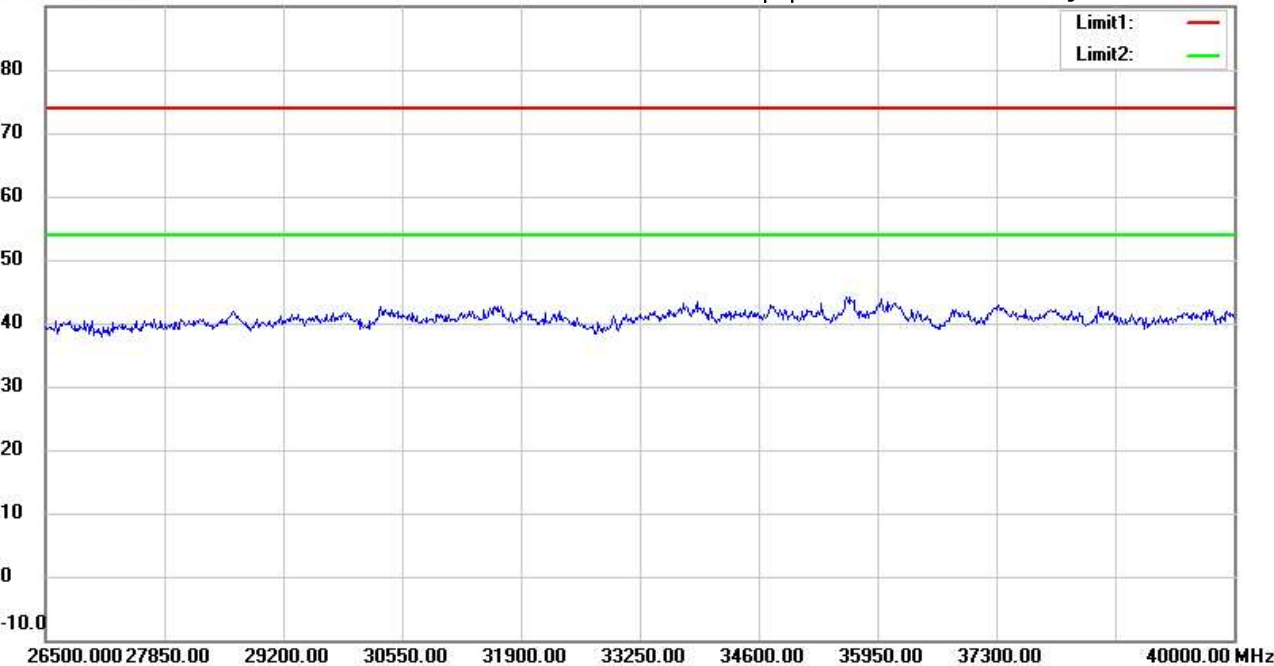
Data :#12

Condition : FCC\_part 15E RE\_Above 1GHz\_PK

Test Mode : TX 802.11a CH105

Polarization: Vertical

Distance: 3m

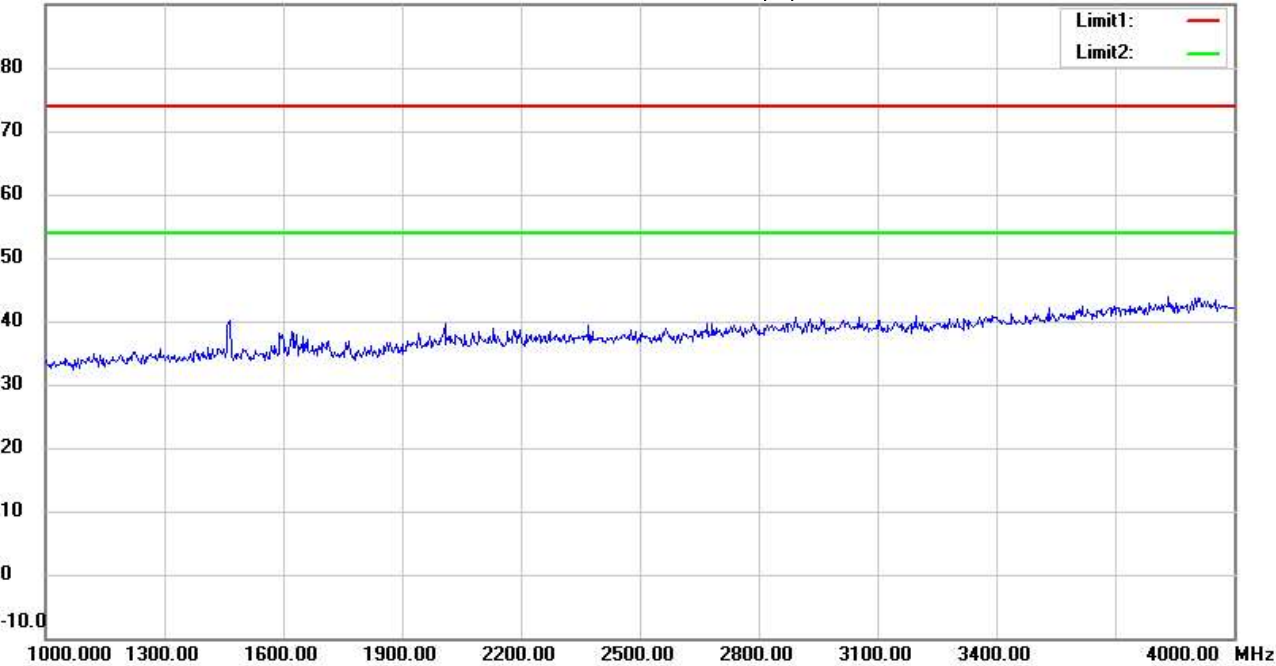
Data :#1

Condition : FCC\_part 15E RE\_Above 1GHz\_PK

Test Mode : TX 802.11a CH113

Polarization: *Horizontal*

Distance: 3m

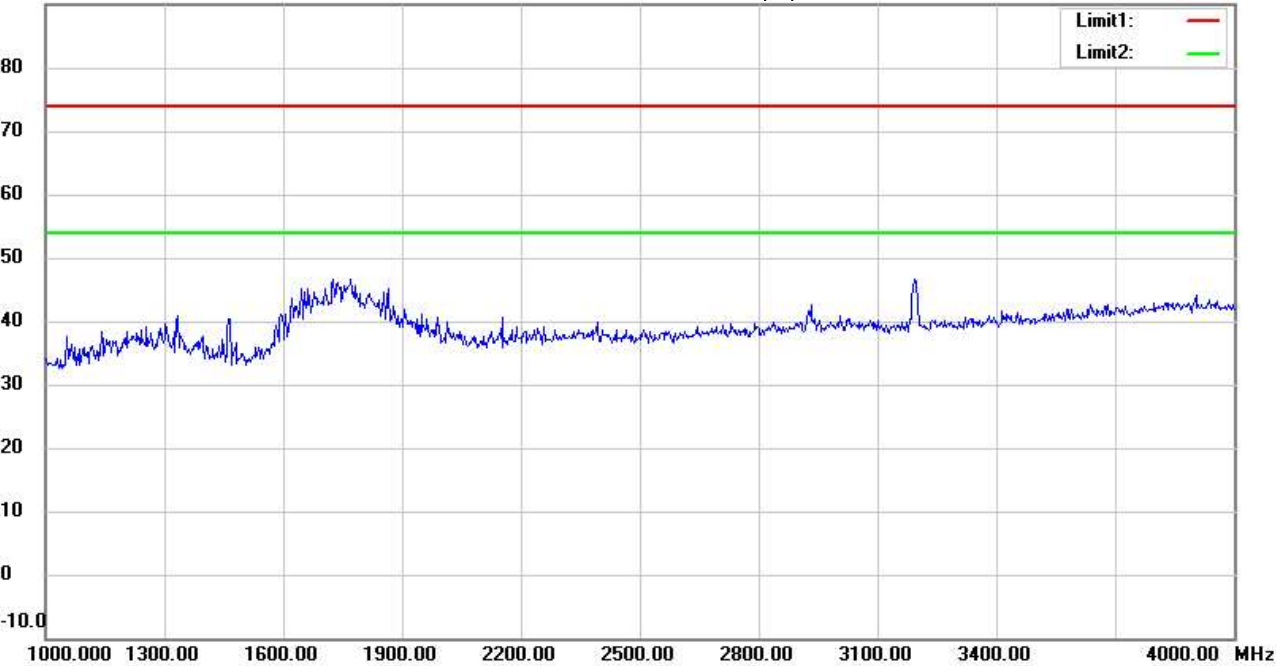
Data :#7

Site : 966A Chamber  
Condition : FCC\_part 15E RE\_Above 1GHz\_PK  
EUT : W6M22409-23739  
M/N:  
Test Mode : TX 802.11a CH113  
Note :

Polarization: Vertical  
Power : 120 Va.c.  
Distance: 3m

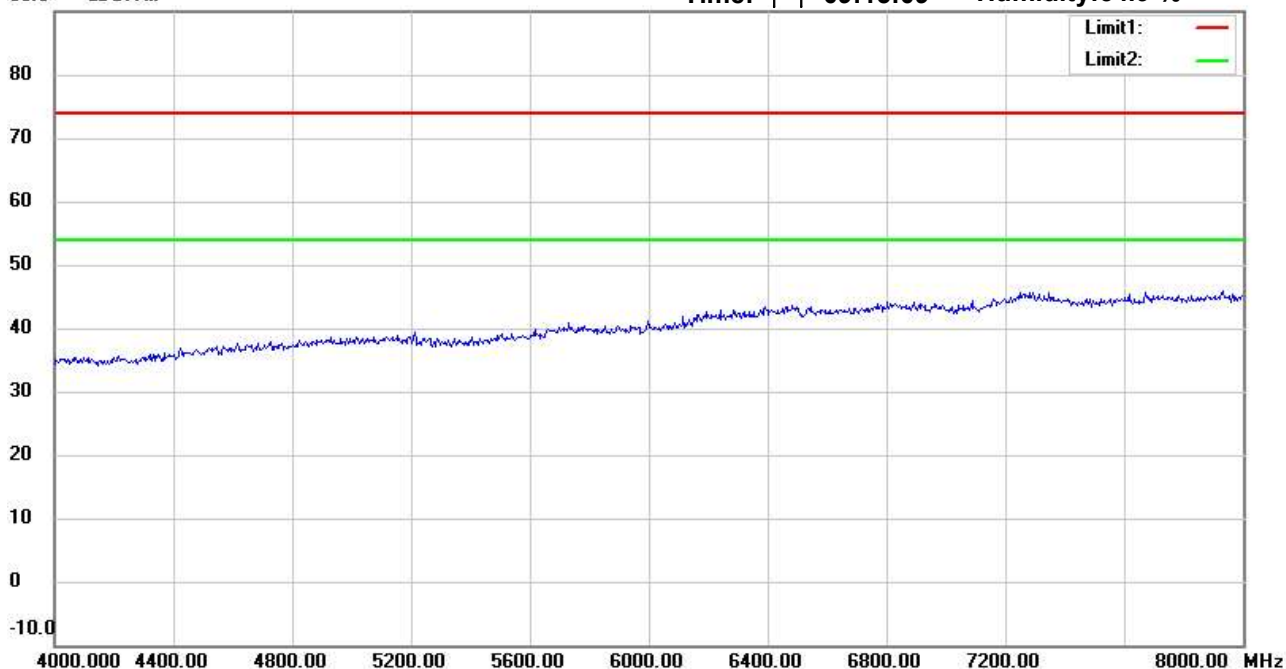
Data : #2

Condition : FCC\_part 15E RE\_Above 1GHz\_PK

Test Mode : TX 802.11a CH113

Polarization: **Horizontal**

Distance: 3m

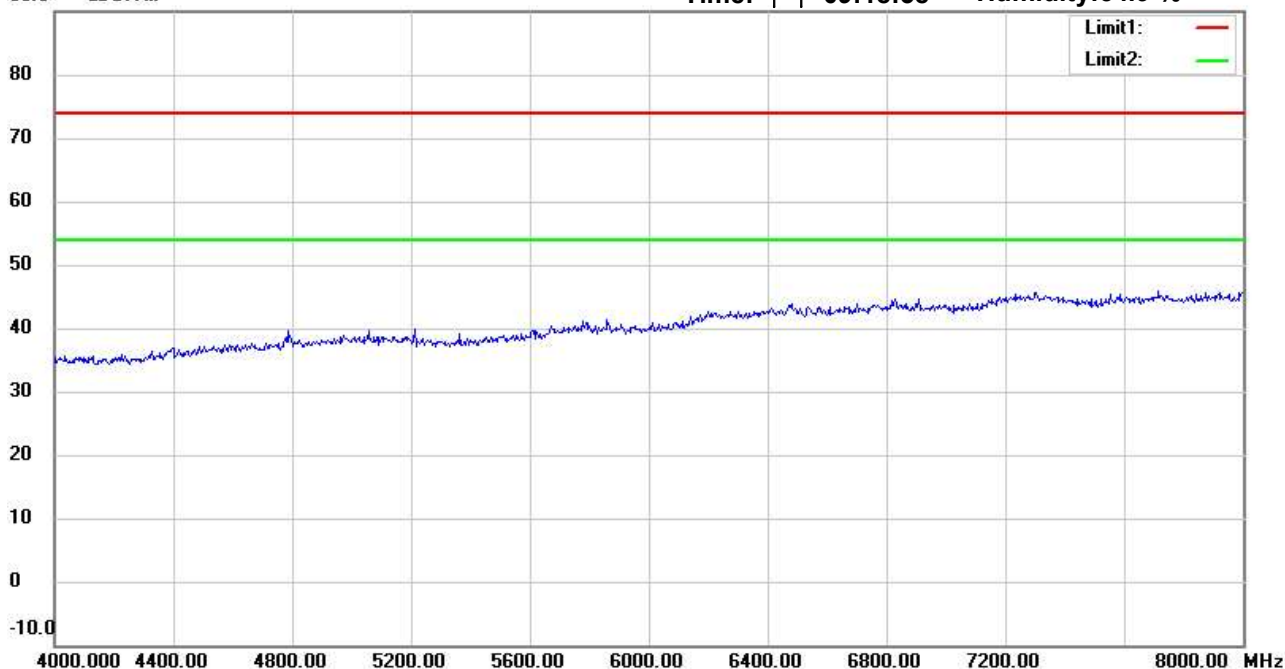
Data : #8

Condition : FCC\_part 15E RE\_Above 1GHz\_PK

Test Mode : TX 802.11a CH113

Polarization: **Vertical**

Distance: 3m

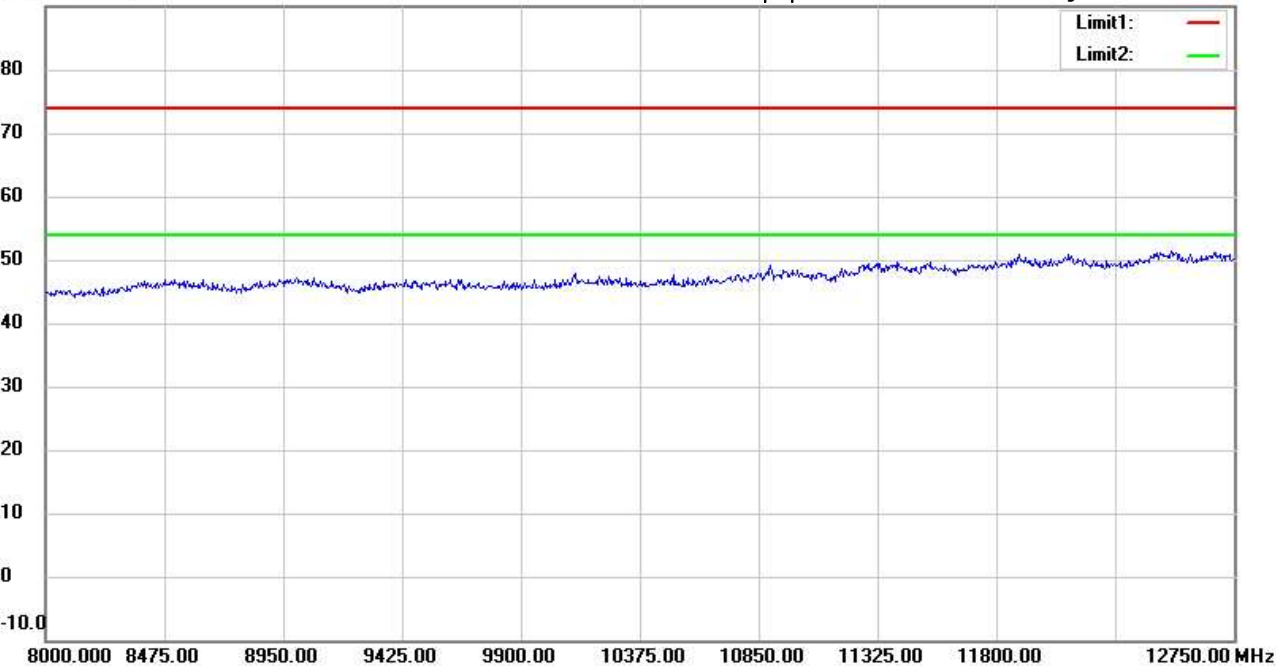
Data :#3

Condition : FCC\_part 15E RE\_Above 1GHz\_PK

Test Mode : TX 802.11a CH113

Polarization: *Horizontal*

Distance: 3m

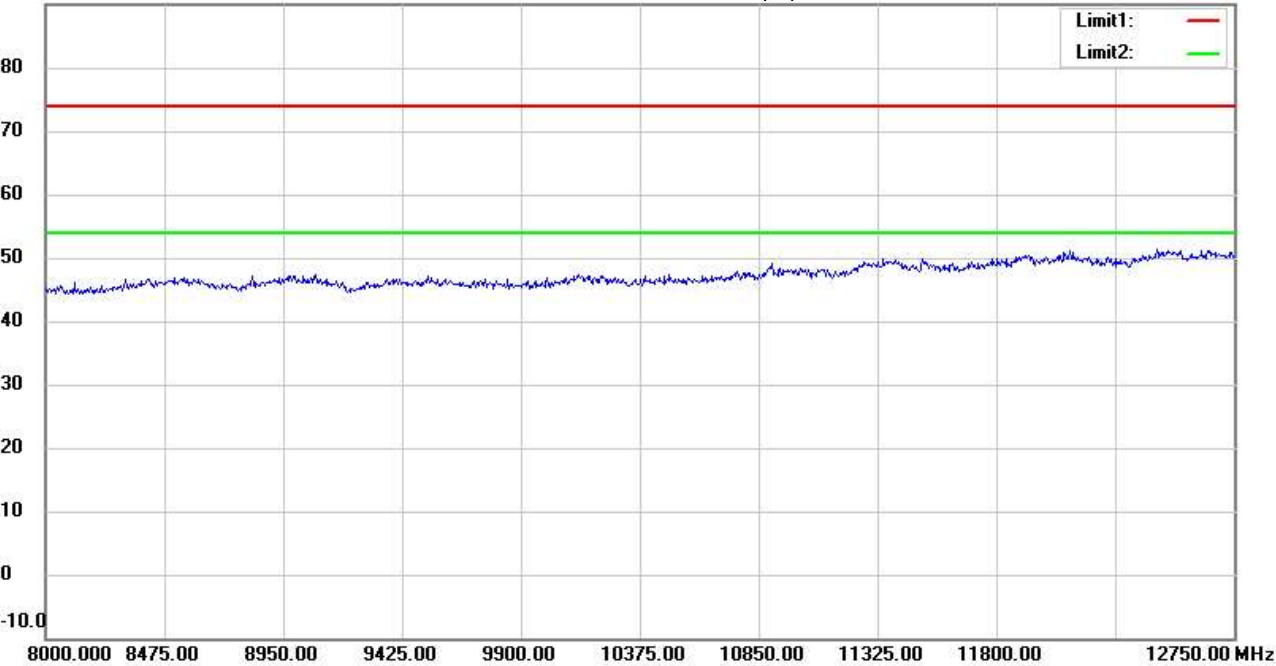
Data :#9

Condition : FCC\_part 15E RE\_Above 1GHz\_PK

Test Mode : TX 802.11a CH113

Polarization: Vertical

Distance: 3m

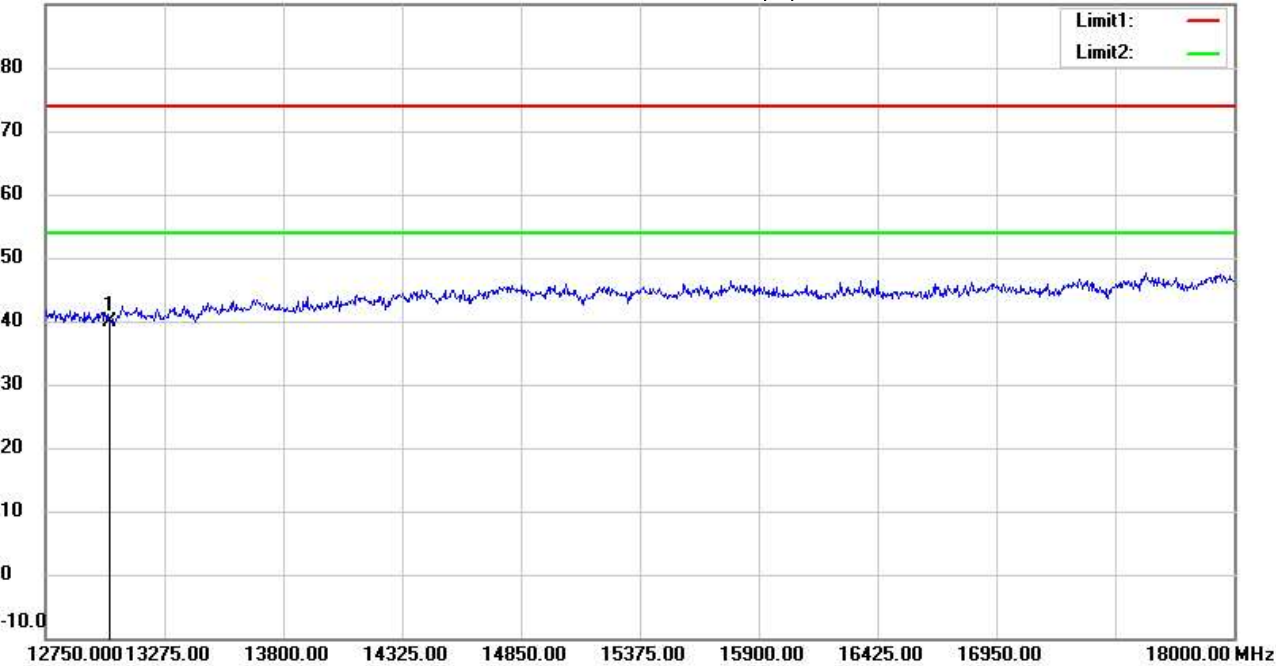
Site : 966A Chamber  
Condition : FCC\_part 15E RE\_Above 1GHz\_PK  
EUT : W6M22409-23739  
M/N:  
Test Mode : TX 802.11a CH113  
Note :

Polarization: **Horizontal**  
Power : 120 Va.c.  
Distance: 3m

| Mk. | Frequency (MHz) | Reading (dBuV) | Detector | Corr. factor (dB/m) | Result (dBuV/m) | Limit (dBuV/m) | Ant.Pos (cm) | Tab.Pos (deg.) | Margin (dB) | Comment |
|---|---|---|---|---|---|---|---|---|---|---|
| * | 13030.000 | 22.83 | peak | 17.10 | 39.93 | 74.00 | 150 | 359 | -34.07 | |

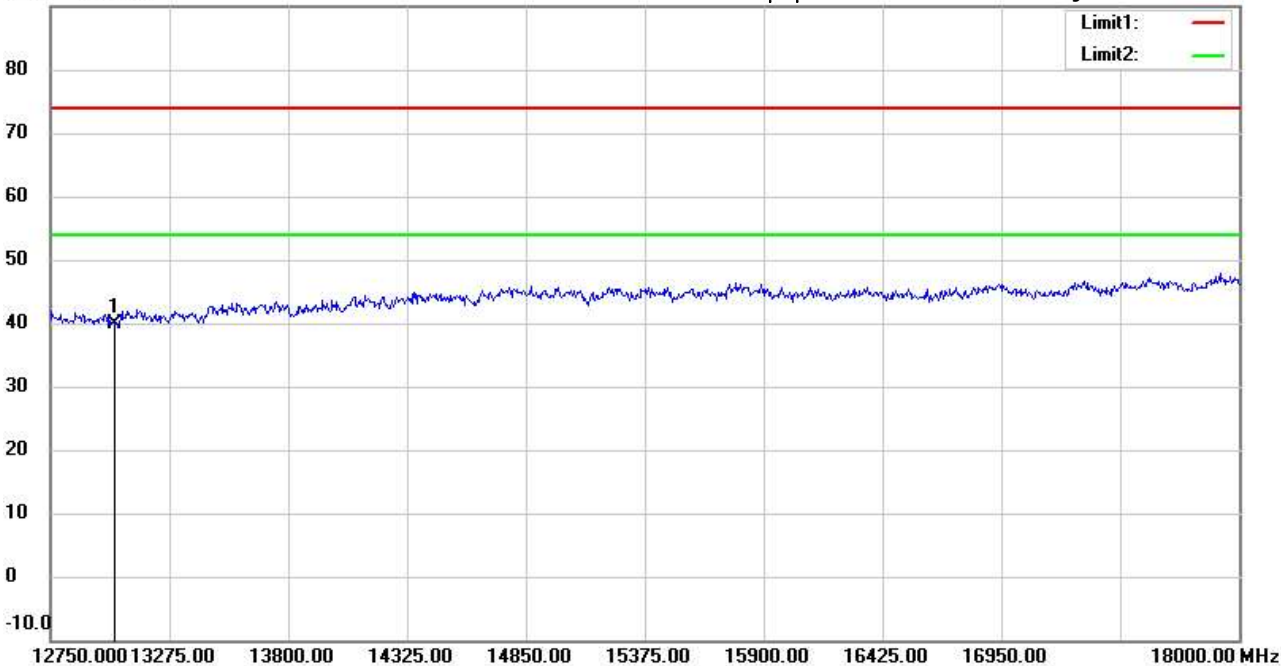
Test Mode : TX 802.11a CH113

Polarization: Vertical

| Mk. | Frequency (MHz) | Reading (dBuV) | Detector | Corr. factor (dB/m) | Result (dBuV/m) | Limit (dBuV/m) | Ant.Pos (cm) | Tab.Pos (deg.) | Margin (dB) | Comment |
|---|---|---|---|---|---|---|---|---|---|---|
| * | 13030.000 | 22.83 | peak | 17.10 | 39.93 | 74.00 | 150 | 317 | -34.07 | |

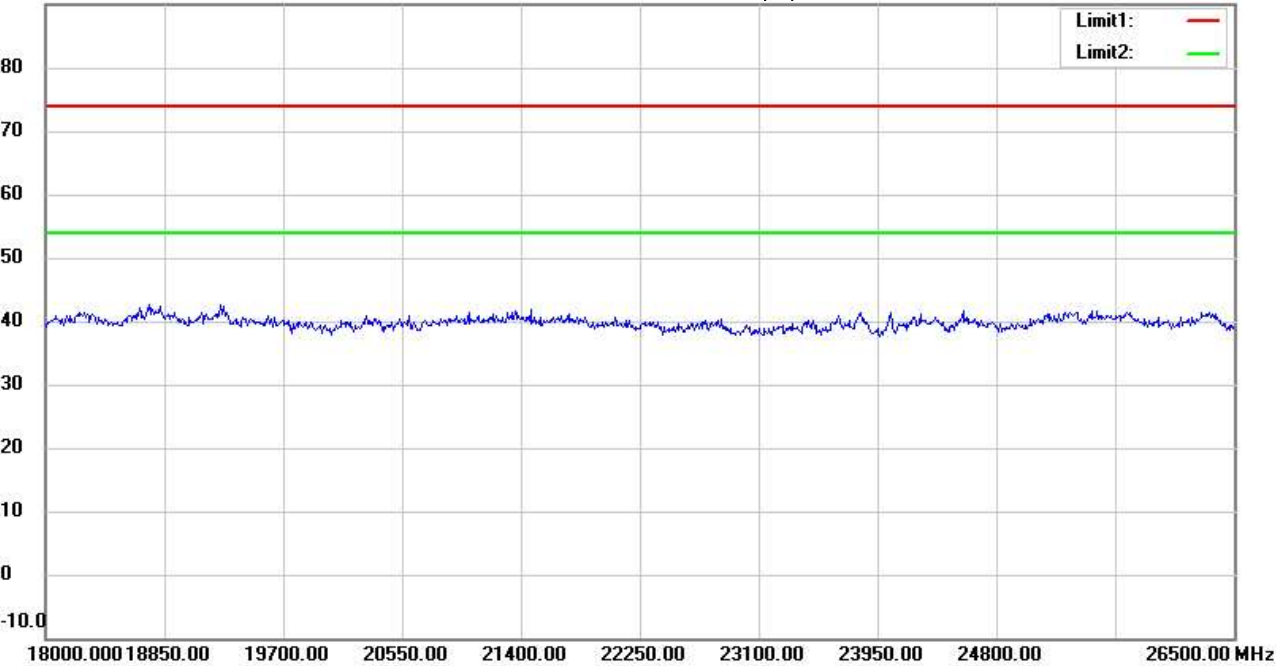
Site : 966A Chamber  
Condition : FCC\_part 15E RE\_Above 1GHz\_PK  
EUT : W6M22409-23739  
M/N:  
Test Mode : TX 802.11a CH113  
Note :

Polarization: *Horizontal*  
Power : 120 Va.c.  
Distance: 3m

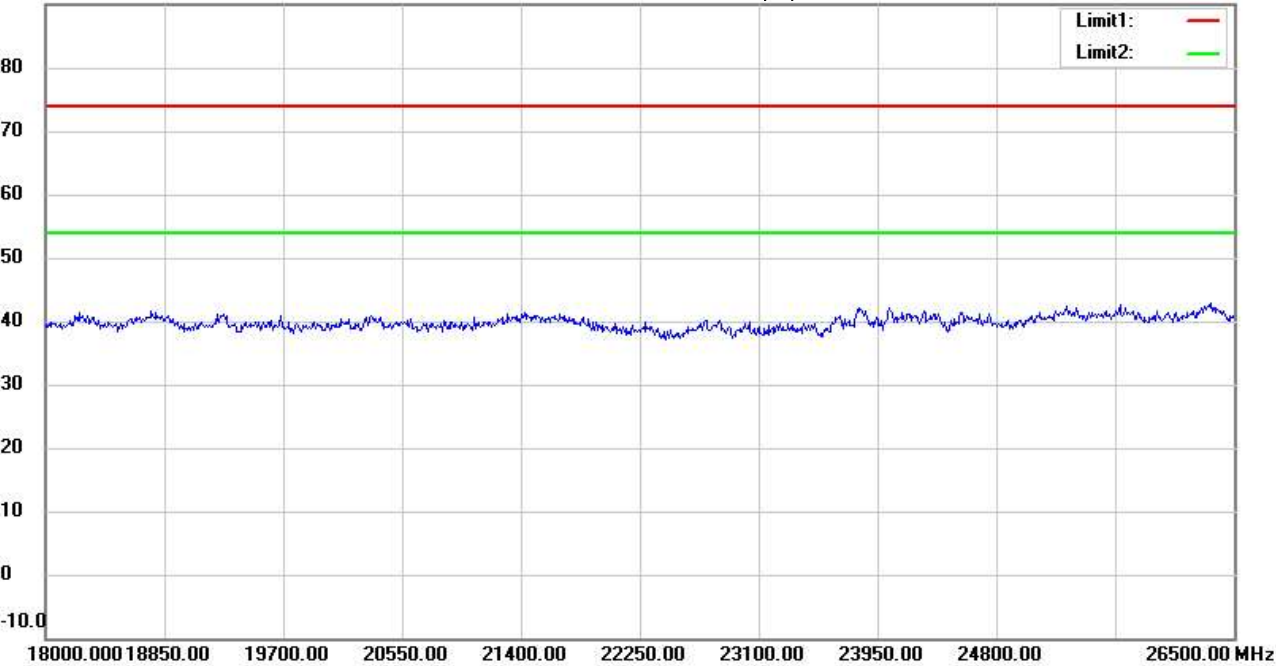
Site : 966A Chamber  
Condition : FCC\_part 15E RE\_Above 1GHz\_PK  
EUT : W6M22409-23739  
M/N:  
Test Mode : TX 802.11a CH113  
Note :

Polarization: Vertical  
Power : 120 Va.c.  
Distance: 3m

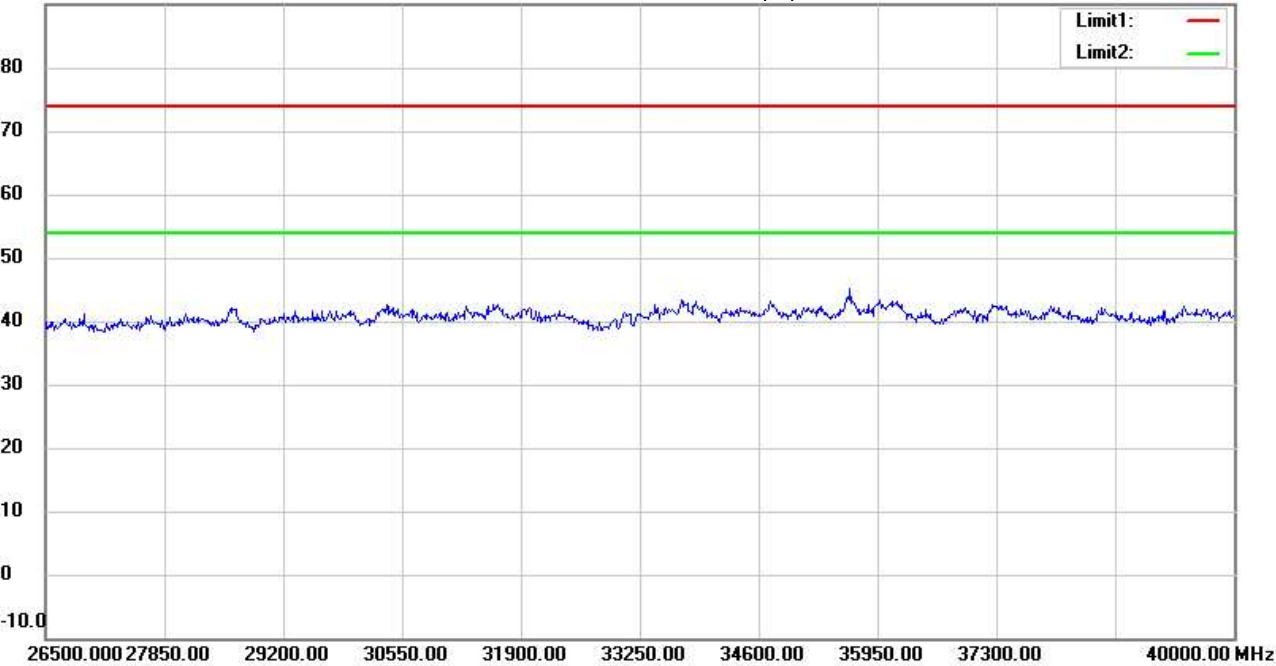
Site : 966A Chamber  
Condition : FCC\_part 15E RE\_Above 1GHz\_PK  
EUT : W6M22409-23739  
M/N:  
Test Mode : TX 802.11a CH113  
Note :

Polarization: Vertical  
Power : 120 Va.c.  
Distance: 3m

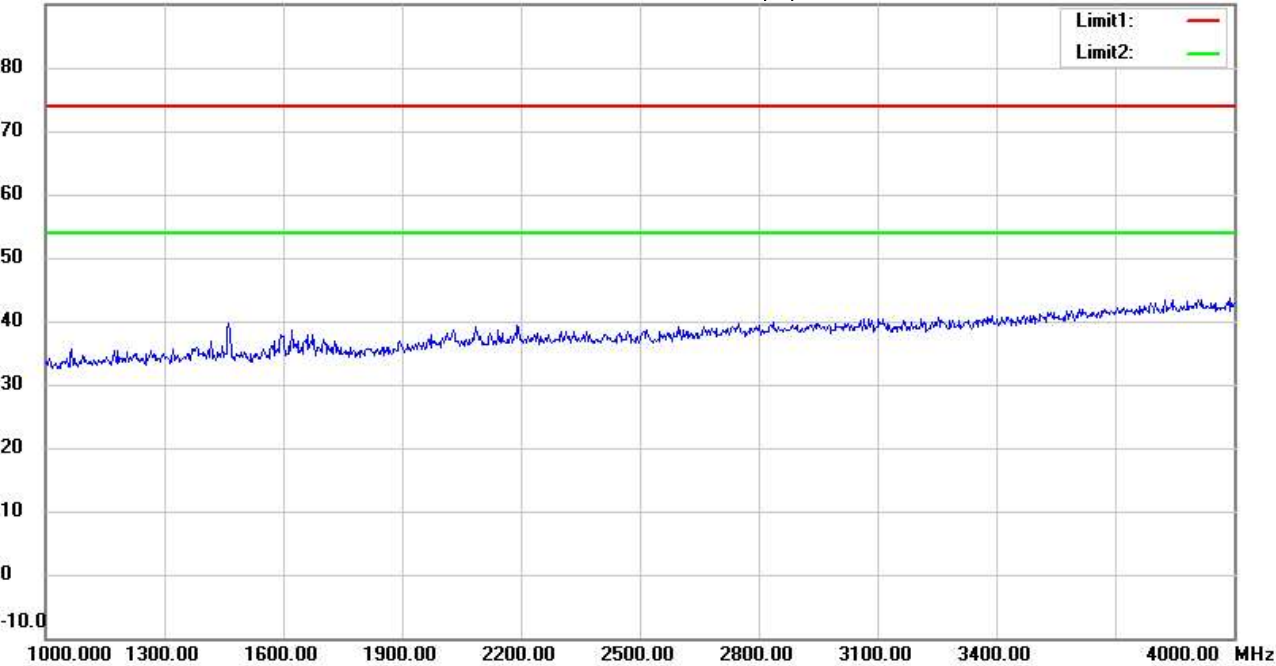
Site : 966A Chamber  
Condition : FCC\_part 15E RE\_Above 1GHz\_PK  
EUT : W6M22409-23739  
M/N:  
Test Mode : TX 802.11a CH97  
Note :

Polarization: Horizontal  
Power : 120 Va.c.  
Distance: 3m

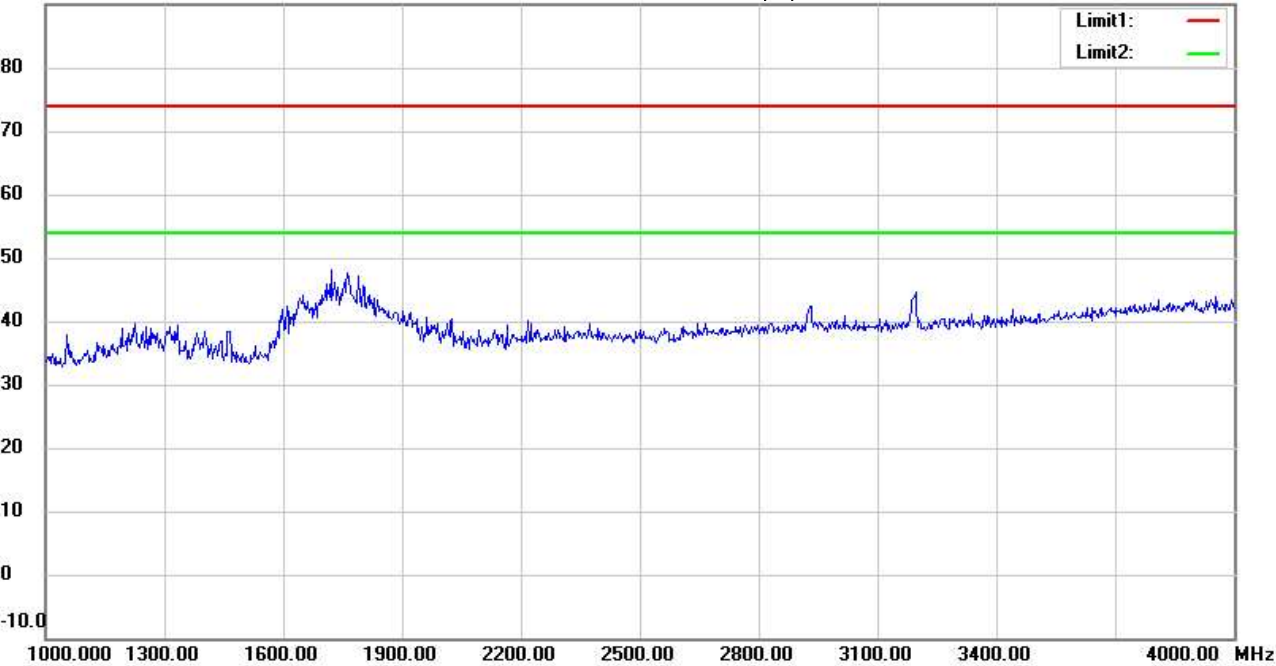
Site : 966A Chamber  
Condition : FCC\_part 15E RE\_Above 1GHz\_PK  
EUT : W6M22409-23739  
M/N:  
Test Mode : TX 802.11a CH97  
Note :

Polarization: Vertical  
Power : 120 Va.c.  
Distance: 3m

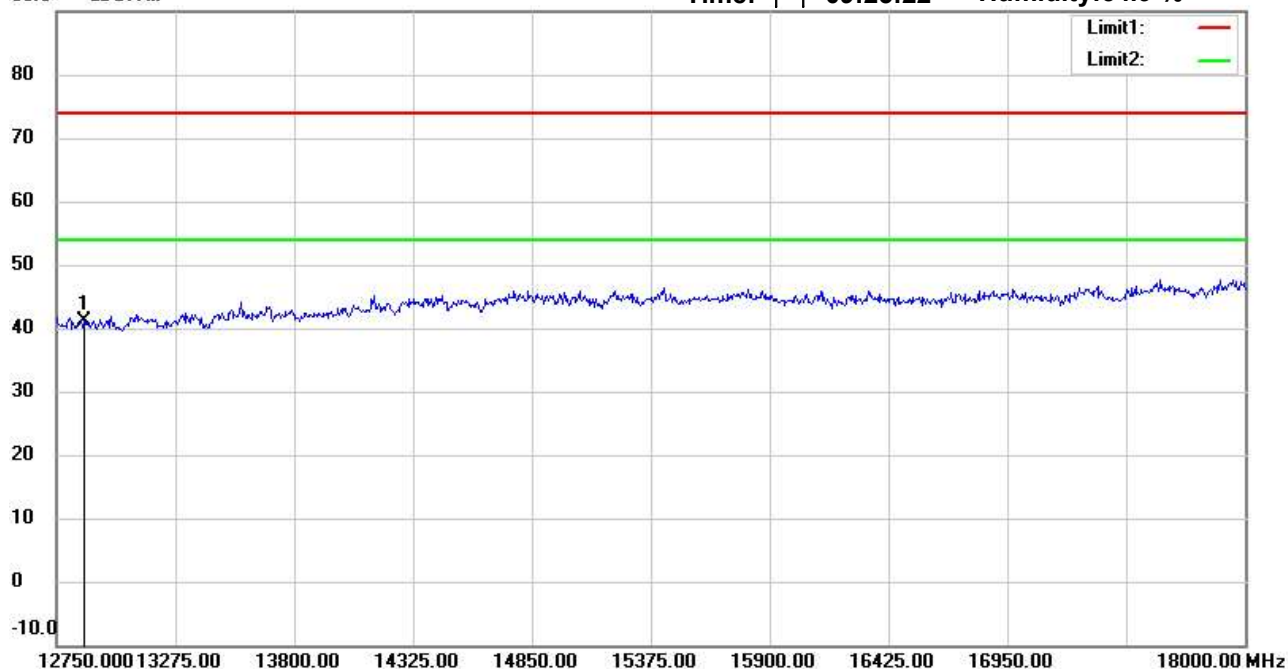
Test Mode : TX 802.11a CH97

Polarization: **Horizontal**

| Mk. | Frequency (MHz) | Reading (dBuV) | Detector | Corr. factor (dB/m) | Result (dBuV/m) | Limit (dBuV/m) | Ant.Pos (cm) | Tab.Pos (deg.) | Margin (dB) | Comment |
|---|---|---|---|---|---|---|---|---|---|---|
| * | 12870.000 | 23.78 | peak | 17.37 | 41.15 | 74.00 | 150 | 0 | -32.85 | |

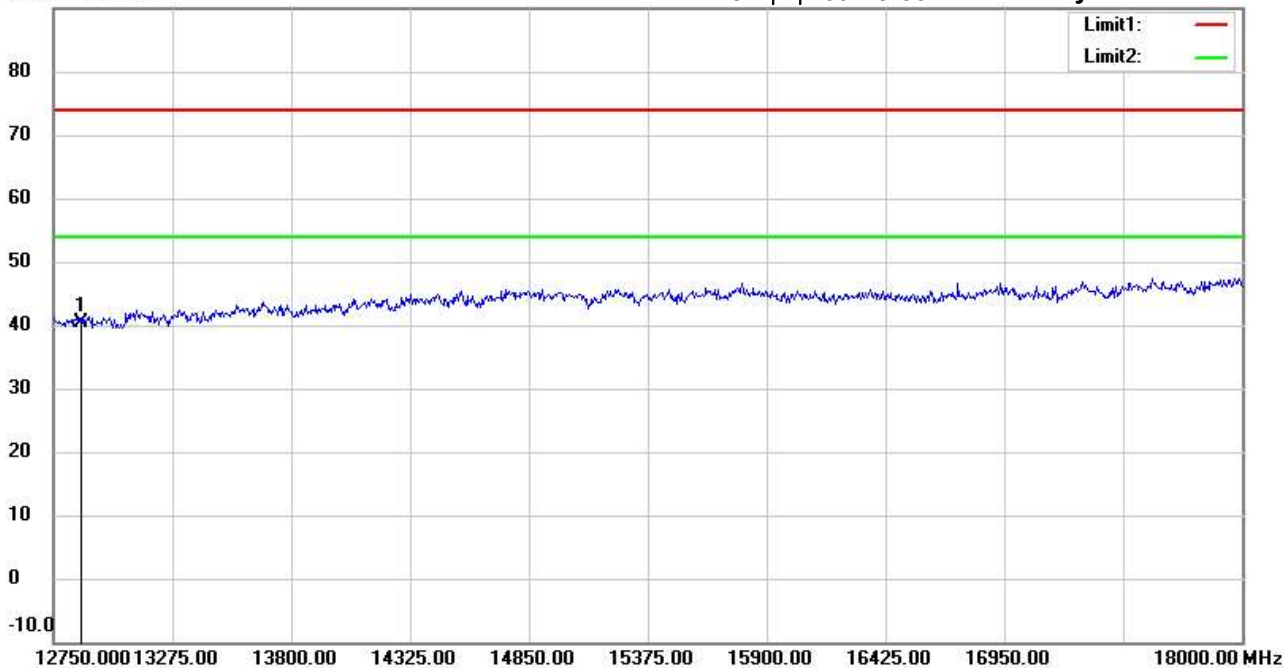
Test Mode : TX 802.11a CH97

Polarization: **Vertical**

| Mk. | Frequency (MHz) | Reading (dBuV) | Detector | Corr. factor (dB/m) | Result (dBuV/m) | Limit (dBuV/m) | Ant.Pos (cm) | Tab.Pos (deg.) | Margin (dB) | Comment |
|---|---|---|---|---|---|---|---|---|---|---|
| * | 12870.000 | 23.05 | peak | 17.37 | 40.42 | 74.00 | 150 | 357 | -33.58 | |

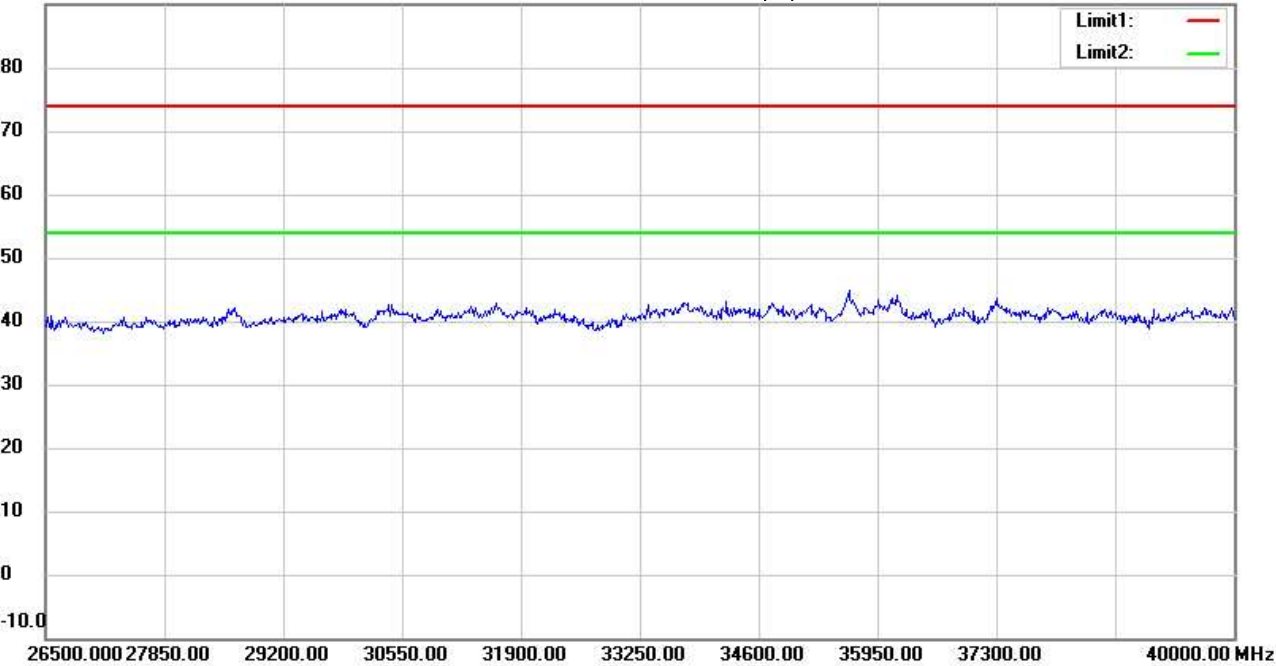
Site : 966A Chamber  
Condition : FCC\_part 15E RE\_Above 1GHz\_PK  
EUT : W6M22409-23739  
M/N:  
Test Mode : TX 802.11a CH97  
Note :

Polarization: Vertical  
Power : 120 Va.c.  
Distance: 3m

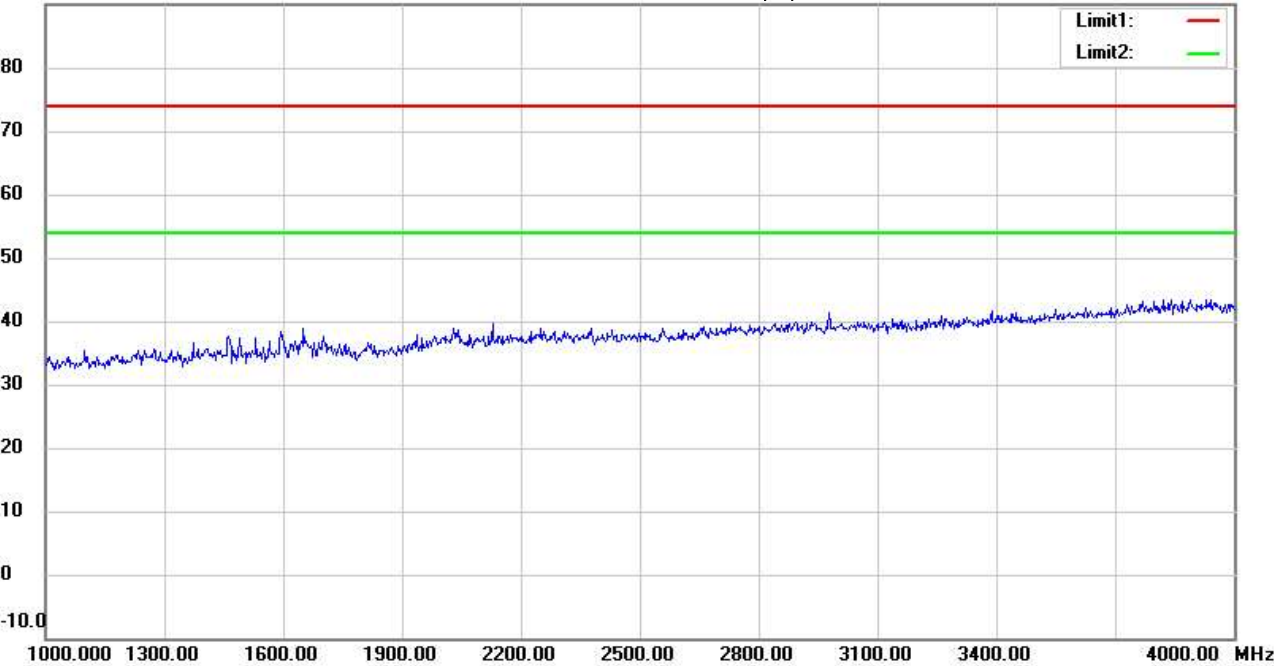
Site : 966A Chamber  
Condition : FCC\_part 15E RE\_Above 1GHz\_PK  
EUT : W6M22409-23739  
M/N:  
Test Mode : TX 802.11a CH105  
Note :

Polarization: Horizontal  
Power : 120 Va.c.  
Distance: 3m
