Radiated Emission Measurement

Site : 966A Chamber  
Condition : FCC\_part 15E RE\_Above 1GHz\_PK  
EUT : W6M22409-23739  
M/N:  
Test Mode : TX 802.11a CH105  
Note :

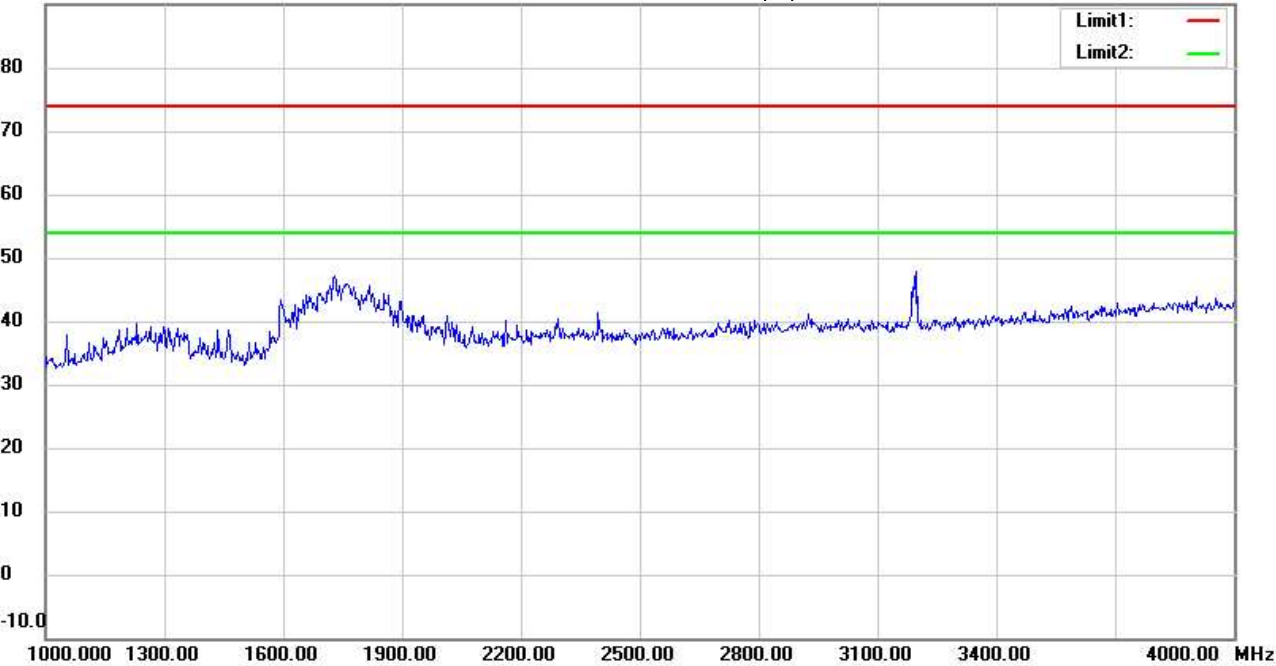
Data :#7

Polarization: Vertical  
Power : 120 Va.c.  
Distance: 3m

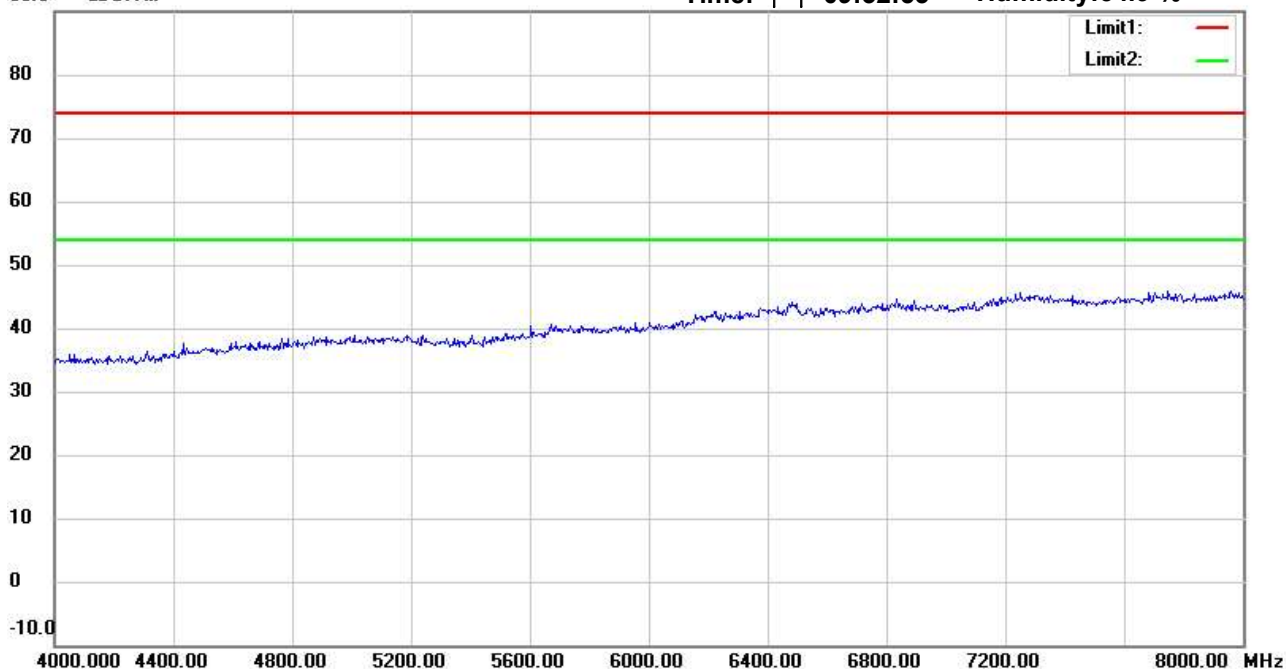
Data : #2

Test Mode : TX 802.11a CH105

Polarization: **Horizontal**

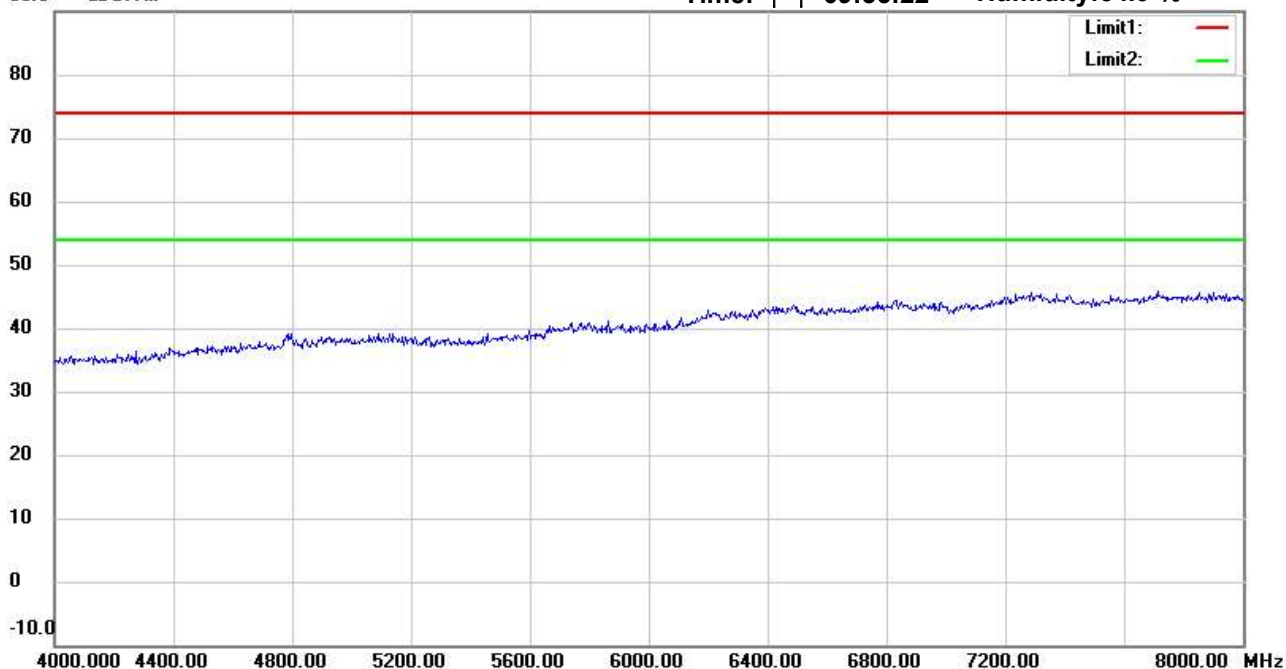
Data : #8

Test Mode : TX 802.11a CH105

Polarization: **Vertical**

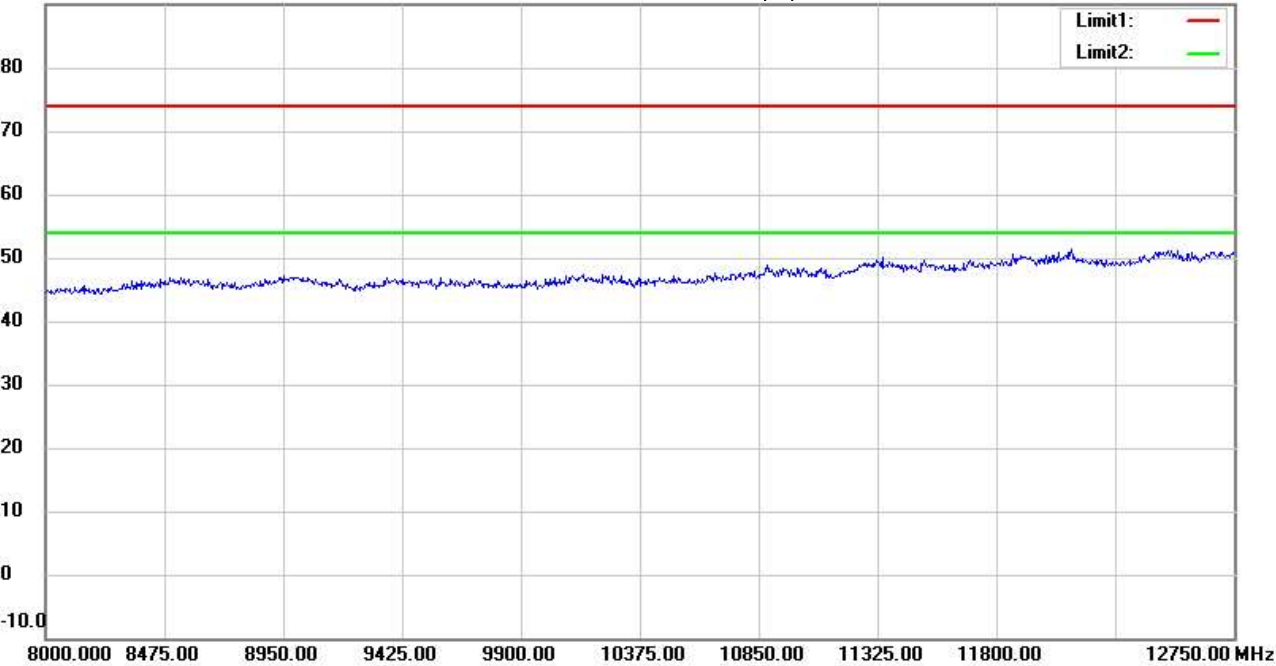
Data :#3

Test Mode : TX 802.11a CH105

Polarization: *Horizontal*

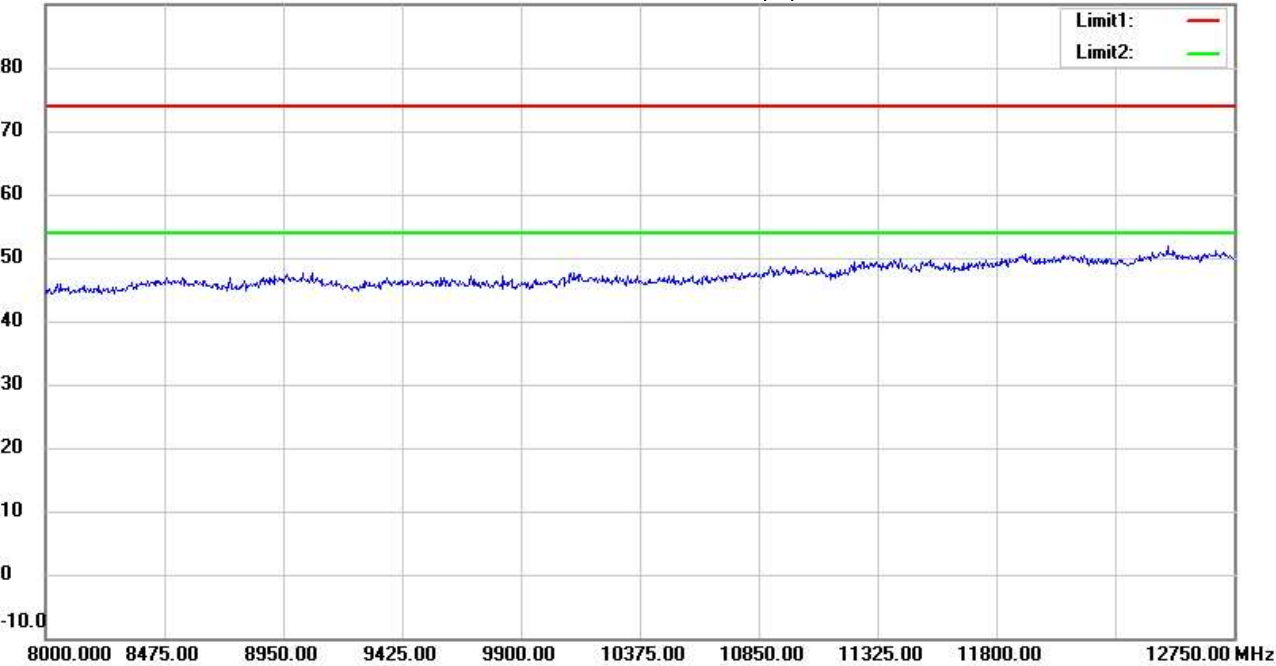
Data :#9

Site : 966A Chamber  
Condition : FCC\_part 15E RE\_Above 1GHz\_PK  
EUT : W6M22409-23739  
M/N:  
Test Mode : TX 802.11a CH105  
Note :

Polarization: Vertical  
Power : 120 V.a.c.  
Distance: 3m

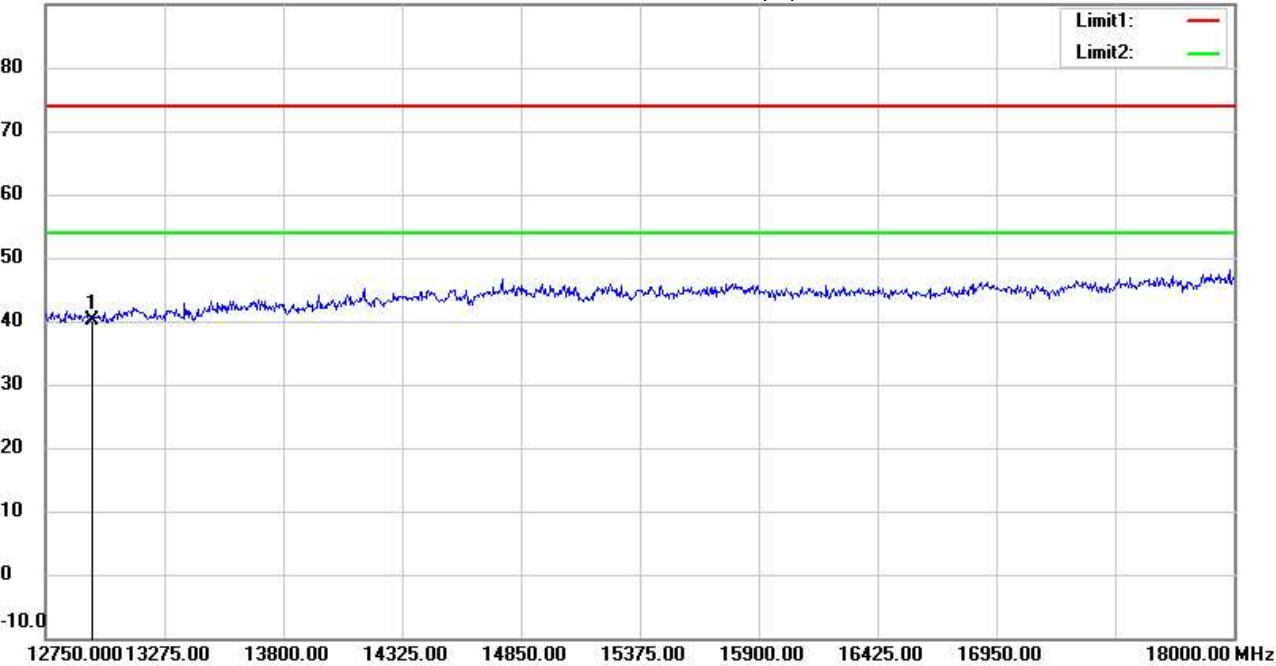
Data :#4

Site : 966A Chamber

Condition : FCC\_part 15E RE\_Above 1GHz\_PK

Test Mode : TX 802.11a CH105

Polarization: *Horizontal*

| Mk. | Frequency (MHz) | Reading (dBuV) | Detector | Corr. factor (dB/m) | Result (dBuV/m) | Limit (dBuV/m) | Ant.Pos (cm) | Tab.Pos (deg.) | Margin (dB) | Comment |
|---|---|---|---|---|---|---|---|---|---|---|
| * | 12950.000 | 22.92 | peak | 17.30 | 40.22 | 74.00 | 150 | 65 | -33.78 | |

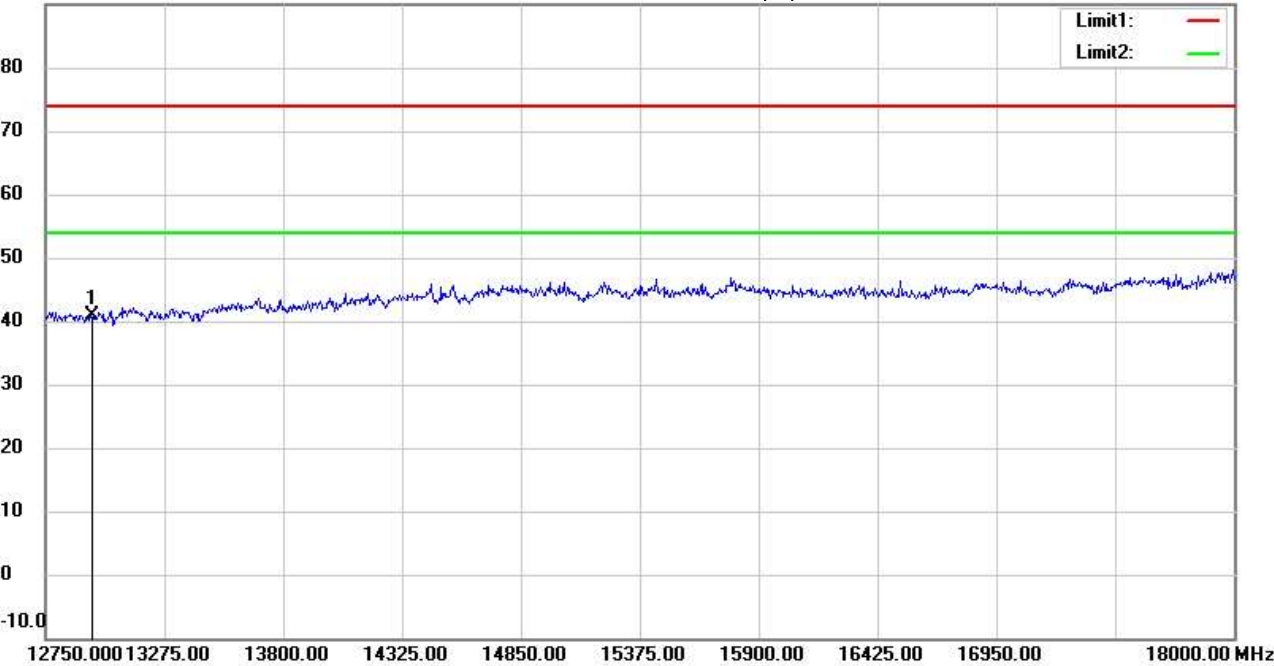
Data :#10

Site : 966A Chamber  
Condition : FCC\_part 15E RE\_Above 1GHz\_PK  
EUT : W6M22409-23739  
M/N:  
Test Mode : TX 802.11a CH105  
Note :

Polarization: Vertical  
Power : 120 Va.c.  
Distance: 3m

| Mk. | Frequency (MHz) | Reading (dBuV) | Detector | Corr. factor (dB/m) | Result (dBuV/m) | Limit (dBuV/m) | Ant.Pos (cm) | Tab.Pos (deg.) | Margin (dB) | Comment |
|---|---|---|---|---|---|---|---|---|---|---|
| * | 12950.000 | 23.51 | peak | 17.30 | 40.81 | 74.00 | 150 | 110 | -33.19 | |

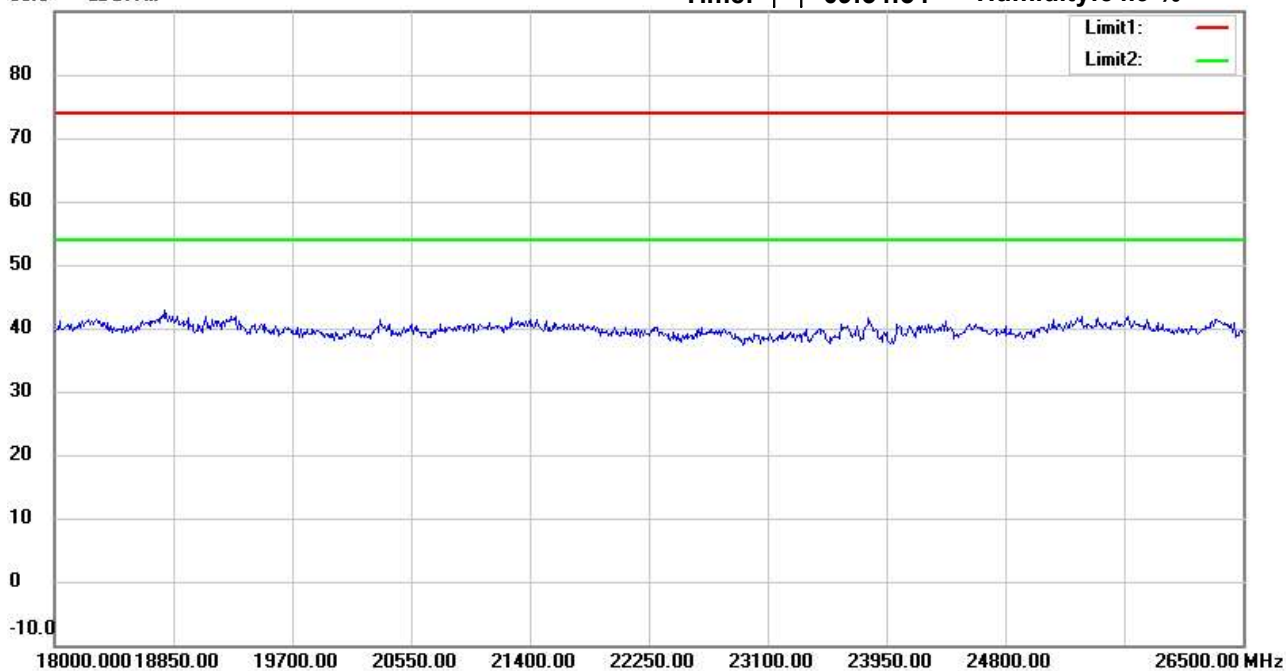
Data : #5

Test Mode : TX 802.11a CH105

Polarization: **Horizontal**

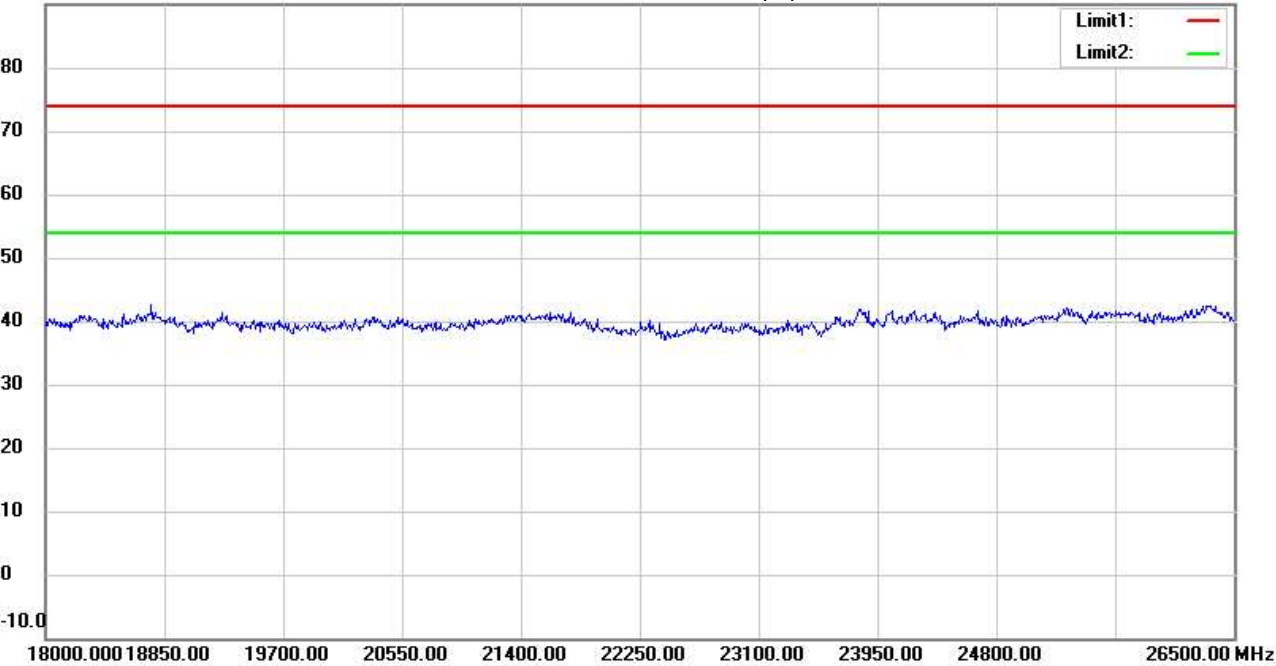
Data :#11

Site : 966A Chamber  
Condition : FCC\_part 15E RE\_Above 1GHz\_PK  
EUT : W6M22409-23739  
M/N:  
Test Mode : TX 802.11a CH105  
Note :

Polarization: Vertical  
Power : 120 Va.c.  
Distance: 3m

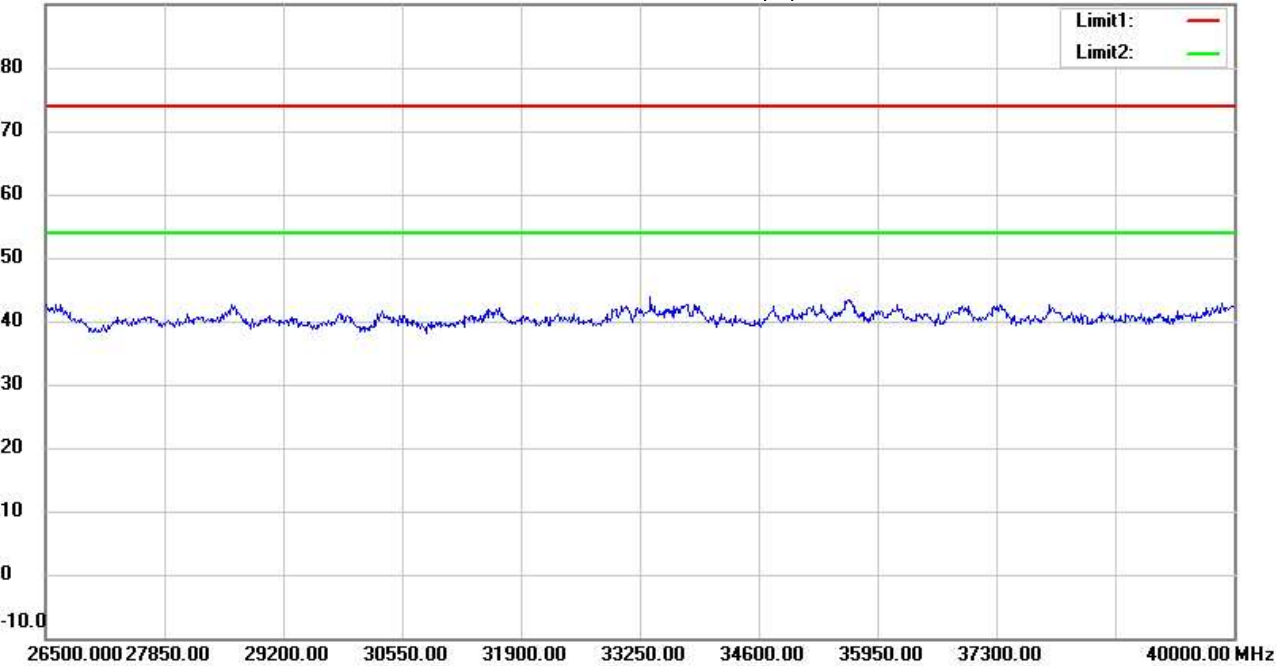
Data :#6

Site : 966A Chamber  
Condition : FCC\_part 15E RE\_Above 1GHz\_PK  
EUT : W6M22409-23739  
M/N:  
Test Mode : TX 802.11a CH105  
Note :

Polarization: Horizontal  
Power : 120 Va.c.  
Distance: 3m

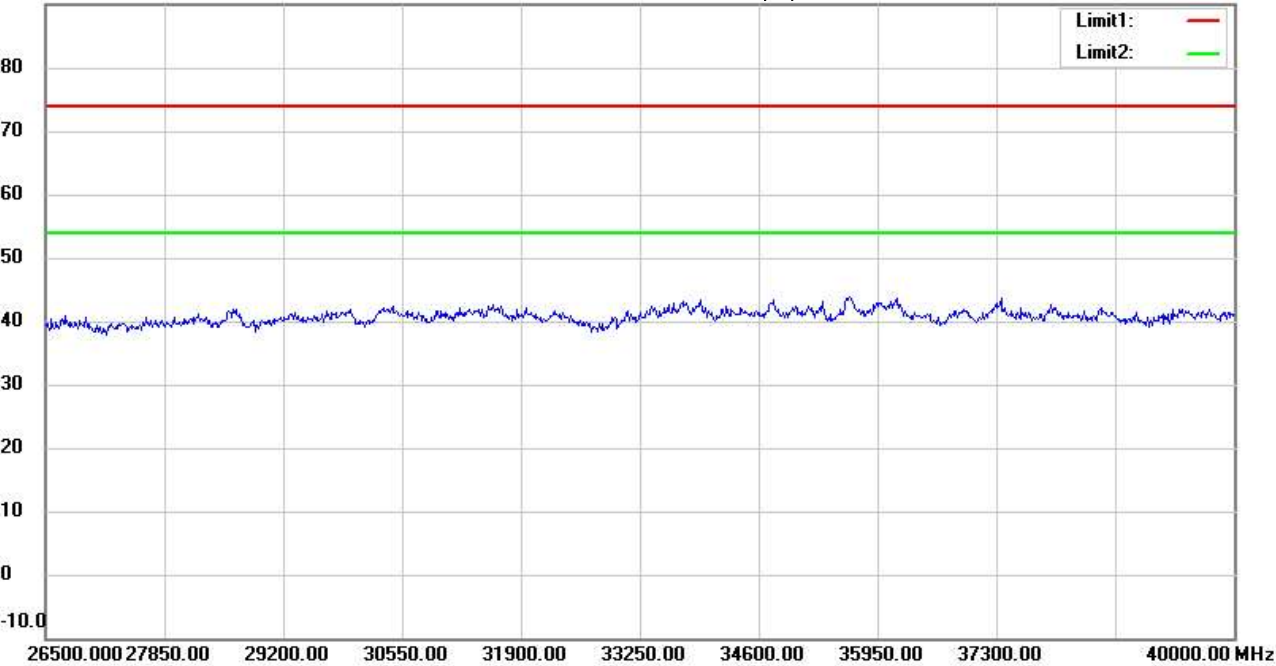
Site : 966A Chamber  
Condition : FCC\_part 15E RE\_Above 1GHz\_PK  
EUT : W6M22409-23739  
M/N:  
Test Mode : TX 802.11a CH105  
Note :

Polarization: Vertical  
Power : 120 Va.c.  
Distance: 3m

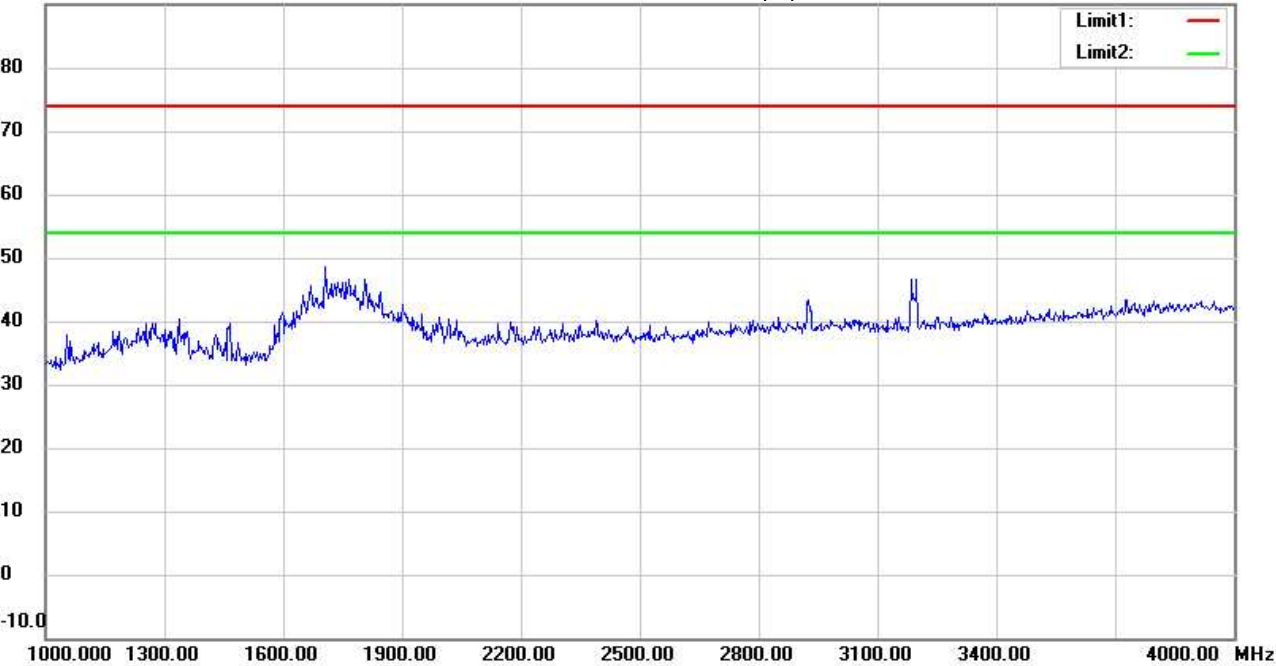
Site : 966A Chamber  
Condition : FCC\_part 15E RE\_Above 1GHz\_PK  
EUT : W6M22409-23739  
M/N:  
Test Mode : TX 802.11a CH113  
Note :

Polarization: Vertical  
Power : 120 Va.c.  
Distance: 3m

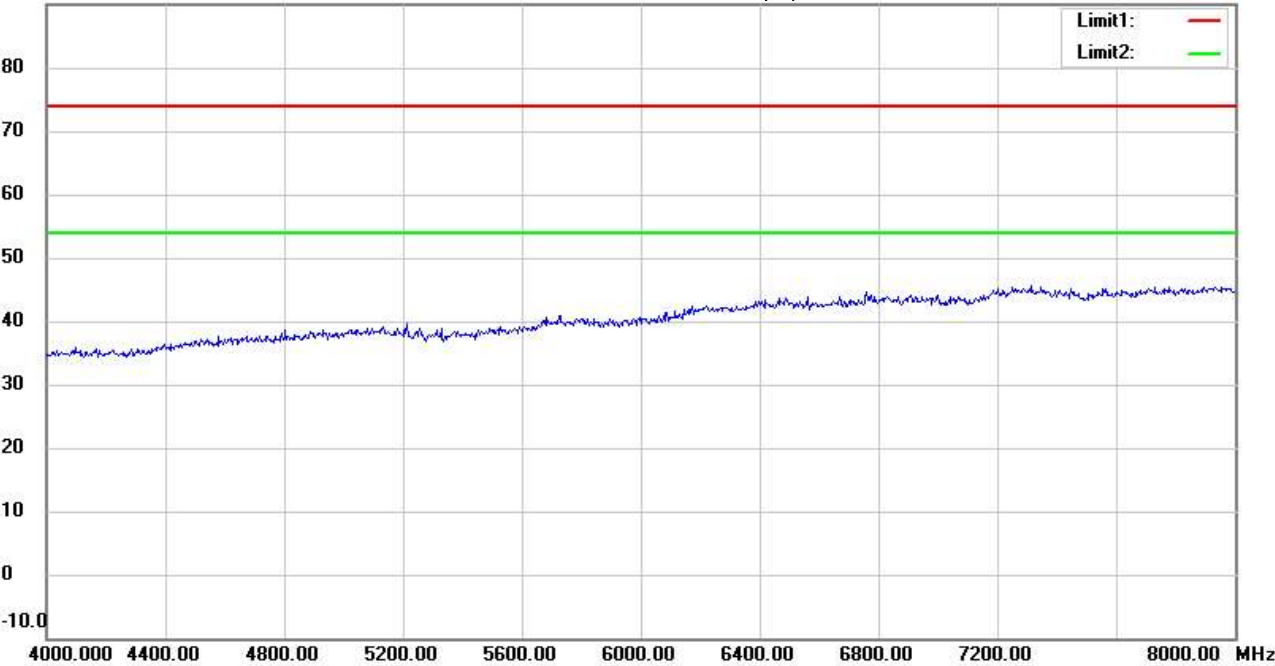
Site : 966A Chamber  
Condition : FCC\_part 15E RE\_Above 1GHz\_PK  
EUT : W6M22409-23739  
M/N:  
Test Mode : TX 802.11a CH113  
Note :

Polarization: **Horizontal**  
Power : 120 Va.c.  
Distance: 3m

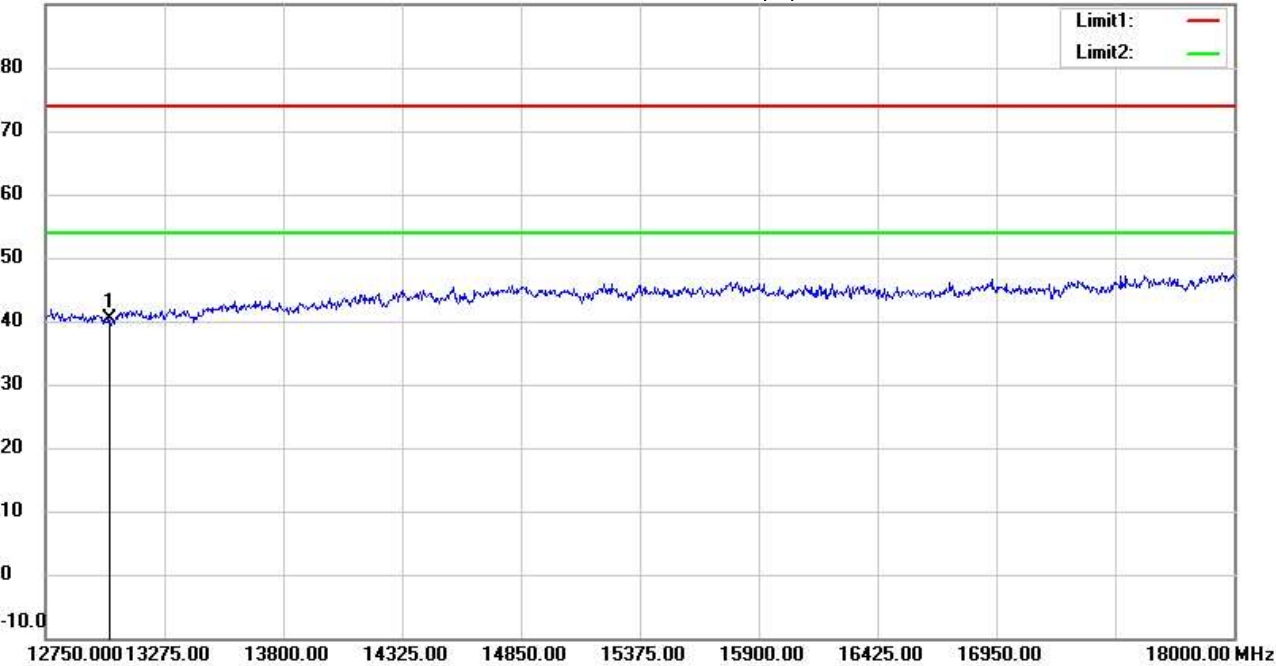
Data :#4

Condition : FCC\_part 15E RE\_Above 1GHz\_PK

Test Mode : TX 802.11a CH113

Polarization: **Horizontal**

| Mk. | Frequency (MHz) | Reading (dBuV) | Detector | Corr. factor (dB/m) | Result (dBuV/m) | Limit (dBuV/m) | Ant.Pos (cm) | Tab.Pos (deg.) | Margin (dB) | Comment |
|---|---|---|---|---|---|---|---|---|---|---|
| * | 13030.000 | 23.31 | peak | 17.10 | 40.41 | 74.00 | 150 | 190 | -33.59 | |

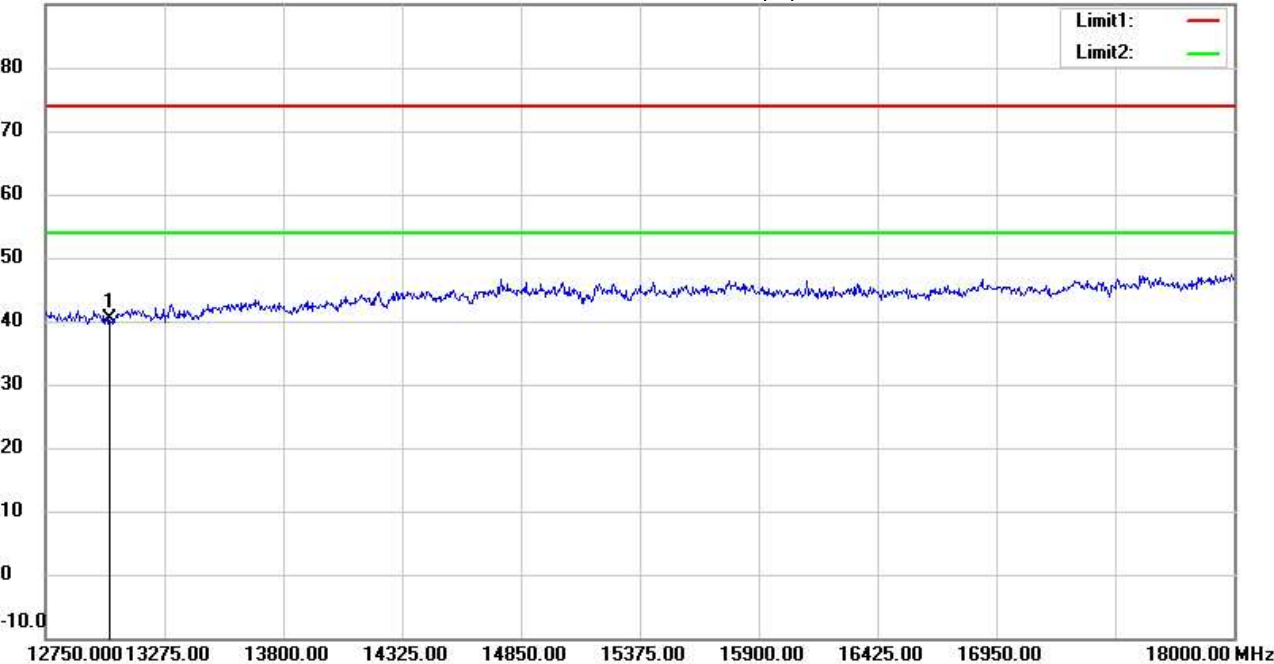
Data :#10

Site : 966A Chamber  
Condition : FCC\_part 15E RE\_Above 1GHz\_PK  
EUT : W6M22409-23739  
M/N:  
Test Mode : TX 802.11a CH113  
Note :

Polarization: Vertical  
Power : 120 Va.c.  
Distance: 3m

| Mk. | Frequency (MHz) | Reading (dBuV) | Detector | Corr. factor (dB/m) | Result (dBuV/m) | Limit (dBuV/m) | Ant.Pos (cm) | Tab.Pos (deg.) | Margin (dB) | Comment |
|---|---|---|---|---|---|---|---|---|---|---|
| * | 13030.000 | 23.19 | peak | 17.10 | 40.29 | 74.00 | 150 | 237 | -33.71 | |

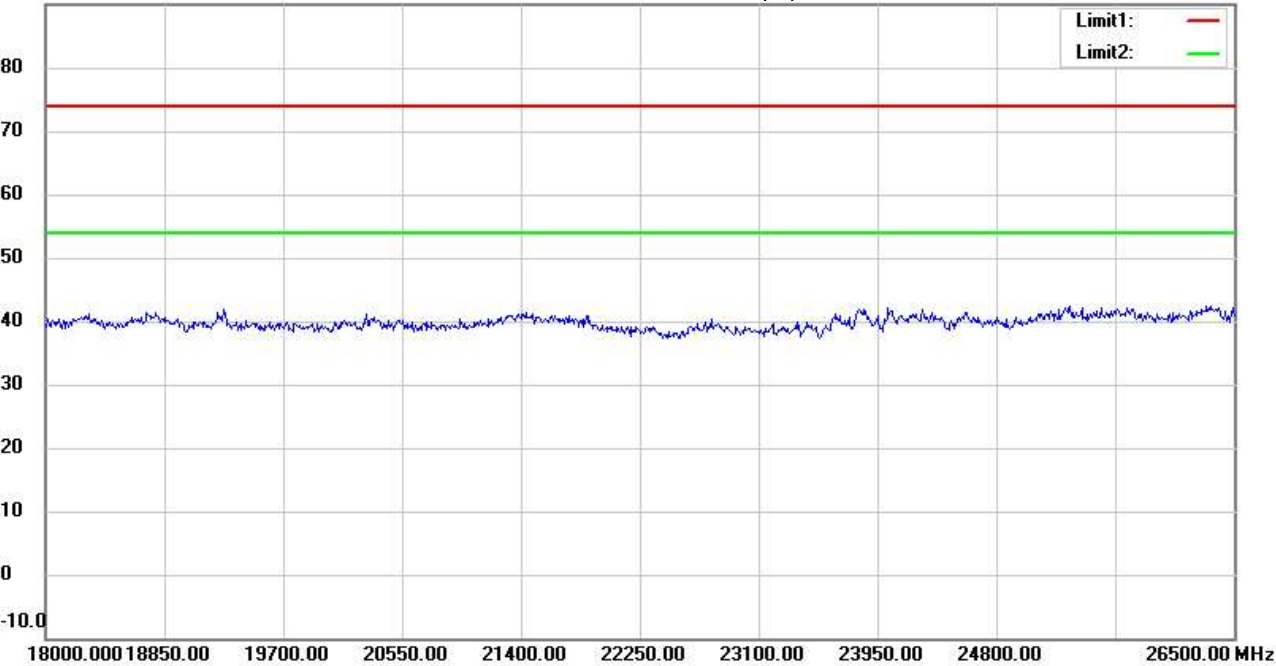
Site : 966A Chamber  
Condition : FCC\_part 15E RE\_Above 1GHz\_PK  
EUT : W6M22409-23739  
M/N:  
Test Mode : TX 802.11a CH113  
Note :

Polarization: Vertical  
Power : 120 Va.c.  
Distance: 3m

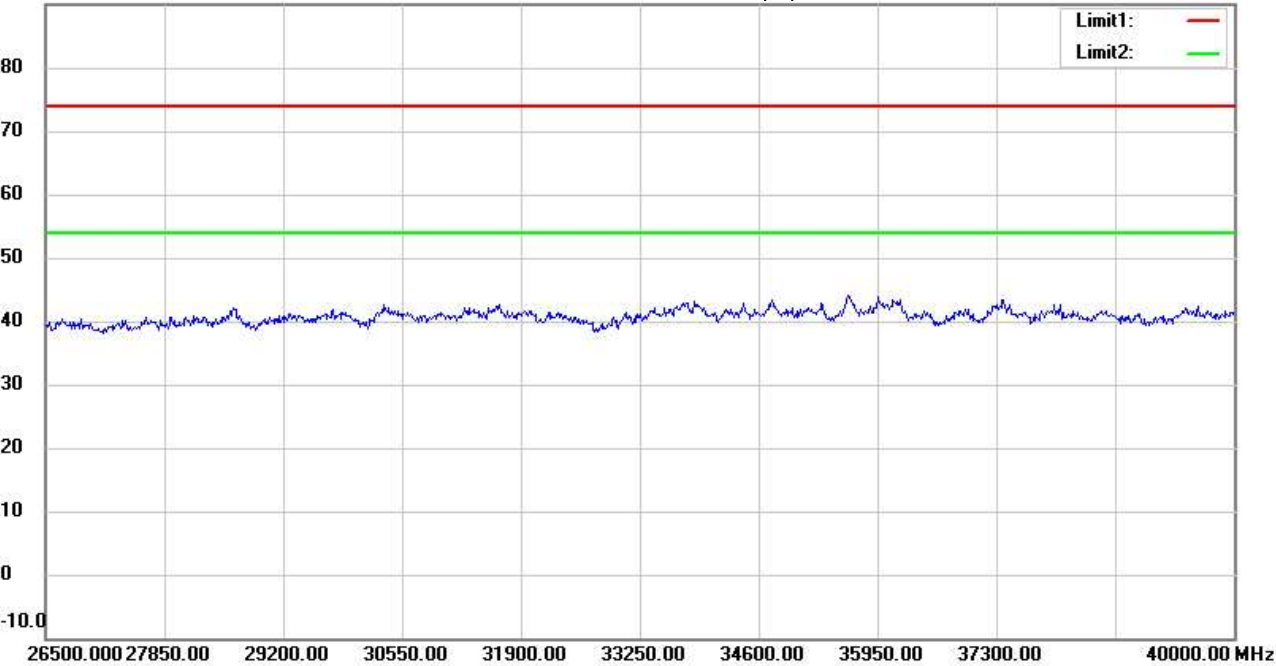
Site : 966A Chamber  
Condition : FCC\_part 15E RE\_Above 1GHz\_PK  
EUT : W6M22409-23739  
M/N:  
Test Mode : TX 802.11a CH113  
Note :

Polarization: Vertical  
Power : 120 Va.c.  
Distance: 3m
