Radiated Emission Measurement

Condition : FCC\_part 15E RE\_Above 1GHz\_PK

EUT : W6M22409-23739

Test Mode : TX 802.11ax20 CH97

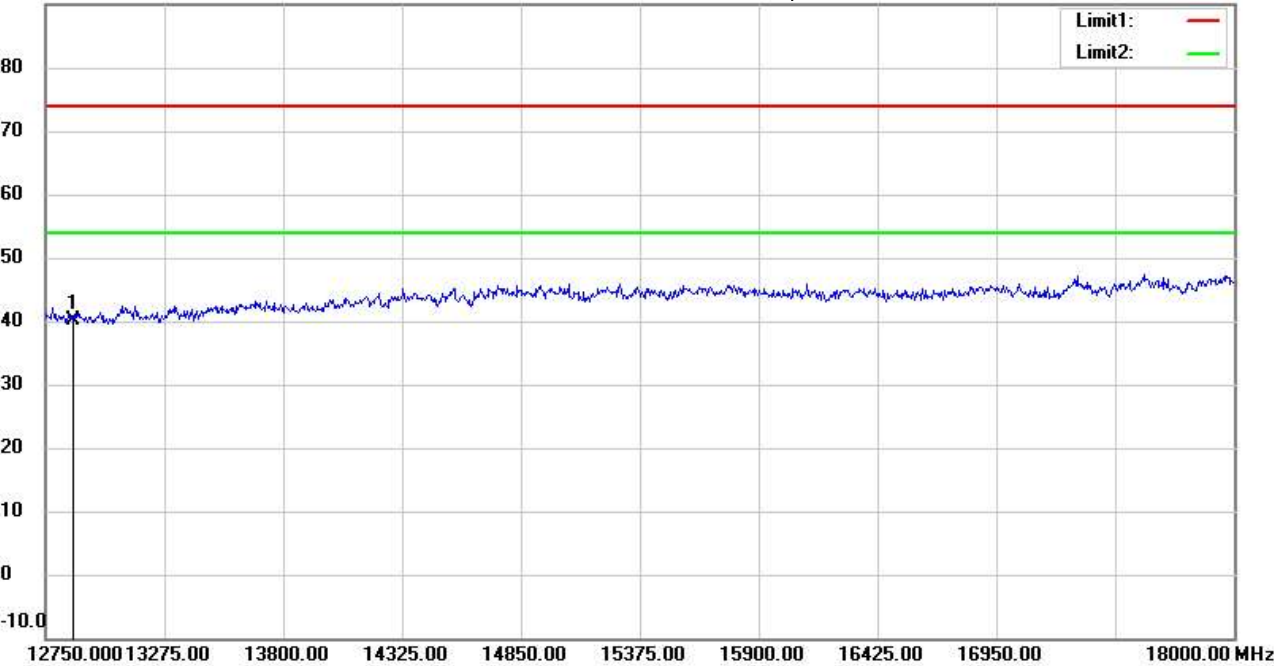
Data :#10

Test Mode : TX 802.11ax20 CH97

Polarization: Vertical

| Mk. | Frequency (MHz) | Reading (dBuV) | Detector | Corr. factor (dB/m) | Result (dBuV/m) | Limit (dBuV/m) | Ant.Pos (cm) | Tab.Pos (deg.) | Margin (dB) | Comment |
|---|---|---|---|---|---|---|---|---|---|---|
| * | 12870.000 | 22.76 | peak | 17.37 | 40.13 | 74.00 | 150 | 359 | -33.87 | |

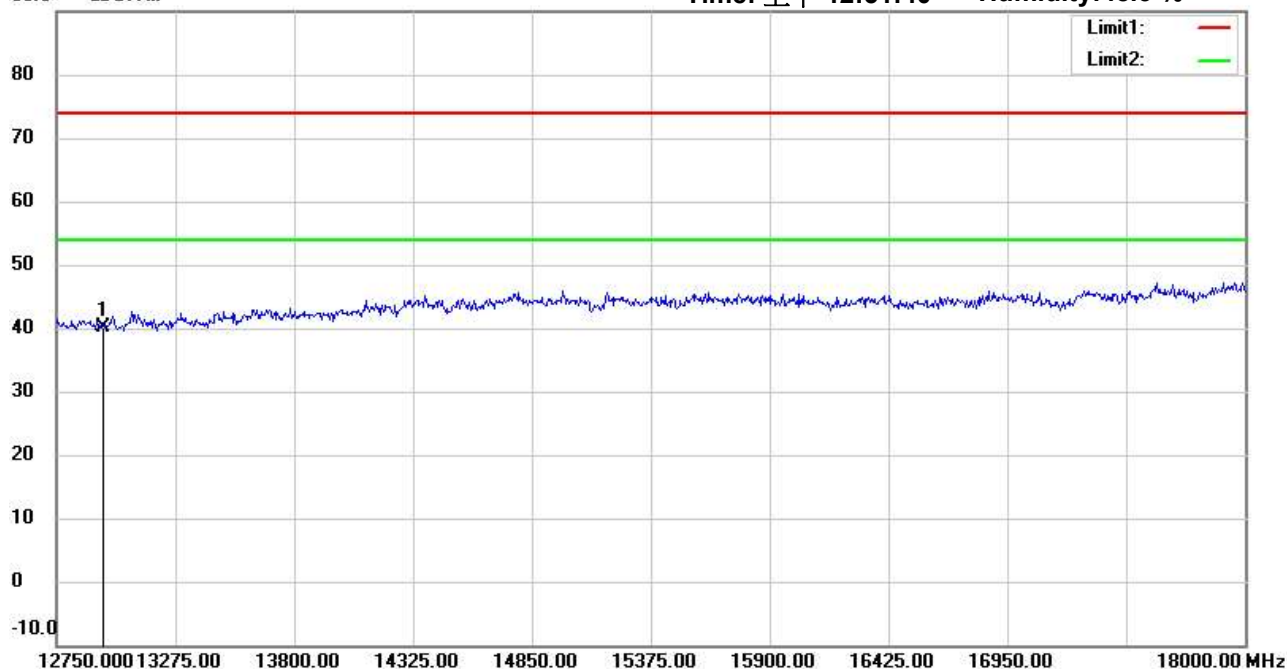
Data : #4

Test Mode : TX 802.11ax20 CH105

Polarization: **Horizontal**

| Mk. | Frequency (MHz) | Reading (dBuV) | Detector | Corr. factor (dB/m) | Result (dBuV/m) | Limit (dBuV/m) | Ant.Pos (cm) | Tab.Pos (deg.) | Margin (dB) | Comment |
|---|---|---|---|---|---|---|---|---|---|---|
| * | 12950.000 | 22.95 | peak | 17.30 | 40.25 | 74.00 | 150 | 279 | -33.75 | |

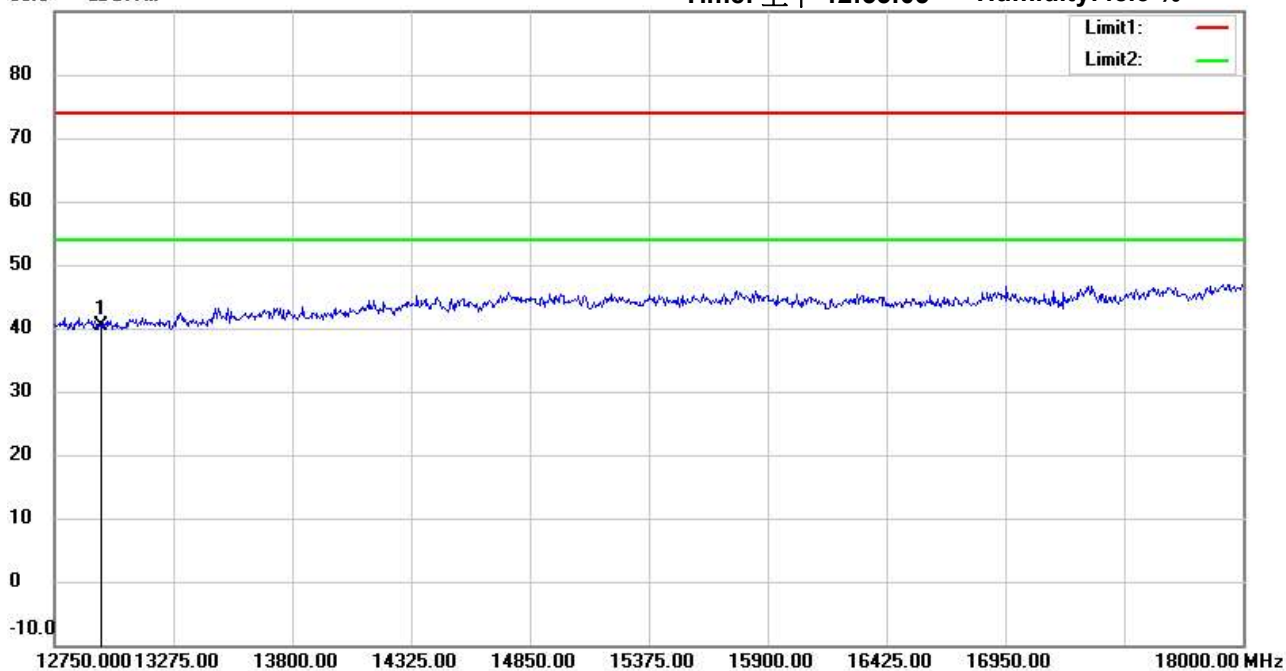
Data : #10

Test Mode : TX 802.11ax20 CH105

Polarization: Vertical

| Mk. | Frequency (MHz) | Reading (dBuV) | Detector | Corr. factor (dB/m) | Result (dBuV/m) | Limit (dBuV/m) | Ant.Pos (cm) | Tab.Pos (deg.) | Margin (dB) | Comment |
|---|---|---|---|---|---|---|---|---|---|---|
| * | 12950.000 | 23.06 | peak | 17.30 | 40.36 | 74.00 | 150 | 359 | -33.64 | |
