Radiated Emission Measurement

Condition : FCC\_part 15E RE\_Above 1GHz\_PK

EUT : W6M22409-23739

Test Mode : TX 802.11ax80 CH119

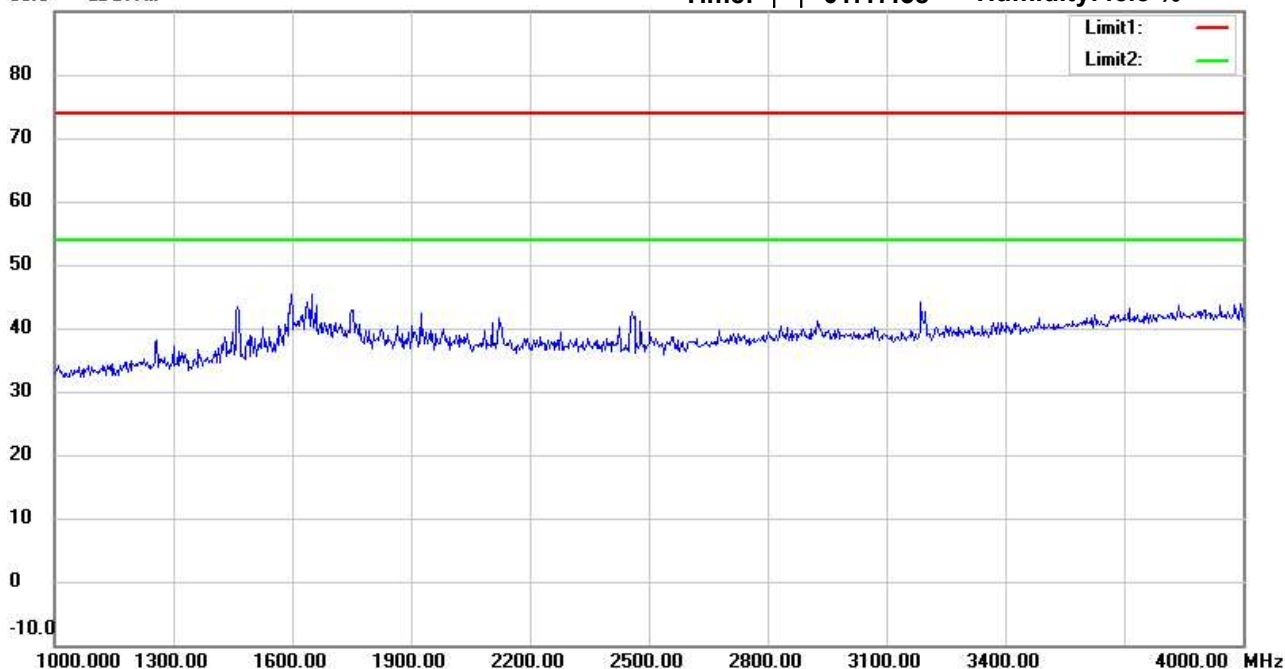
Data : #7

Polarization: Vertical

Distance: 3m

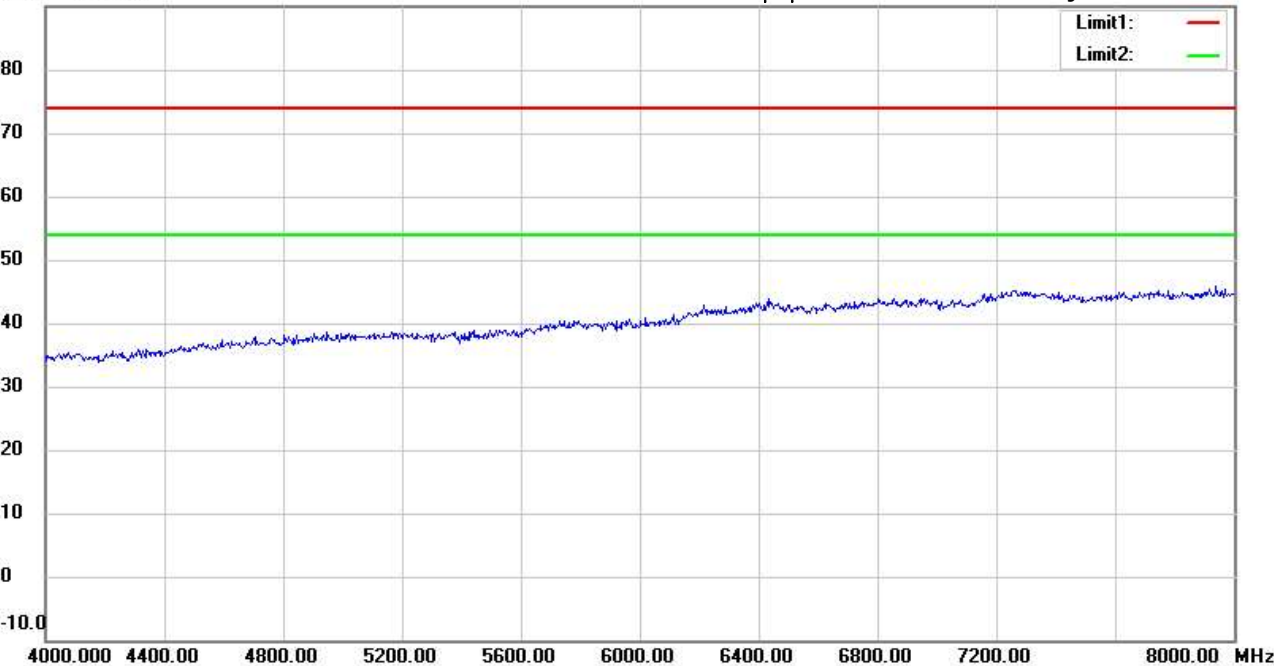
Data :#2

Condition : FCC\_part 15E RE\_Above 1GHz\_PK

Test Mode : TX 802.11ax80 CH119

Polarization: **Horizontal**

Distance: 3m

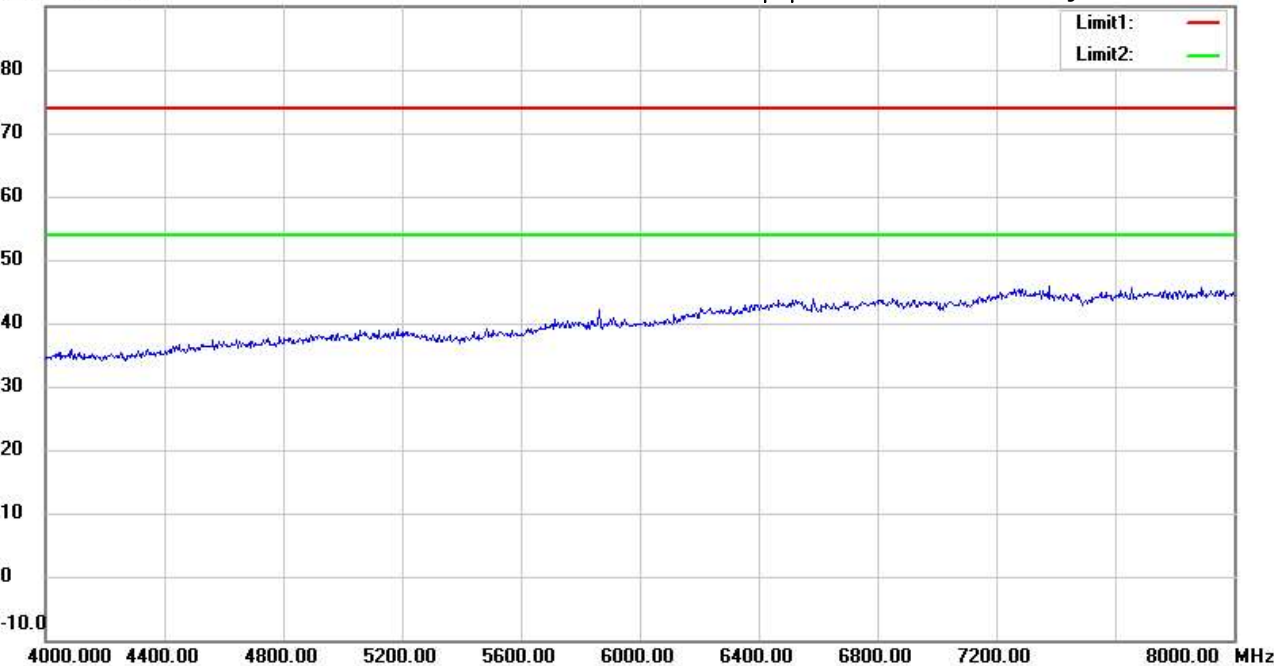
Data :#8

Condition : FCC\_part 15E RE\_Above 1GHz\_PK

Test Mode : TX 802.11ax80 CH119

Polarization: Vertical

Distance: 3m

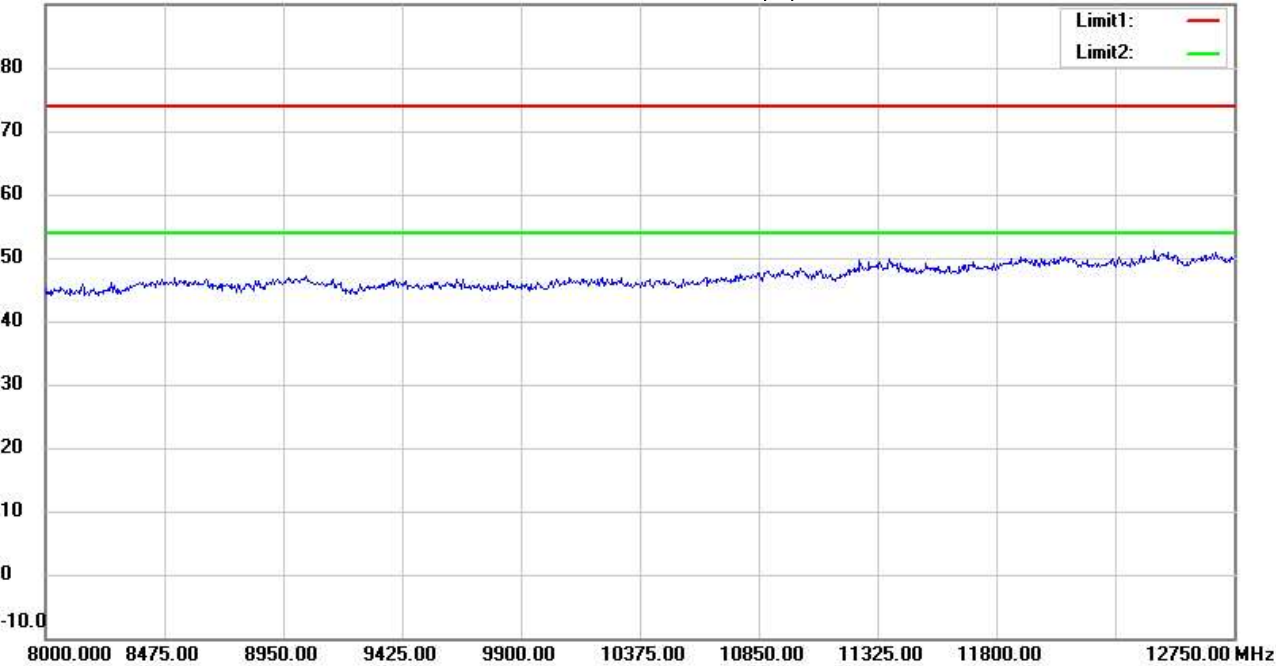
Data :#3

Condition : FCC\_part 15E RE\_Above 1GHz\_PK

Test Mode : TX 802.11ax80 CH119

Polarization: *Horizontal*

Distance: 3m

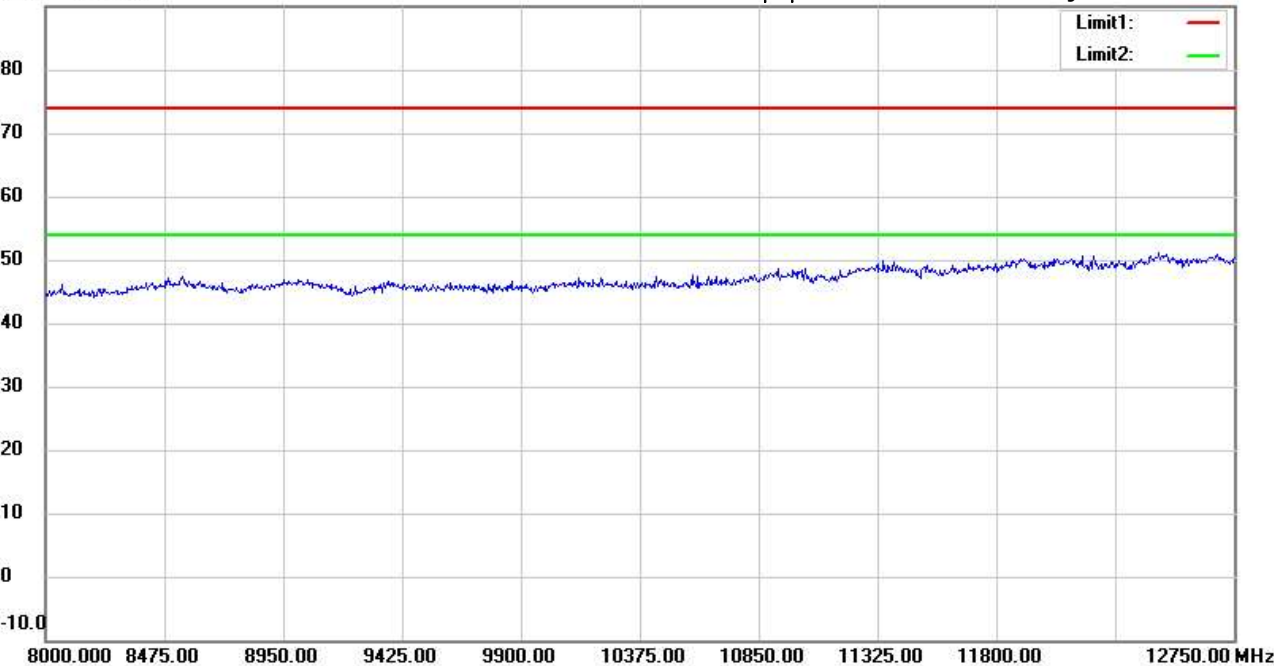
Data :#9

Condition : FCC\_part 15E RE\_Above 1GHz\_PK

Test Mode : TX 802.11ax80 CH119

Polarization: Vertical

Distance: 3m

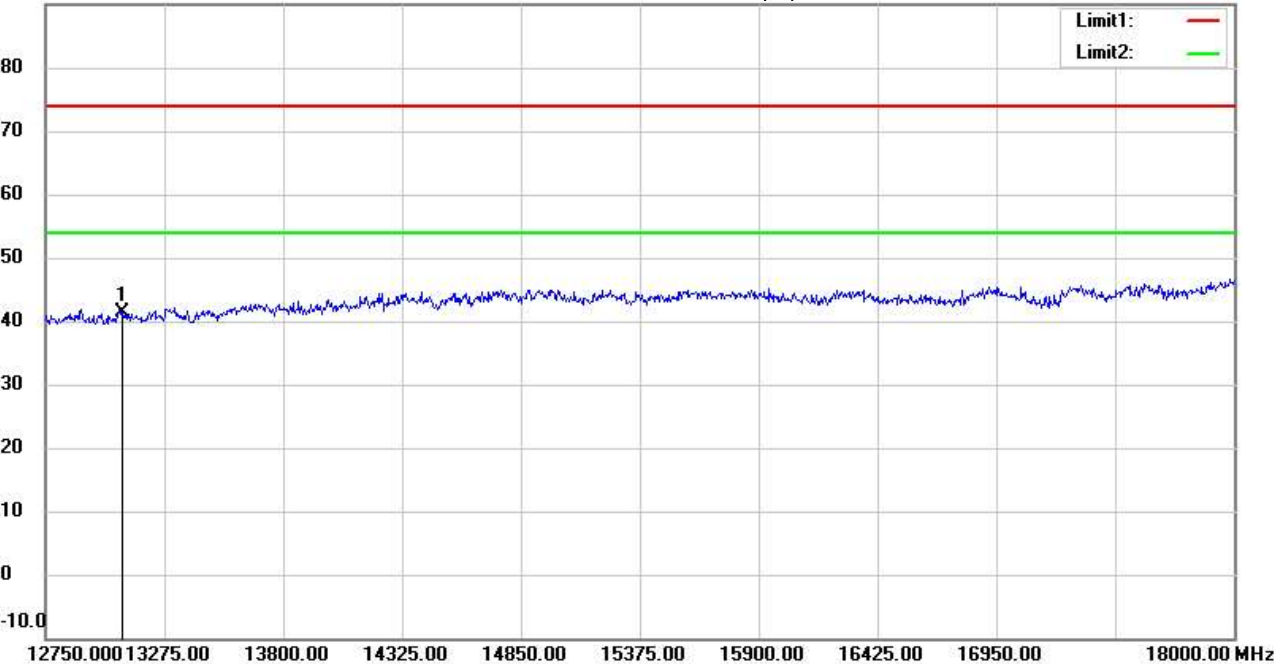
Site : 966A Chamber

Condition : FCC\_part 15E RE\_Above 1GHz\_PK

Test Mode : TX 802.11ax80 CH119

Polarization: *Horizontal*

| Mk. | Frequency (MHz) | Reading (dBuV) | Detector | Corr. factor (dB/m) | Result (dBuV/m) | Limit (dBuV/m) | Ant.Pos (cm) | Tab.Pos (deg.) | Margin (dB) | Comment |
|---|---|---|---|---|---|---|---|---|---|---|
| * | 13090.000 | 24.06 | peak | 17.26 | 41.32 | 74.00 | 150 | 25 | -32.68 | |

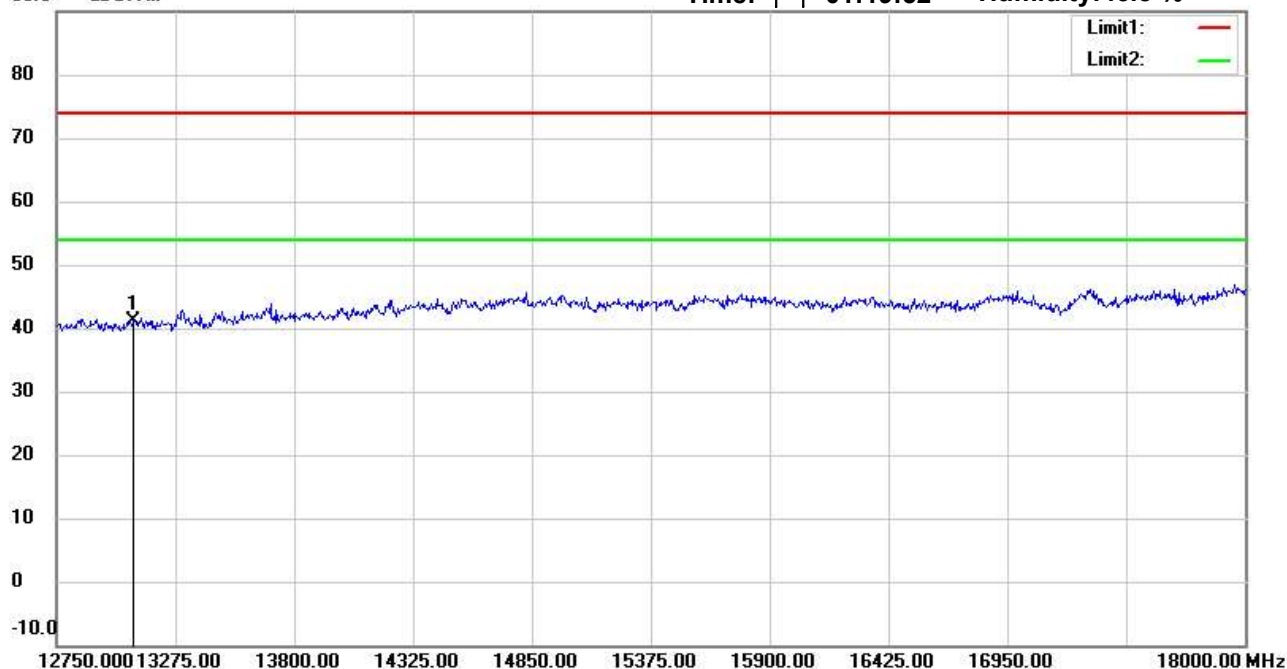
Site : 966A Chamber

Condition : FCC\_part 15E RE\_Above 1GHz\_PK

Test Mode : TX 802.11ax80 CH119

Polarization: Vertical

| Mk. | Frequency (MHz) | Reading (dBuV) | Detector | Corr. factor (dB/m) | Result (dBuV/m) | Limit (dBuV/m) | Ant.Pos (cm) | Tab.Pos (deg.) | Margin (dB) | Comment |
|---|---|---|---|---|---|---|---|---|---|---|
| * | 13090.000 | 23.98 | peak | 17.26 | 41.24 | 74.00 | 150 | 359 | -32.76 | |

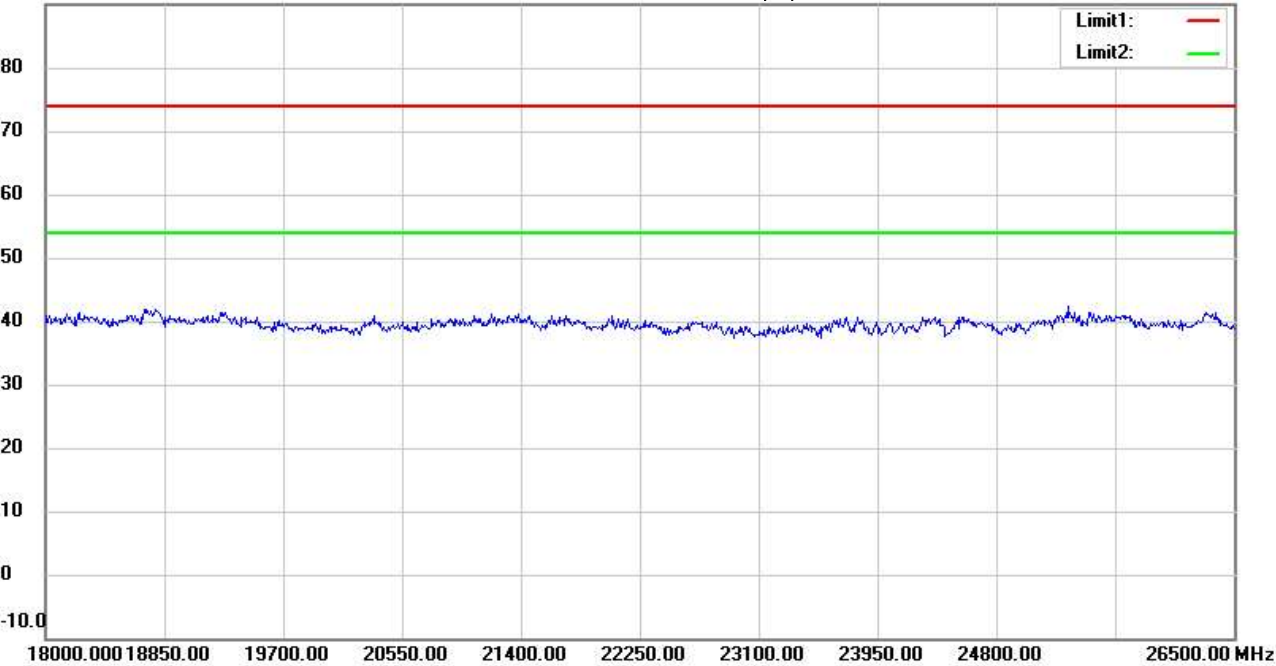
Data :#5

Condition : FCC\_part 15E RE\_Above 1GHz\_PK

Test Mode : TX 802.11ax80 CH119

Polarization: *Horizontal*

Distance: 3m

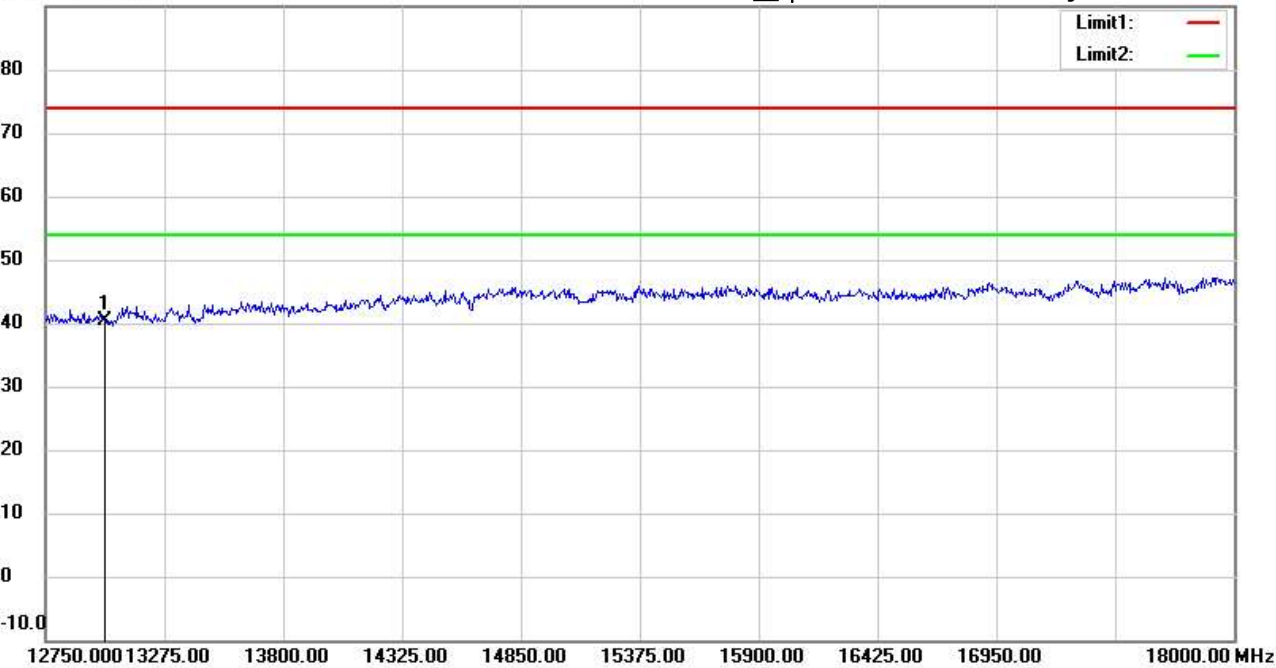
Site : 966A Chamber

Condition : FCC\_part 15E RE\_Above 1GHz\_PK

Test Mode : TX 802.11ax160 CH111

Polarization: *Horizontal*

| Mk. | Frequency (MHz) | Reading (dBuV) | Detector | Corr. factor (dB/m) | Result (dBuV/m) | Limit (dBuV/m) | Ant.Pos (cm) | Tab.Pos (deg.) | Margin (dB) | Comment |
|---|---|---|---|---|---|---|---|---|---|---|
| * | 13010.000 | 23.35 | peak | 17.05 | 40.40 | 74.00 | 150 | 111 | -33.60 | |

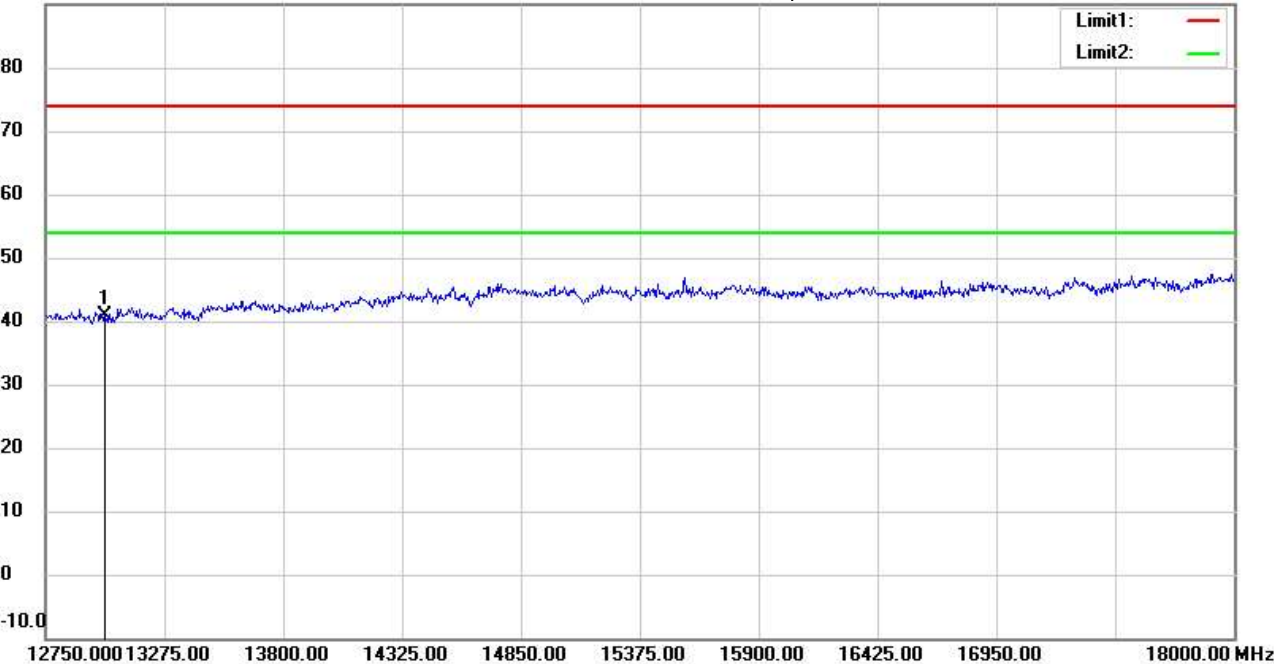
Site : 966A Chamber

Condition : FCC\_part 15E RE\_Above 1GHz\_PK

Test Mode : TX 802.11ax160 CH111

Polarization: Vertical

| Mk. | Frequency (MHz) | Reading (dBuV) | Detector | Corr. factor (dB/m) | Result (dBuV/m) | Limit (dBuV/m) | Ant.Pos (cm) | Tab.Pos (deg.) | Margin (dB) | Comment |
|---|---|---|---|---|---|---|---|---|---|---|
| * | 13010.000 | 23.91 | peak | 17.05 | 40.96 | 74.00 | 150 | 317 | -33.04 | |

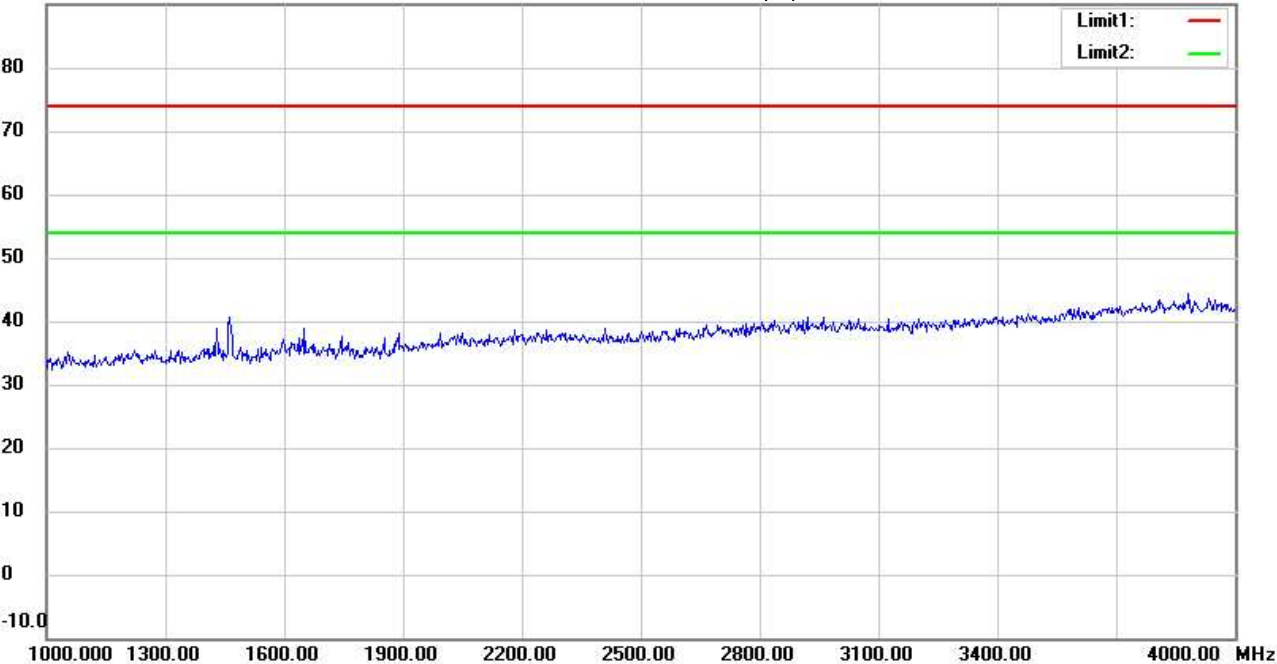
Site : 966A Chamber  
Condition : FCC\_part 15E RE\_Above 1GHz\_PK  
EUT : W6M22409-23739  
M/N:  
Test Mode : TX 802.11a CH117  
Note :

Polarization: Horizontal  
Power : 120 Va.c.  
Distance: 3m

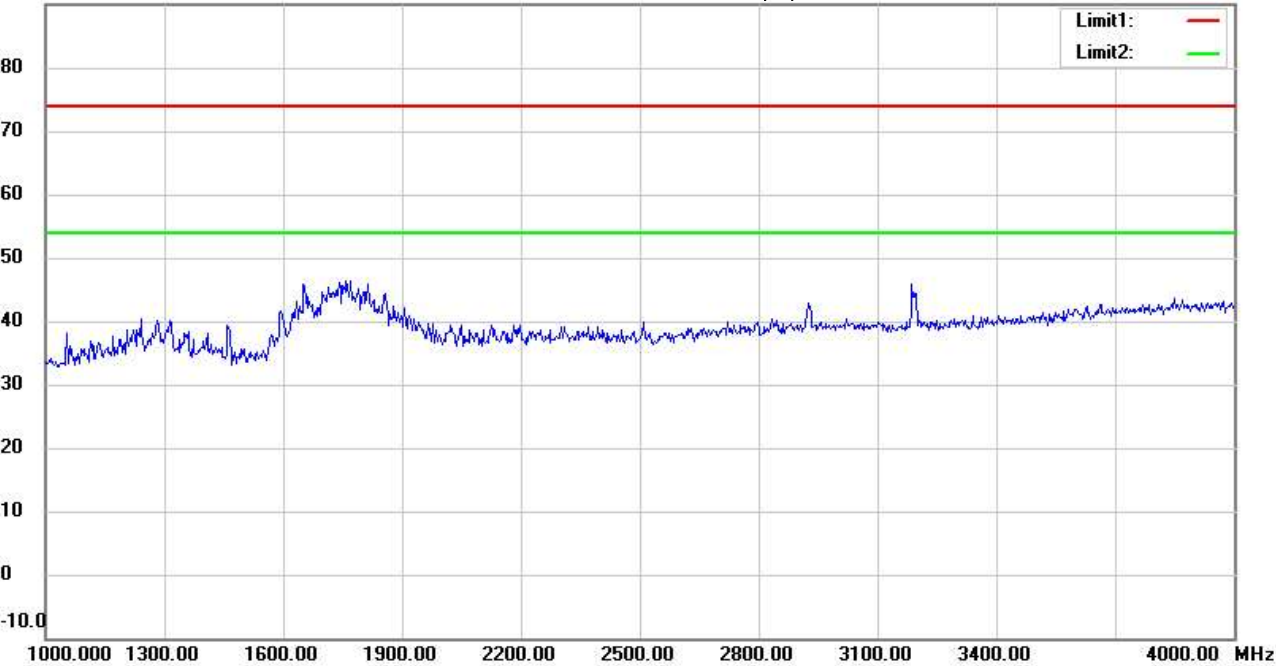
Site : 966A Chamber  
Condition : FCC\_part 15E RE\_Above 1GHz\_PK  
EUT : W6M22409-23739  
M/N:  
Test Mode : TX 802.11a CH117  
Note :

Polarization: Vertical  
Power : 120 Va.c.  
Distance: 3m

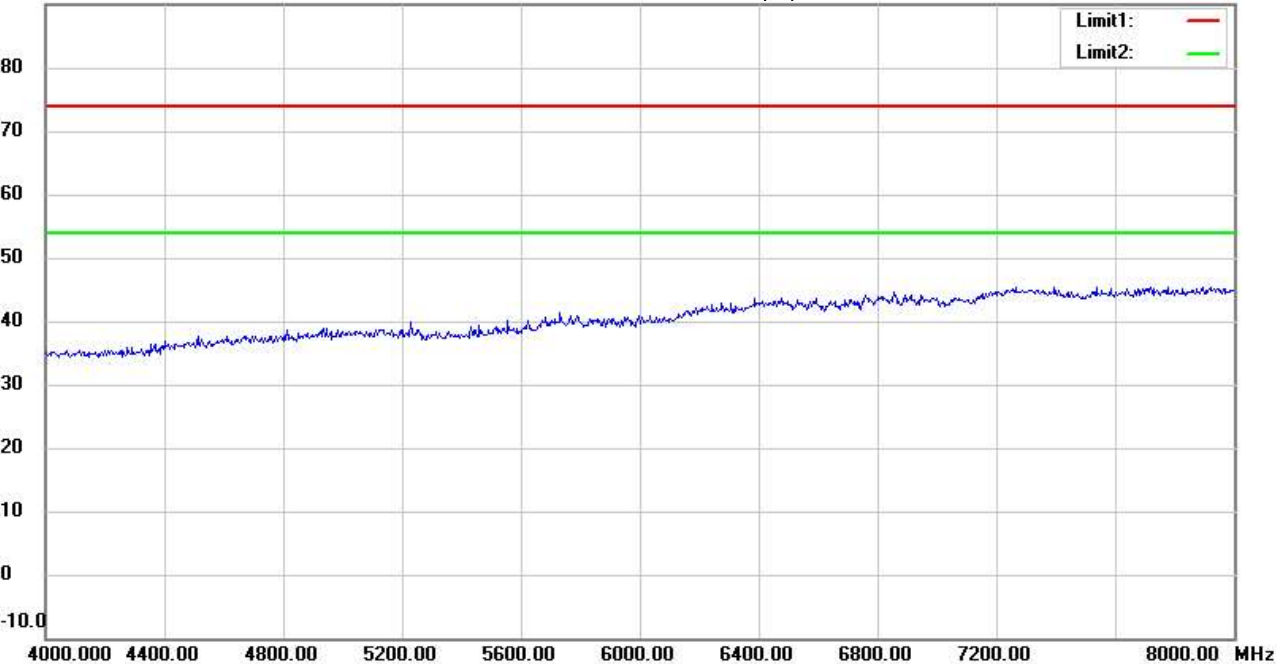
Site : 966A Chamber  
Condition : FCC\_part 15E RE\_Above 1GHz\_PK  
EUT : W6M22409-23739  
M/N:  
Test Mode : TX 802.11a CH117  
Note :

Polarization: Horizontal  
Power : 120 Va.c.  
Distance: 3m
