Radiated Emission Measurement

Site : 966A Chamber  
Condition : FCC\_part 15E RE\_Above 1GHz\_PK  
EUT : W6M22409-23739  
M/N:  
Test Mode : TX 802.11a CH117  
Note :

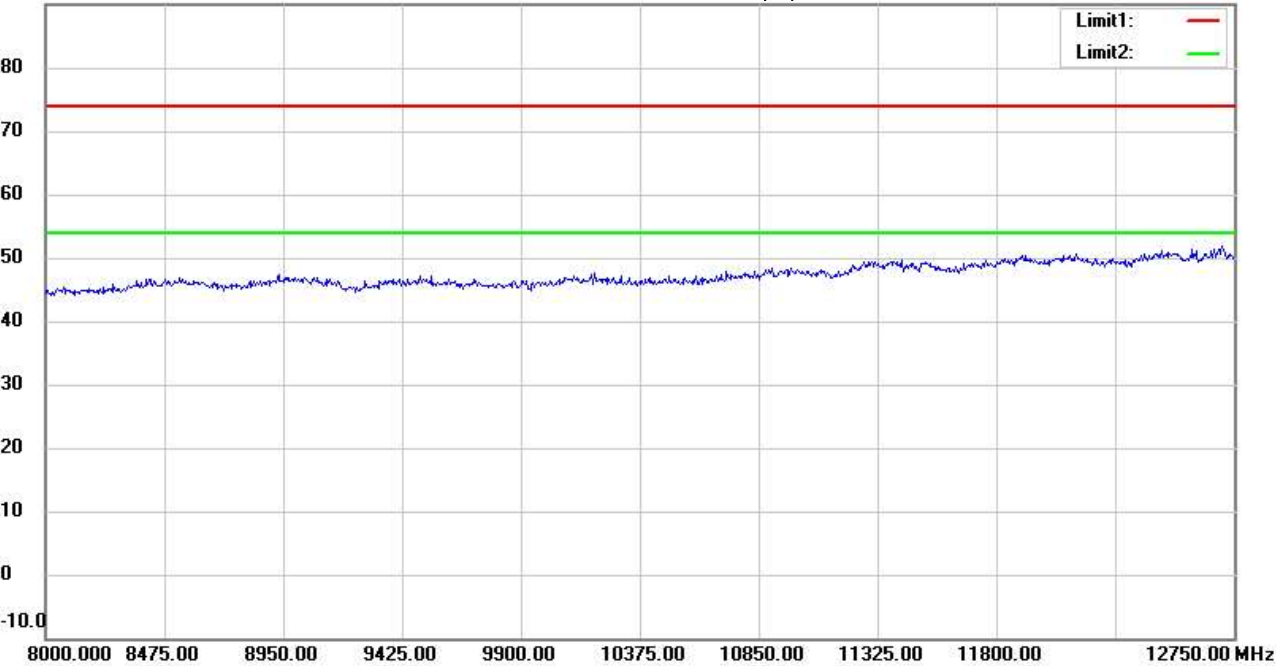
Data :#3

Polarization: Horizontal  
Power : 120 Va.c.  
Distance: 3m

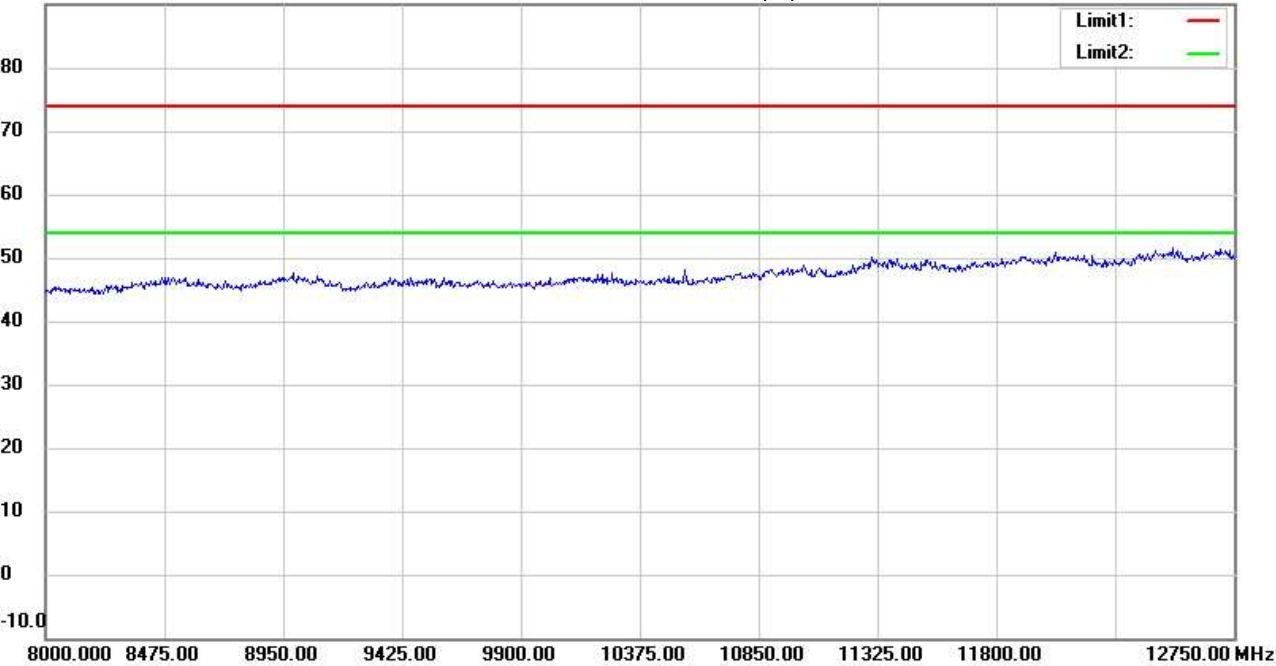
Data :#9

Condition : FCC\_part 15E RE\_Above 1GHz\_PK

Test Mode : TX 802.11a CH117

Polarization: Vertical

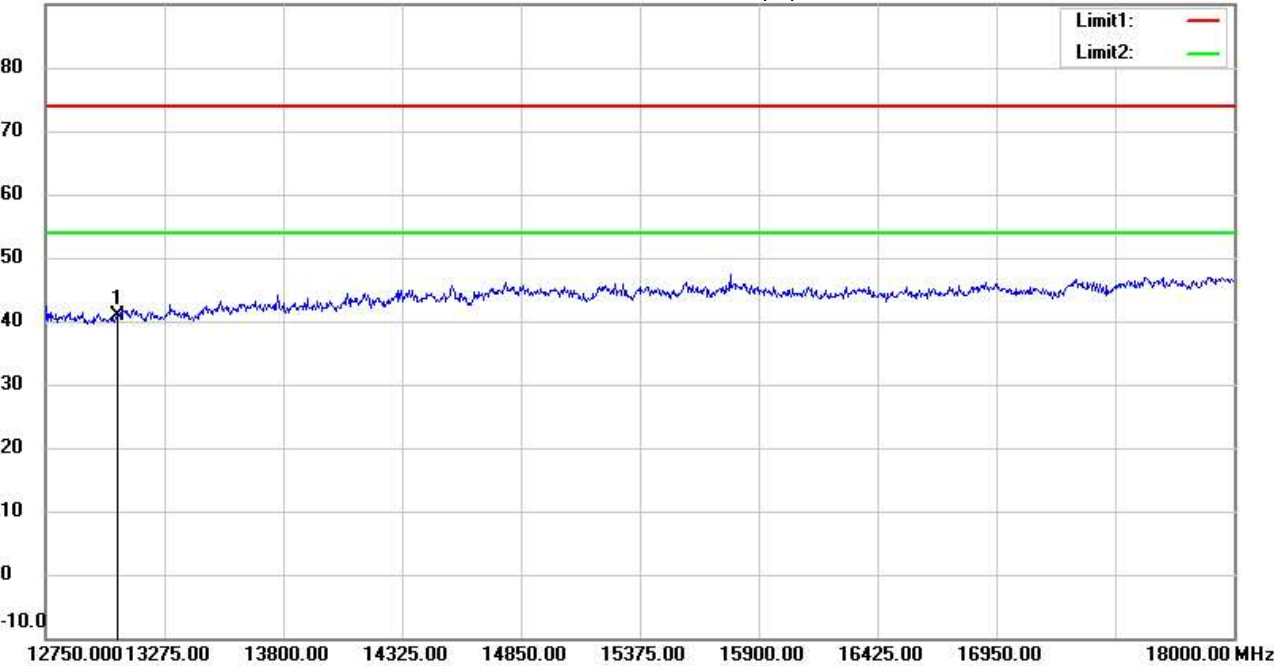
Data :#4

Site : 966A Chamber  
Condition : FCC\_part 15E RE\_Above 1GHz\_PK  
EUT : W6M22409-23739  
M/N:  
Test Mode : TX 802.11a CH117  
Note :

Polarization: **Horizontal**  
Power : 120 Va.c.  
Distance: 3m

| Mk. | Frequency (MHz) | Reading (dBuV) | Detector | Corr. factor (dB/m) | Result (dBuV/m) | Limit (dBuV/m) | Ant.Pos (cm) | Tab.Pos (deg.) | Margin (dB) | Comment |
|---|---|---|---|---|---|---|---|---|---|---|
| * | 13070.000 | 23.76 | peak | 17.21 | 40.97 | 74.00 | 150 | 66 | -33.03 | |

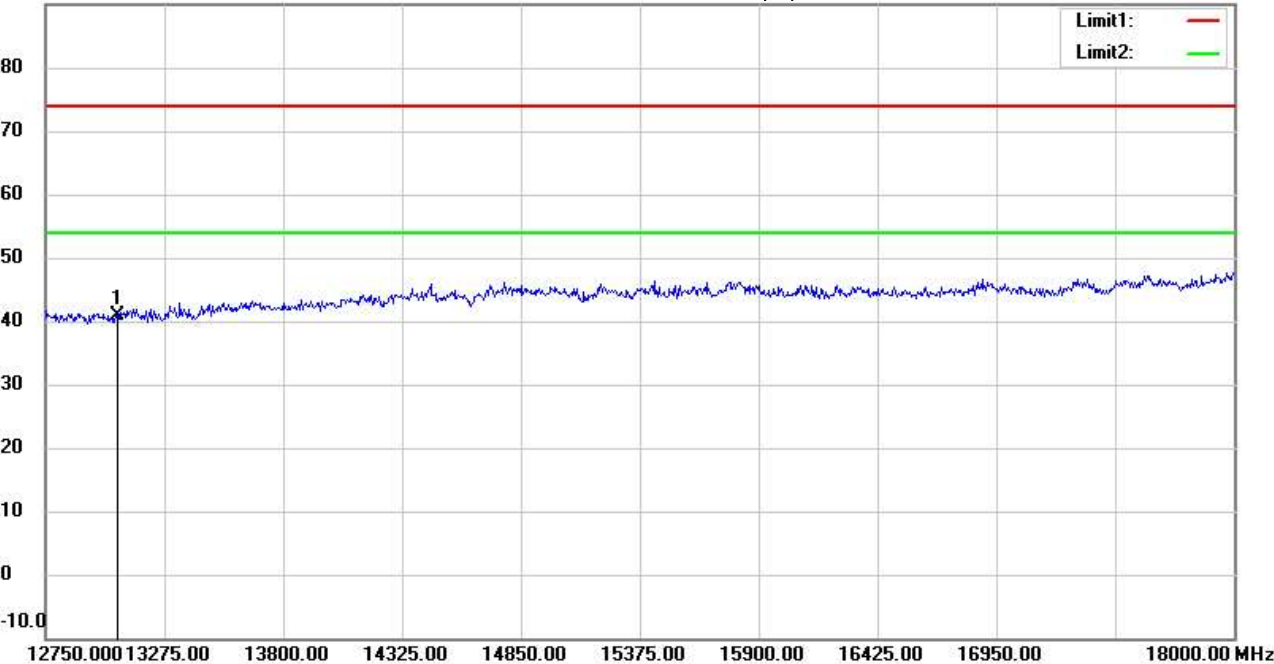
Data :#10

Test Mode : TX 802.11a CH117

Polarization: Vertical

| Mk. | Frequency (MHz) | Reading (dBuV) | Detector | Corr. factor (dB/m) | Result (dBuV/m) | Limit (dBuV/m) | Ant.Pos (cm) | Tab.Pos (deg.) | Margin (dB) | Comment |
|---|---|---|---|---|---|---|---|---|---|---|
| * | 13070.000 | 23.76 | peak | 17.21 | 40.97 | 74.00 | 150 | 318 | -33.03 | |

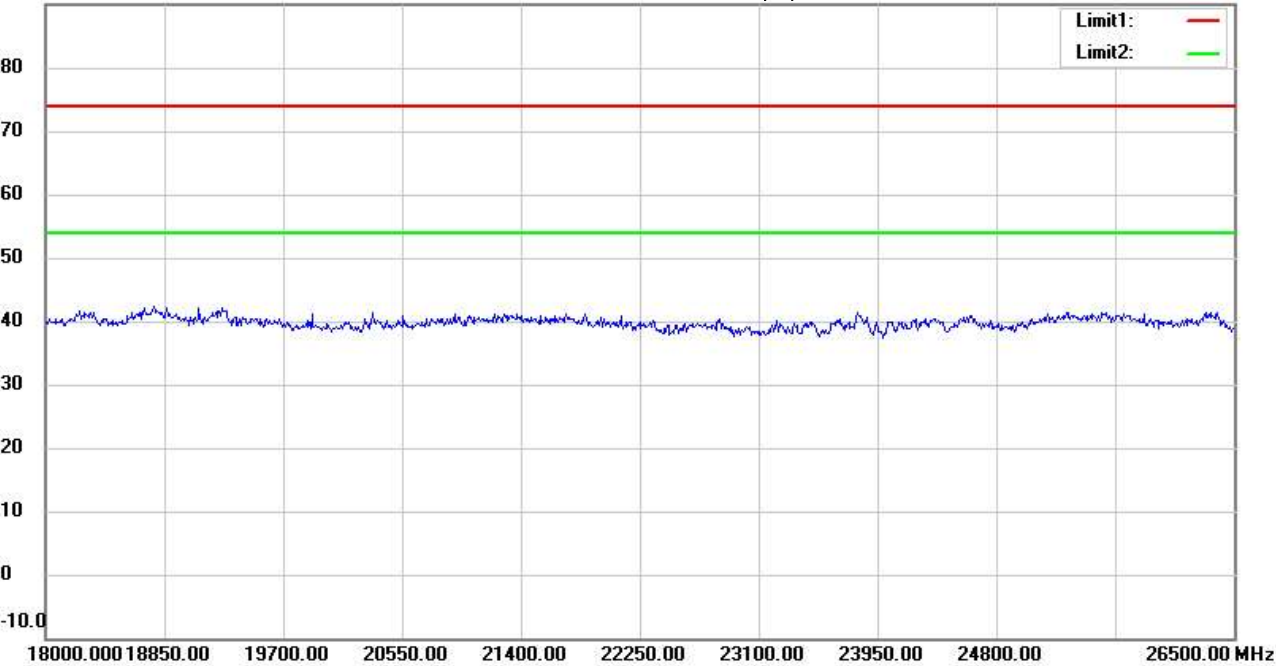
Data :#5

Site : 966A Chamber  
Condition : FCC\_part 15E RE\_Above 1GHz\_PK  
EUT : W6M22409-23739  
M/N:  
Test Mode : TX 802.11a CH117  
Note :

Polarization: *Horizontal*  
Power : 120 Va.c.  
Distance: 3m

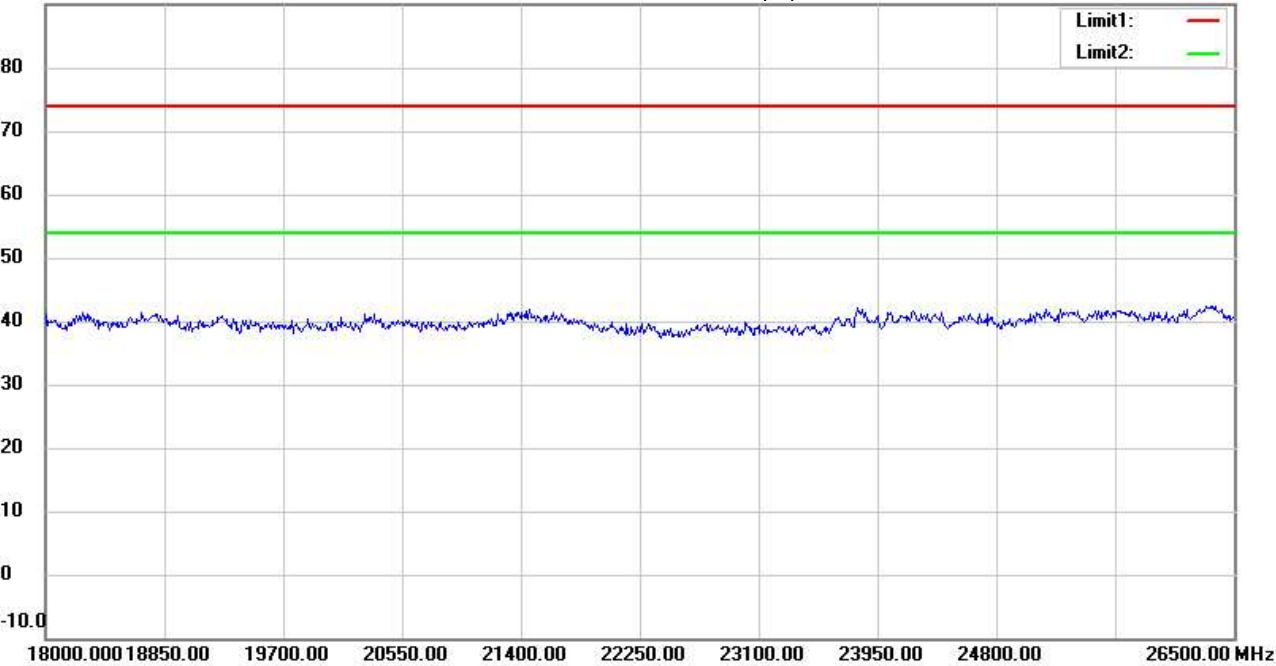
Data :#11

Site : 966A Chamber  
Condition : FCC\_part 15E RE\_Above 1GHz\_PK  
EUT : W6M22409-23739  
M/N:  
Test Mode : TX 802.11a CH117  
Note :

Polarization: Vertical  
Power : 120 Va.c.  
Distance: 3m

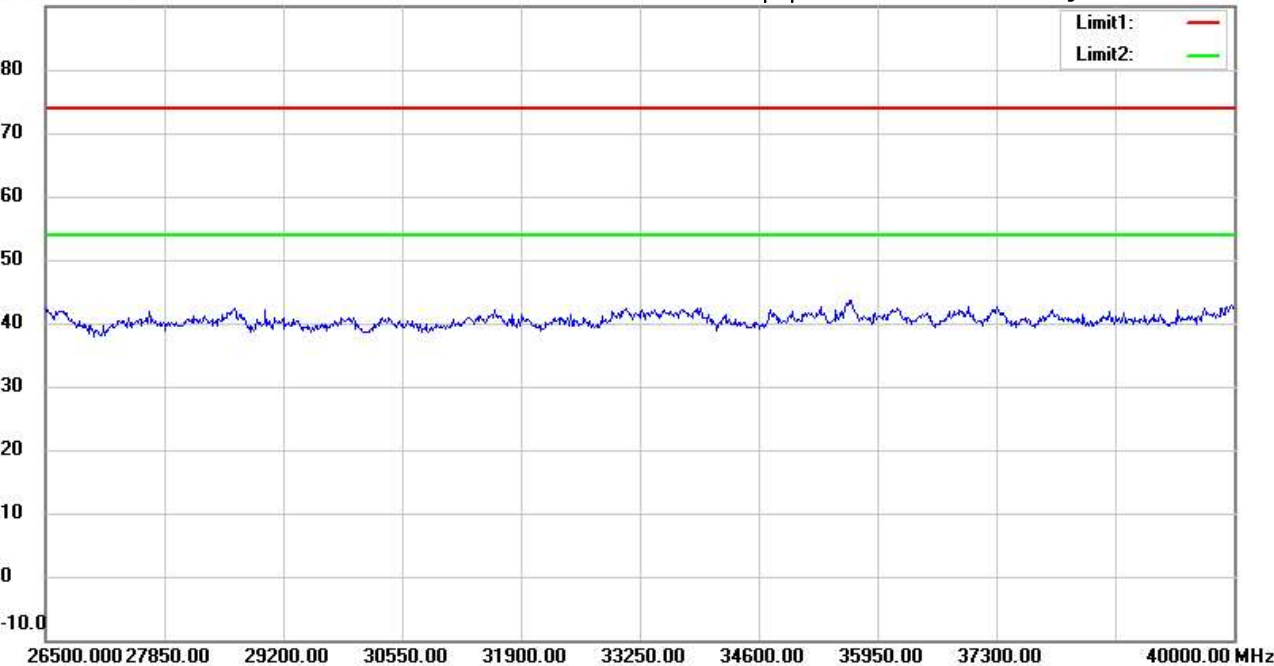
Data :#6

Condition : FCC\_part 15E RE\_Above 1GHz\_PK

Test Mode : TX 802.11a CH117

Polarization: Horizontal

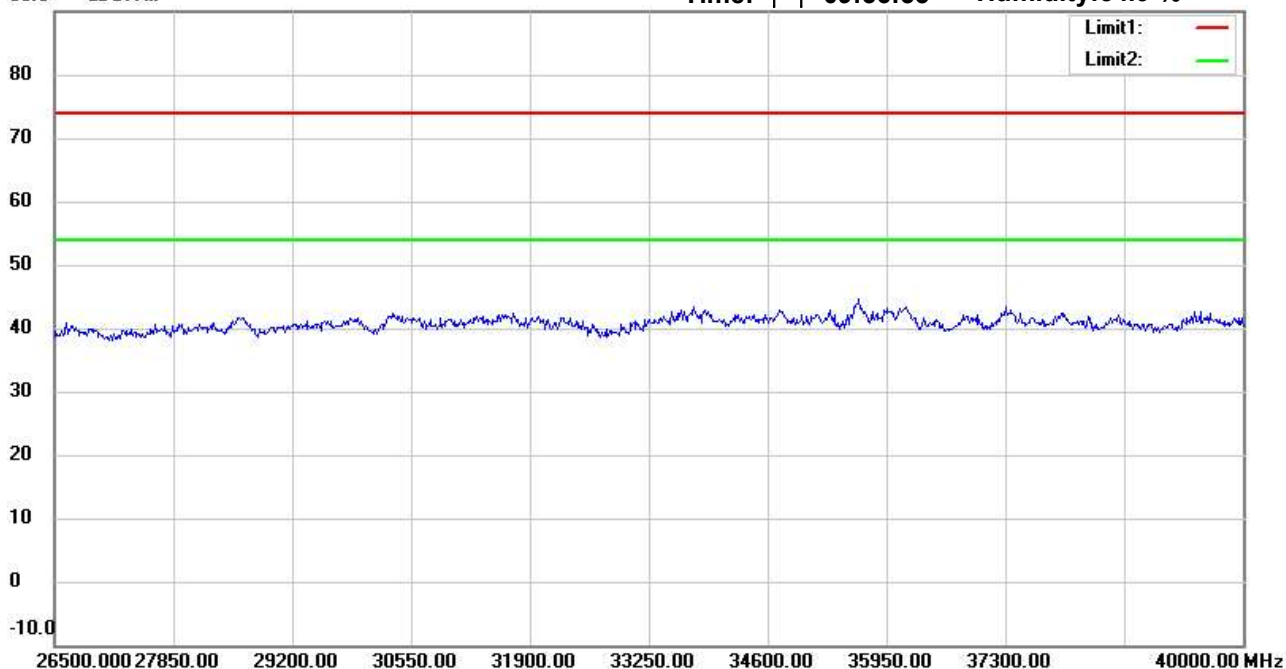
Data : #12

Condition : FCC\_part 15E RE\_Above 1GHz\_PK

Test Mode : TX 802.11a CH117

Polarization: Vertical

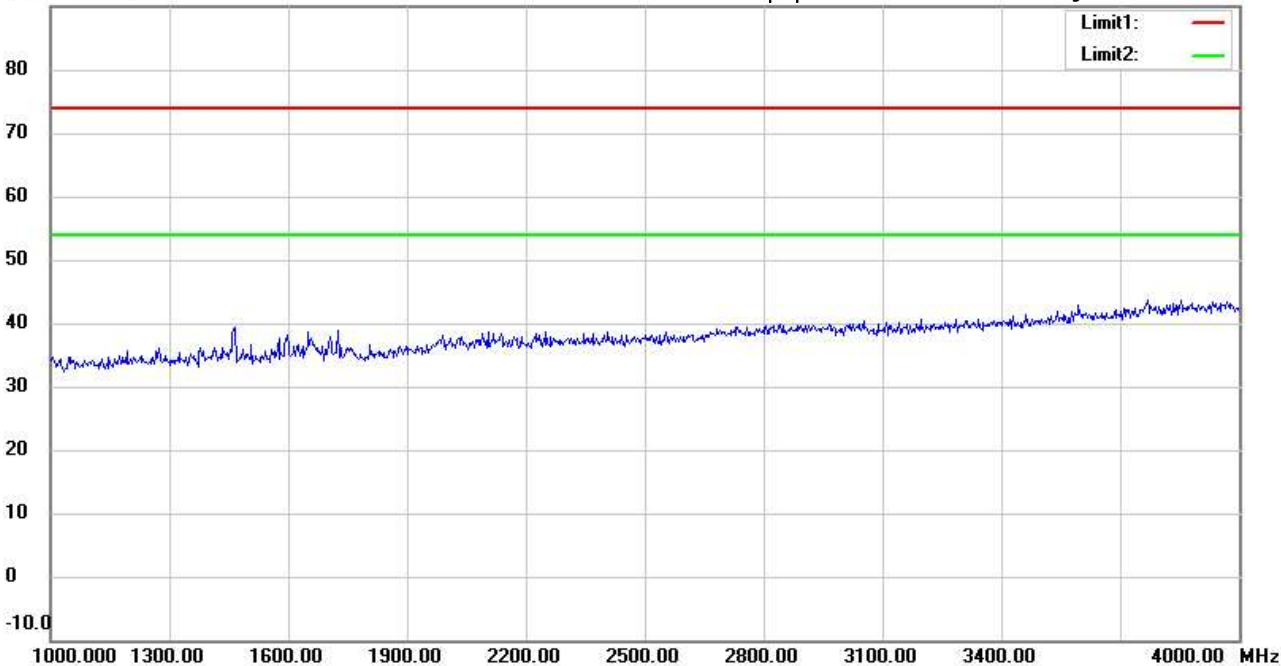
Data :#1

Condition : FCC\_part 15E RE\_Above 1GHz\_PK

Test Mode : TX 802.11a CH149

Polarization: *Horizontal*

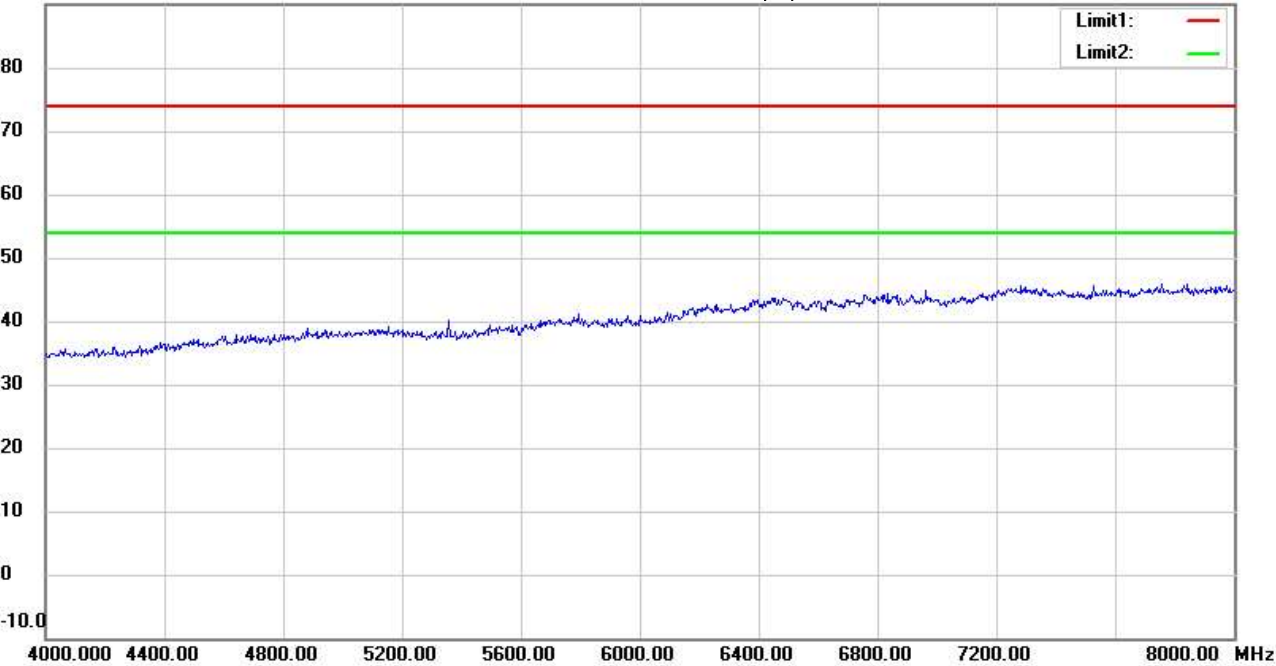
Site : 966A Chamber  
Condition : FCC\_part 15E RE\_Above 1GHz\_PK  
EUT : W6M22409-23739  
M/N:  
Test Mode : TX 802.11a CH149  
Note :

Polarization: *Horizontal*  
Power : 120 Va.c.  
Distance: 3m

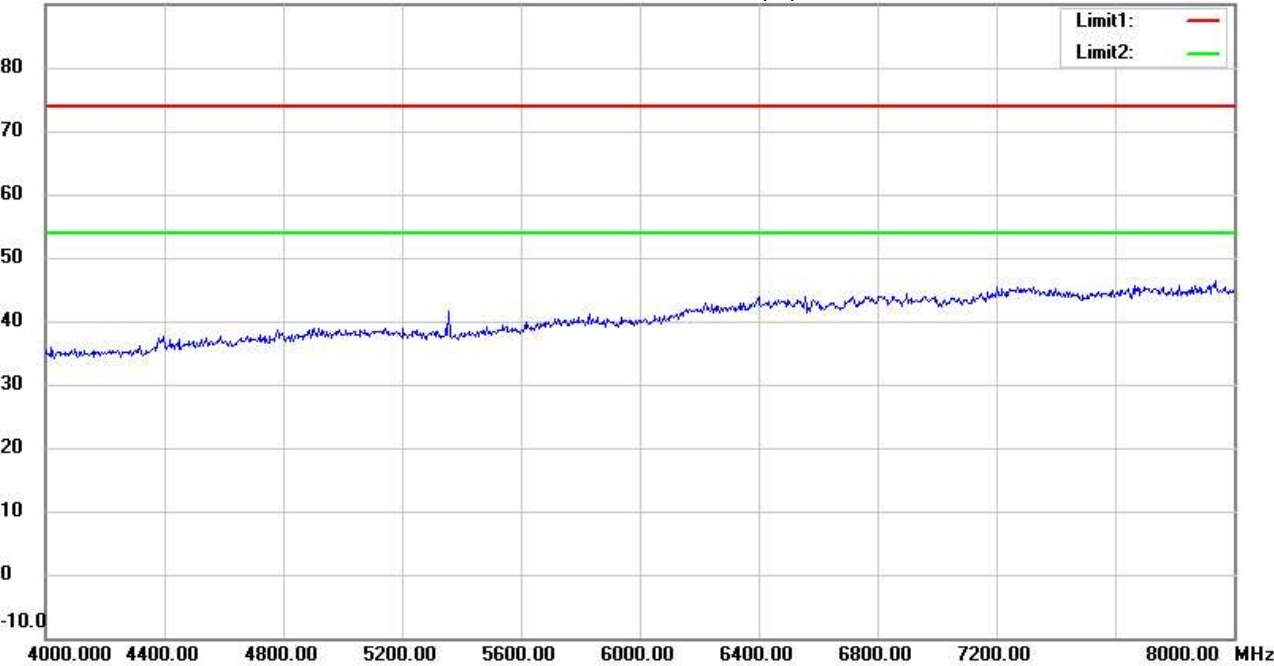
Site : 966A Chamber  
Condition : FCC\_part 15E RE\_Above 1GHz\_PK  
EUT : W6M22409-23739  
M/N:  
Test Mode : TX 802.11a CH149  
Note :

Polarization: Vertical  
Power : 120 Va.c.  
Distance: 3m

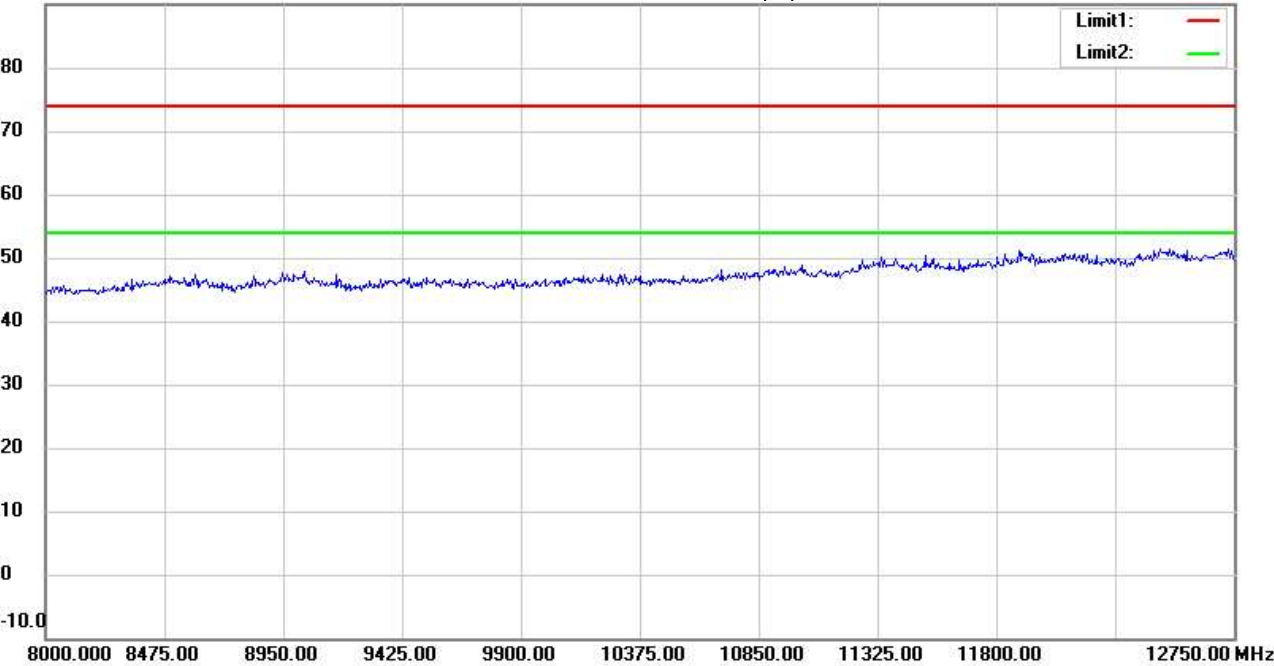
Site : 966A Chamber  
Condition : FCC\_part 15E RE\_Above 1GHz\_PK  
EUT : W6M22409-23739  
M/N:  
Test Mode : TX 802.11a CH149  
Note :

Polarization: Vertical  
Power : 120 Va.c.  
Distance: 3m

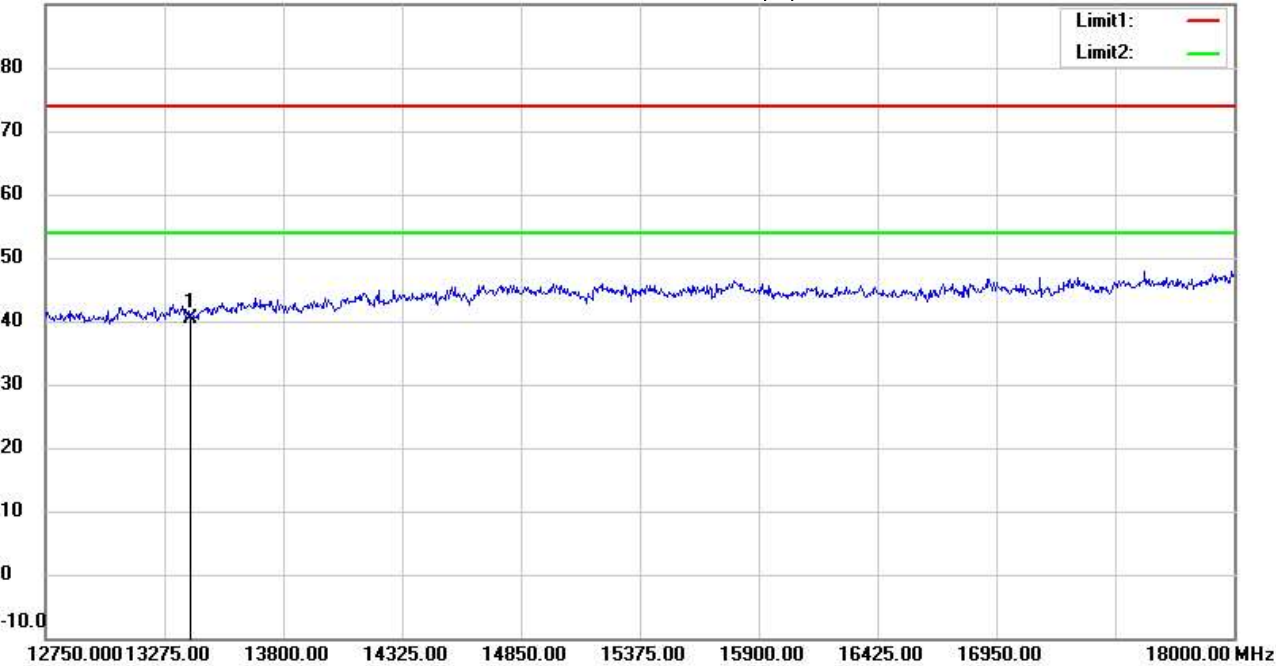
Data :#10

Site : 966A Chamber  
Condition : FCC\_part 15E RE\_Above 1GHz\_PK  
EUT : W6M22409-23739  
M/N:  
Test Mode : TX 802.11a CH149  
Note :

Polarization: Vertical  
Power : 120 Va.c.  
Distance: 3m

| Mk. | Frequency (MHz) | Reading (dBuV) | Detector | Corr. factor (dB/m) | Result (dBuV/m) | Limit (dBuV/m) | Ant.Pos (cm) | Tab.Pos (deg.) | Margin (dB) | Comment |
|---|---|---|---|---|---|---|---|---|---|---|
| * | 13390.000 | 22.32 | peak | 18.10 | 40.42 | 74.00 | 150 | 26 | -33.58 | |

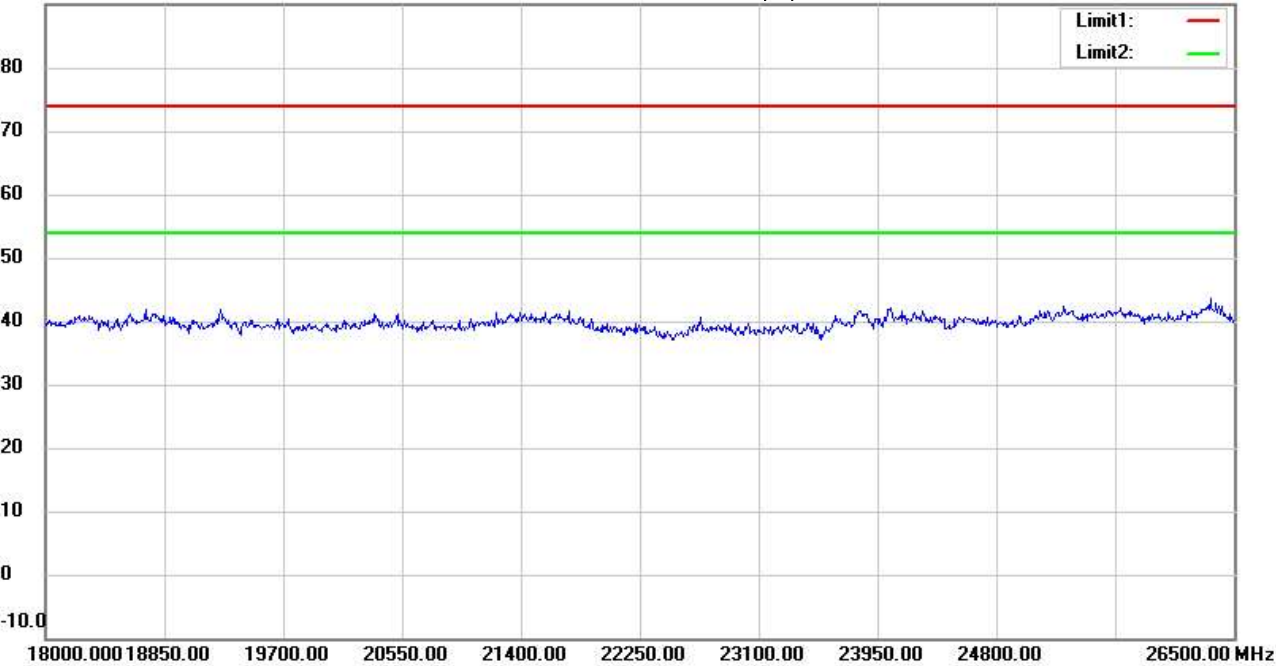
Site : 966A Chamber  
Condition : FCC\_part 15E RE\_Above 1GHz\_PK  
EUT : W6M22409-23739  
M/N:  
Test Mode : TX 802.11a CH149  
Note :

Polarization: Vertical  
Power : 120 Va.c.  
Distance: 3m

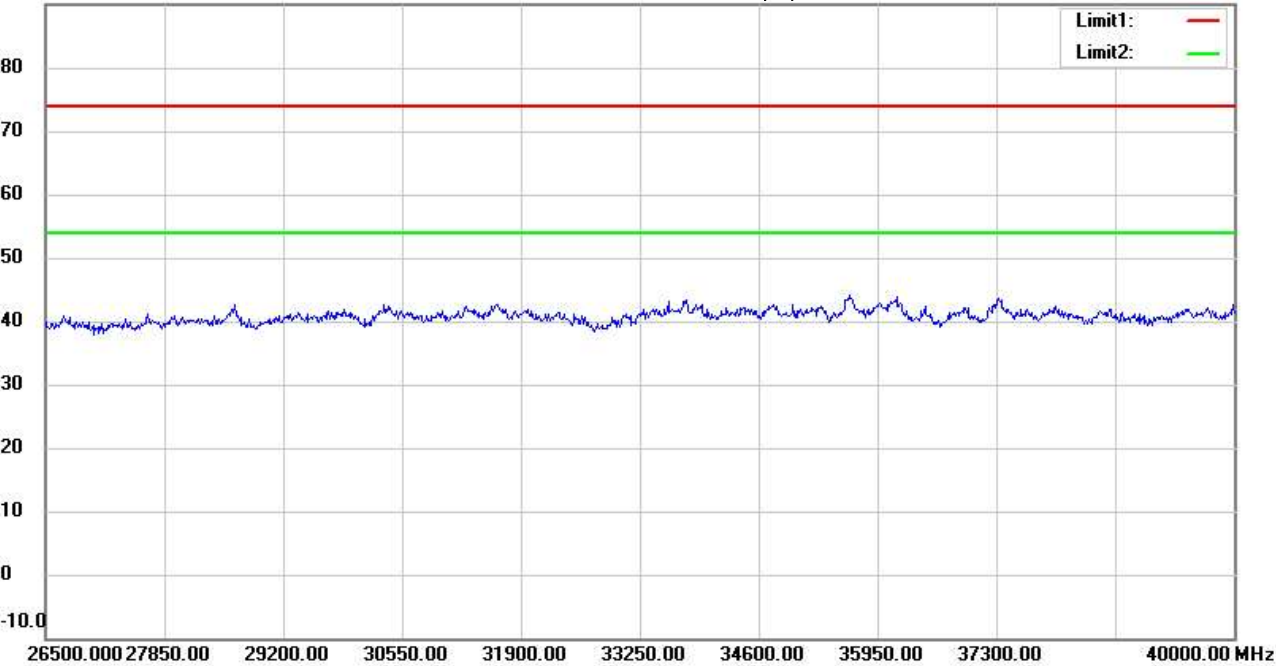
Site : 966A Chamber  
Condition : FCC\_part 15E RE\_Above 1GHz\_PK  
EUT : W6M22409-23739  
M/N:  
Test Mode : TX 802.11a CH149  
Note :

Polarization: Vertical  
Power : 120 Va.c.  
Distance: 3m

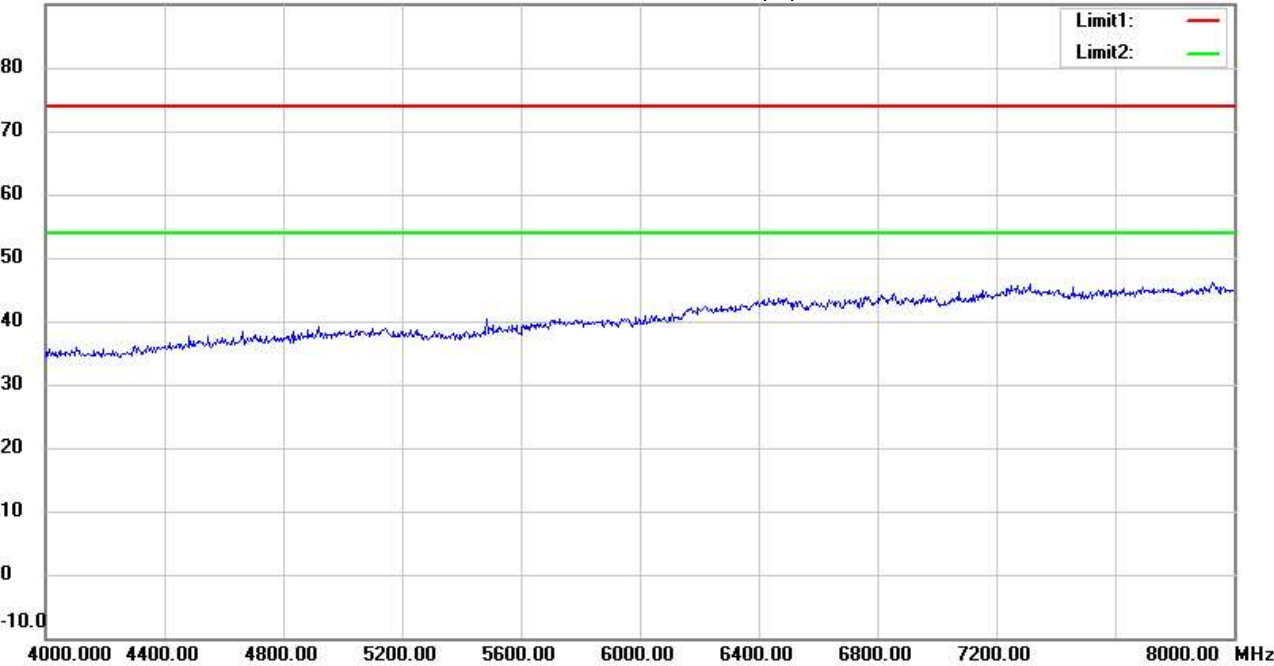
Site : 966A Chamber  
Condition : FCC\_part 15E RE\_Above 1GHz\_PK  
EUT : W6M22409-23739  
M/N:  
Test Mode : TX 802.11a CH181  
Note :

Polarization: *Horizontal*  
Power : 120 Va.c.  
Distance: 3m

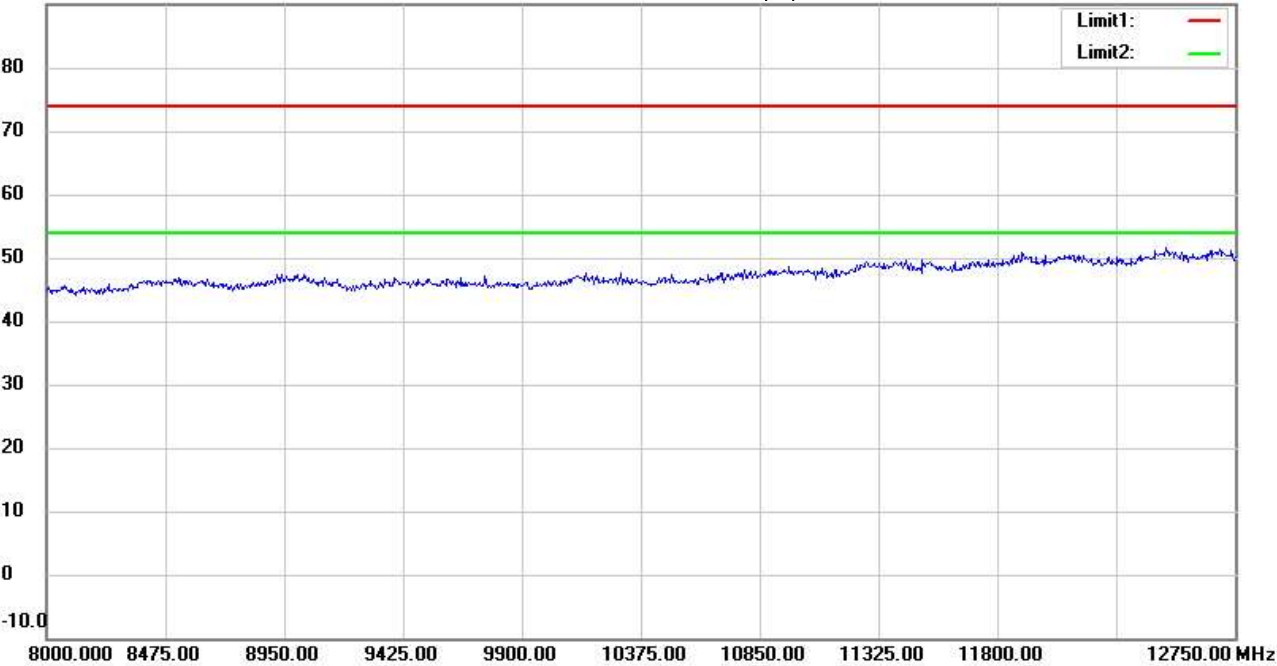
Site : 966A Chamber  
Condition : FCC\_part 15E RE\_Above 1GHz\_PK  
EUT : W6M22409-23739  
M/N:  
Test Mode : TX 802.11a CH181  
Note :

Polarization: Vertical  
Power : 120 Va.c.  
Distance: 3m

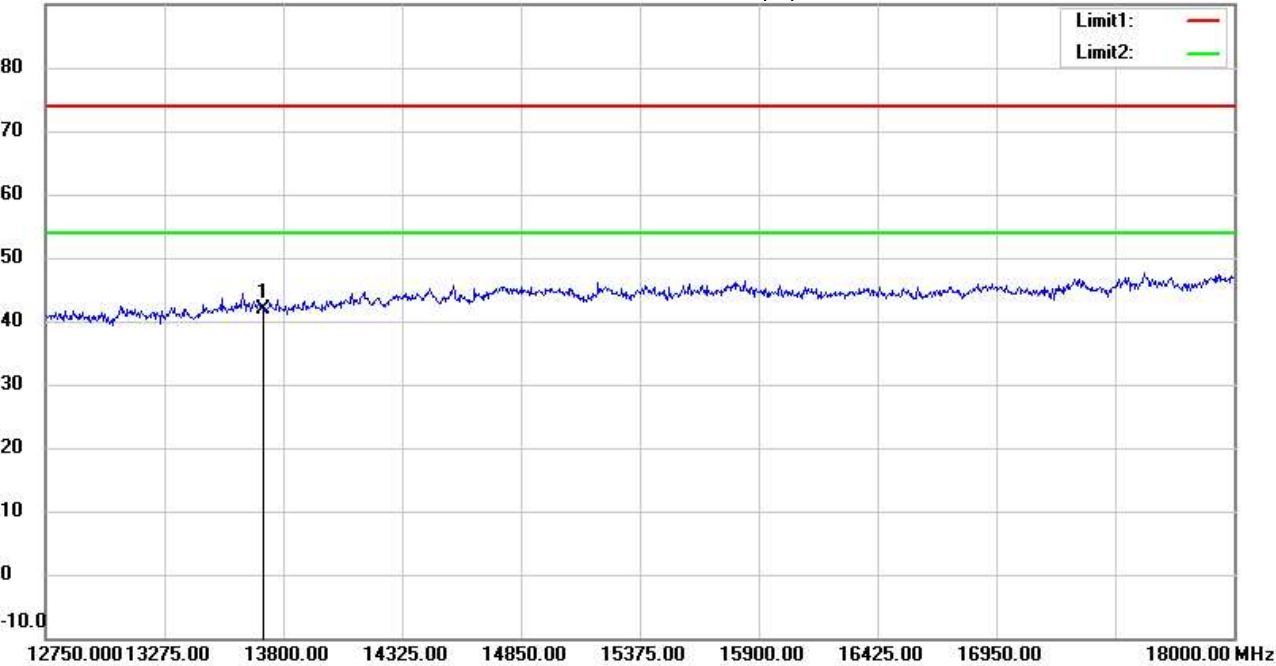
Data :#4

Test Mode : TX 802.11a CH181

Polarization: **Horizontal**

| Mk. | Frequency (MHz) | Reading (dBuV) | Detector | Corr. factor (dB/m) | Result (dBuV/m) | Limit (dBuV/m) | Ant.Pos (cm) | Tab.Pos (deg.) | Margin (dB) | Comment |
|---|---|---|---|---|---|---|---|---|---|---|
| * | 13710.000 | 21.93 | peak | 20.03 | 41.96 | 74.00 | 150 | 271 | -32.04 | |
