Radiated Emission Measurement

Site : 966A Chamber  
Condition : FCC\_part 15E RE\_Above 1GHz\_PK  
EUT : W6M22409-23739  
M/N:  
Test Mode : TX 802.11a CH181  
Note :

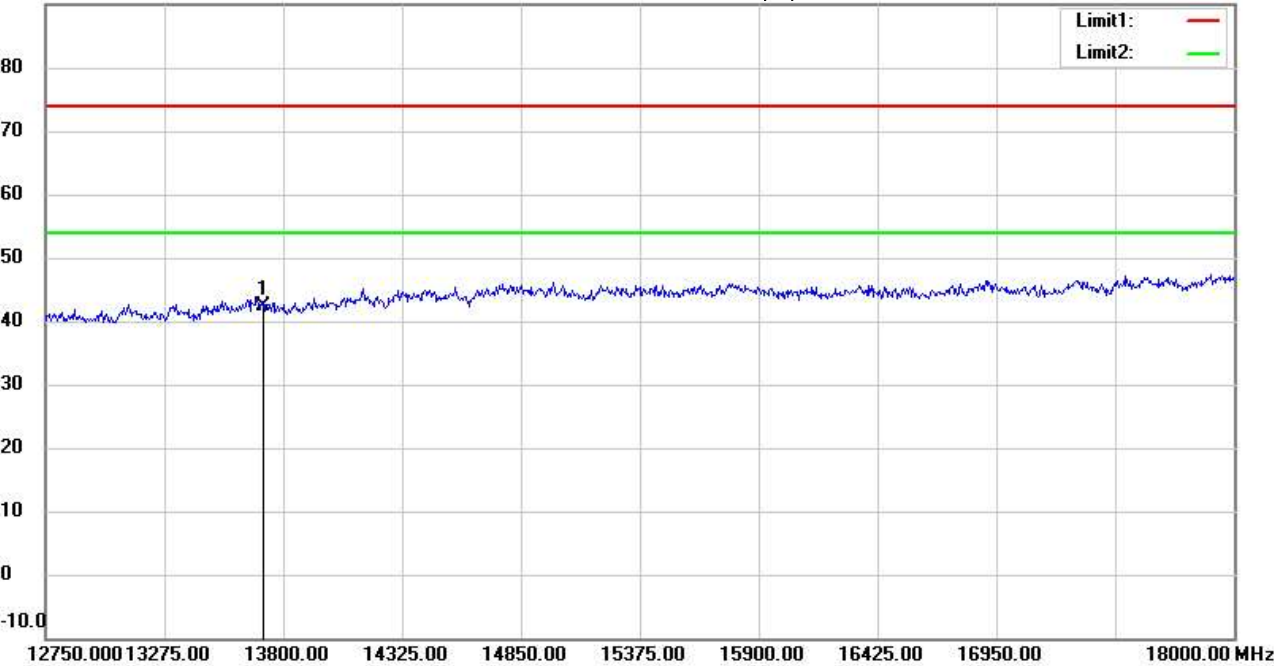
Polarization: Vertical  
Power : 120 Va.c.  
Distance: 3m

| Mk. | Frequency (MHz) | Reading (dBuV) | Detector | Corr. factor (dB/m) | Result (dBuV/m) | Limit (dBuV/m) | Ant.Pos (cm) | Tab.Pos (deg.) | Margin (dB) | Comment |
|---|---|---|---|---|---|---|---|---|---|---|
| * | 13710.000 | 22.27 | peak | 20.03 | 42.30 | 74.00 | 150 | 359 | -31.70 | |

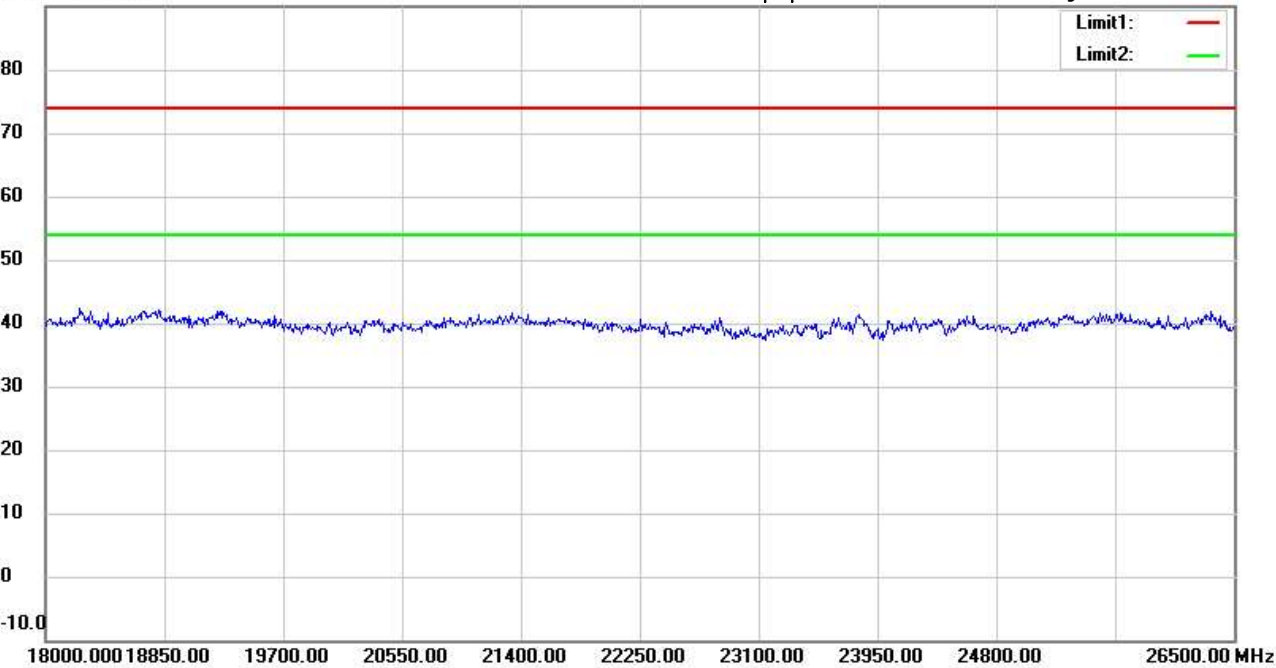
Condition : FCC\_part 15E RE\_Above 1GHz\_PK

Test Mode : TX 802.11a CH181

Polarization: **Horizontal**

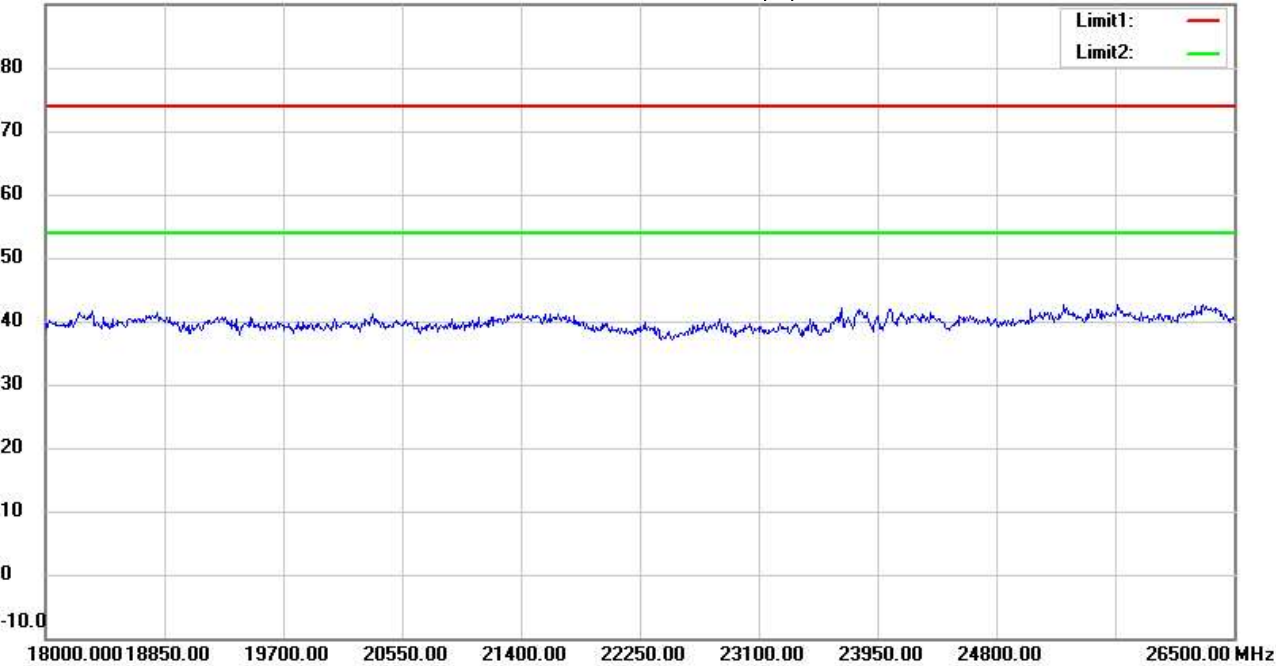
Site : 966A Chamber  
Condition : FCC\_part 15E RE\_Above 1GHz\_PK  
EUT : W6M22409-23739  
M/N:  
Test Mode : TX 802.11a CH181  
Note :

Polarization: Vertical  
Power : 120 Va.c.  
Distance: 3m

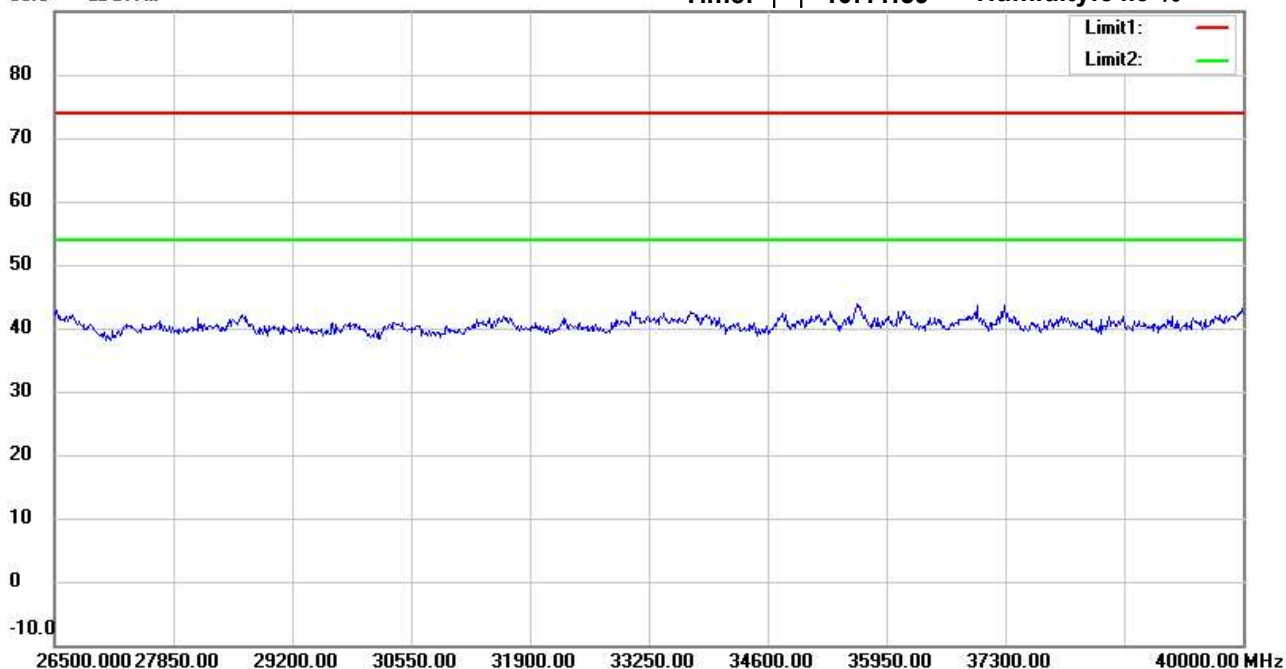
Condition : FCC\_part 15E RE\_Above 1GHz\_PK

Test Mode : TX 802.11a CH181

Polarization: **Horizontal**

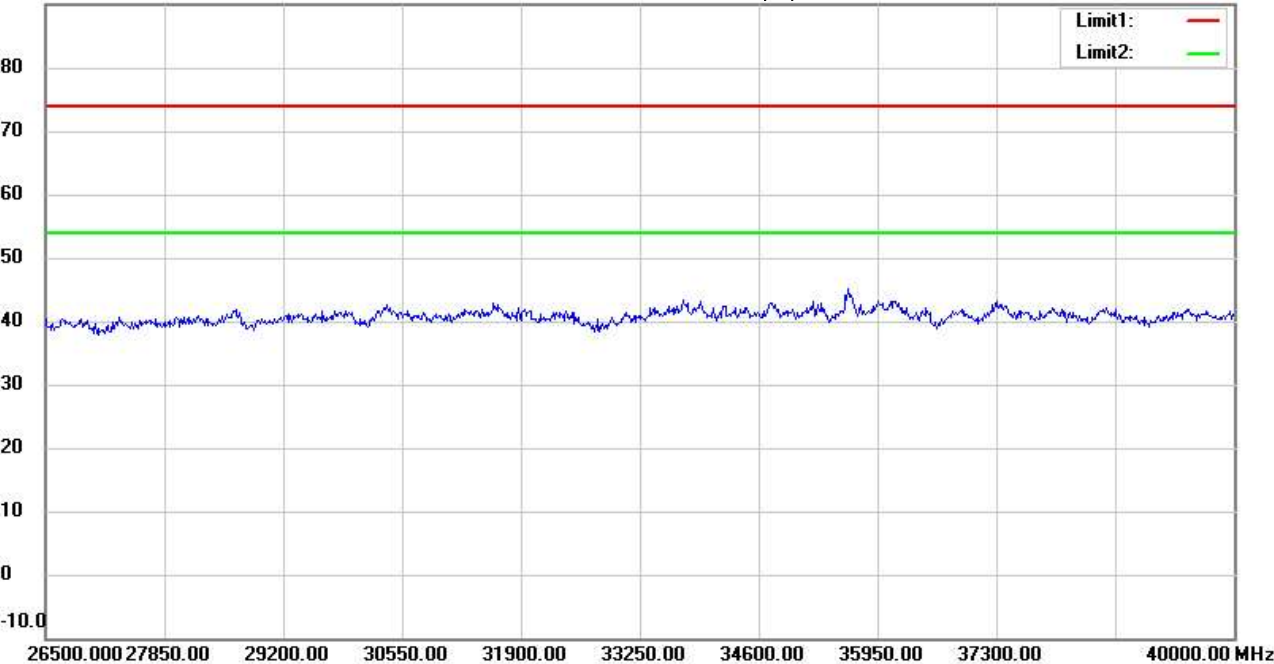
Condition : FCC\_part 15E RE\_Above 1GHz\_PK

Test Mode : TX 802.11a CH181

Polarization: Vertical

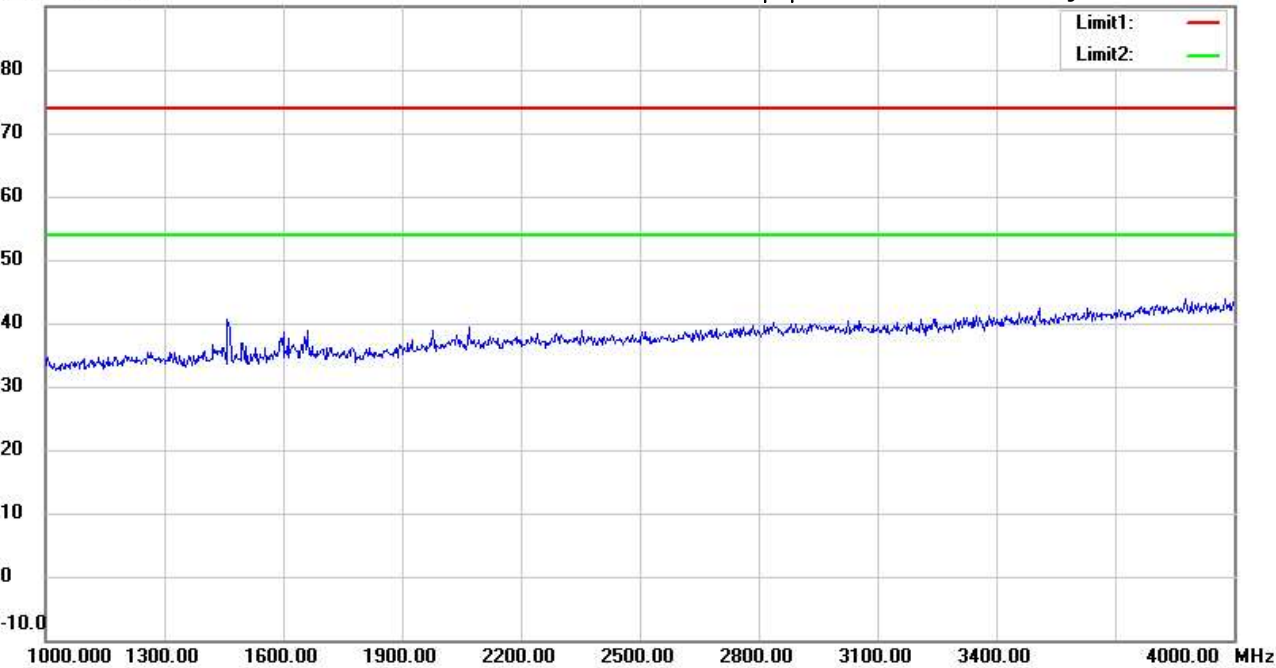
Condition : FCC\_part 15E RE\_Above 1GHz\_PK

Test Mode : TX 802.11a CH117

Polarization: Horizontal

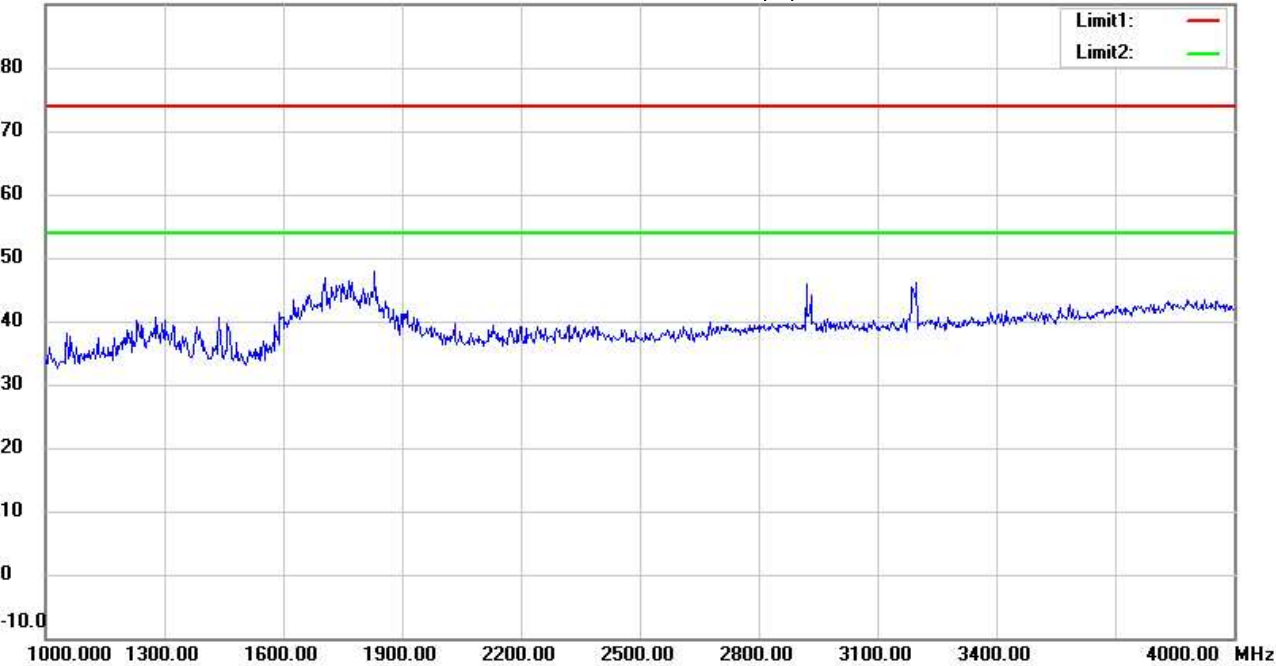
Condition : FCC\_part 15E RE\_Above 1GHz\_PK

Test Mode : TX 802.11a CH117

Polarization: Vertical

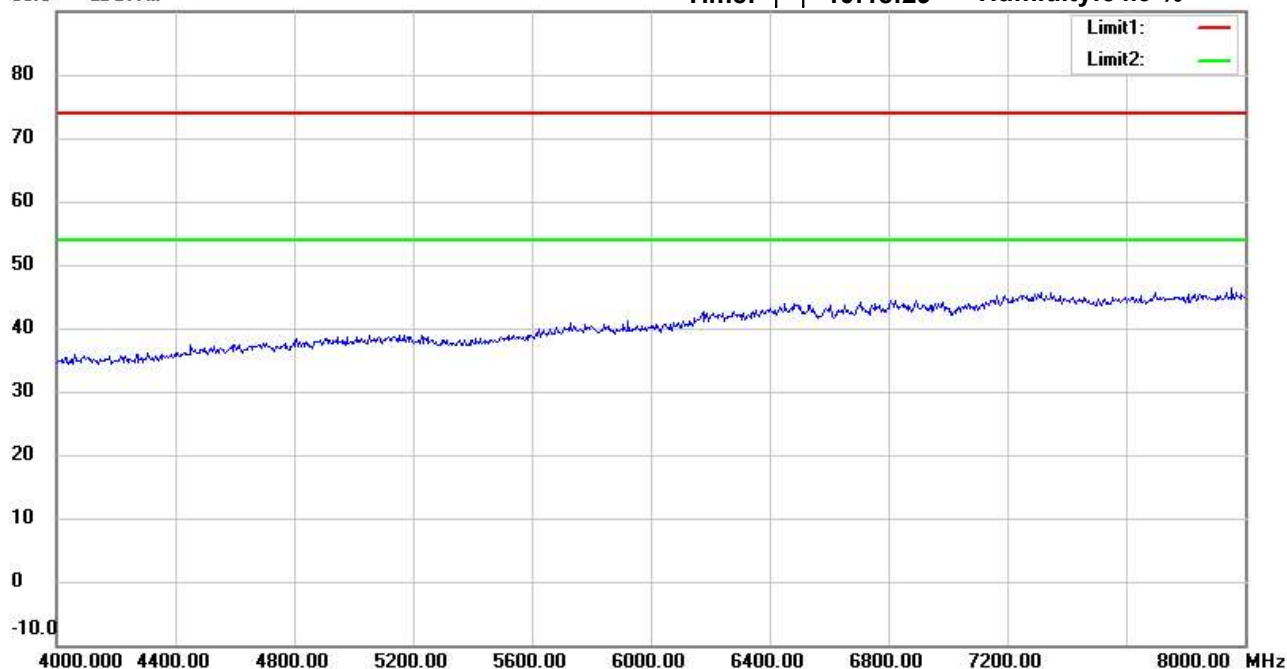
Condition : FCC\_part 15E RE\_Above 1GHz\_PK

Test Mode : TX 802.11a CH117

Polarization: **Horizontal**

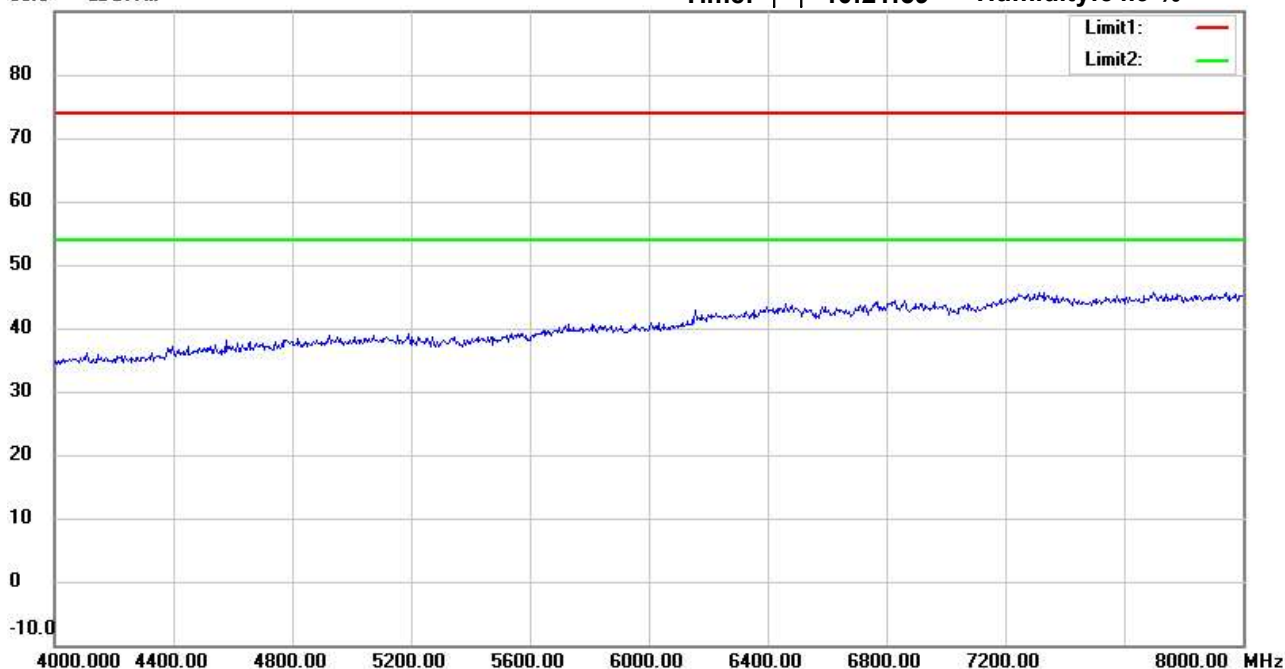
Condition : FCC\_part 15E RE\_Above 1GHz\_PK

Test Mode : TX 802.11a CH117

Polarization: **Vertical**

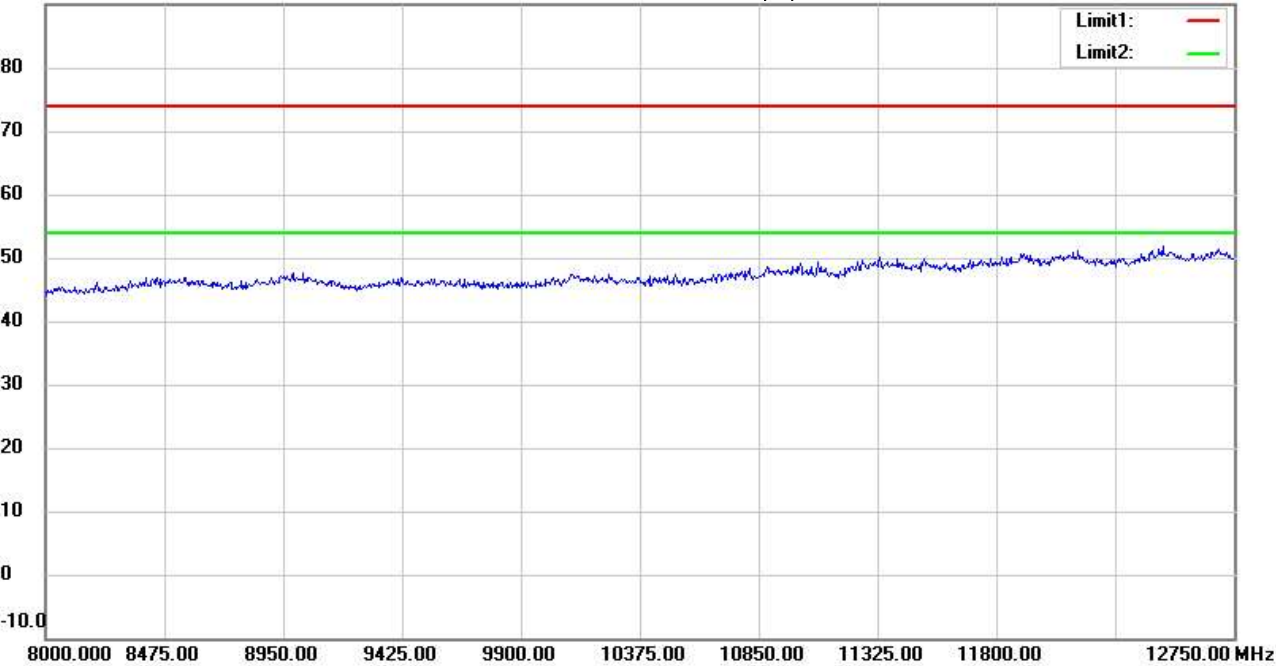
Condition : FCC\_part 15E RE\_Above 1GHz\_PK

Test Mode : TX 802.11a CH117

Polarization: *Horizontal*

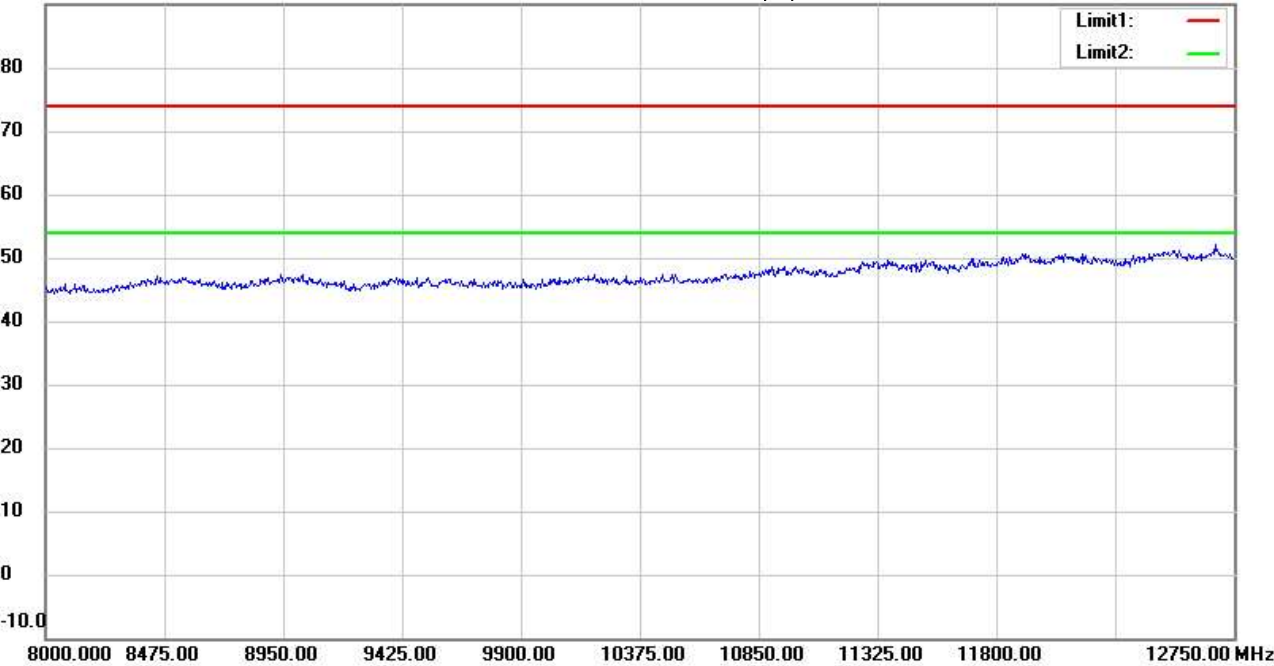
Site : 966A Chamber  
Condition : FCC\_part 15E RE\_Above 1GHz\_PK  
EUT : W6M22409-23739  
M/N:  
Test Mode : TX 802.11a CH117  
Note :

Polarization: Vertical  
Power : 120 Va.c.  
Distance: 3m

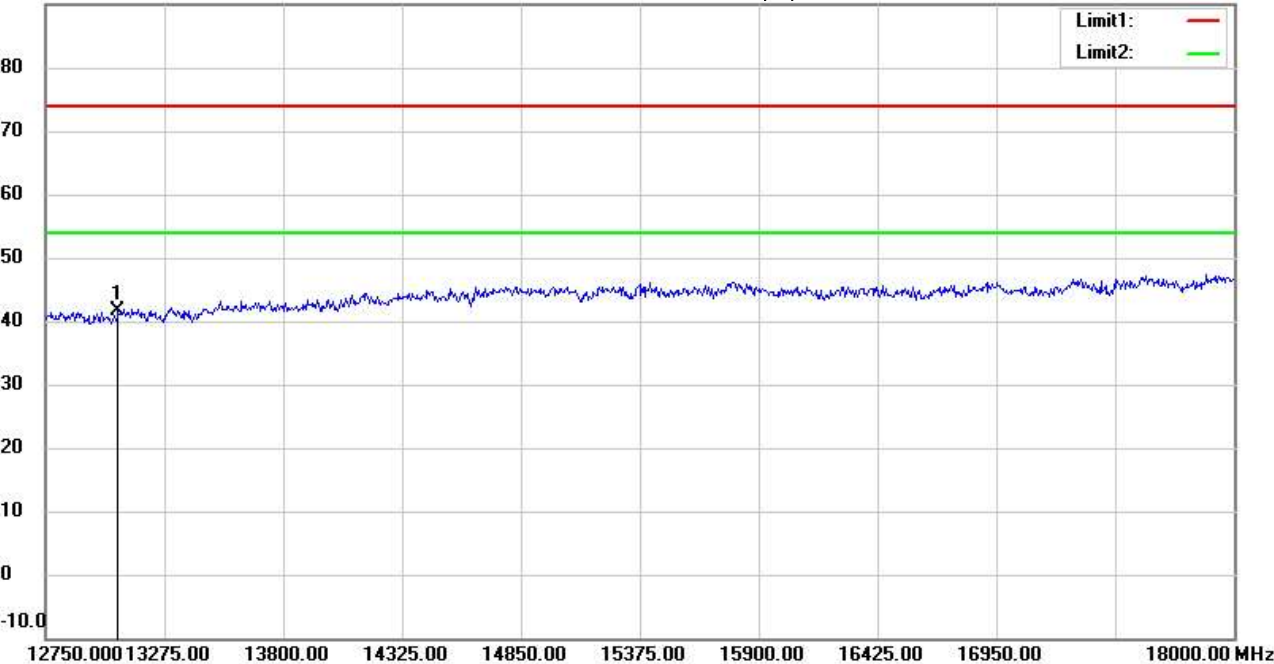
Site : 966A Chamber  
Condition : FCC\_part 15E RE\_Above 1GHz\_PK  
EUT : W6M22409-23739  
M/N:  
Test Mode : TX 802.11a CH117  
Note :

Polarization: **Horizontal**  
Power : 120 Va.c.  
Distance: 3m

| Mk. | Frequency (MHz) | Reading (dBuV) | Detector | Corr. factor (dB/m) | Result (dBuV/m) | Limit (dBuV/m) | Ant.Pos (cm) | Tab.Pos (deg.) | Margin (dB) | Comment |
|---|---|---|---|---|---|---|---|---|---|---|
| * | 13070.000 | 24.36 | peak | 17.21 | 41.57 | 74.00 | 150 | 28 | -32.43 | |

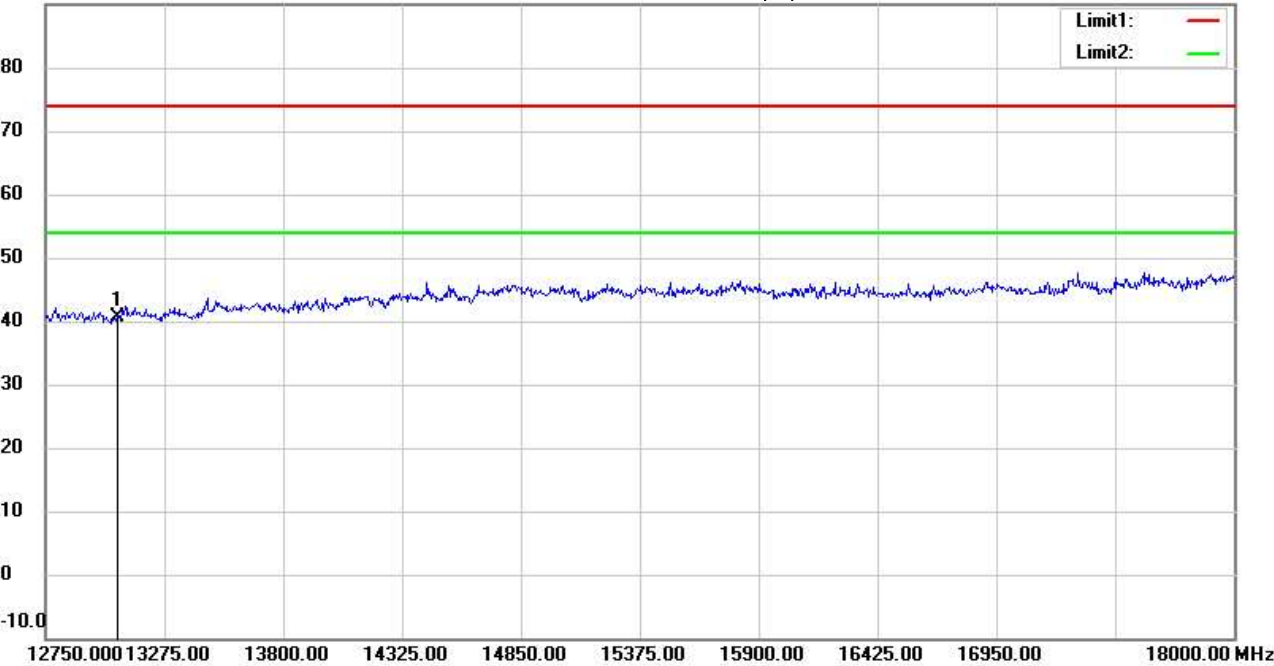
Site : 966A Chamber  
Condition : FCC\_part 15E RE\_Above 1GHz\_PK  
EUT : W6M22409-23739  
M/N:  
Test Mode : TX 802.11a CH117  
Note :

Polarization: Vertical  
Power : 120 Va.c.  
Distance: 3m

| Mk. | Frequency (MHz) | Reading (dBuV) | Detector | Corr. factor (dB/m) | Result (dBuV/m) | Limit (dBuV/m) | Ant.Pos (cm) | Tab.Pos (deg.) | Margin (dB) | Comment |
|---|---|---|---|---|---|---|---|---|---|---|
| * | 13070.000 | 23.38 | peak | 17.21 | 40.59 | 74.00 | 150 | 0 | -33.41 | |

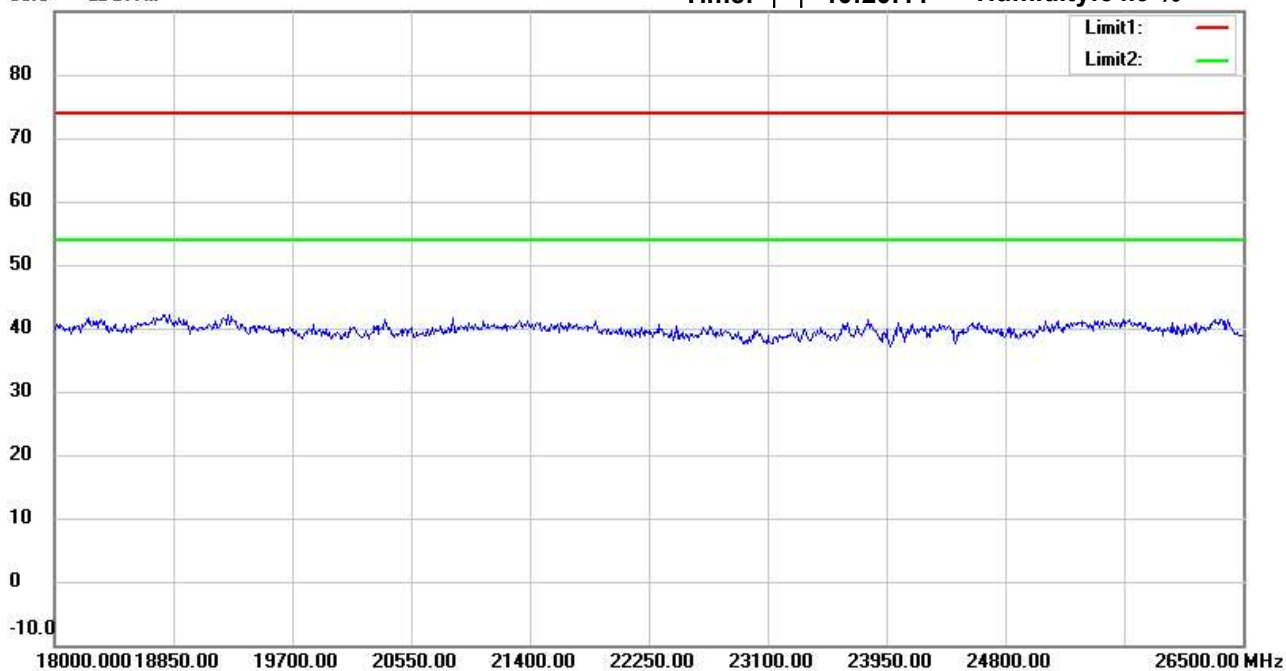
Condition : FCC\_part 15E RE\_Above 1GHz\_PK

Test Mode : TX 802.11a CH117

Polarization: **Horizontal**

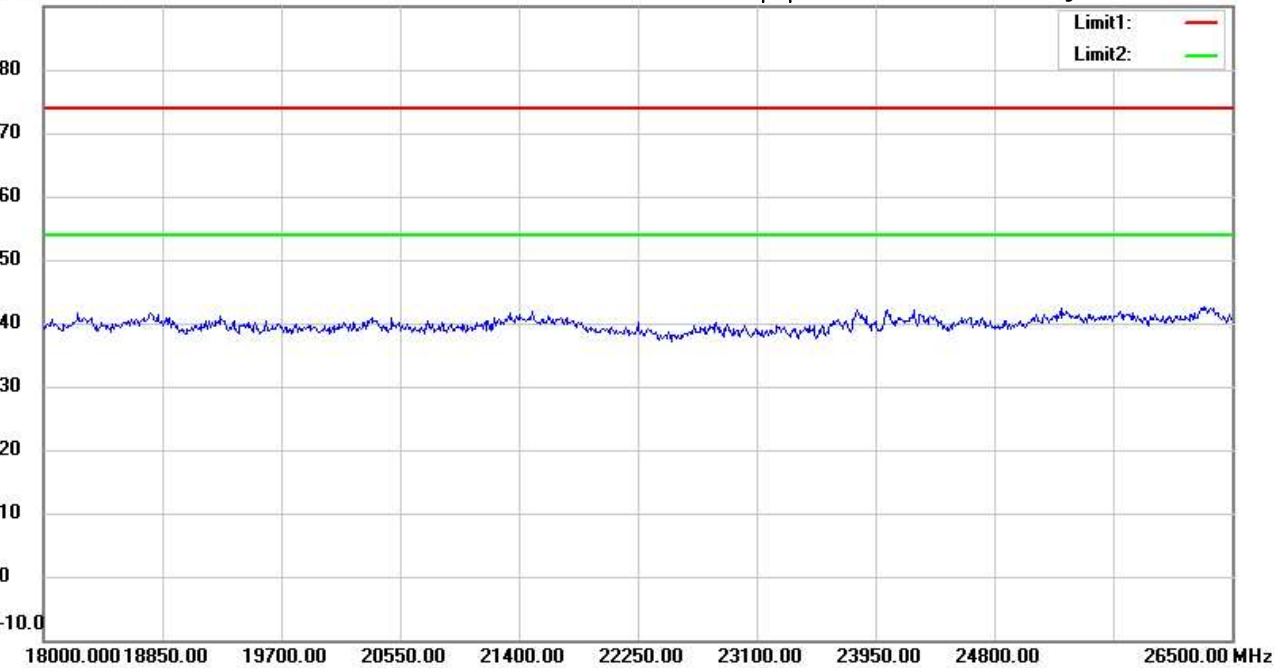
Condition : FCC\_part 15E RE\_Above 1GHz\_PK

Test Mode : TX 802.11a CH117

Polarization: Vertical

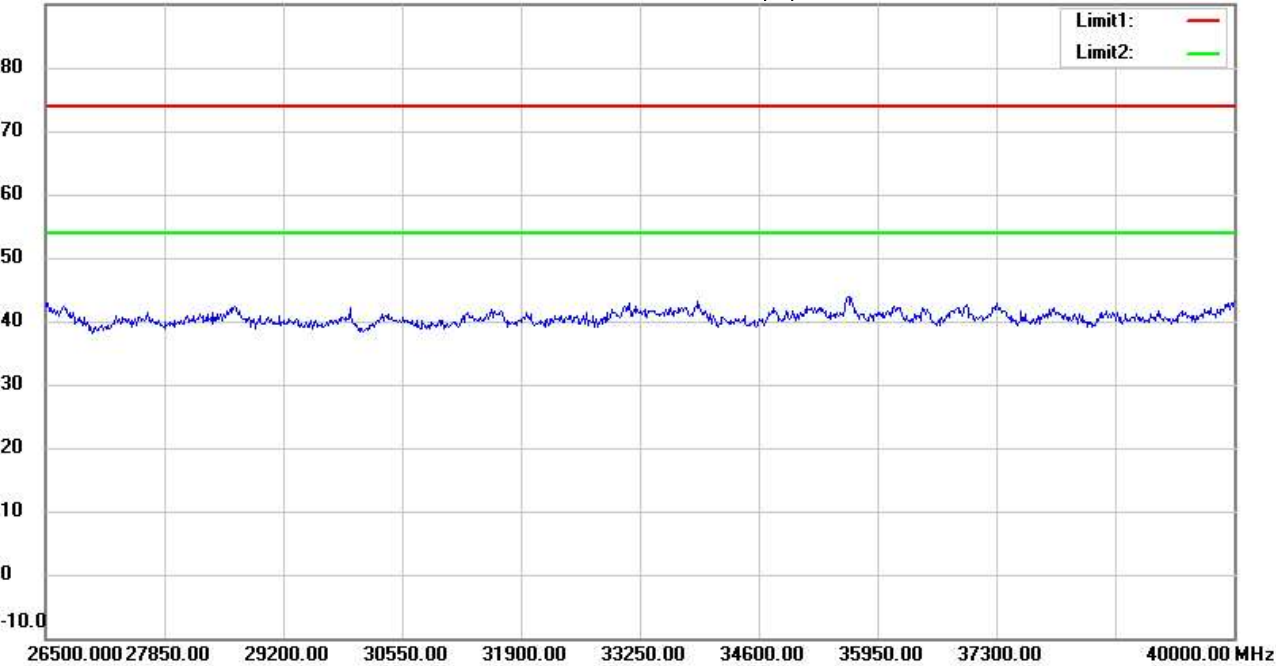
Site : 966A Chamber  
Condition : FCC\_part 15E RE\_Above 1GHz\_PK  
EUT : W6M22409-23739  
M/N:  
Test Mode : TX 802.11a CH117  
Note :

Polarization: Horizontal  
Power : 120 Va.c.  
Distance: 3m

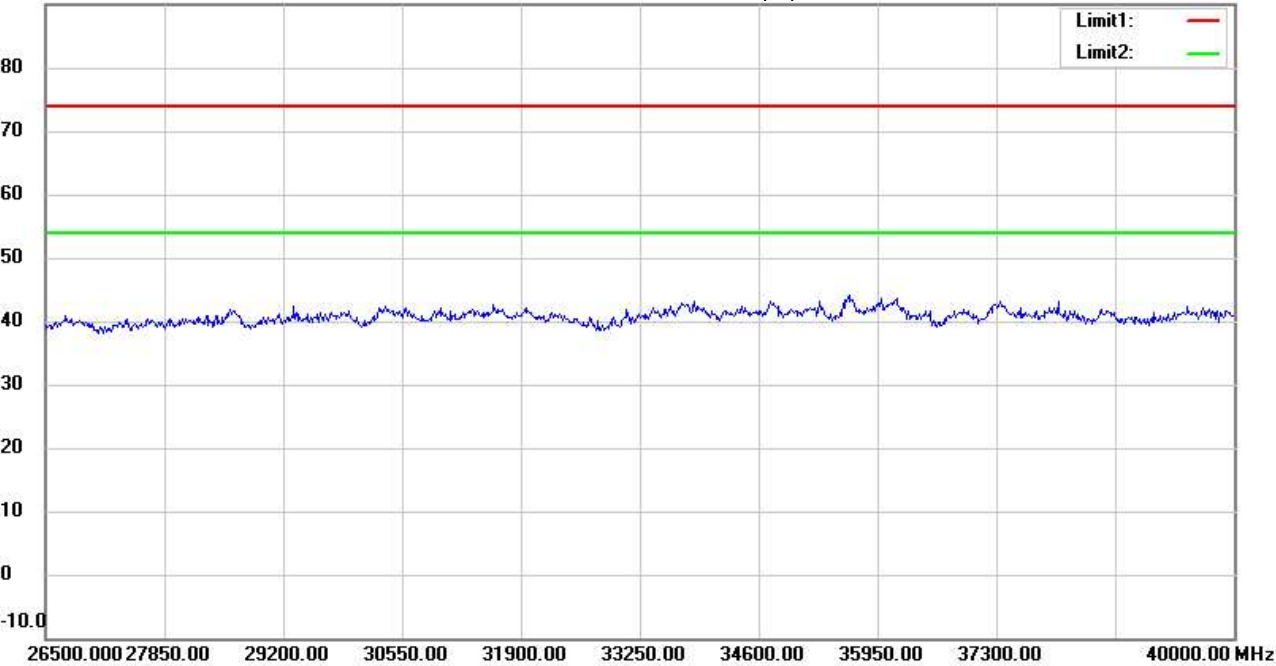
Site : 966A Chamber  
Condition : FCC\_part 15E RE\_Above 1GHz\_PK  
EUT : W6M22409-23739  
M/N:  
Test Mode : TX 802.11a CH117  
Note :

Polarization: Vertical  
Power : 120 Va.c.  
Distance: 3m

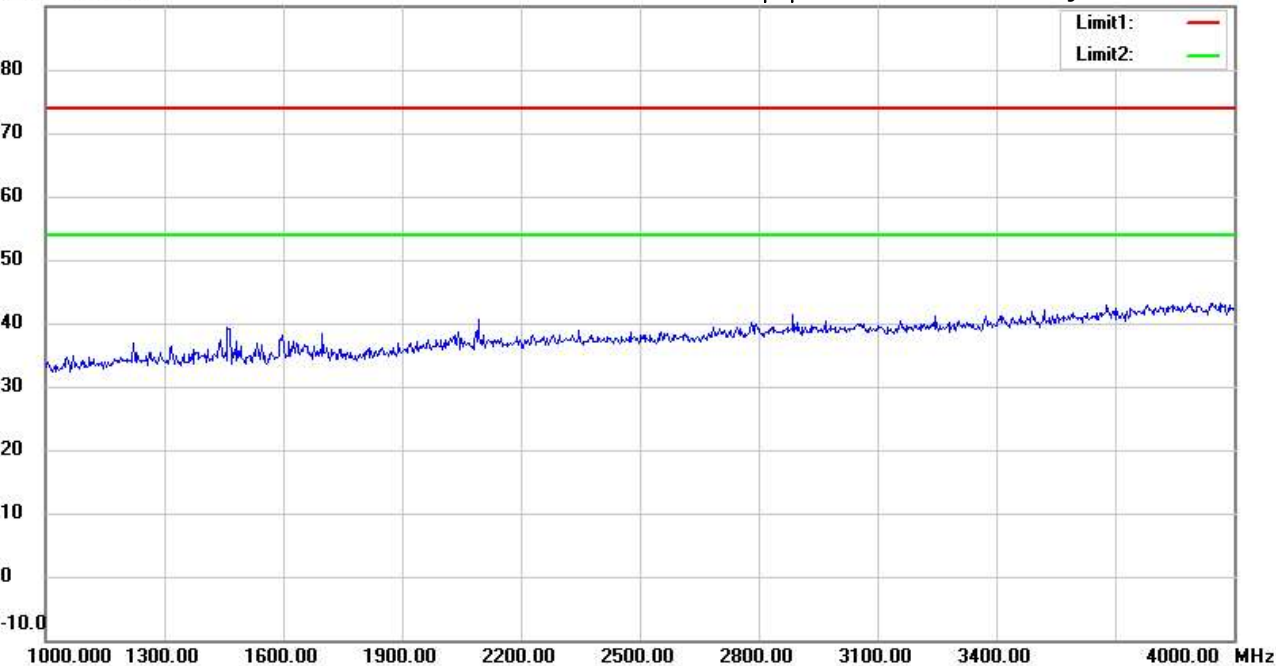
Condition : FCC\_part 15E RE\_Above 1GHz\_PK

Test Mode : TX 802.11a CH149

Polarization: Horizontal

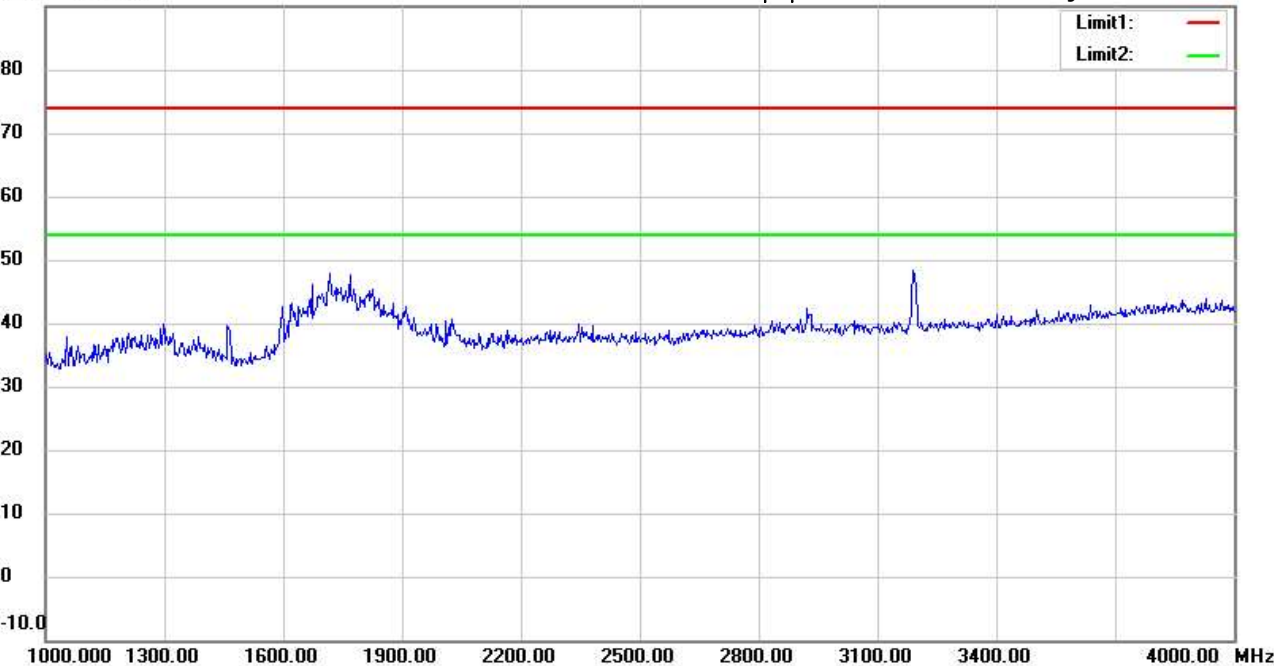
Condition : FCC\_part 15E RE\_Above 1GHz\_PK

Test Mode : TX 802.11a CH149

Polarization: Vertical

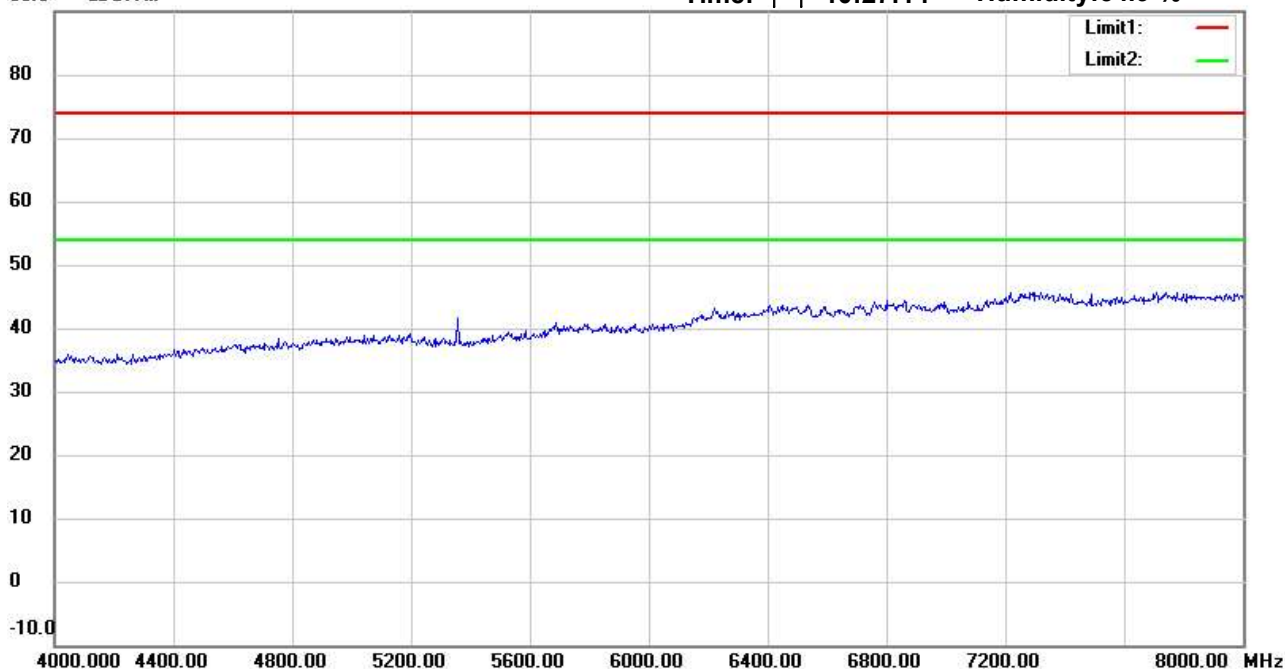
Condition : FCC\_part 15E RE\_Above 1GHz\_PK

Test Mode : TX 802.11a CH149

Polarization: **Horizontal**

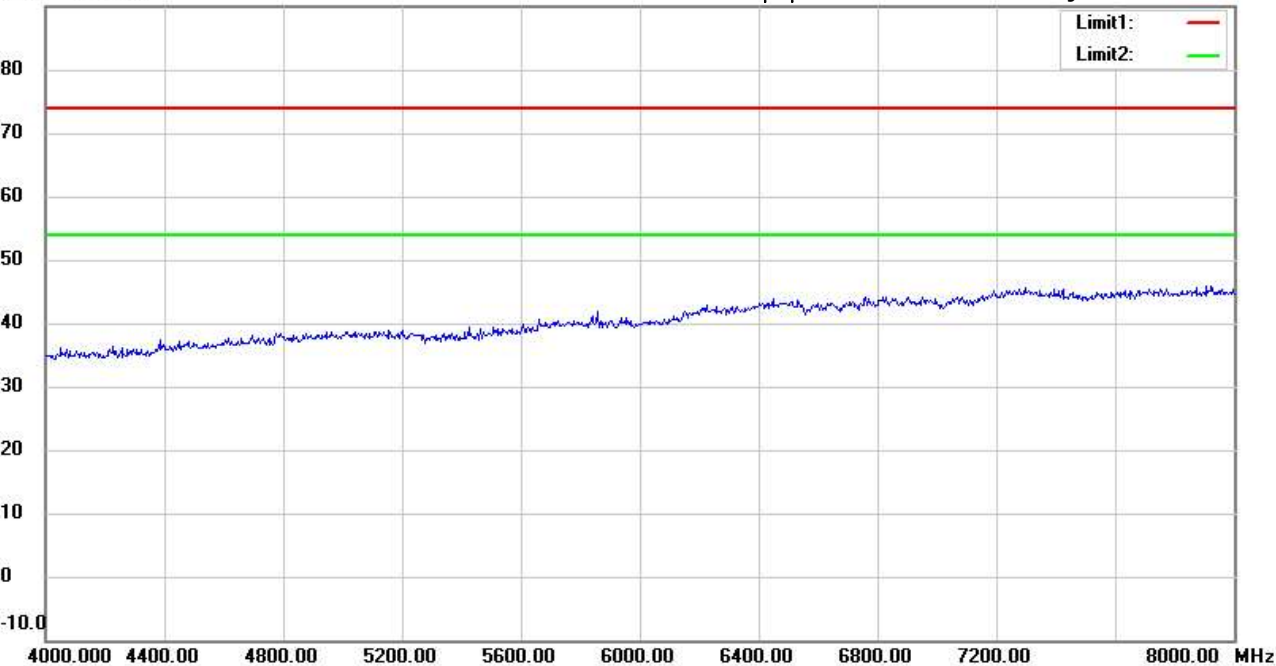
Condition : FCC\_part 15E RE\_Above 1GHz\_PK

Test Mode : TX 802.11a CH149

Polarization: Vertical

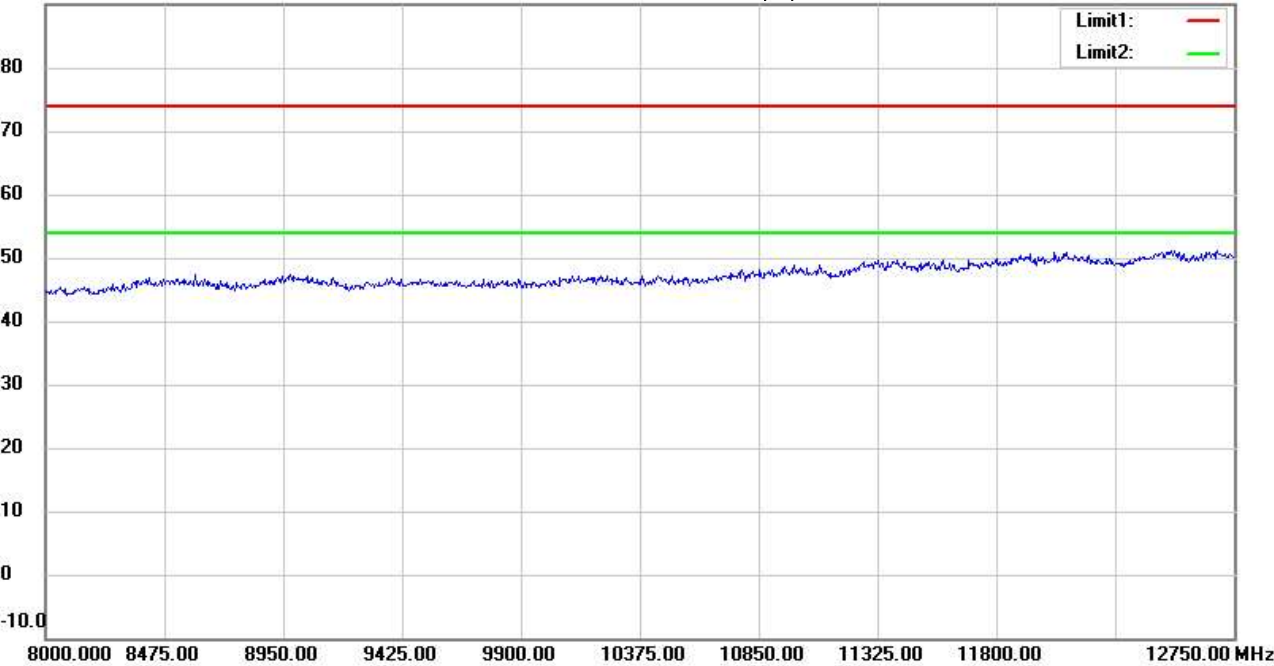
Site : 966A Chamber  
Condition : FCC\_part 15E RE\_Above 1GHz\_PK  
EUT : W6M22409-23739  
M/N:  
Test Mode : TX 802.11a CH149  
Note :

Polarization: Horizontal  
Power : 120 V.a.c.  
Distance: 3m

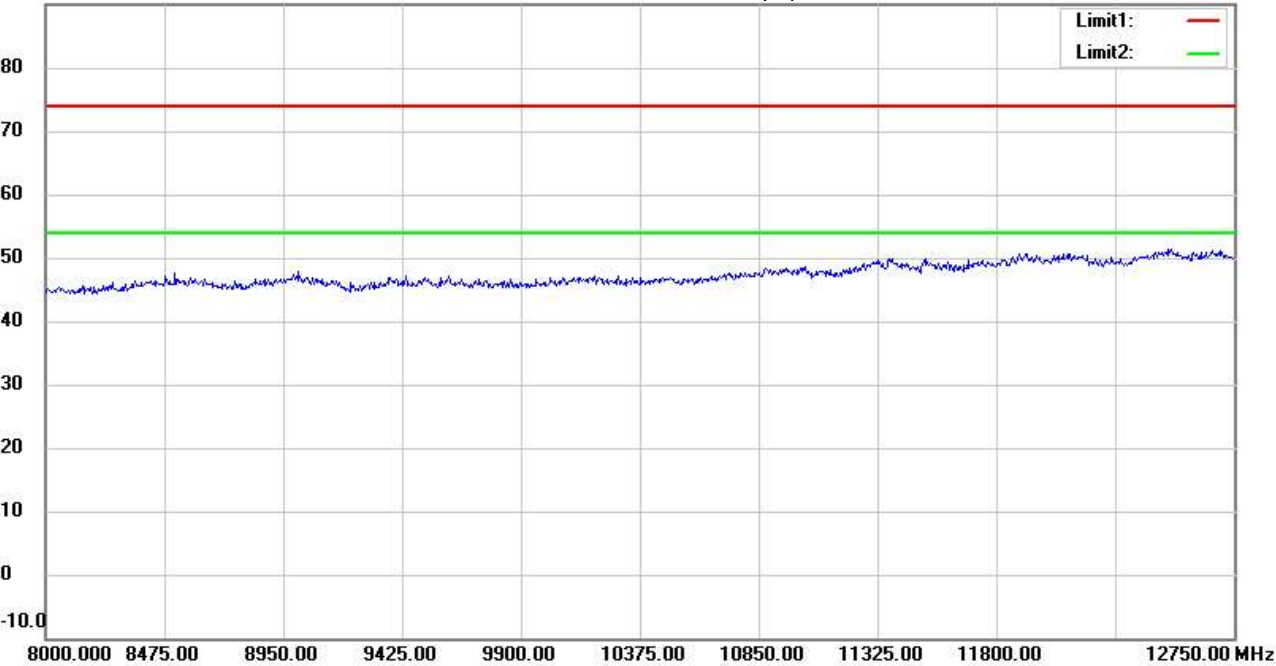
Site : 966A Chamber  
Condition : FCC\_part 15E RE\_Above 1GHz\_PK  
EUT : W6M22409-23739  
M/N:  
Test Mode : TX 802.11a CH149  
Note :

Polarization: Vertical  
Power : 120 Va.c.  
Distance: 3m

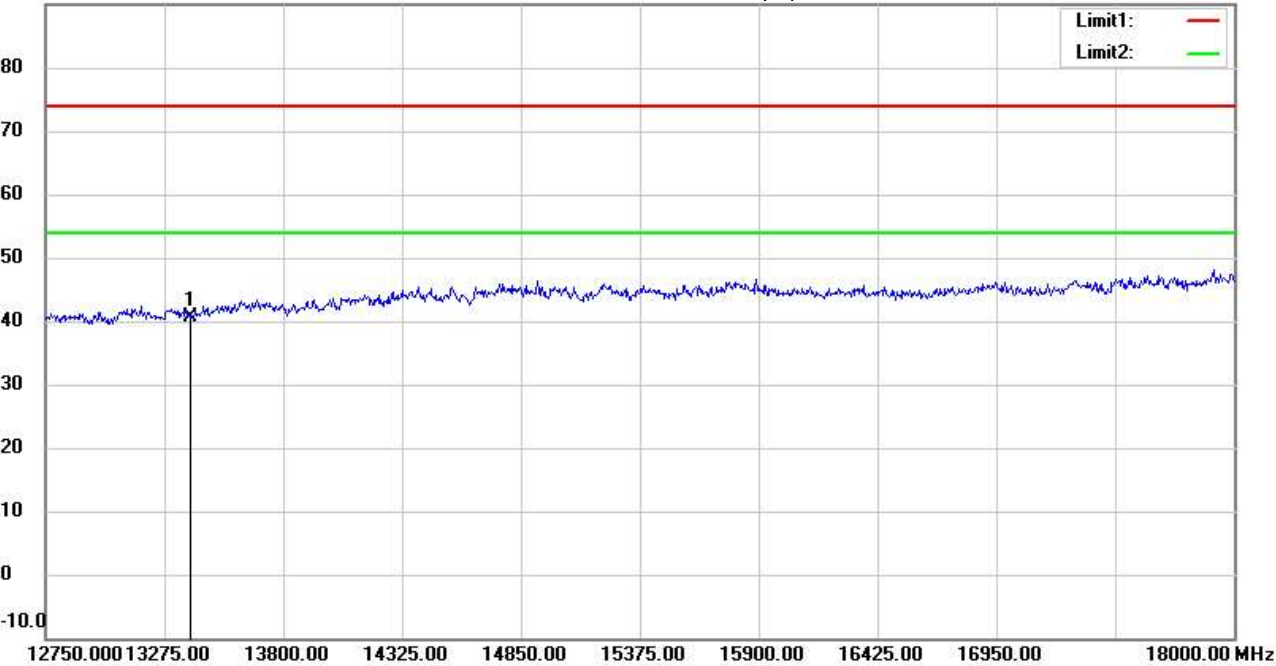
Site : 966A Chamber  
Condition : FCC\_part 15E RE\_Above 1GHz\_PK  
EUT : W6M22409-23739  
M/N:  
Test Mode : TX 802.11a CH149  
Note :

Polarization: **Horizontal**  
Power : 120 Va.c.  
Distance: 3m

| Mk. | Frequency (MHz) | Reading (dBuV) | Detector | Corr. factor (dB/m) | Result (dBuV/m) | Limit (dBuV/m) | Ant.Pos (cm) | Tab.Pos (deg.) | Margin (dB) | Comment |
|---|---|---|---|---|---|---|---|---|---|---|
| * | 13390.000 | 22.41 | peak | 18.10 | 40.51 | 74.00 | 150 | 64 | -33.49 | |

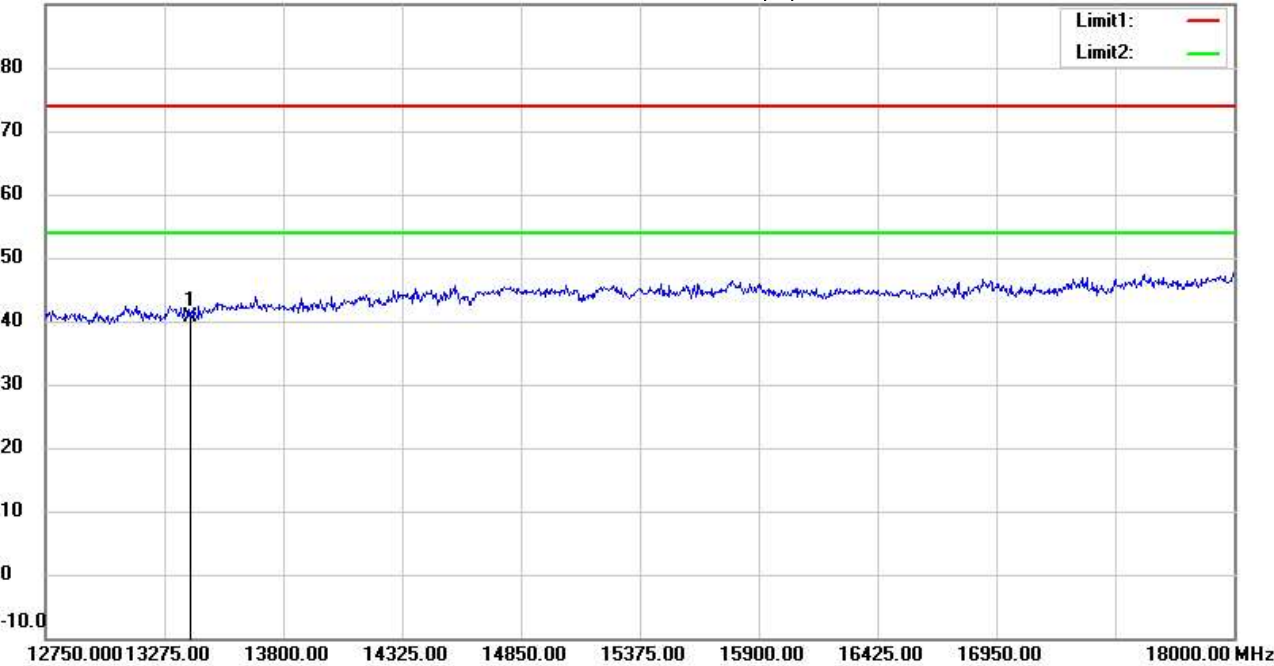
Site : 966A Chamber  
Condition : FCC\_part 15E RE\_Above 1GHz\_PK  
EUT : W6M22409-23739  
M/N:  
Test Mode : TX 802.11a CH149  
Note :

Polarization: Vertical  
Power : 120 Va.c.  
Distance: 3m

| Mk. | Frequency (MHz) | Reading (dBuV) | Detector | Corr. factor (dB/m) | Result (dBuV/m) | Limit (dBuV/m) | Ant.Pos (cm) | Tab.Pos (deg.) | Margin (dB) | Comment |
|---|---|---|---|---|---|---|---|---|---|---|
| * | 13390.000 | 22.46 | peak | 18.10 | 40.56 | 74.00 | 150 | 359 | -33.44 | |
