Radiated Emission Measurement

Site : 966A Chamber  
Condition : FCC\_part 15E RE\_Above 1GHz\_PK  
EUT : W6M22409-23739  
M/N:  
Test Mode : TX 802.11a CH181  
Note :

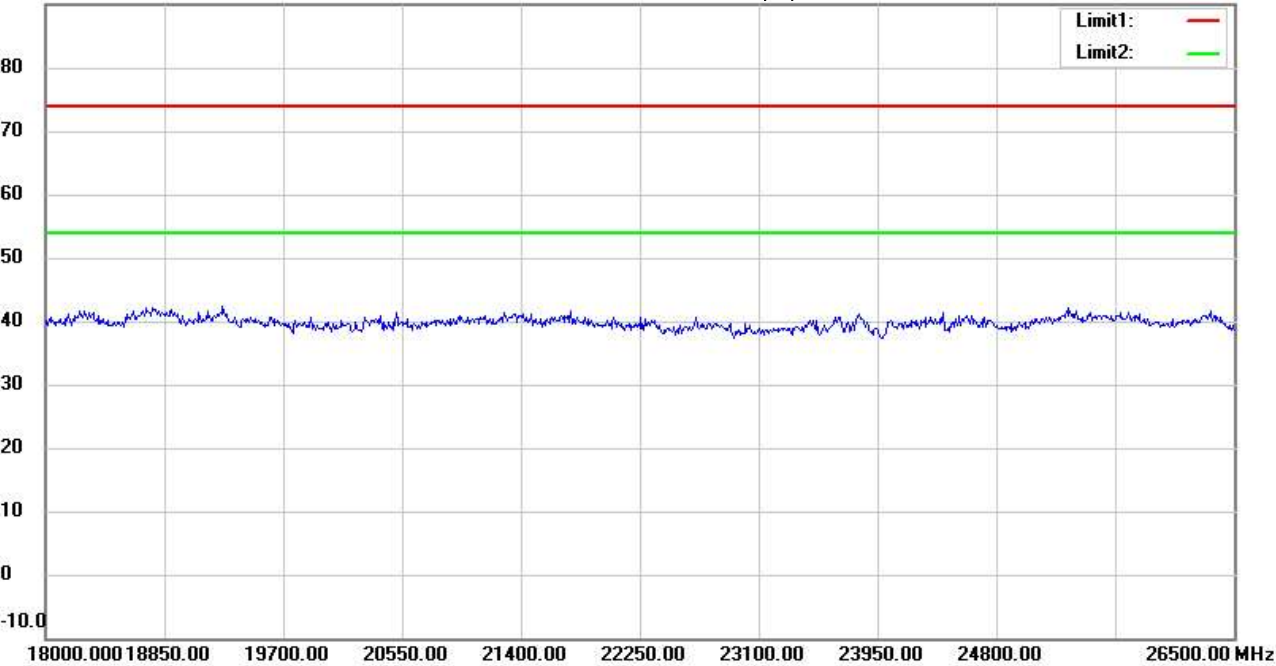
Site : 966A Chamber  
Condition : FCC\_part 15E RE\_Above 1GHz\_PK  
EUT : W6M22409-23739  
M/N:  
Test Mode : TX 802.11a CH149  
Note :

Polarization: **Horizontal**  
Power : 120 Va.c.  
Distance: 3m

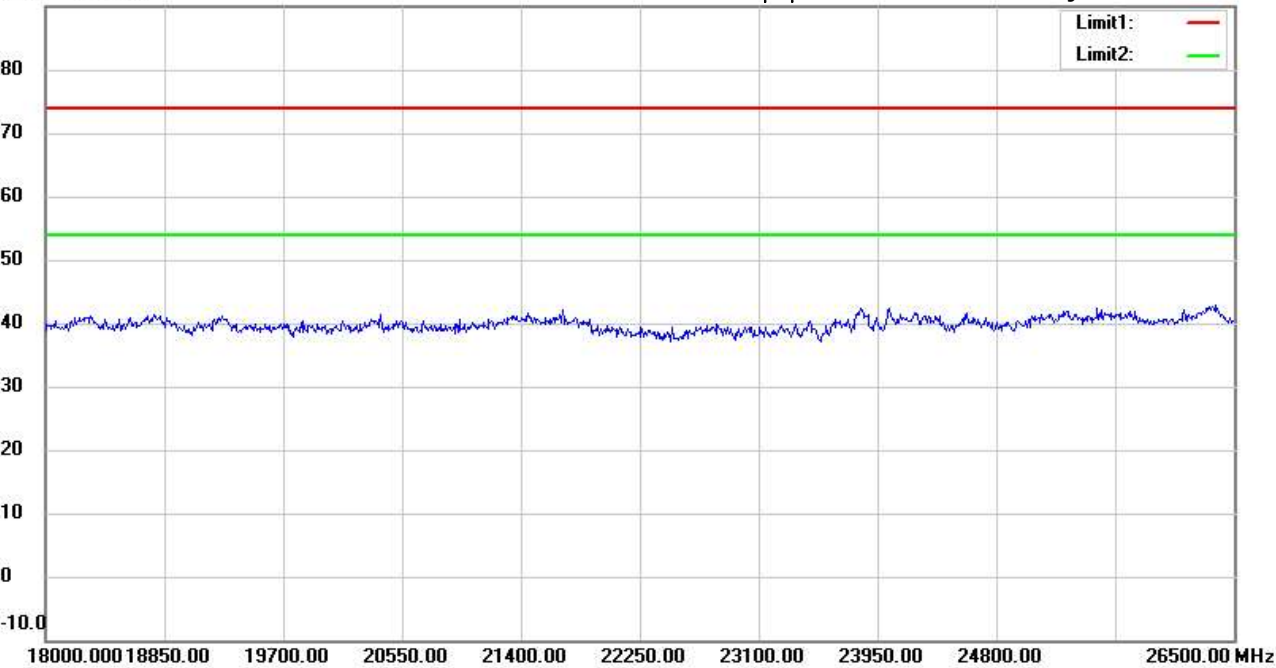
Condition : FCC\_part 15E RE\_Above 1GHz\_PK

Test Mode : TX 802.11a CH149

Polarization: Vertical
