Radiated Emission Measurement

Site : 966A Chamber  
Condition : FCC\_part 15E RE\_Above 1GHz\_PK  
EUT : W6M22409-23739  
M/N:  
Test Mode : TX 802.11a CH149  
Note :

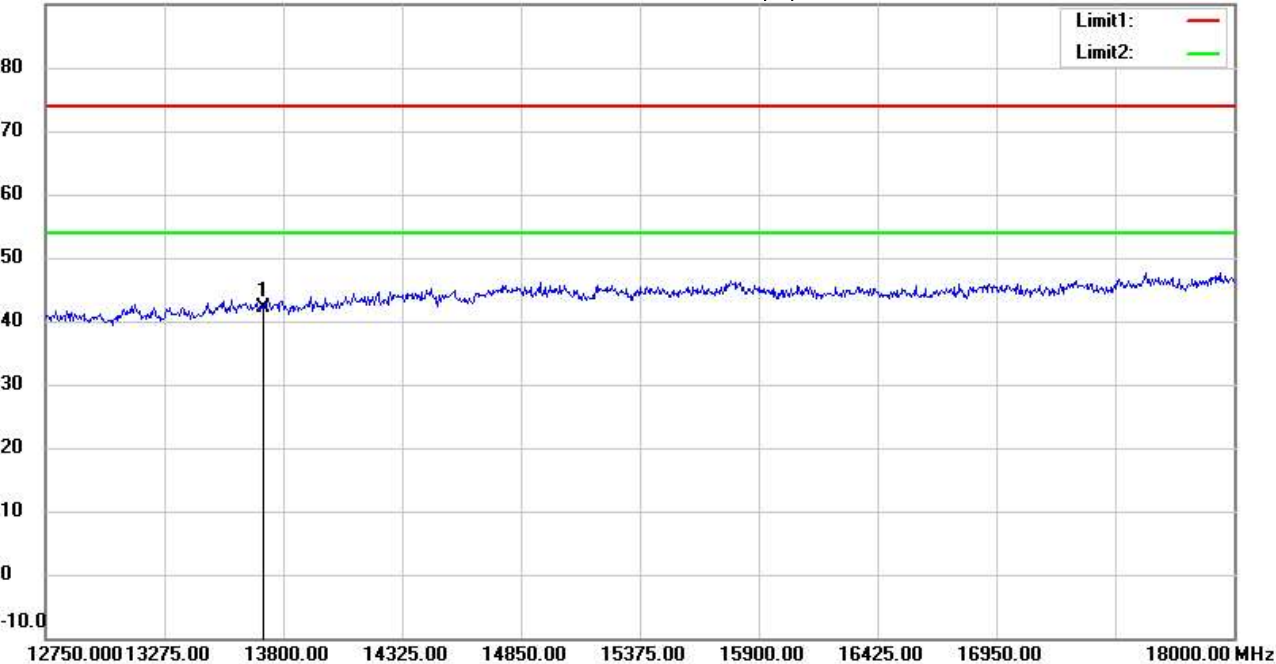
Data :#4

Condition : FCC\_part 15E RE\_Above 1GHz\_PK

Test Mode : TX 802.11a CH181

Polarization: **Horizontal**

| Mk. | Frequency (MHz) | Reading (dBuV) | Detector | Corr. factor (dB/m) | Result (dBuV/m) | Limit (dBuV/m) | Ant.Pos (cm) | Tab.Pos (deg.) | Margin (dB) | Comment |
|---|---|---|---|---|---|---|---|---|---|---|
| * | 13710.000 | 22.09 | peak | 20.03 | 42.12 | 74.00 | 150 | 65 | -31.88 | |

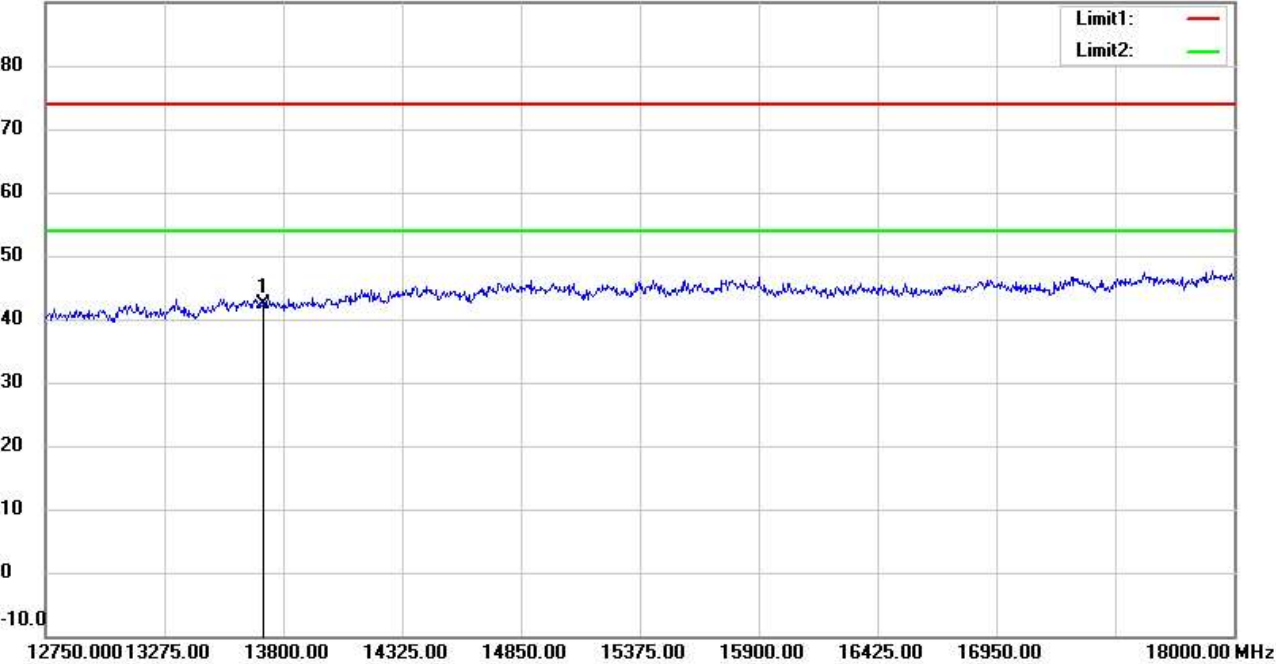
Data :#10

Condition : FCC\_part 15E RE\_Above 1GHz\_PK

Test Mode : TX 802.11a CH181

Polarization: Vertical

| Mk. | Frequency (MHz) | Reading (dBuV) | Detector | Corr. factor (dB/m) | Result (dBuV/m) | Limit (dBuV/m) | Ant.Pos (cm) | Tab.Pos (deg.) | Margin (dB) | Comment |
|---|---|---|---|---|---|---|---|---|---|---|
| * | 13710.000 | 22.31 | peak | 20.03 | 42.34 | 74.00 | 150 | 143 | -31.66 | |

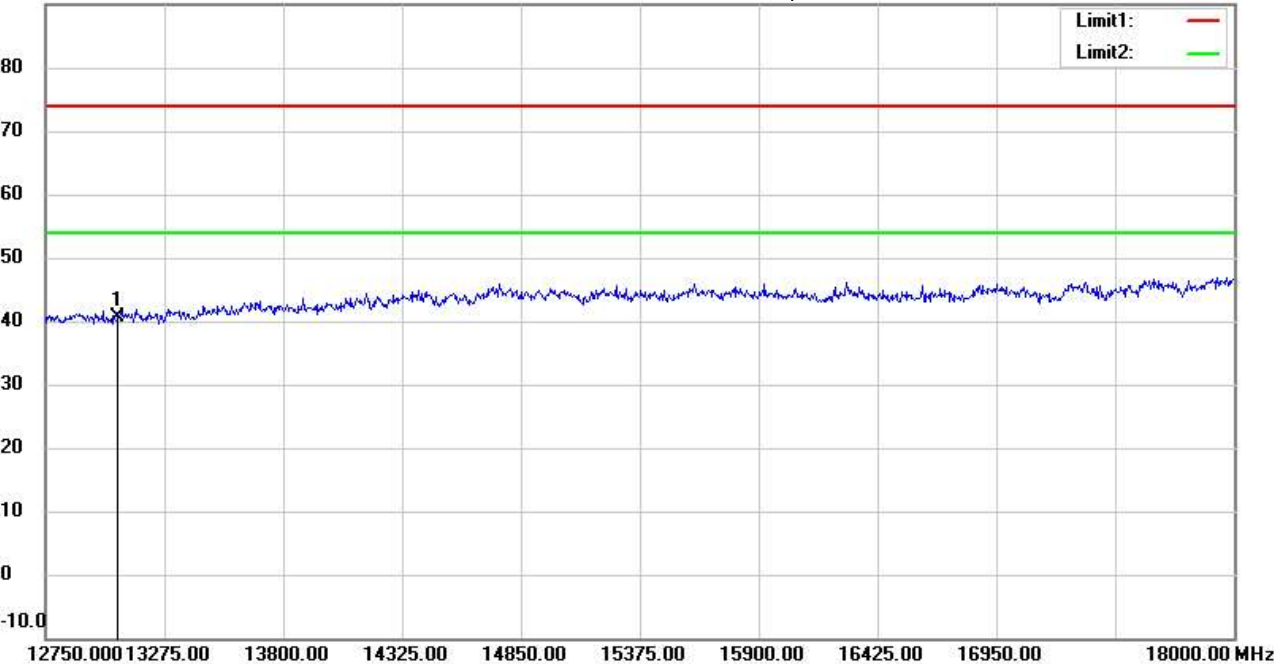
Data :#4

Condition : FCC\_part 15E RE\_Above 1GHz\_PK

Test Mode : TX 802.11ax20 CH117

Polarization: **Horizontal**

| Mk. | Frequency (MHz) | Reading (dBuV) | Detector | Corr. factor (dB/m) | Result (dBuV/m) | Limit (dBuV/m) | Ant.Pos (cm) | Tab.Pos (deg.) | Margin (dB) | Comment |
|---|---|---|---|---|---|---|---|---|---|---|
| * | 13070.000 | 23.41 | peak | 17.21 | 40.62 | 74.00 | 150 | 149 | -33.38 | |

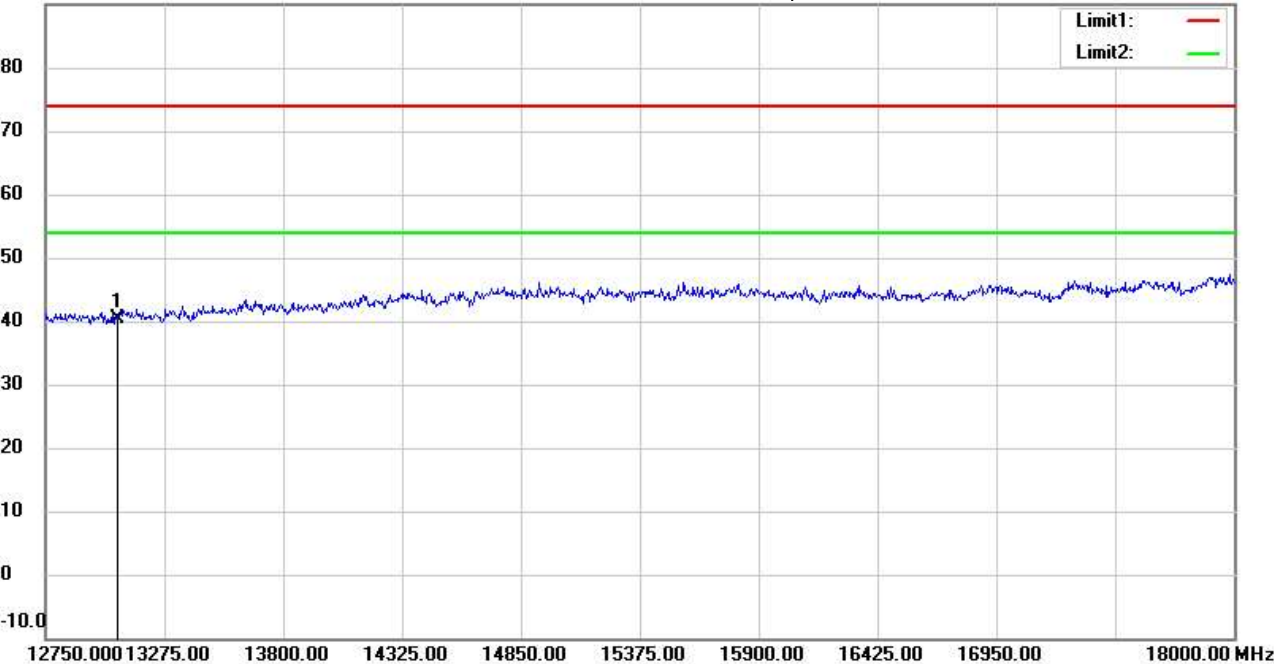
Data :#10

Condition : FCC\_part 15E RE\_Above 1GHz\_PK

Test Mode : TX 802.11ax20 CH117

Polarization: Vertical

| Mk. | Frequency (MHz) | Reading (dBuV) | Detector | Corr. factor (dB/m) | Result (dBuV/m) | Limit (dBuV/m) | Ant.Pos (cm) | Tab.Pos (deg.) | Margin (dB) | Comment |
|---|---|---|---|---|---|---|---|---|---|---|
| * | 13070.000 | 23.16 | peak | 17.21 | 40.37 | 74.00 | 150 | 149 | -33.63 | |
