Radiated Emission Measurement

Condition : FCC\_part 15E RE\_Above 1GHz\_PK

EUT : W6M22409-23739

Test Mode : TX 802.11ax20 CH149

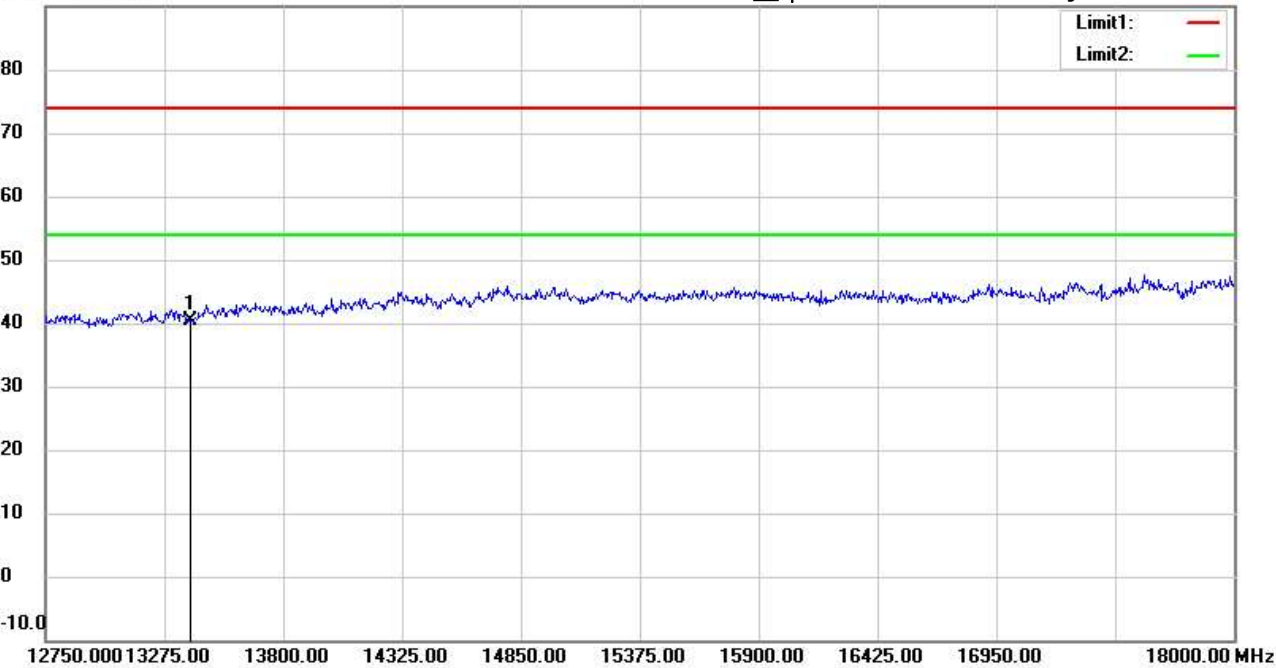
Data :#10

Condition : FCC\_part 15E RE\_Above 1GHz\_PK

Test Mode : TX 802.11ax20 CH149

Polarization: Vertical

| Mk. | Frequency (MHz) | Reading (dBuV) | Detector | Corr. factor (dB/m) | Result (dBuV/m) | Limit (dBuV/m) | Ant.Pos (cm) | Tab.Pos (deg.) | Margin (dB) | Comment |
|---|---|---|---|---|---|---|---|---|---|---|
| * | 13390.000 | 22.40 | peak | 18.10 | 40.50 | 74.00 | 150 | 149 | -33.50 | |

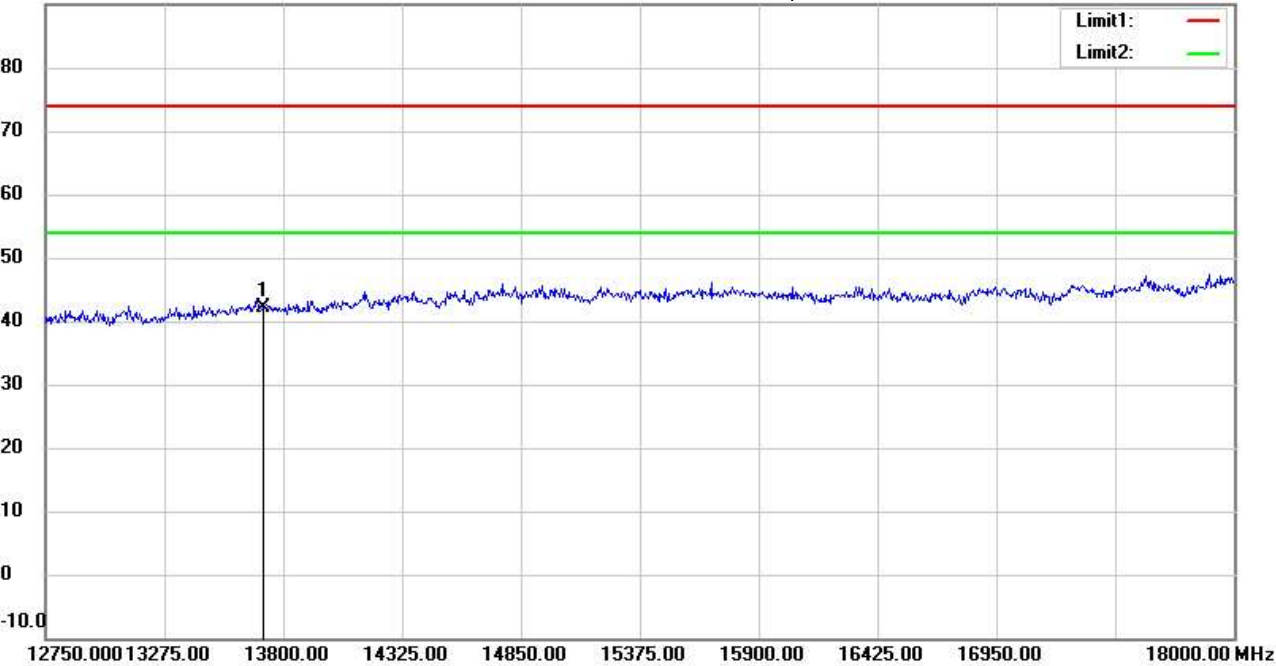
Data :#4

Condition : FCC\_part 15E RE\_Above 1GHz\_PK

Test Mode : TX 802.11ax20 CH181

Polarization: Horizontal

| Mk. | Frequency (MHz) | Reading (dBuV) | Detector | Corr. factor (dB/m) | Result (dBuV/m) | Limit (dBuV/m) | Ant.Pos (cm) | Tab.Pos (deg.) | Margin (dB) | Comment |
|---|---|---|---|---|---|---|---|---|---|---|
| * | 13710.000 | 22.00 | peak | 20.03 | 42.03 | 74.00 | 150 | 102 | -31.97 | |

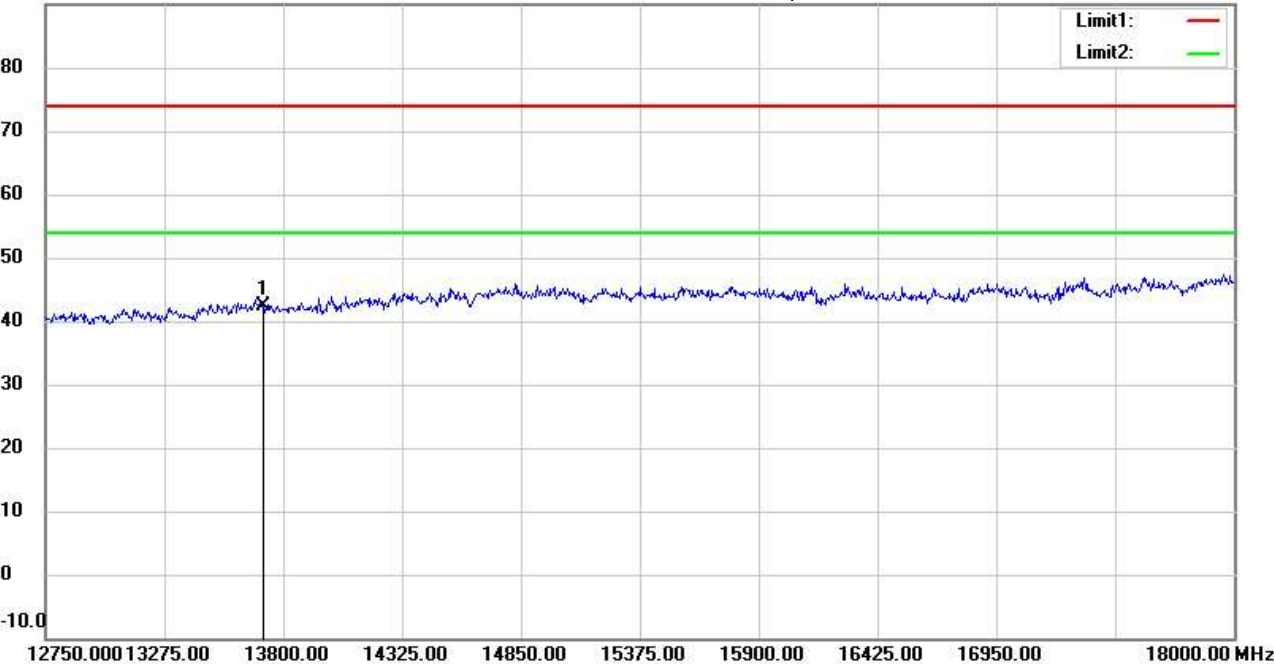
Data :#10

Condition : FCC\_part 15E RE\_Above 1GHz\_PK

Test Mode : TX 802.11ax20 CH181

Polarization: Vertical

| Mk. | Frequency (MHz) | Reading (dBuV) | Detector | Corr. factor (dB/m) | Result (dBuV/m) | Limit (dBuV/m) | Ant.Pos (cm) | Tab.Pos (deg.) | Margin (dB) | Comment |
|---|---|---|---|---|---|---|---|---|---|---|
| * | 13710.000 | 22.44 | peak | 20.03 | 42.47 | 74.00 | 150 | 355 | -31.53 | |
