Radiated Emission Measurement

Condition : FCC\_part 15E RE\_Above 1GHz\_PK

EUT : W6M22409-23739

Test Mode : TX 802.11ax40 CH123

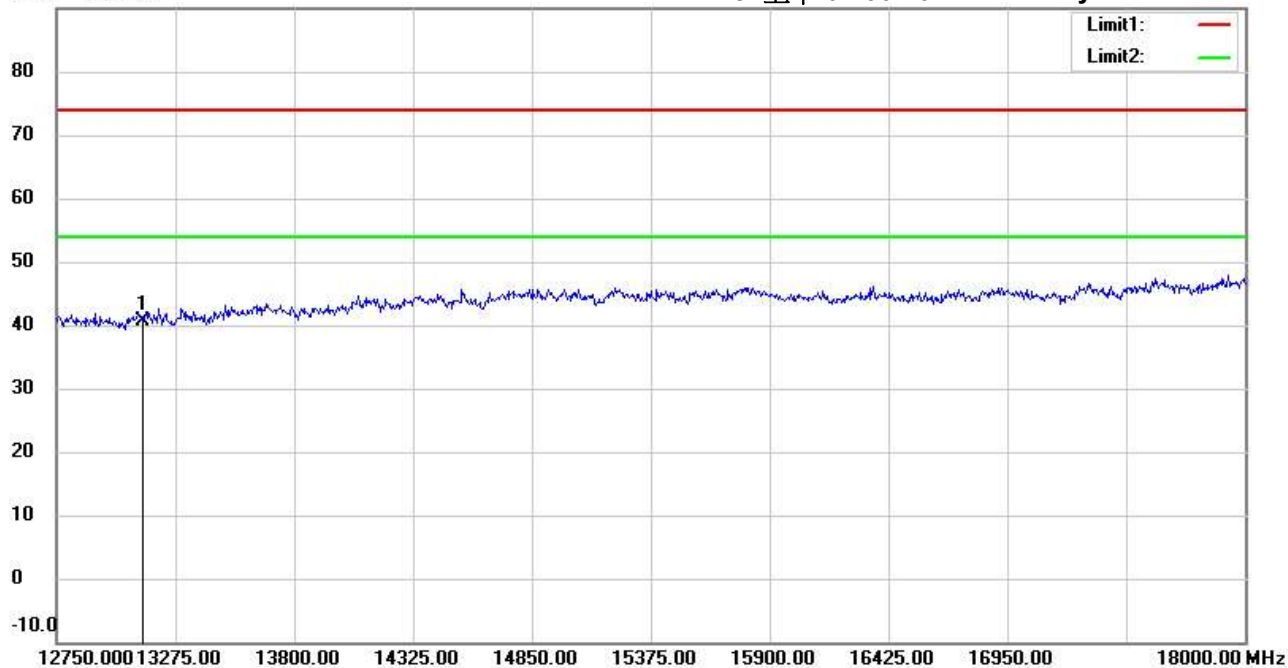
Test Mode : TX 802.11ax40 CH123

Polarization: **Horizontal**

| Mk. | Frequency (MHz) | Reading (dBuV) | Detector | Corr. factor (dB/m) | Result (dBuV/m) | Limit (dBuV/m) | Ant.Pos (cm) | Tab.Pos (deg.) | Margin (dB) | Comment |
|---|---|---|---|---|---|---|---|---|---|---|
| * | 13130.000 | 23.30 | peak | 17.31 | 40.61 | 74.00 | 150 | 359 | -33.39 | |

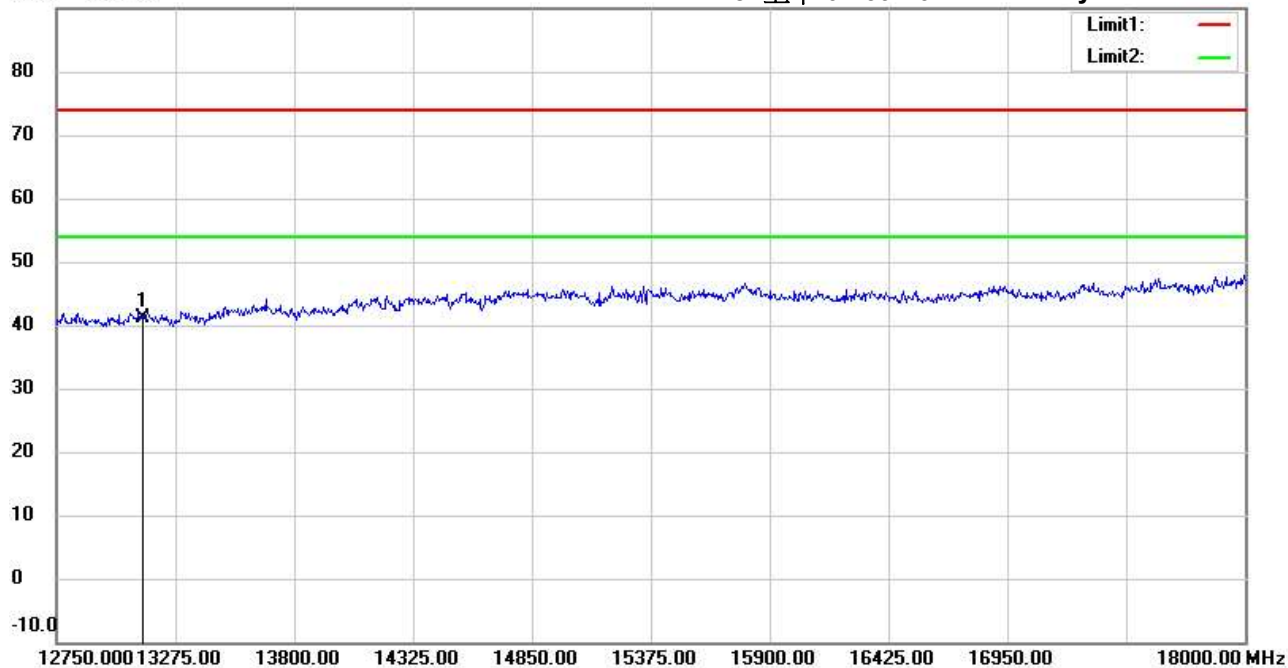
Test Mode : TX 802.11ax40 CH123

Polarization: Vertical

| Mk. | Frequency (MHz) | Reading (dBuV) | Detector | Corr. factor (dB/m) | Result (dBuV/m) | Limit (dBuV/m) | Ant.Pos (cm) | Tab.Pos (deg.) | Margin (dB) | Comment |
|---|---|---|---|---|---|---|---|---|---|---|
| * | 13130.000 | 23.93 | peak | 17.31 | 41.24 | 74.00 | 150 | 277 | -32.76 | |

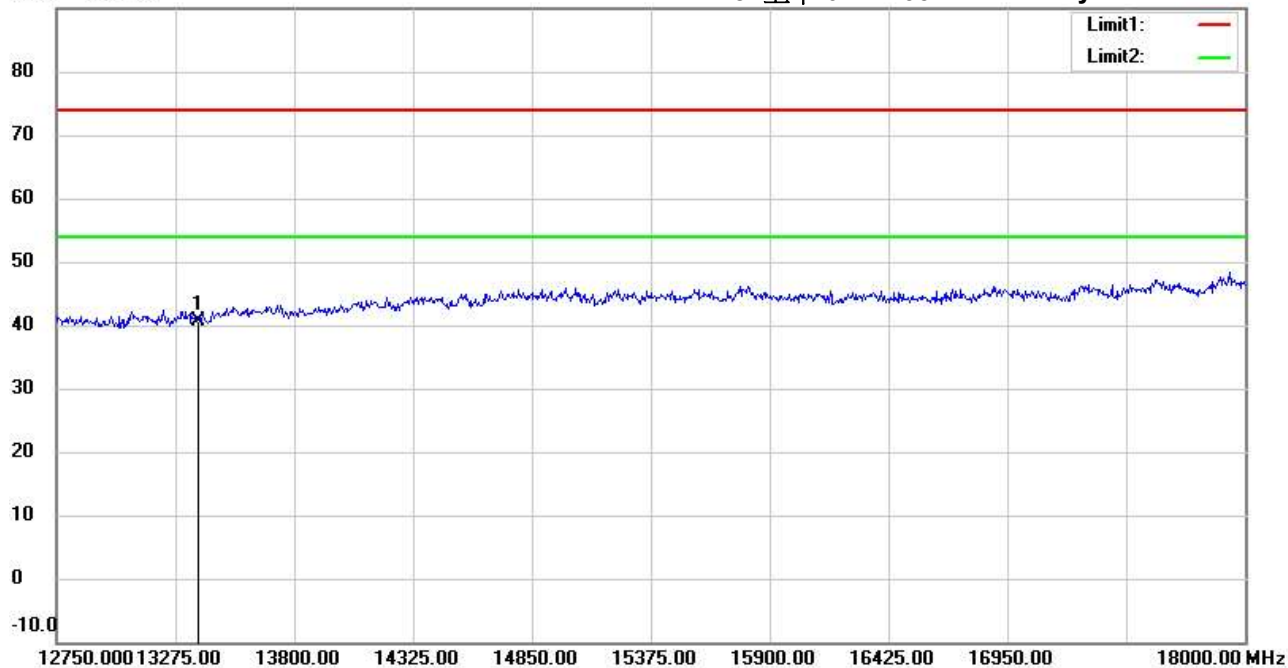
Test Mode : TX 802.11ax40 CH147

Polarization: **Horizontal**

| Mk. | Frequency (MHz) | Reading (dBuV) | Detector | Corr. factor (dB/m) | Result (dBuV/m) | Limit (dBuV/m) | Ant.Pos (cm) | Tab.Pos (deg.) | Margin (dB) | Comment |
|---|---|---|---|---|---|---|---|---|---|---|
| * | 13370.000 | 22.46 | peak | 18.17 | 40.63 | 74.00 | 150 | 24 | -33.37 | |

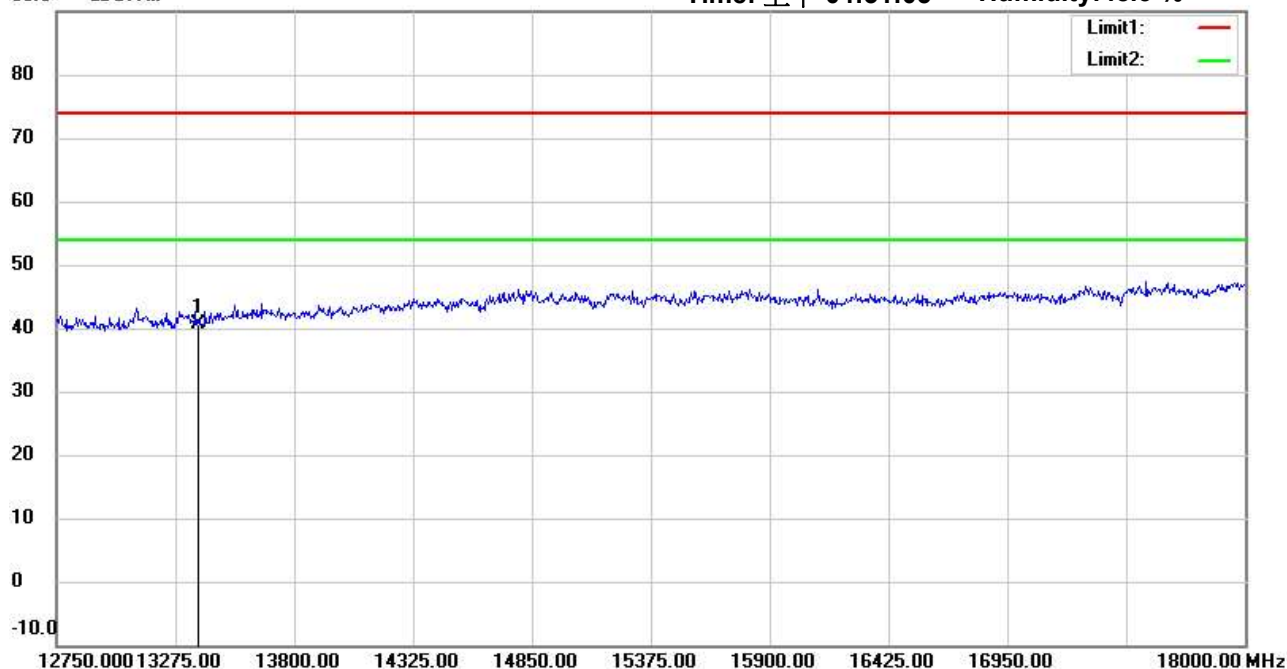
Test Mode : TX 802.11ax40 CH147

Polarization: Vertical

| Mk. | Frequency (MHz) | Reading (dBuV) | Detector | Corr. factor (dB/m) | Result (dBuV/m) | Limit (dBuV/m) | Ant.Pos (cm) | Tab.Pos (deg.) | Margin (dB) | Comment |
|---|---|---|---|---|---|---|---|---|---|---|
| * | 13370.000 | 22.42 | peak | 18.17 | 40.59 | 74.00 | 150 | 359 | -33.41 | |

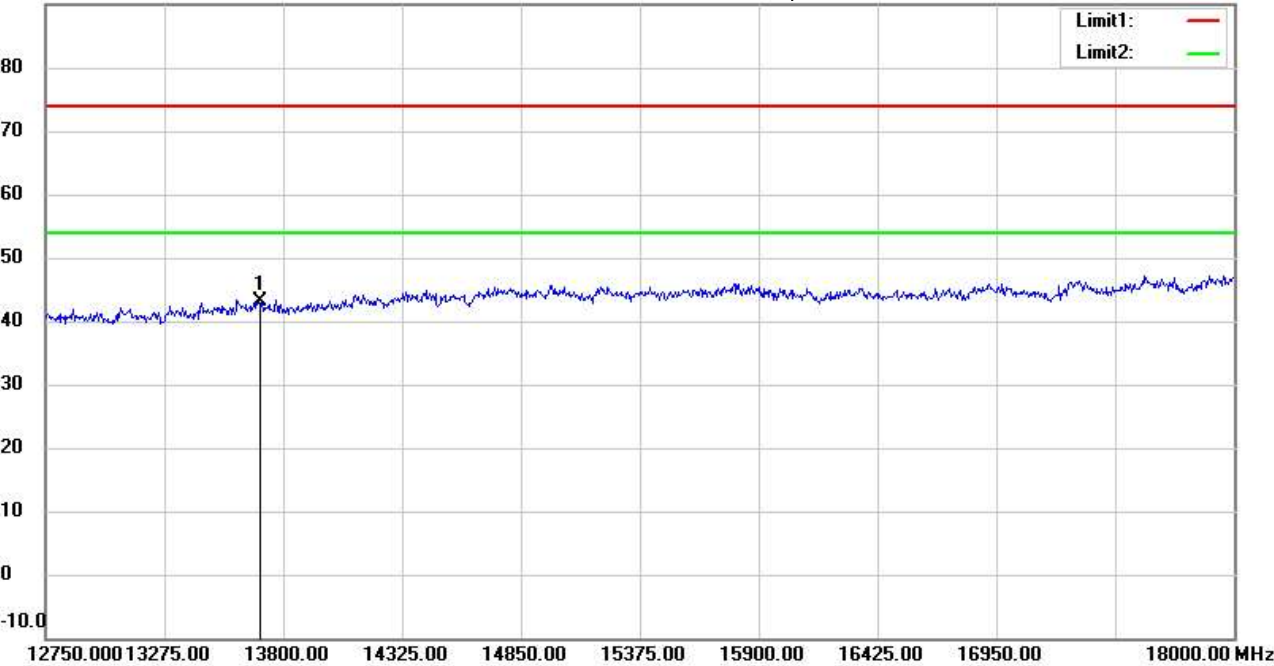
Test Mode : TX 802.11ax40 CH179

Polarization: **Horizontal**

| Mk. | Frequency (MHz) | Reading (dBuV) | Detector | Corr. factor (dB/m) | Result (dBuV/m) | Limit (dBuV/m) | Ant.Pos (cm) | Tab.Pos (deg.) | Margin (dB) | Comment |
|---|---|---|---|---|---|---|---|---|---|---|
| * | 13690.000 | 23.01 | peak | 20.04 | 43.05 | 74.00 | 150 | 143 | -30.95 | |
