Radiated Emission Measurement

Condition : FCC\_part 15E RE\_Above 1GHz\_PK

EUT : W6M22409-23739

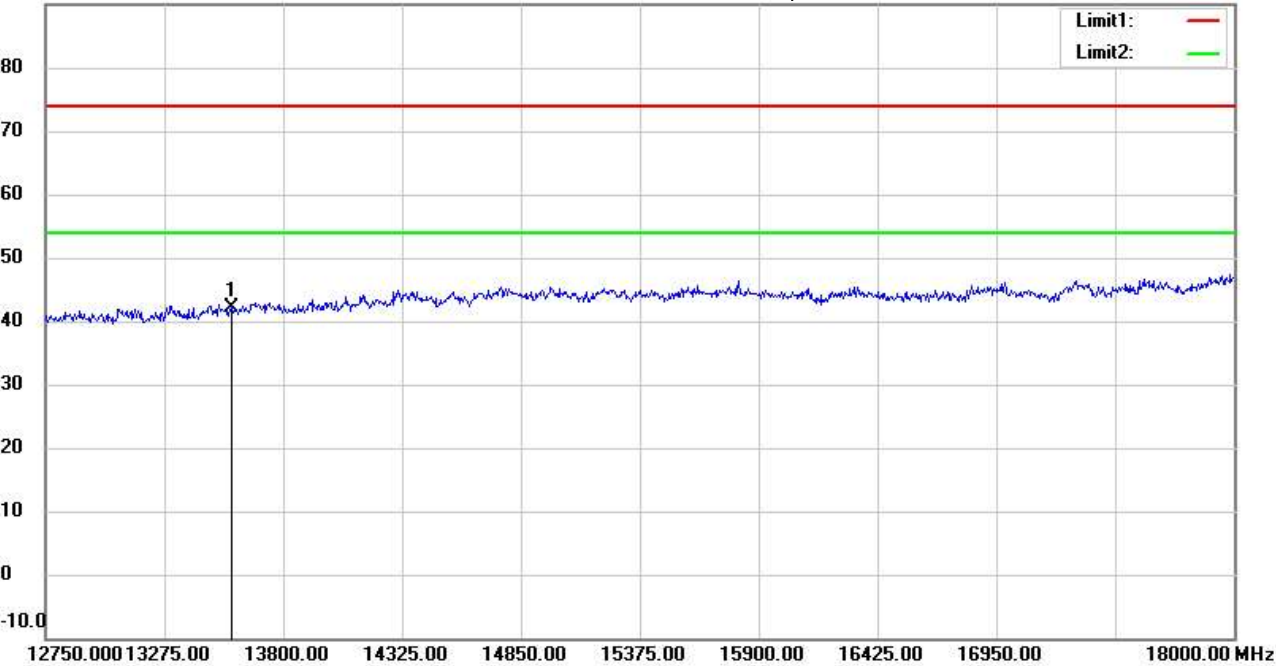
Test Mode : TX 802.11ax80 CH167

Polarization: **Horizontal**

| Mk. | Frequency (MHz) | Reading (dBuV) | Detector | Corr. factor (dB/m) | Result (dBuV/m) | Limit (dBuV/m) | Ant.Pos (cm) | Tab.Pos (deg.) | Margin (dB) | Comment |
|---|---|---|---|---|---|---|---|---|---|---|
| * | 13570.000 | 22.47 | peak | 19.56 | 42.03 | 74.00 | 150 | 143 | -31.97 | |

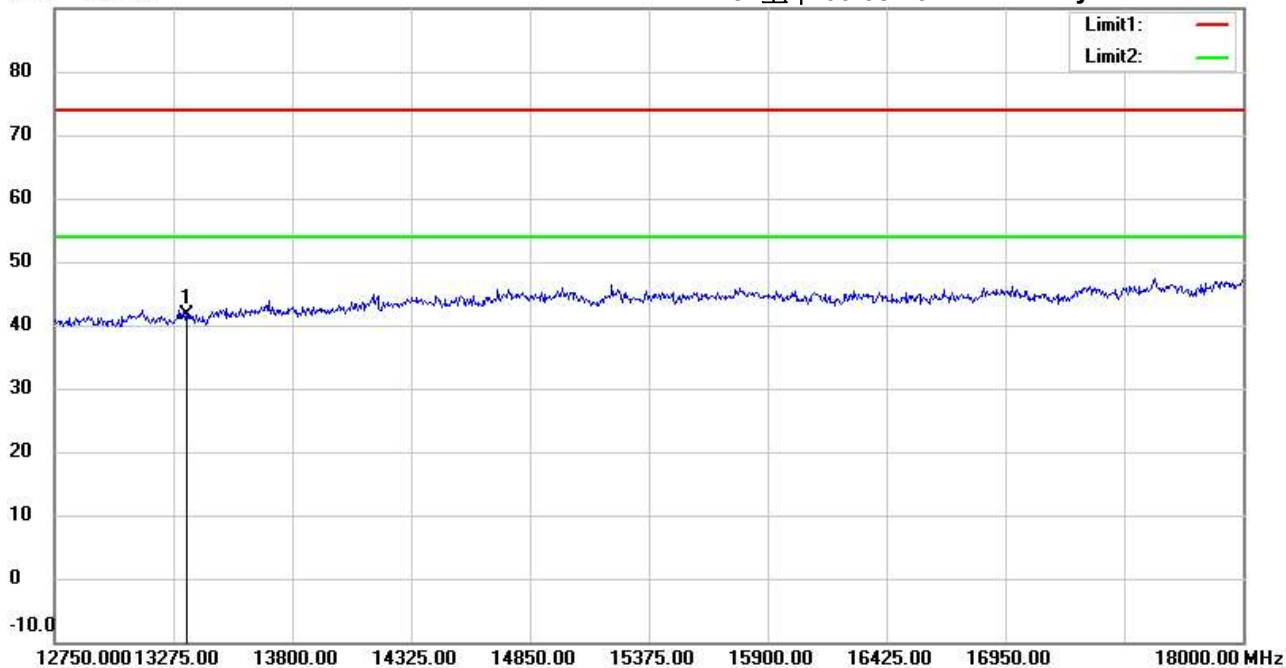
Test Mode : TX 802.11ax160 CH143

Polarization: **Horizontal**

| Mk. | Frequency (MHz) | Reading (dBuV) | Detector | Corr. factor (dB/m) | Result (dBuV/m) | Limit (dBuV/m) | Ant.Pos (cm) | Tab.Pos (deg.) | Margin (dB) | Comment |
|---|---|---|---|---|---|---|---|---|---|---|
| * | 13330.000 | 23.28 | peak | 18.29 | 41.57 | 74.00 | 150 | 359 | -32.43 | |

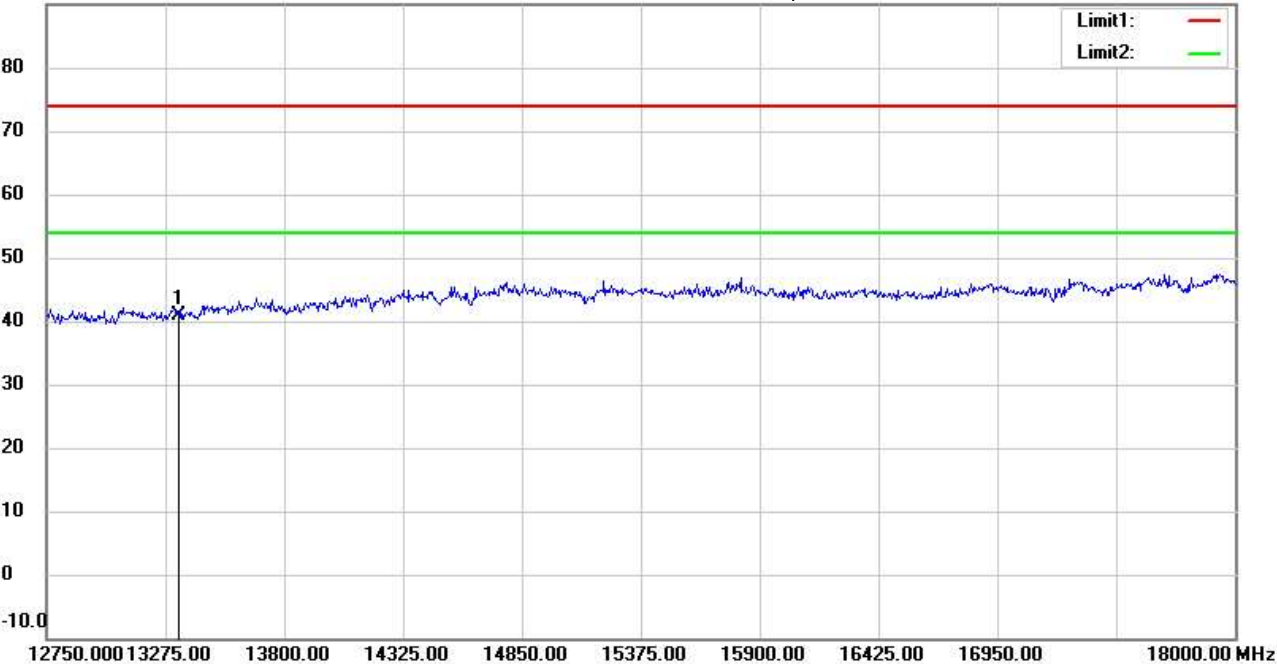
Test Mode : TX 802.11ax160 CH143

Polarization: Vertical

| Mk. | Frequency (MHz) | Reading (dBuV) | Detector | Corr. factor (dB/m) | Result (dBuV/m) | Limit (dBuV/m) | Ant.Pos (cm) | Tab.Pos (deg.) | Margin (dB) | Comment |
|---|---|---|---|---|---|---|---|---|---|---|
| * | 13330.000 | 22.71 | peak | 18.29 | 41.00 | 74.00 | 150 | 231 | -33.00 | |
