Radiated Emission Measurement

Condition : FCC\_part 15E RE\_Above 1GHz\_PK

EUT : W6M22409-23739

Test Mode : TX 802.11a CH185

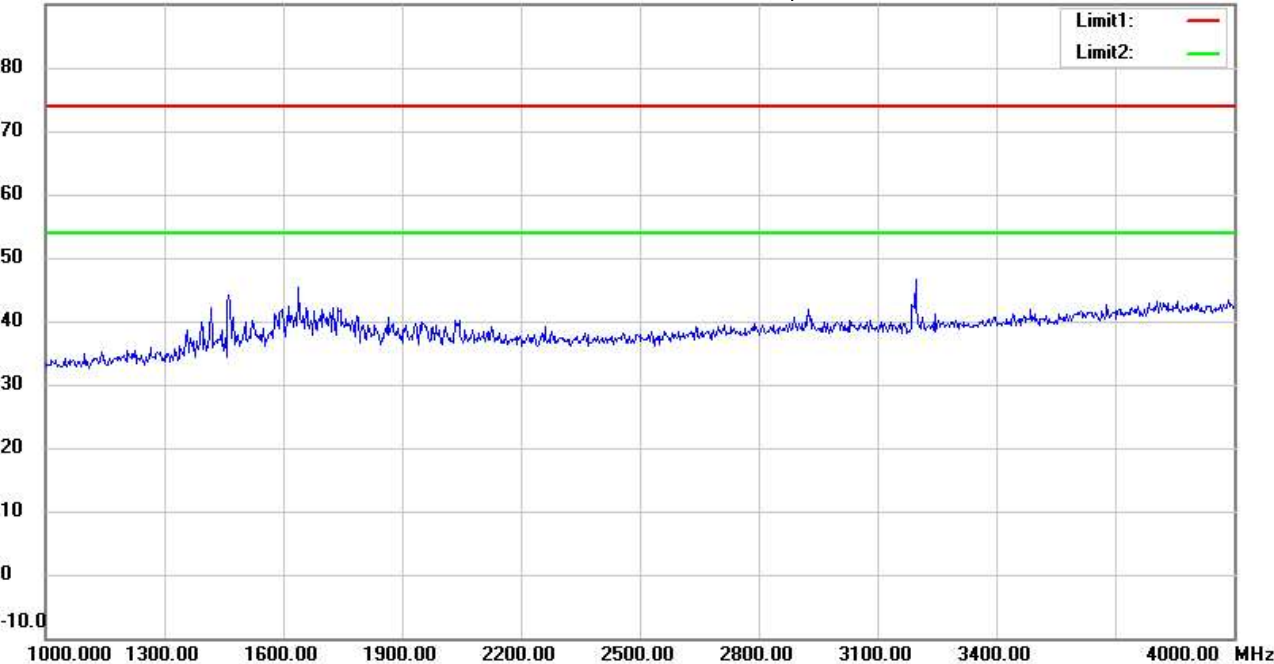
Data :#7

Polarization: Vertical

Distance: 3m

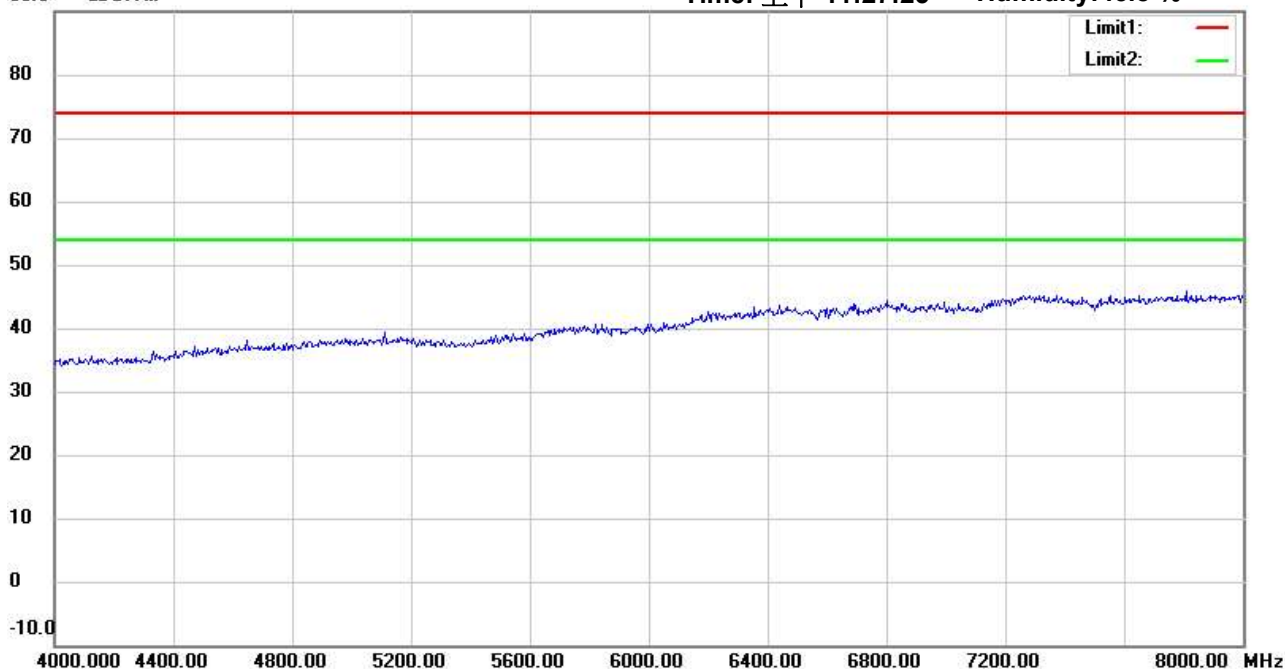
Data : #2

Condition : FCC\_part 15E RE\_Above 1GHz\_PK

Test Mode : TX 802.11a CH185

Polarization: **Horizontal**

Distance: 3m

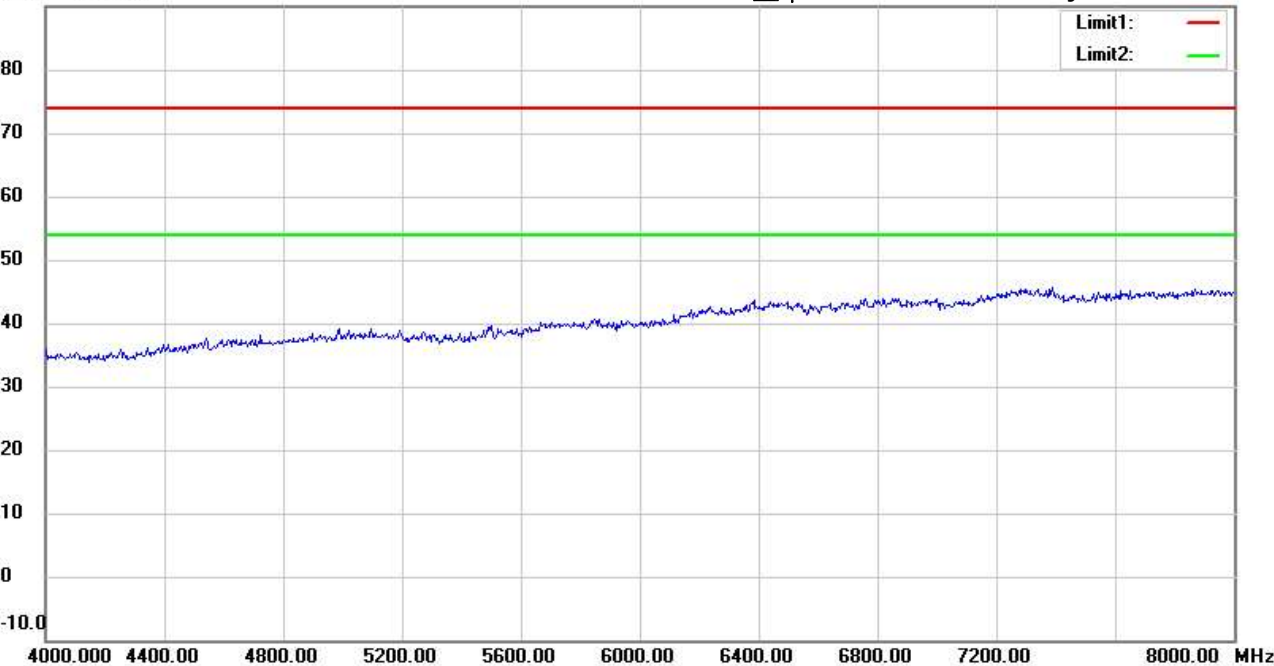
Data :#8

Condition : FCC\_part 15E RE\_Above 1GHz\_PK

Test Mode : TX 802.11a CH185

Polarization: Vertical

Distance: 3m

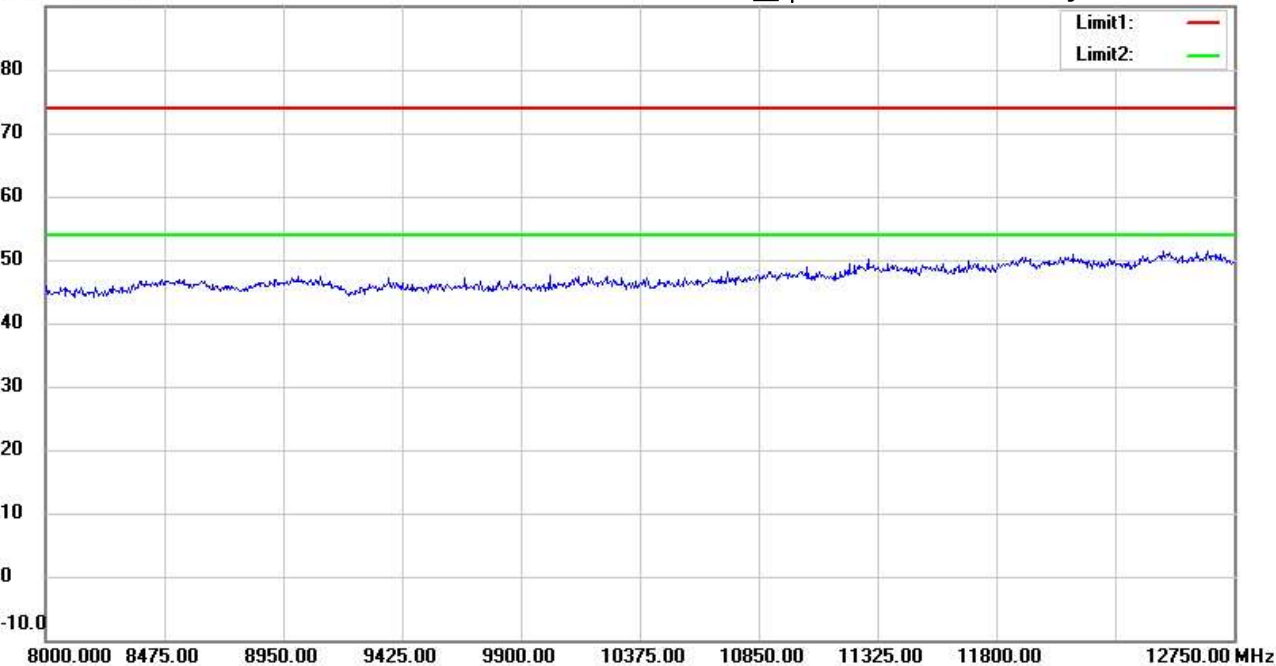
Data :#3

Condition : FCC\_part 15E RE\_Above 1GHz\_PK

Test Mode : TX 802.11a CH185

Polarization: Horizontal

Distance: 3m

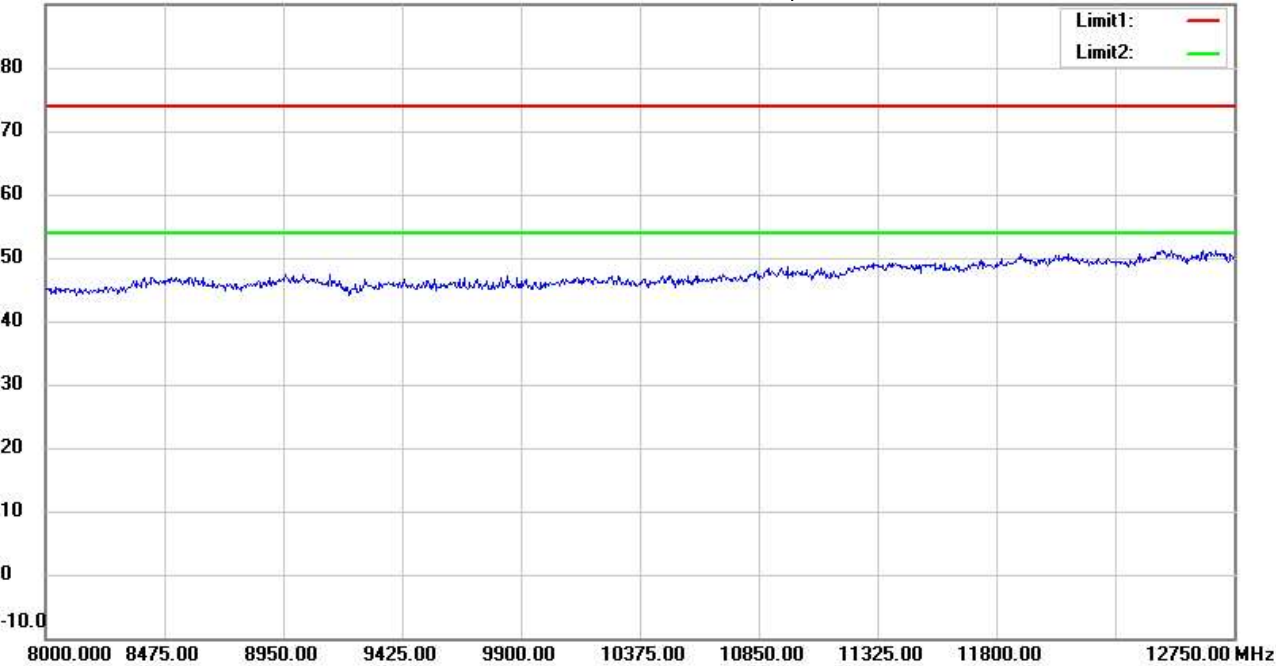
Data :#9

Condition : FCC\_part 15E RE\_Above 1GHz\_PK

Test Mode : TX 802.11a CH185

Polarization: Vertical

Distance: 3m

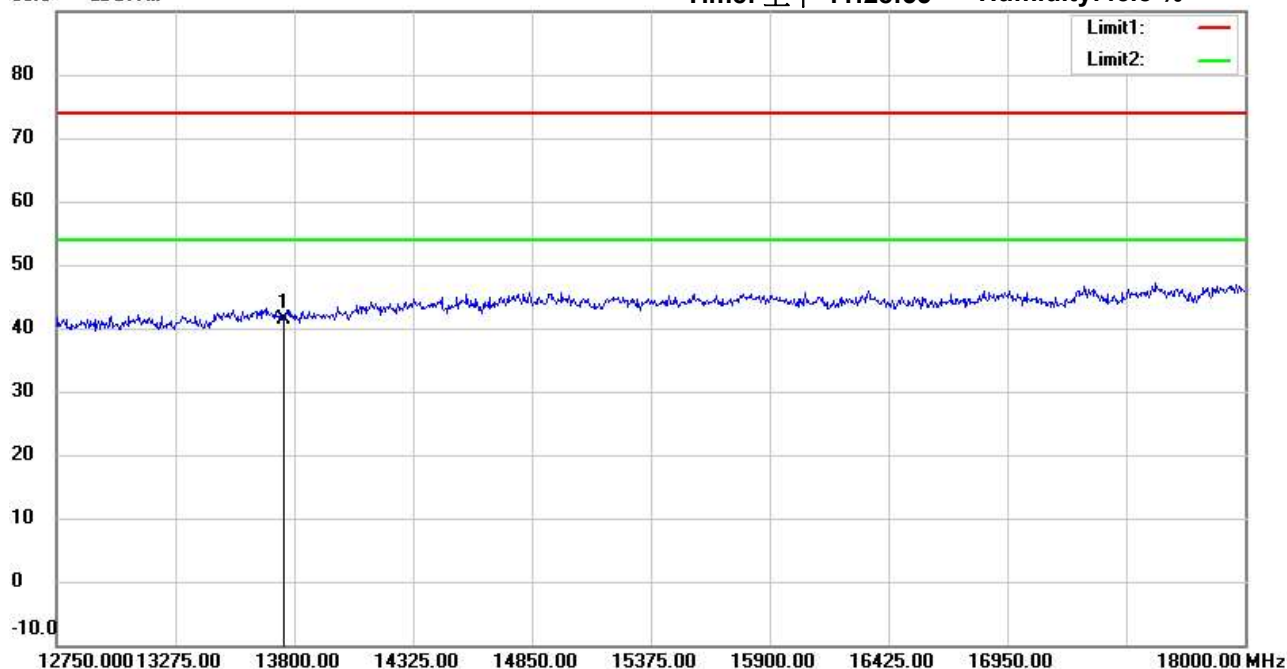
Data : #4

Site : 966A Chamber

Condition : FCC\_part 15E RE\_Above 1GHz\_PK

Test Mode : TX 802.11a CH185

Polarization: **Horizontal**

| Mk. | Frequency (MHz) | Reading (dBuV) | Detector | Corr. factor (dB/m) | Result (dBuV/m) | Limit (dBuV/m) | Ant.Pos (cm) | Tab.Pos (deg.) | Margin (dB) | Comment |
|---|---|---|---|---|---|---|---|---|---|---|
| * | 13750.000 | 21.69 | peak | 19.81 | 41.50 | 74.00 | 150 | 18 | -32.50 | |

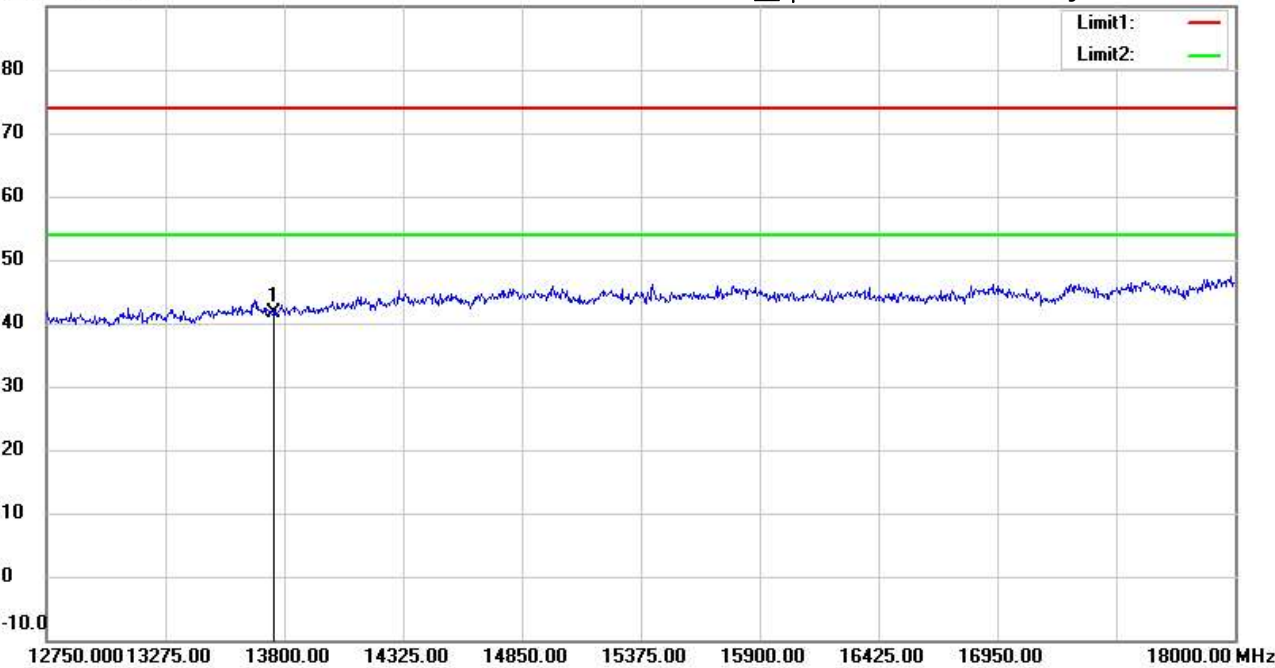
Data :#10

Site : 966A Chamber

Condition : FCC\_part 15E RE\_Above 1GHz\_PK

Test Mode : TX 802.11a CH185

Polarization: **Vertical**

| Mk. | Frequency (MHz) | Reading (dBuV) | Detector | Corr. factor (dB/m) | Result (dBuV/m) | Limit (dBuV/m) | Ant.Pos (cm) | Tab.Pos (deg.) | Margin (dB) | Comment |
|---|---|---|---|---|---|---|---|---|---|---|
| * | 13750.000 | 21.71 | peak | 19.81 | 41.52 | 74.00 | 150 | 359 | -32.48 | |

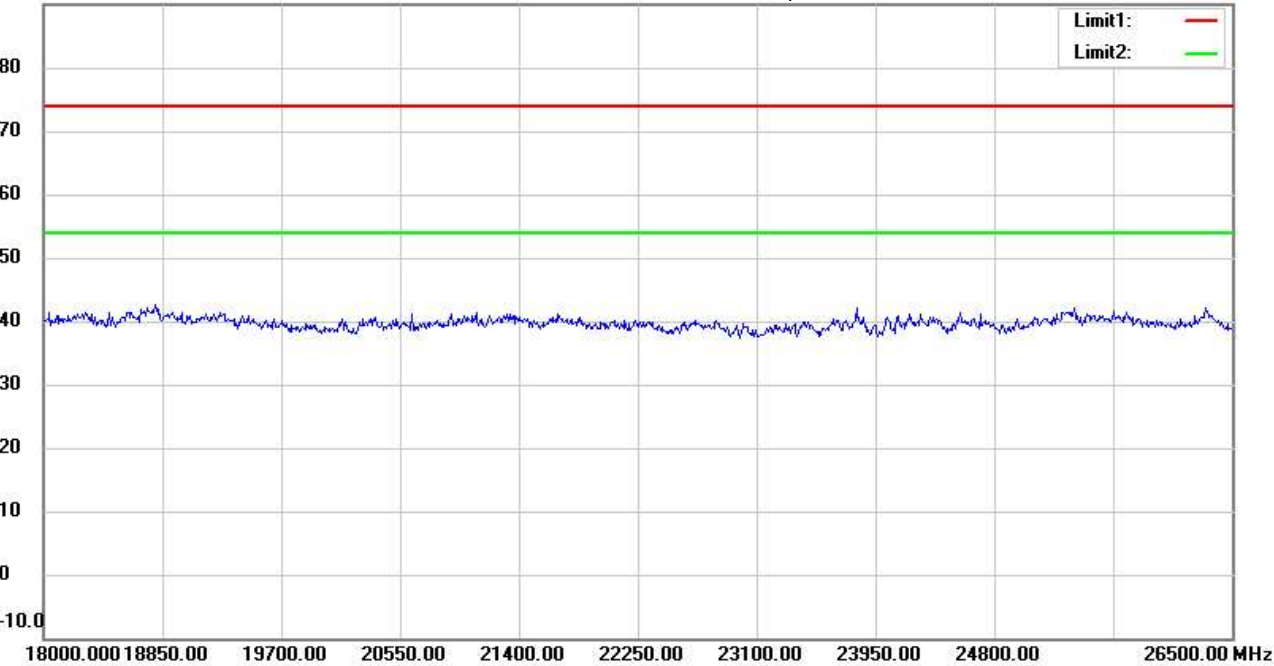
Data :#5

Condition : FCC\_part 15E RE\_Above 1GHz\_PK

Test Mode : TX 802.11a CH185

Polarization: *Horizontal*

Distance: 3m

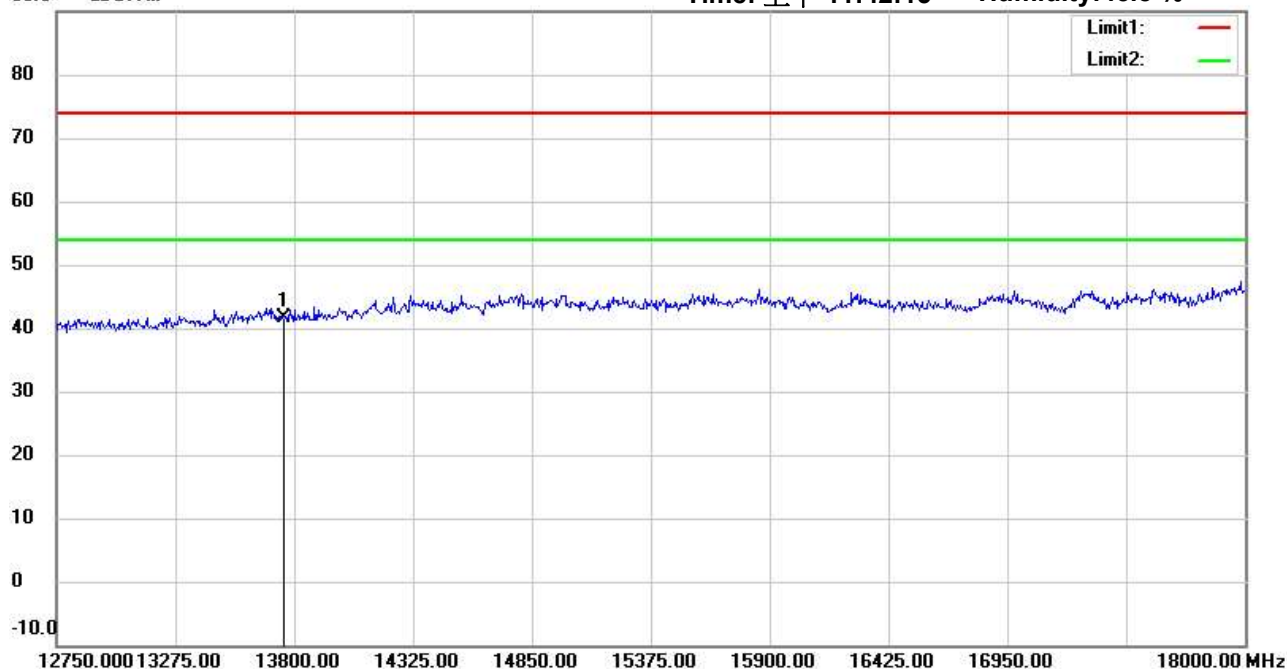
Data : #4

Site : 966A Chamber

Condition : FCC\_part 15E RE\_Above 1GHz\_PK

Test Mode : TX 802.11a CH185

Polarization: **Horizontal**

| Mk. | Frequency (MHz) | Reading (dBuV) | Detector | Corr. factor (dB/m) | Result (dBuV/m) | Limit (dBuV/m) | Ant.Pos (cm) | Tab.Pos (deg.) | Margin (dB) | Comment |
|---|---|---|---|---|---|---|---|---|---|---|
| * | 13750.000 | 21.70 | peak | 19.81 | 41.51 | 74.00 | 150 | 142 | -32.49 | |

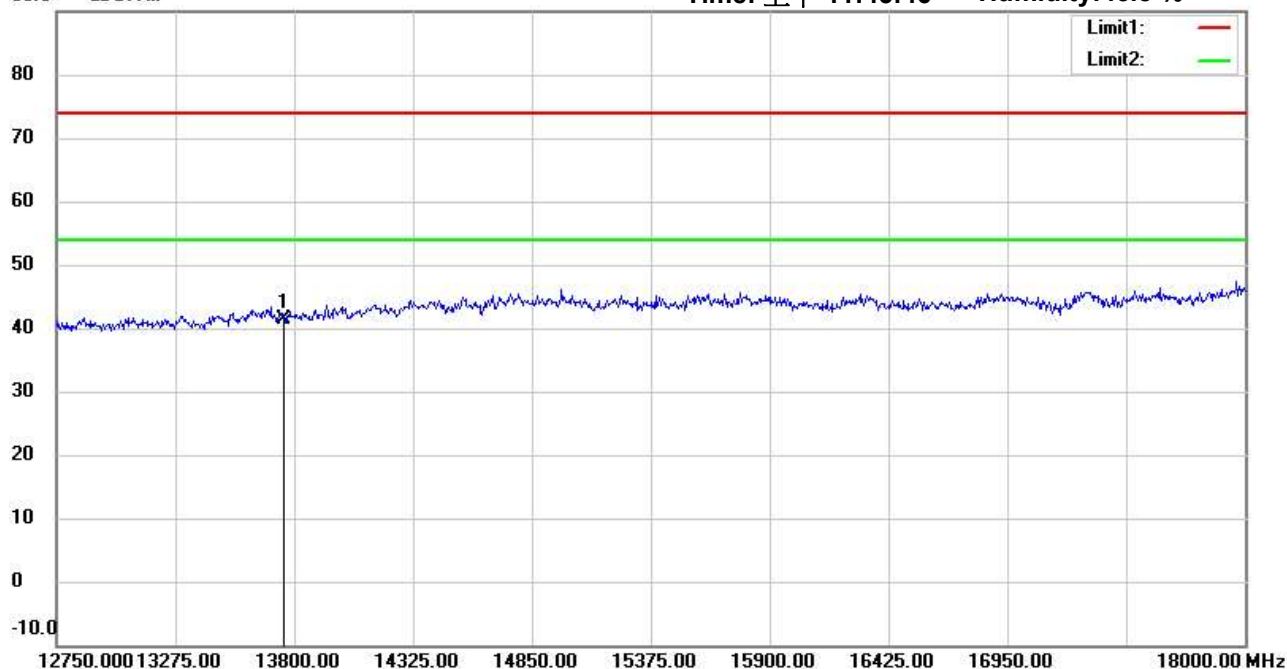
Data : #10

Site : 966A Chamber

Condition : FCC\_part 15E RE\_Above 1GHz\_PK

Test Mode : TX 802.11a CH185

Polarization: Vertical

| Mk. | Frequency (MHz) | Reading (dBuV) | Detector | Corr. factor (dB/m) | Result (dBuV/m) | Limit (dBuV/m) | Ant.Pos (cm) | Tab.Pos (deg.) | Margin (dB) | Comment |
|---|---|---|---|---|---|---|---|---|---|---|
| * | 13750.000 | 21.67 | peak | 19.81 | 41.48 | 74.00 | 150 | 270 | -32.52 | |
