Radiated Emission Measurement

Condition : FCC\_part 15E RE\_Above 1GHz\_PK

EUT : W6M22409-23739

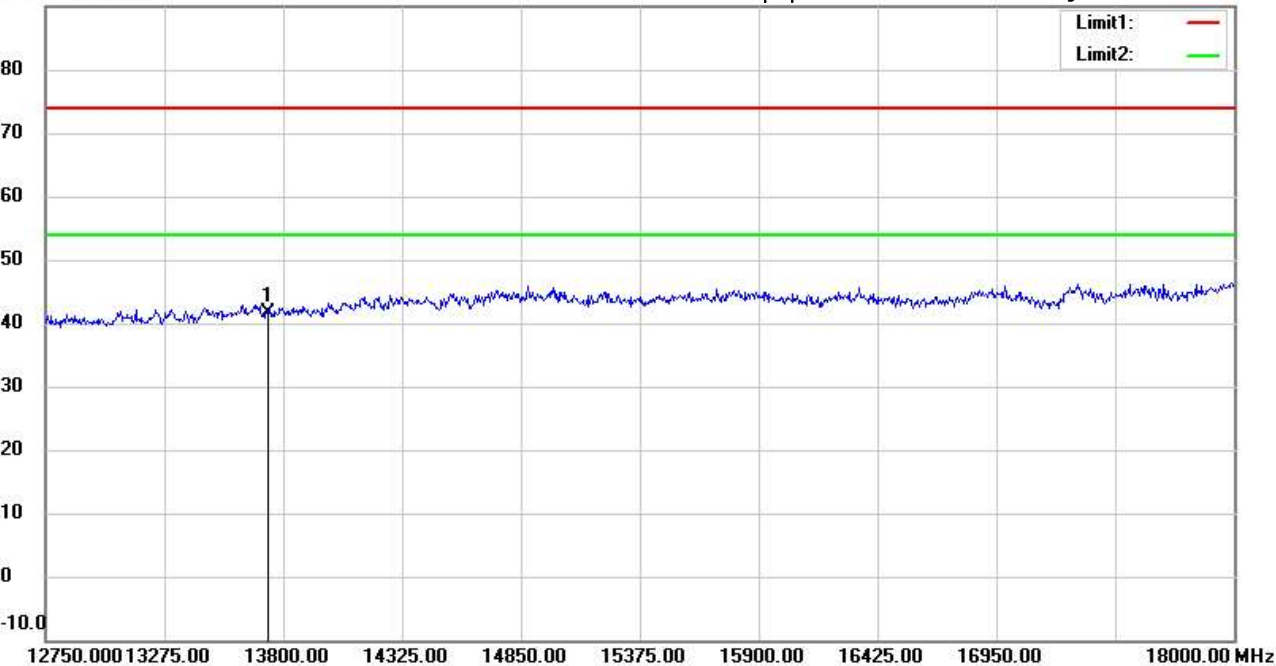
Data :#10

Test Mode : TX 802.11ax80 CH183

Polarization: Vertical

| Mk. | Frequency (MHz) | Reading (dBuV) | Detector | Corr. factor (dB/m) | Result (dBuV/m) | Limit (dBuV/m) | Ant.Pos (cm) | Tab.Pos (deg.) | Margin (dB) | Comment |
|---|---|---|---|---|---|---|---|---|---|---|
| * | 13730.000 | 21.73 | peak | 19.92 | 41.65 | 74.00 | 150 | 350 | -32.35 | |

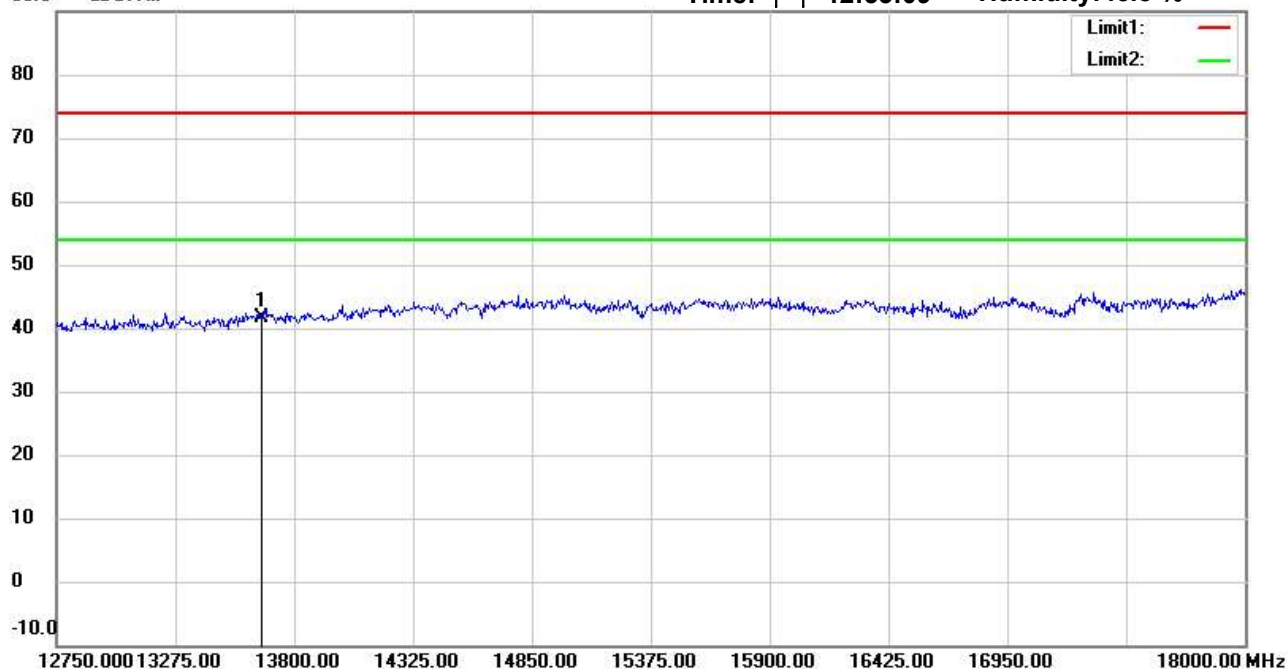
Data : #4

Condition : FCC\_part 15E RE\_Above 1GHz\_PK

Test Mode : TX 802.11ax160 CH175

Polarization: **Horizontal**

| Mk. | Frequency (MHz) | Reading (dBuV) | Detector | Corr. factor (dB/m) | Result (dBuV/m) | Limit (dBuV/m) | Ant.Pos (cm) | Tab.Pos (deg.) | Margin (dB) | Comment |
|---|---|---|---|---|---|---|---|---|---|---|
| * | 13650.000 | 21.81 | peak | 19.84 | 41.65 | 74.00 | 150 | 359 | -32.35 | |

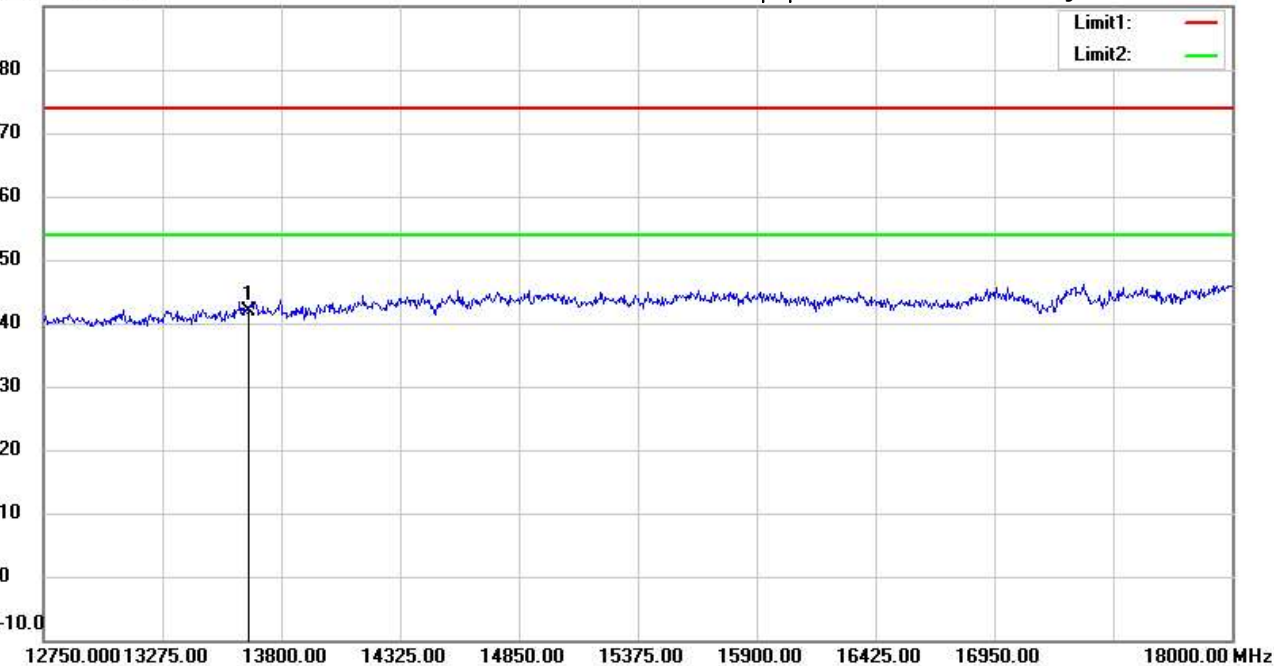
Data :#10

Condition : FCC\_part 15E RE\_Above 1GHz\_PK

Test Mode : TX 802.11ax160 CH175

Polarization: Vertical

| Mk. | Frequency (MHz) | Reading (dBuV) | Detector | Corr. factor (dB/m) | Result (dBuV/m) | Limit (dBuV/m) | Ant.Pos (cm) | Tab.Pos (deg.) | Margin (dB) | Comment |
|---|---|---|---|---|---|---|---|---|---|---|
| * | 13650.000 | 21.93 | peak | 19.84 | 41.77 | 74.00 | 150 | 144 | -32.23 | |

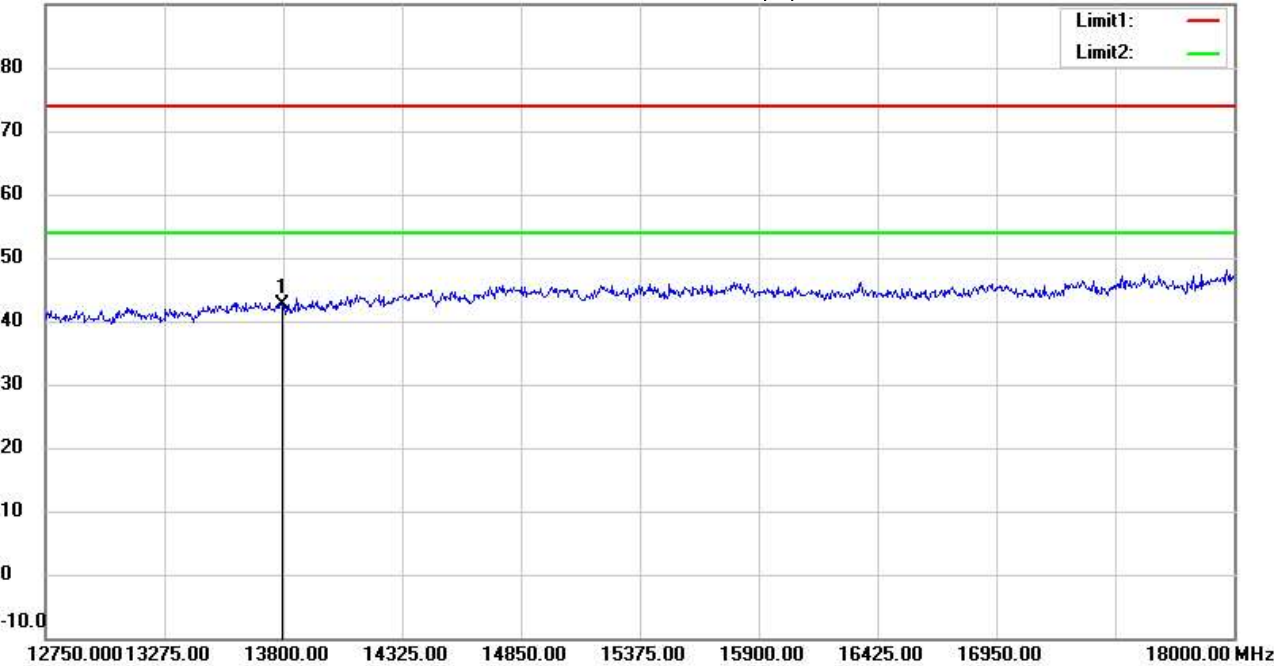
Data :#4

Site : 966A Chamber  
Condition : FCC\_part 15E RE\_Above 1GHz\_PK  
EUT : W6M22409-23739  
M/N:  
Test Mode : TX 802.11a CH189  
Note :

Polarization: Horizontal  
Power : 120 Va.c.  
Distance: 3m

| Mk. | Frequency (MHz) | Reading (dBuV) | Detector | Corr. factor (dB/m) | Result (dBuV/m) | Limit (dBuV/m) | Ant.Pos (cm) | Tab.Pos (deg.) | Margin (dB) | Comment |
|---|---|---|---|---|---|---|---|---|---|---|
| * | 13790.000 | 22.92 | peak | 19.59 | 42.51 | 74.00 | 150 | 311 | -31.49 | |

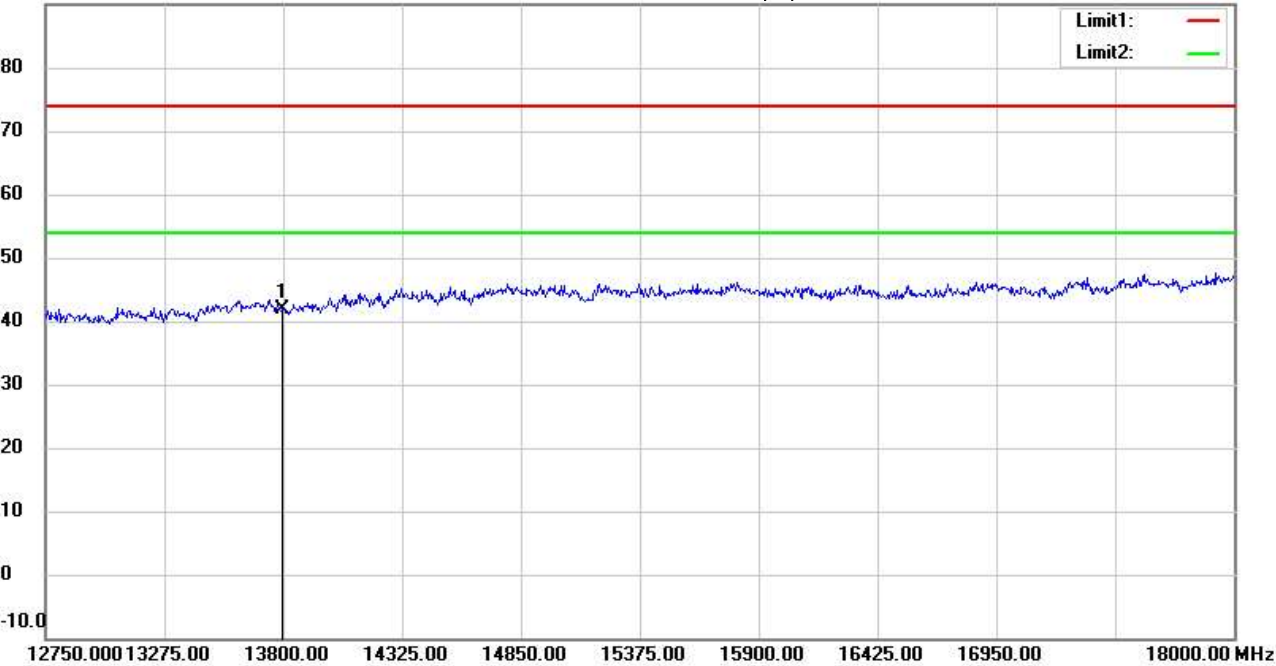
Data :#10

Site : 966A Chamber  
Condition : FCC\_part 15E RE\_Above 1GHz\_PK  
EUT : W6M22409-23739  
M/N:  
Test Mode : TX 802.11a CH189  
Note :

Polarization: Vertical  
Power : 120 Va.c.  
Distance: 3m

| Mk. | Frequency (MHz) | Reading (dBuV) | Detector | Corr. factor (dB/m) | Result (dBuV/m) | Limit (dBuV/m) | Ant.Pos (cm) | Tab.Pos (deg.) | Margin (dB) | Comment |
|---|---|---|---|---|---|---|---|---|---|---|
| * | 13790.000 | 22.40 | peak | 19.59 | 41.99 | 74.00 | 150 | 231 | -32.01 | |
