Radiated Emission Measurement

Condition : FCC\_part 15E RE\_Above 1GHz\_PK

EUT : W6M22409-23739

Test Mode : TX 802.11a CH189

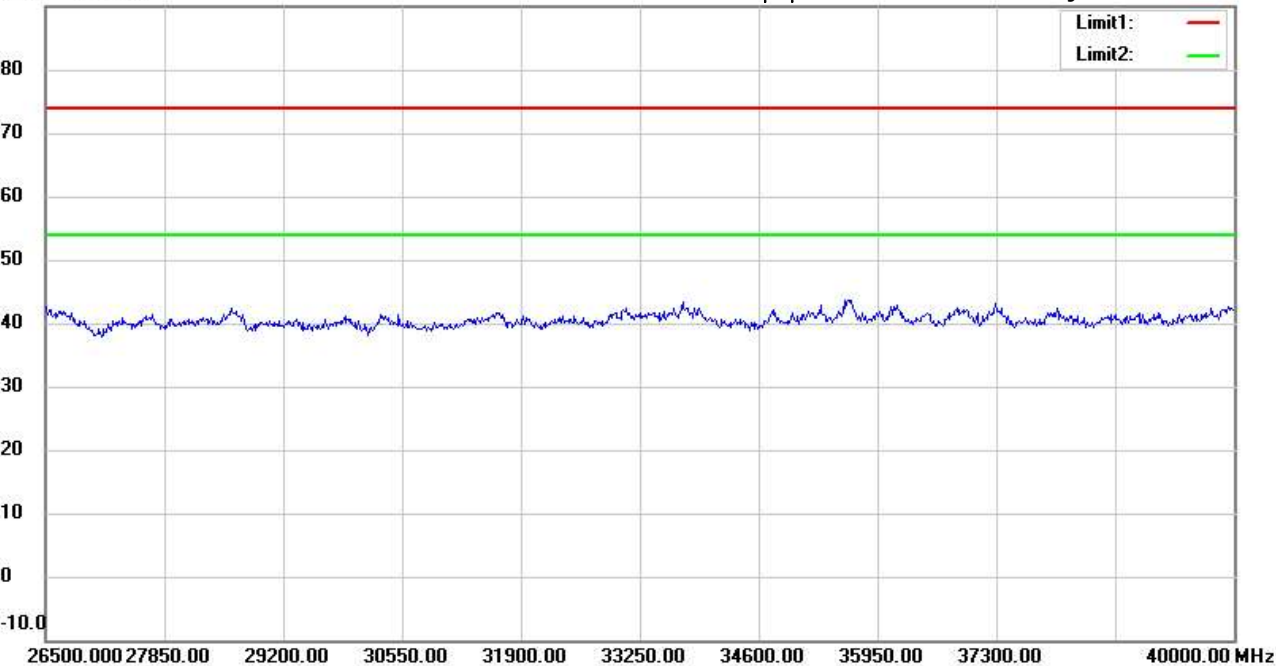
Polarization: **Horizontal**

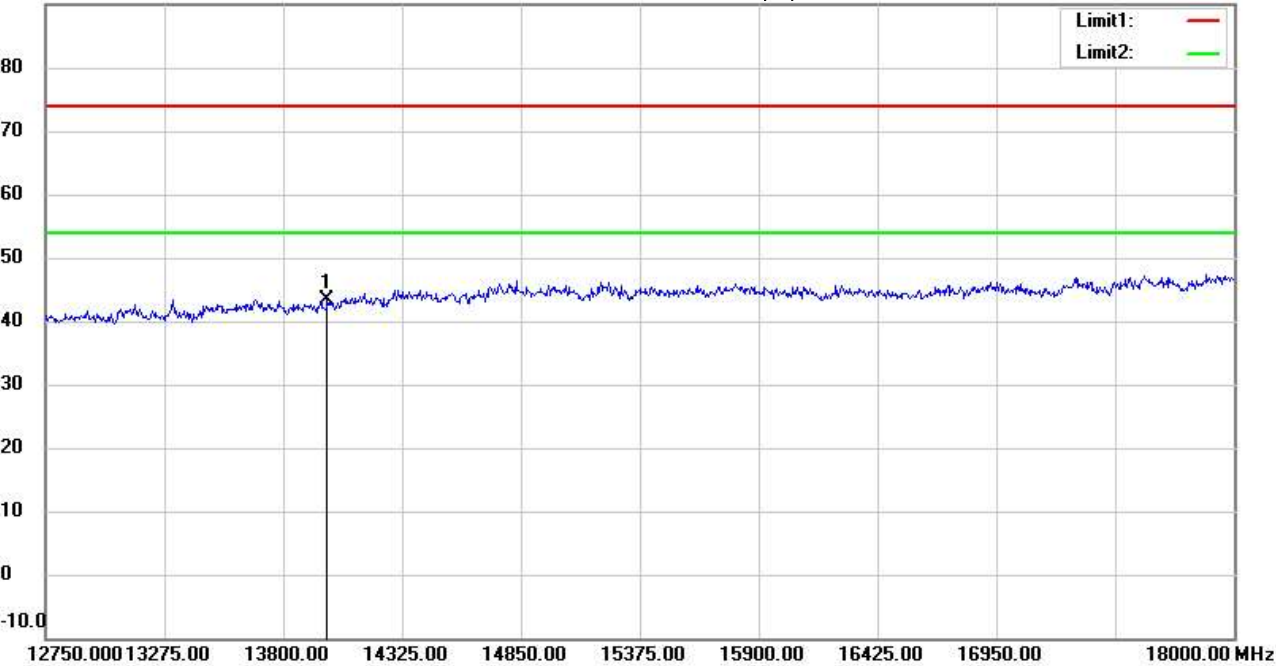
Site : 966A Chamber  
Condition : FCC\_part 15E RE\_Above 1GHz\_PK  
EUT : W6M22409-23739  
M/N:  
Test Mode : TX 802.11a CH209  
Note :

Polarization: Horizontal  
Power : 120 Va.c.  
Distance: 3m

| Mk. | Frequency (MHz) | Reading (dBuV) | Detector | Corr. factor (dB/m) | Result (dBuV/m) | Limit (dBuV/m) | Ant.Pos (cm) | Tab.Pos (deg.) | Margin (dB) | Comment |
|---|---|---|---|---|---|---|---|---|---|---|
| * | 13990.000 | 22.40 | peak | 20.93 | 43.33 | 74.00 | 150 | 271 | -30.67 | |

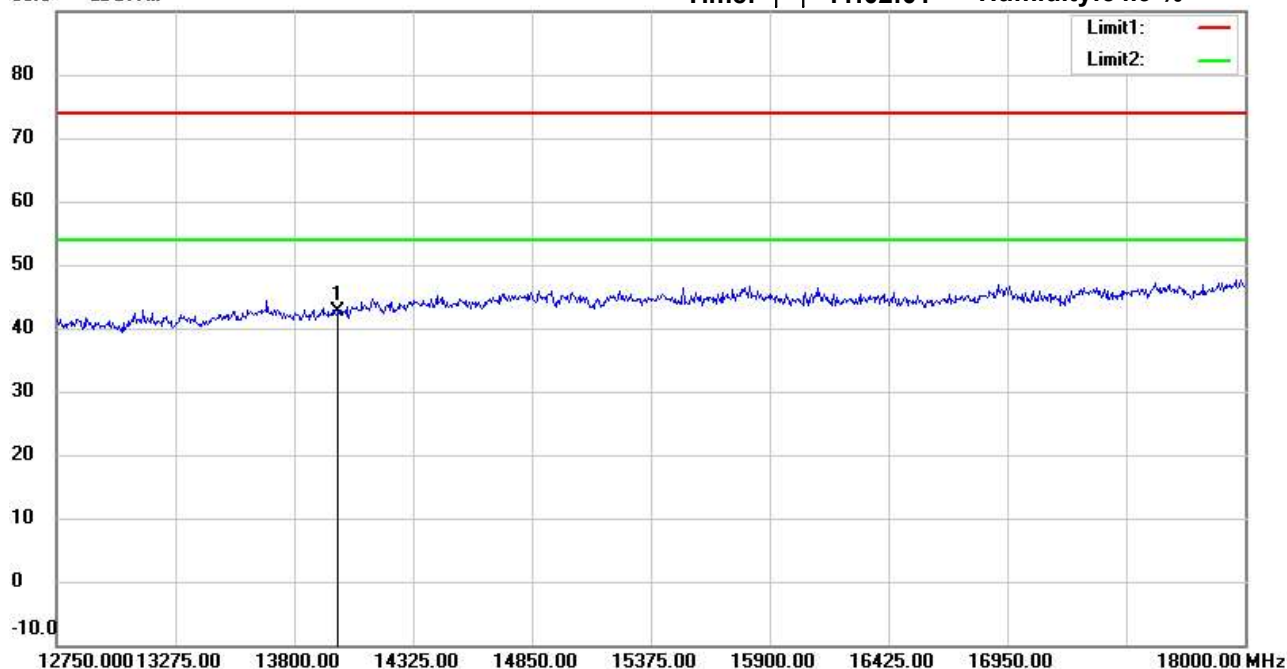
Test Mode : TX 802.11a CH209

Polarization: Vertical

| Mk. | Frequency (MHz) | Reading (dBuV) | Detector | Corr. factor (dB/m) | Result (dBuV/m) | Limit (dBuV/m) | Ant.Pos (cm) | Tab.Pos (deg.) | Margin (dB) | Comment |
|---|---|---|---|---|---|---|---|---|---|---|
| * | 13990.000 | 21.78 | peak | 20.93 | 42.71 | 74.00 | 150 | 350 | -31.29 | |

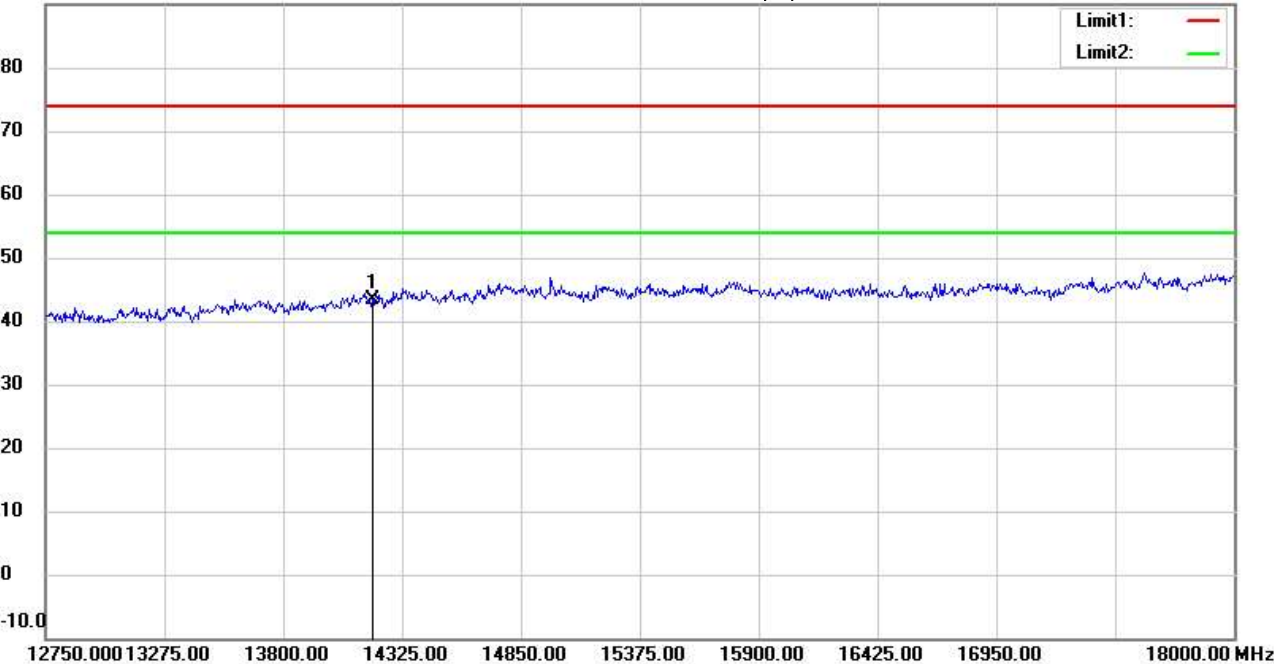
Test Mode : TX 802.11a CH229

Polarization: **Horizontal**

| Mk. | Frequency (MHz) | Reading (dBuV) | Detector | Corr. factor (dB/m) | Result (dBuV/m) | Limit (dBuV/m) | Ant.Pos (cm) | Tab.Pos (deg.) | Margin (dB) | Comment |
|---|---|---|---|---|---|---|---|---|---|---|
| * | 14190.000 | 21.32 | peak | 21.94 | 43.26 | 74.00 | 150 | 224 | -30.74 | |

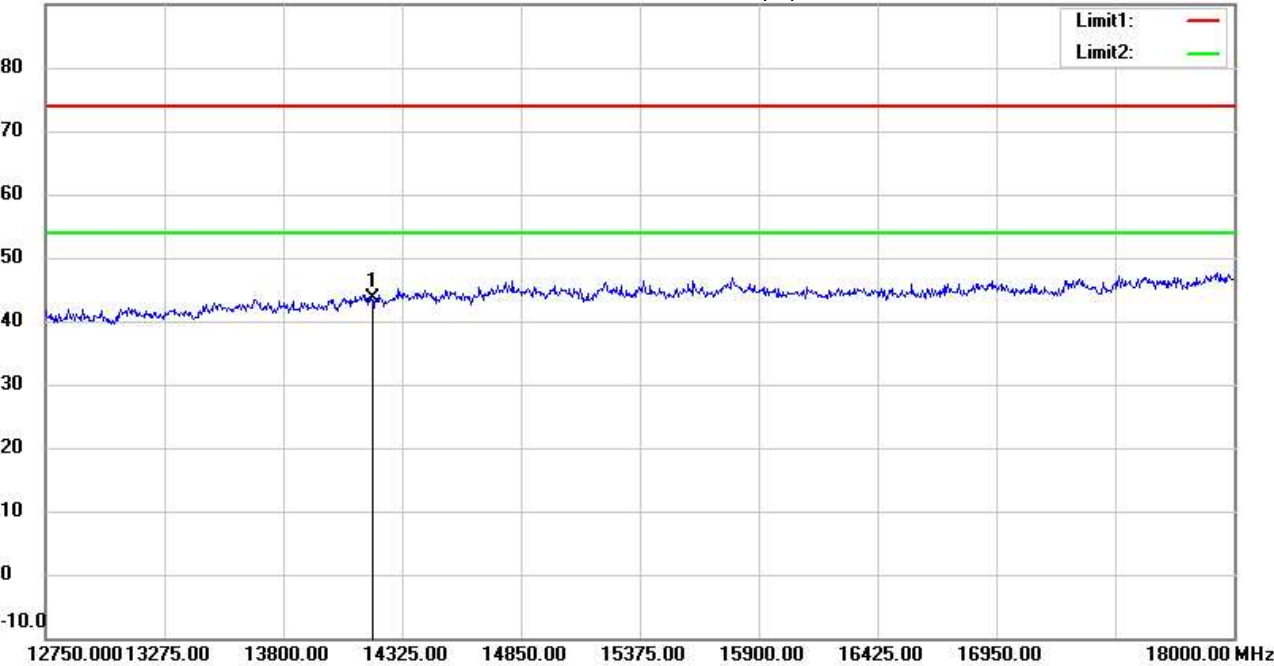
Site : 966A Chamber  
Condition : FCC\_part 15E RE\_Above 1GHz\_PK  
EUT : W6M22409-23739  
M/N:  
Test Mode : TX 802.11a CH229  
Note :

Polarization: Vertical  
Power : 120 Va.c.  
Distance: 3m

| Mk. | Frequency (MHz) | Reading (dBuV) | Detector | Corr. factor (dB/m) | Result (dBuV/m) | Limit (dBuV/m) | Ant.Pos (cm) | Tab.Pos (deg.) | Margin (dB) | Comment |
|---|---|---|---|---|---|---|---|---|---|---|
| * | 14190.000 | 21.57 | peak | 21.94 | 43.51 | 74.00 | 150 | 359 | -30.49 | |
