Radiated Emission Measurement

Condition : FCC\_part 15E RE\_Above 1GHz\_PK

EUT : W6M22409-23739

Test Mode : TX 802.11a CH189

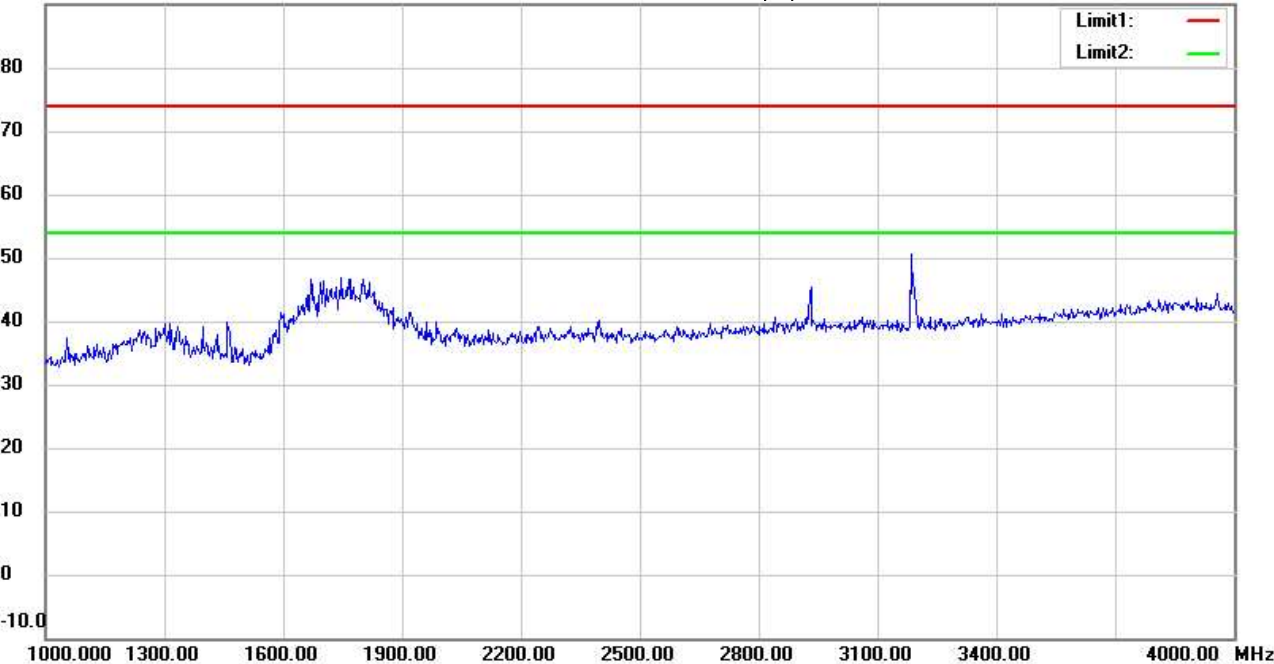
Data :#7

Polarization: Vertical

Distance: 3m

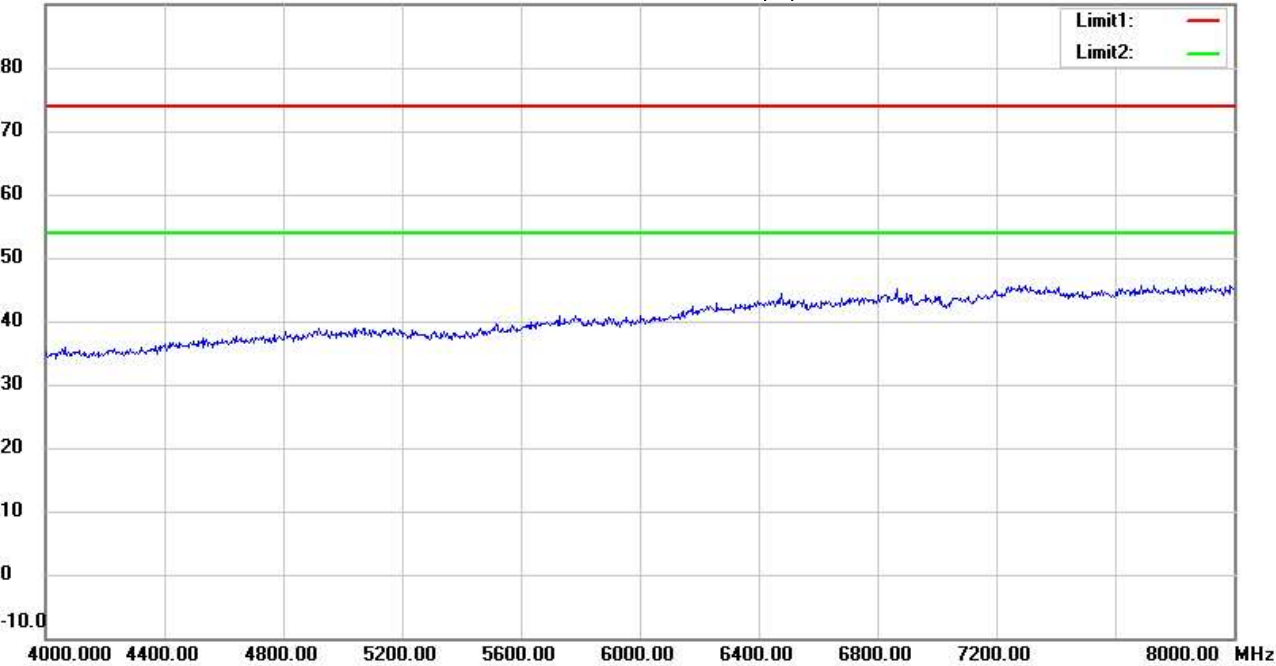
Data :#2

Condition : FCC\_part 15E RE\_Above 1GHz\_PK

Test Mode : TX 802.11a CH189

Polarization: **Horizontal**

Distance: 3m

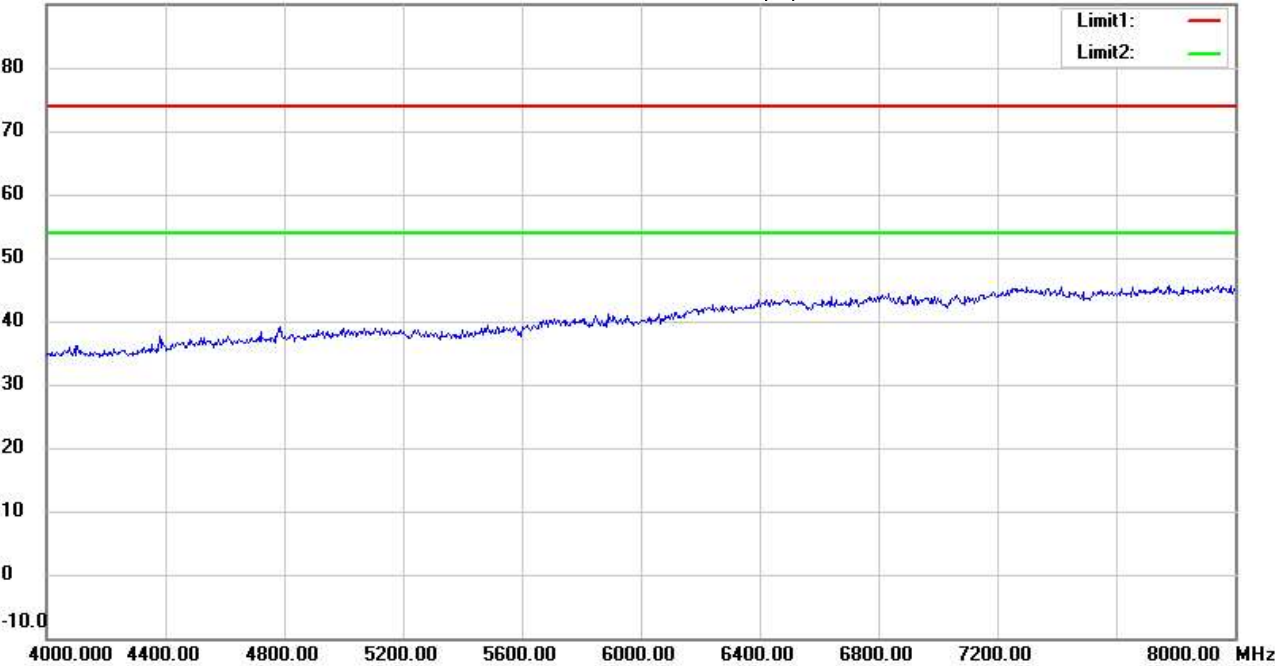
Data :#8

Site : 966A Chamber  
Condition : FCC\_part 15E RE\_Above 1GHz\_PK  
EUT : W6M22409-23739  
M/N:  
Test Mode : TX 802.11a CH189  
Note :

Polarization: Vertical  
Power : 120 Va.c.  
Distance: 3m

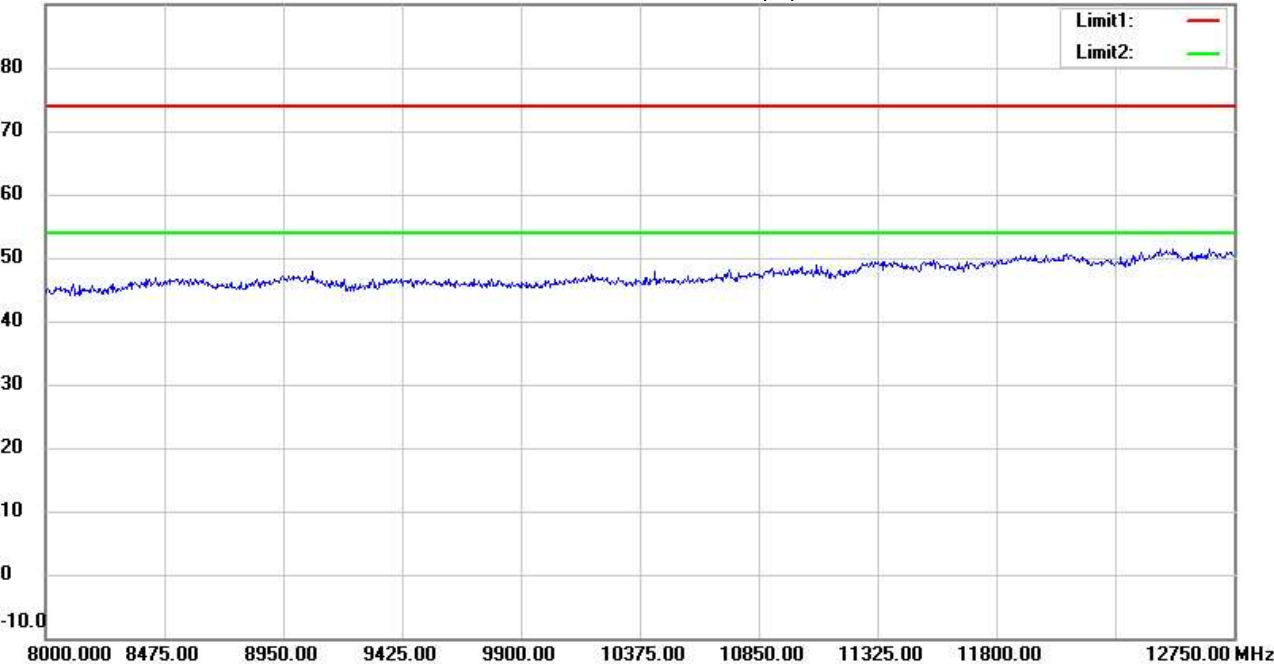
Data :#3

Condition : FCC\_part 15E RE\_Above 1GHz\_PK

Test Mode : TX 802.11a CH189

Polarization: **Horizontal**

Distance: 3m

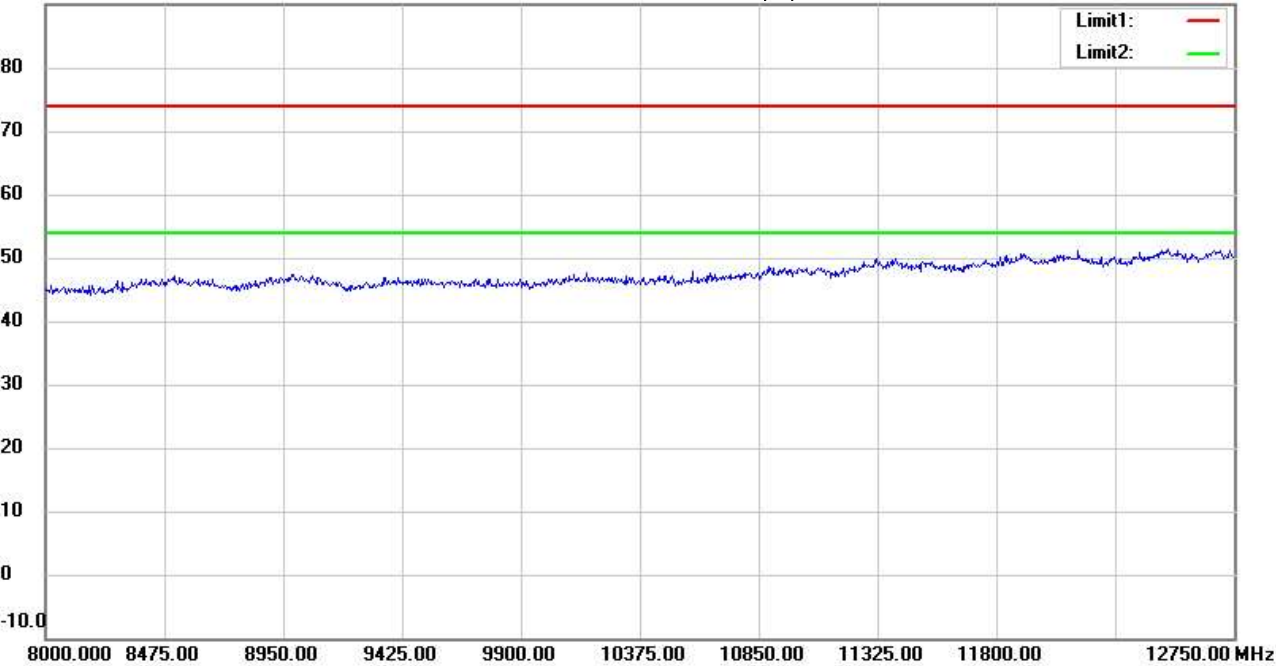
Data :#9

Site : 966A Chamber  
Condition : FCC\_part 15E RE\_Above 1GHz\_PK  
EUT : W6M22409-23739  
M/N:  
Test Mode : TX 802.11a CH189  
Note :

Polarization: Vertical  
Power : 120 Va.c.  
Distance: 3m

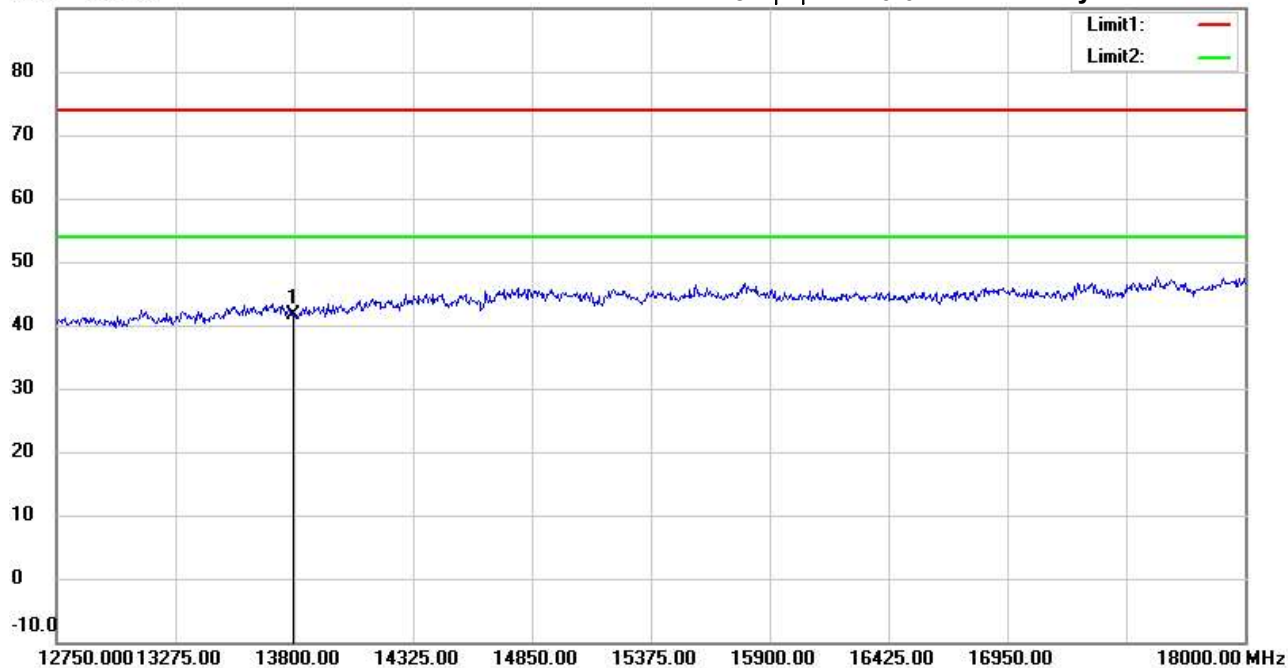
Data : #4

Site : 966A Chamber

Condition : FCC\_part 15E RE\_Above 1GHz\_PK

Polarization: **Horizontal**

| Mk. | Frequency (MHz) | Reading (dBuV) | Detector | Corr. factor (dB/m) | Result (dBuV/m) | Limit (dBuV/m) | Ant.Pos (cm) | Tab.Pos (deg.) | Margin (dB) | Comment |
|---|---|---|---|---|---|---|---|---|---|---|
| * | 13790.000 | 22.06 | peak | 19.59 | 41.65 | 74.00 | 150 | 359 | -32.35 | |

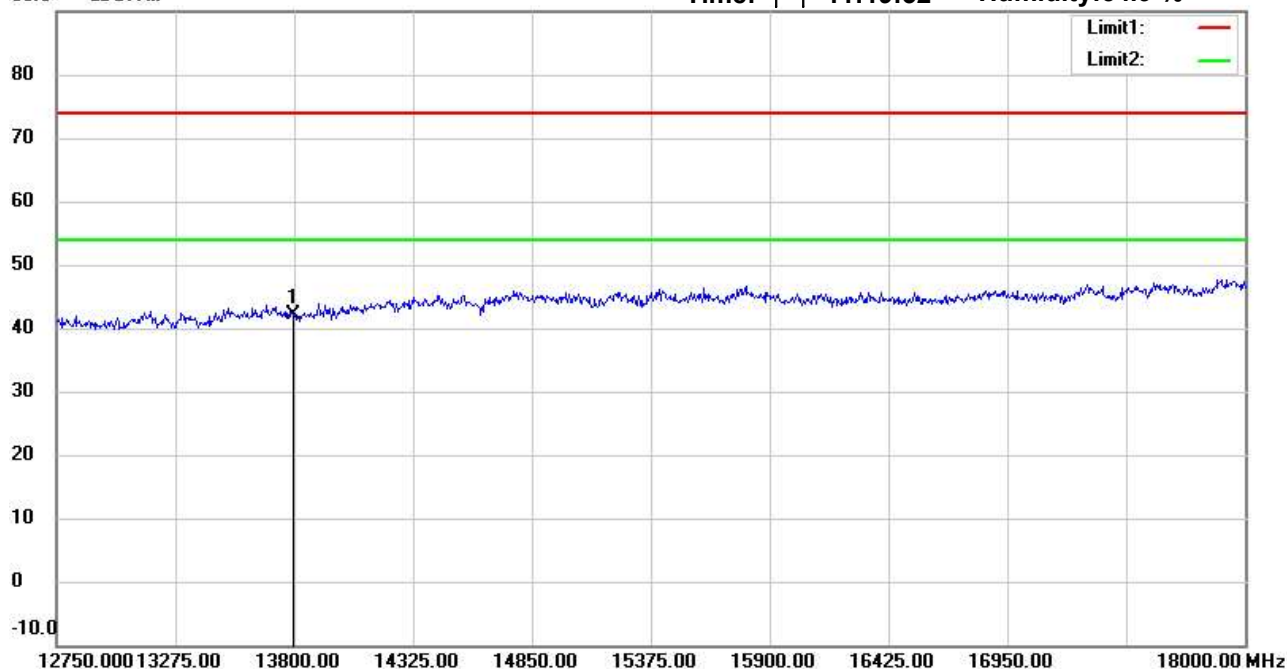
Data : #10

Site : 966A Chamber

Condition : FCC\_part 15E RE\_Above 1GHz\_PK

Polarization: **Vertical**

| Mk. | Frequency (MHz) | Reading (dBuV) | Detector | Corr. factor (dB/m) | Result (dBuV/m) | Limit (dBuV/m) | Ant.Pos (cm) | Tab.Pos (deg.) | Margin (dB) | Comment |
|---|---|---|---|---|---|---|---|---|---|---|
| * | 13790.000 | 22.46 | peak | 19.59 | 42.05 | 74.00 | 150 | 359 | -31.95 | |

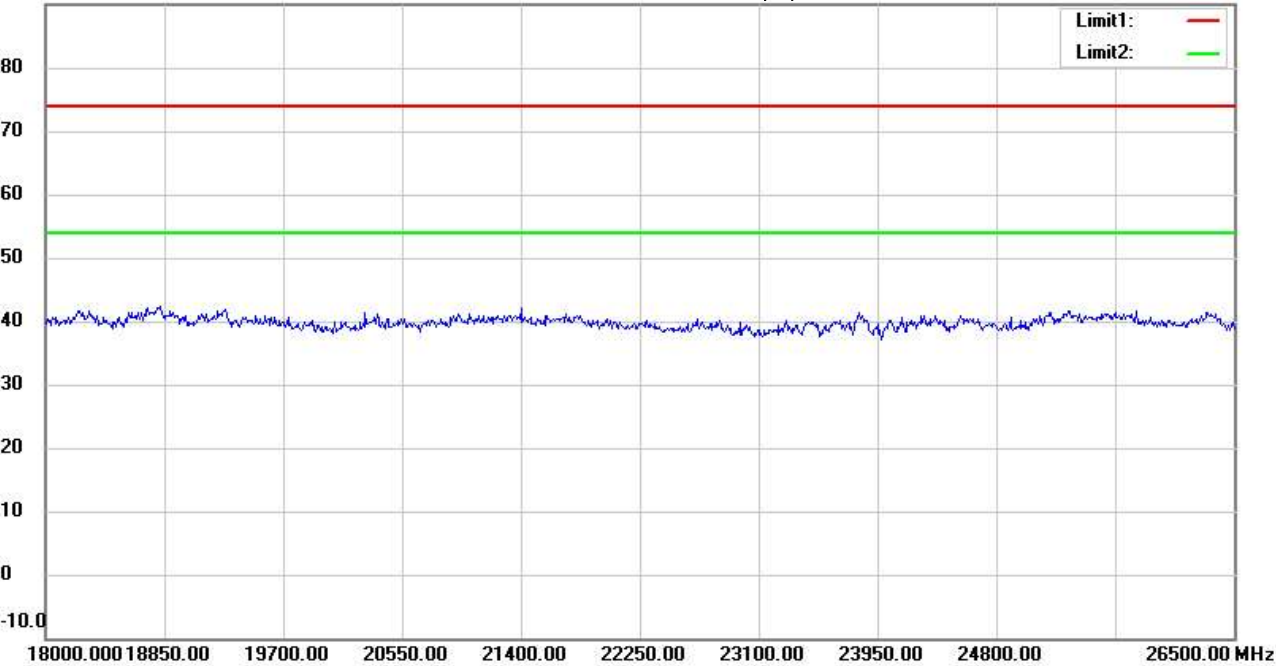
Data :#5

Condition : FCC\_part 15E RE\_Above 1GHz\_PK

Test Mode : TX 802.11a CH189

Polarization: **Horizontal**

Distance: 3m

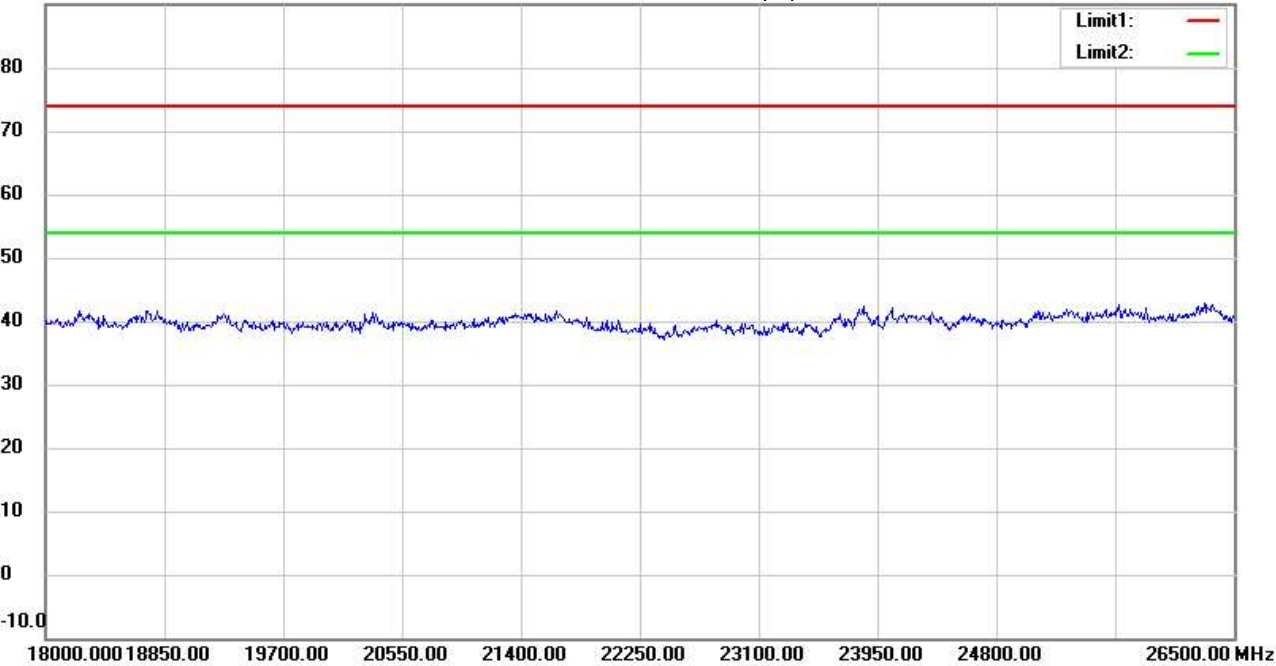
Data :#11

Site : 966A Chamber  
Condition : FCC\_part 15E RE\_Above 1GHz\_PK  
EUT : W6M22409-23739  
M/N:  
Test Mode : TX 802.11a CH189  
Note :

Polarization: Vertical  
Power : 120 Va.c.  
Distance: 3m

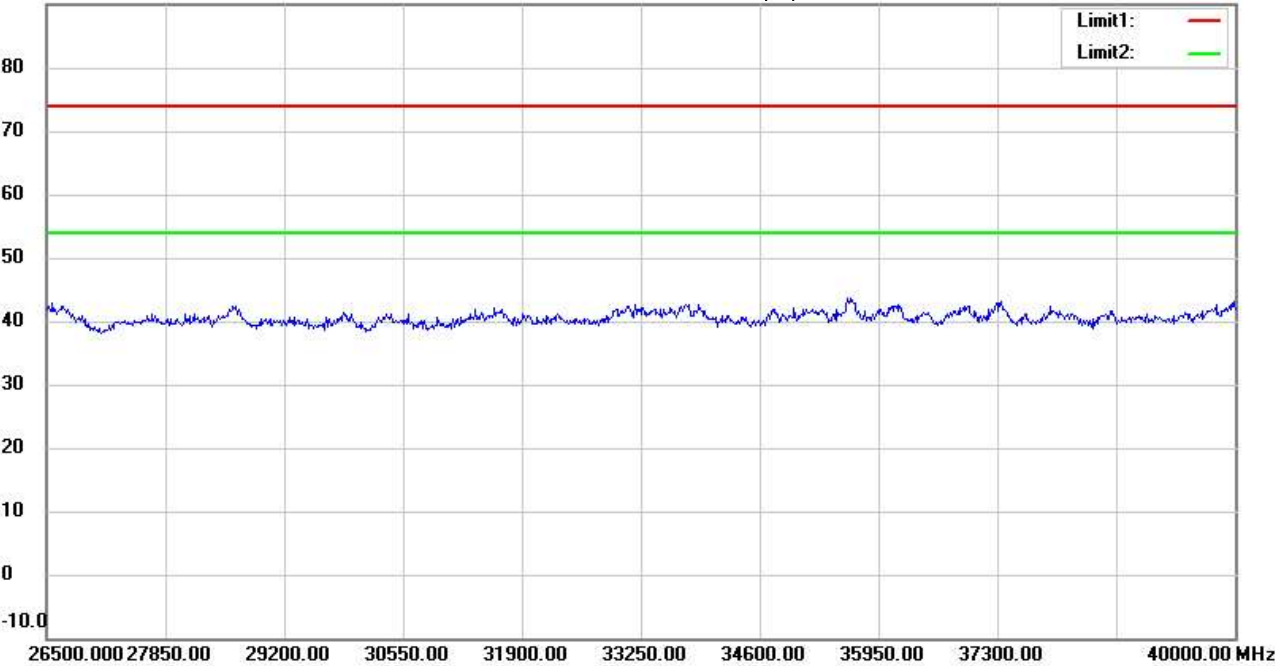
Site : 966A Chamber  
Condition : FCC\_part 15E RE\_Above 1GHz\_PK  
EUT : W6M22409-23739  
M/N:  
Test Mode : TX 802.11a CH189  
Note :

Polarization: Horizontal  
Power : 120 Va.c.  
Distance: 3m

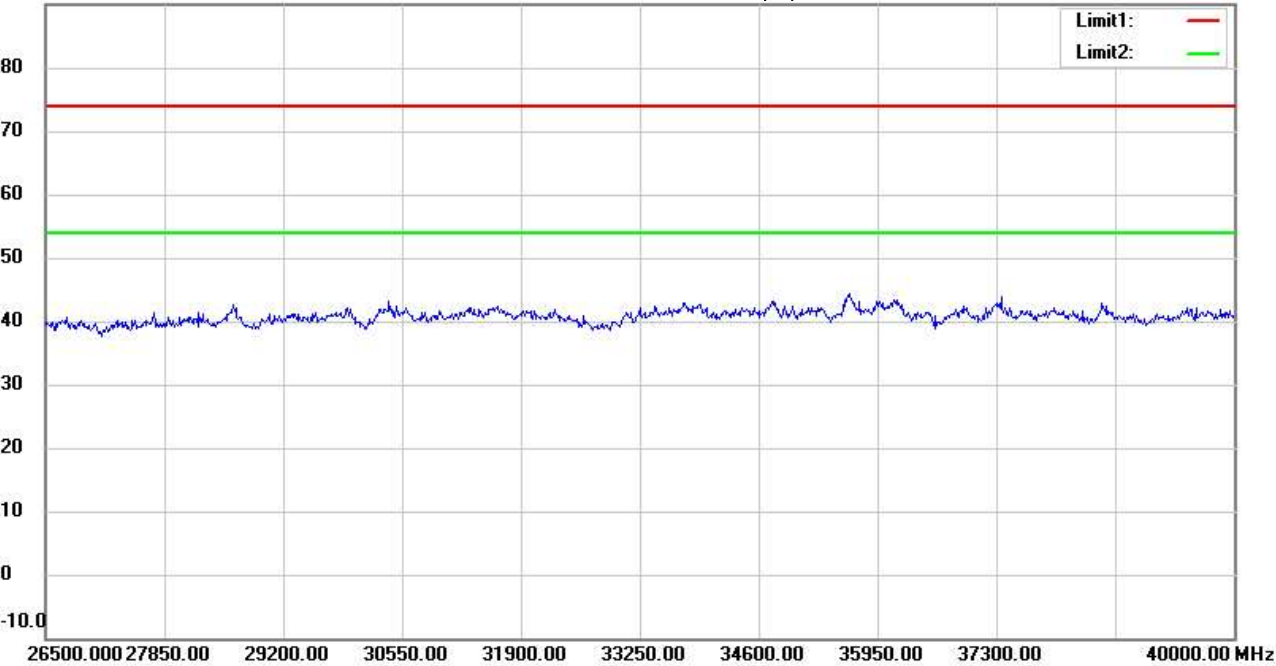
Site : 966A Chamber  
Condition : FCC\_part 15E RE\_Above 1GHz\_PK  
EUT : W6M22409-23739  
M/N:  
Test Mode : TX 802.11a CH189  
Note :

Polarization: Vertical  
Power : 120 Va.c.  
Distance: 3m

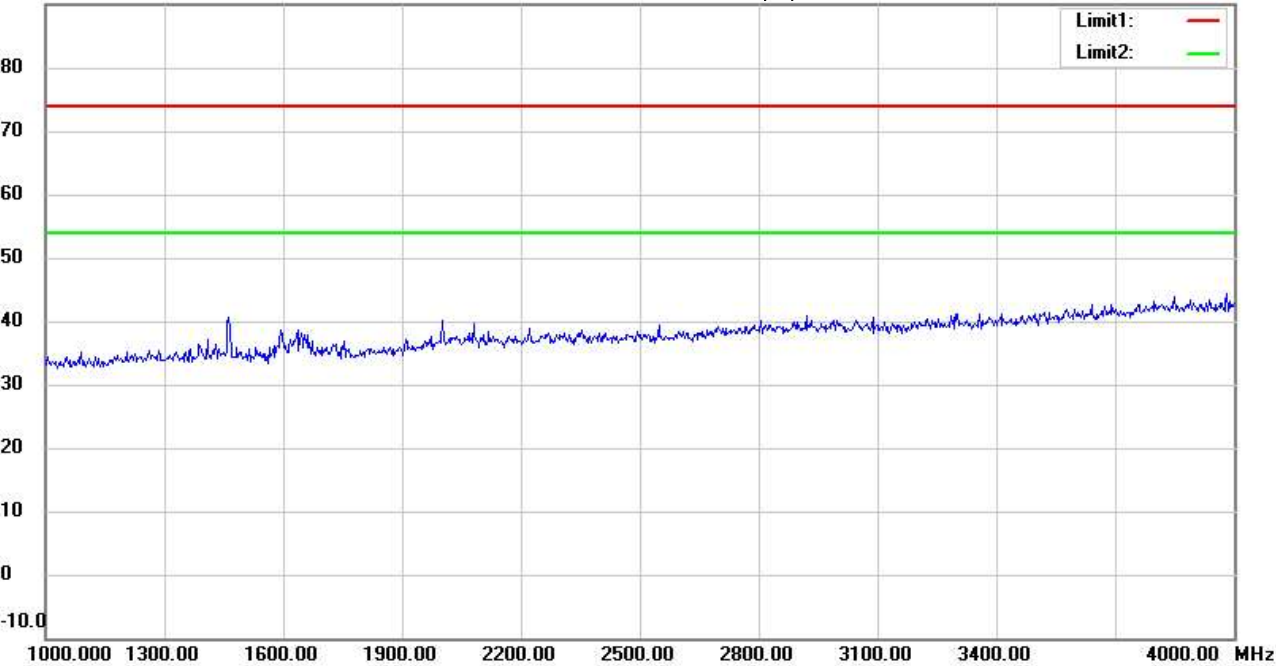
Site : 966A Chamber  
Condition : FCC\_part 15E RE\_Above 1GHz\_PK  
EUT : W6M22409-23739  
M/N:  
Test Mode : TX 802.11a CH209  
Note :

Polarization: Horizontal  
Power : 120 Va.c.  
Distance: 3m

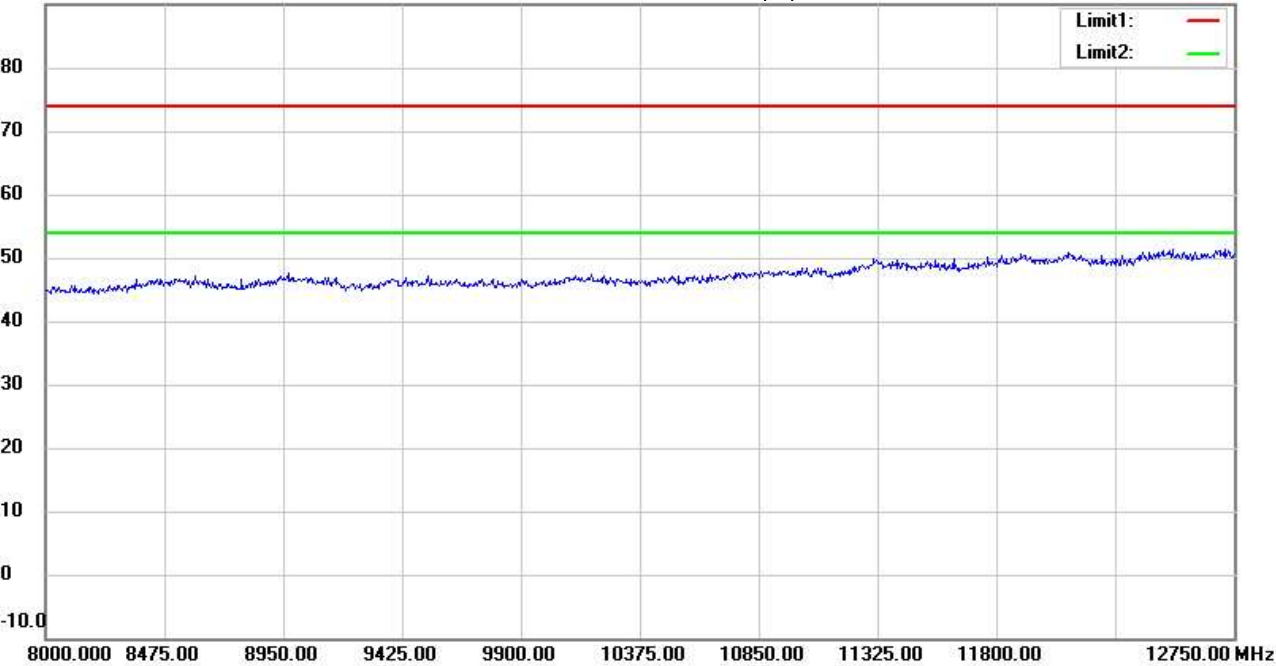
Site : 966A Chamber  
Condition : FCC\_part 15E RE\_Above 1GHz\_PK  
EUT : W6M22409-23739  
M/N:  
Test Mode : TX 802.11a CH209  
Note :

Polarization: Vertical  
Power : 120 Va.c.  
Distance: 3m

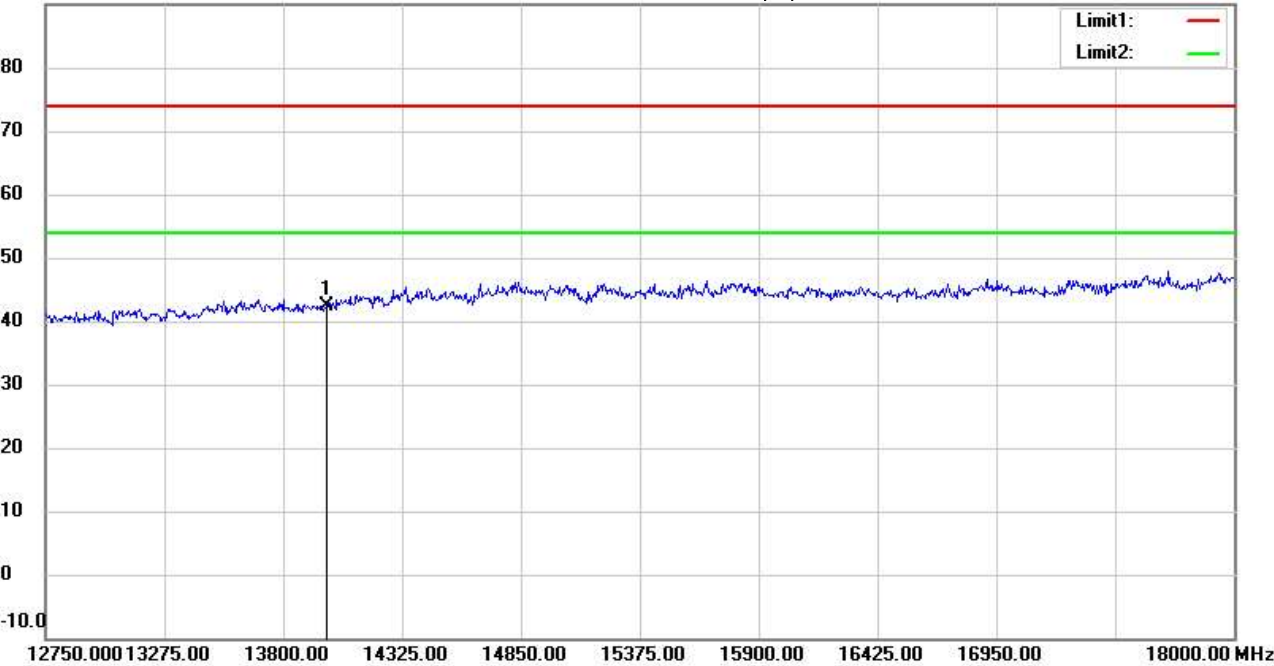
Data :#4

Site : 966A Chamber  
Condition : FCC\_part 15E RE\_Above 1GHz\_PK  
EUT : W6M22409-23739  
M/N:  
Test Mode : TX 802.11a CH209  
Note :

Polarization: Horizontal  
Power : 120 Va.c.  
Distance: 3m

| Mk. | Frequency (MHz) | Reading (dBuV) | Detector | Corr. factor (dB/m) | Result (dBuV/m) | Limit (dBuV/m) | Ant.Pos (cm) | Tab.Pos (deg.) | Margin (dB) | Comment |
|---|---|---|---|---|---|---|---|---|---|---|
| * | 13990.000 | 21.47 | peak | 20.93 | 42.40 | 74.00 | 150 | 104 | -31.60 | |

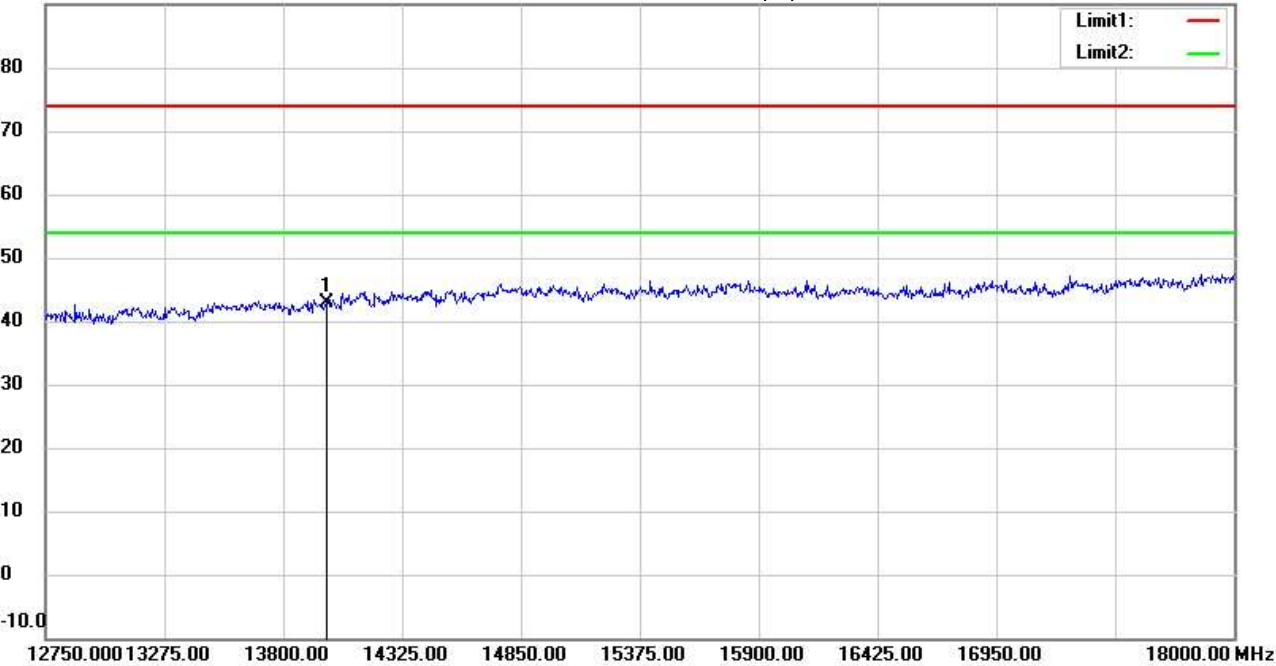
Data :#10

Site : 966A Chamber  
Condition : FCC\_part 15E RE\_Above 1GHz\_PK  
EUT : W6M22409-23739  
M/N:  
Test Mode : TX 802.11a CH209  
Note :

Polarization: Vertical  
Power : 120 Va.c.  
Distance: 3m

| Mk. | Frequency (MHz) | Reading (dBuV) | Detector | Corr. factor (dB/m) | Result (dBuV/m) | Limit (dBuV/m) | Ant.Pos (cm) | Tab.Pos (deg.) | Margin (dB) | Comment |
|---|---|---|---|---|---|---|---|---|---|---|
| * | 13990.000 | 21.92 | peak | 20.93 | 42.85 | 74.00 | 150 | 58 | -31.15 | |

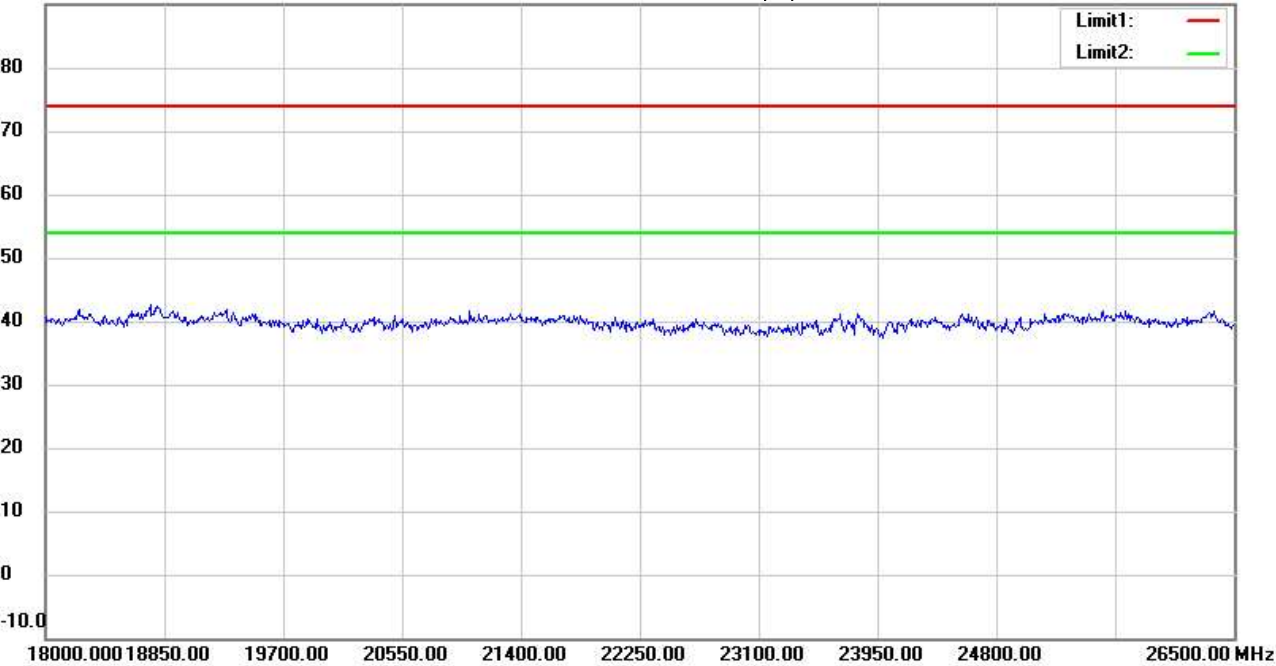
Site : 966A Chamber  
Condition : FCC\_part 15E RE\_Above 1GHz\_PK  
EUT : W6M22409-23739  
M/N:  
Test Mode : TX 802.11a CH209  
Note :

Polarization: Horizontal  
Power : 120 Va.c.  
Distance: 3m

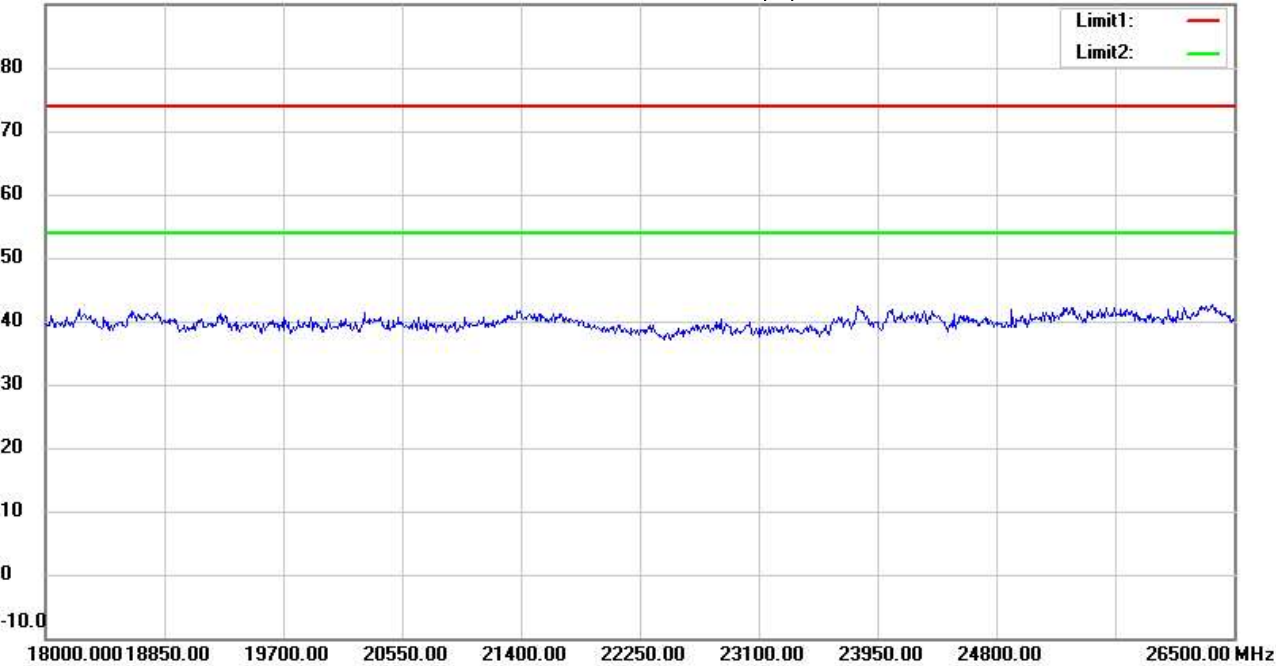
Site : 966A Chamber  
Condition : FCC\_part 15E RE\_Above 1GHz\_PK  
EUT : W6M22409-23739  
M/N:  
Test Mode : TX 802.11a CH209  
Note :

Polarization: Vertical  
Power : 120 Va.c.  
Distance: 3m

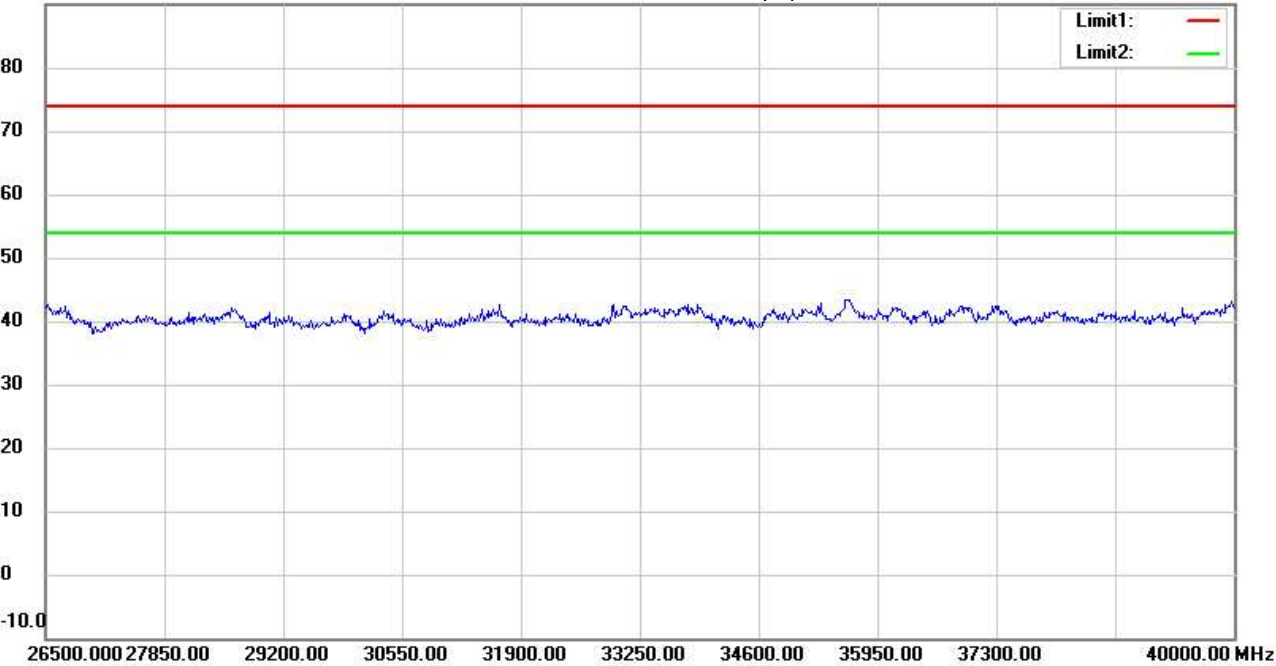
Site : 966A Chamber  
Condition : FCC\_part 15E RE\_Above 1GHz\_PK  
EUT : W6M22409-23739  
M/N:  
Test Mode : TX 802.11a CH209  
Note :

Polarization: **Horizontal**  
Power : 120 Va.c.  
Distance: 3m

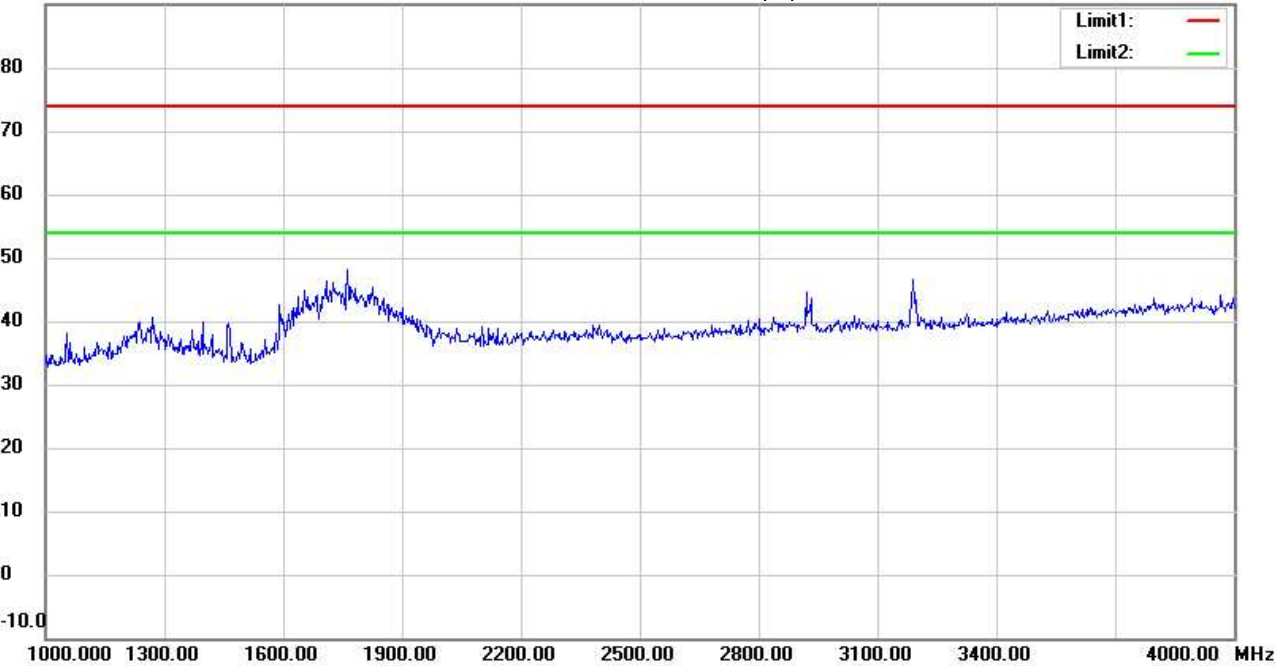
Site : 966A Chamber  
Condition : FCC\_part 15E RE\_Above 1GHz\_PK  
EUT : W6M22409-23739  
M/N:  
Test Mode : TX 802.11a CH229  
Note :

Polarization: Vertical  
Power : 120 Va.c.  
Distance: 3m

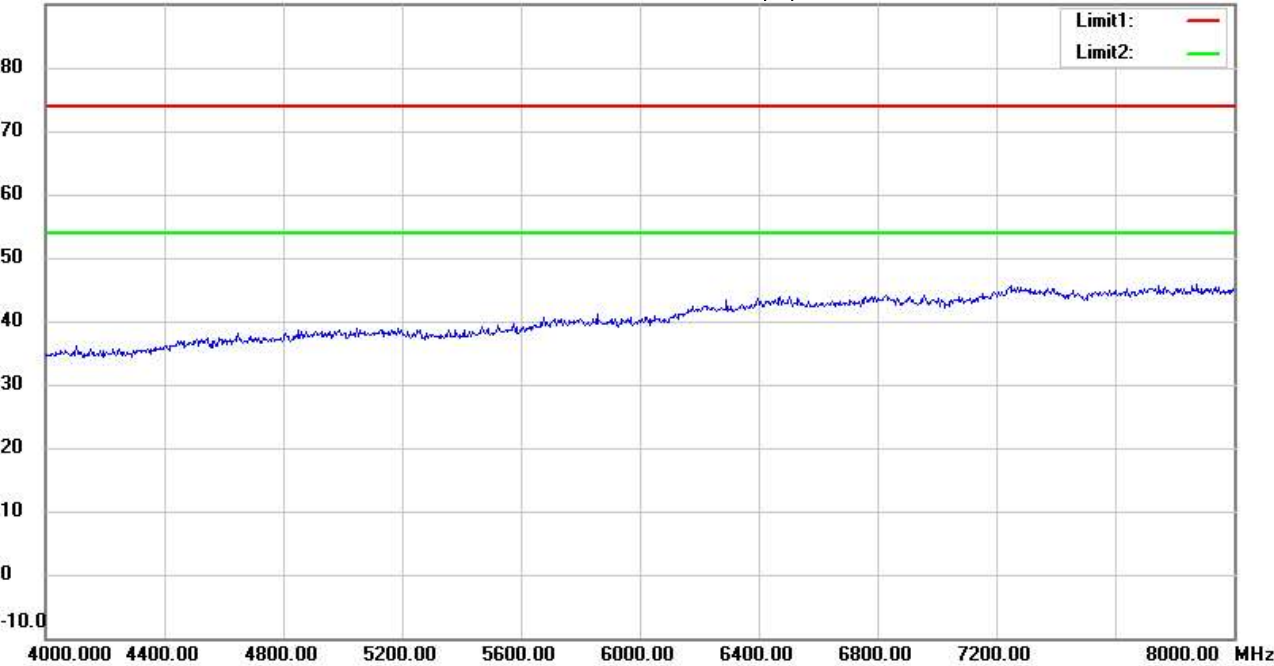
Site : 966A Chamber  
Condition : FCC\_part 15E RE\_Above 1GHz\_PK  
EUT : W6M22409-23739  
M/N:  
Test Mode : TX 802.11a CH229  
Note :

Polarization: *Horizontal*  
Power : 120 Va.c.  
Distance: 3m

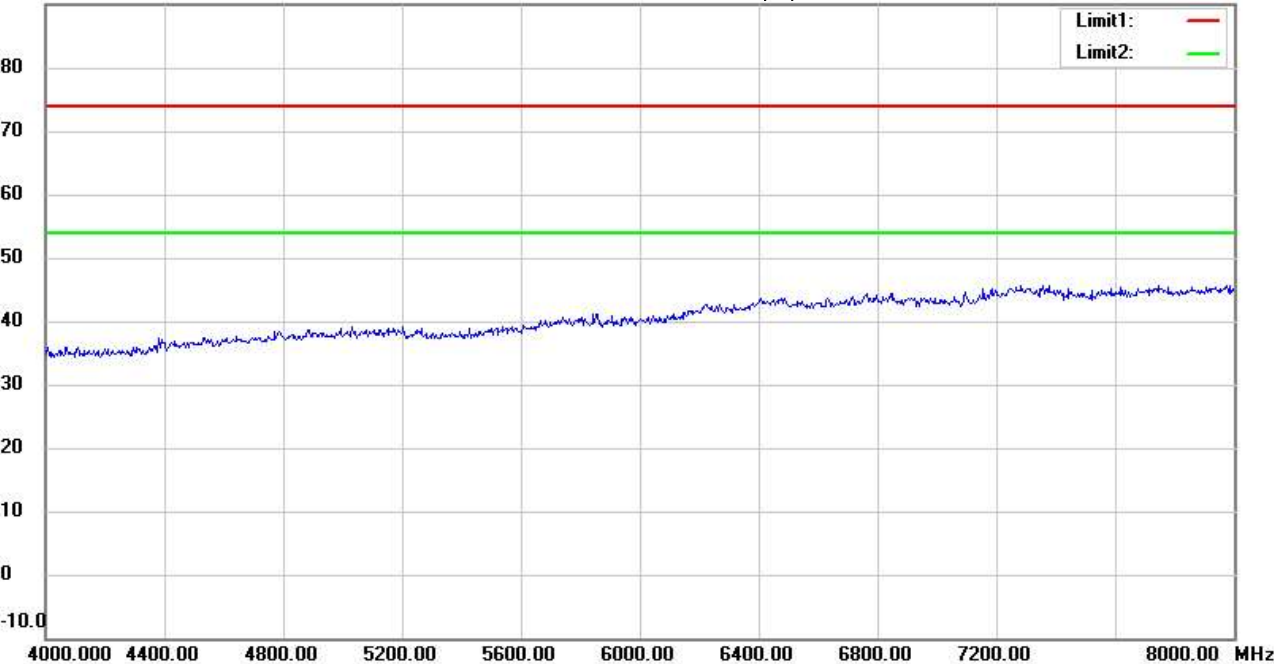
Site : 966A Chamber  
Condition : FCC\_part 15E RE\_Above 1GHz\_PK  
EUT : W6M22409-23739  
M/N:  
Test Mode : TX 802.11a CH229  
Note :

Polarization: Vertical  
Power : 120 Va.c.  
Distance: 3m
