Radiated Emission Measurement

Site : 966A Chamber  
Condition : FCC\_part 15E RE\_Above 1GHz\_PK  
EUT : W6M22409-23739  
M/N:  
Test Mode : TX 802.11a CH229  
Note :

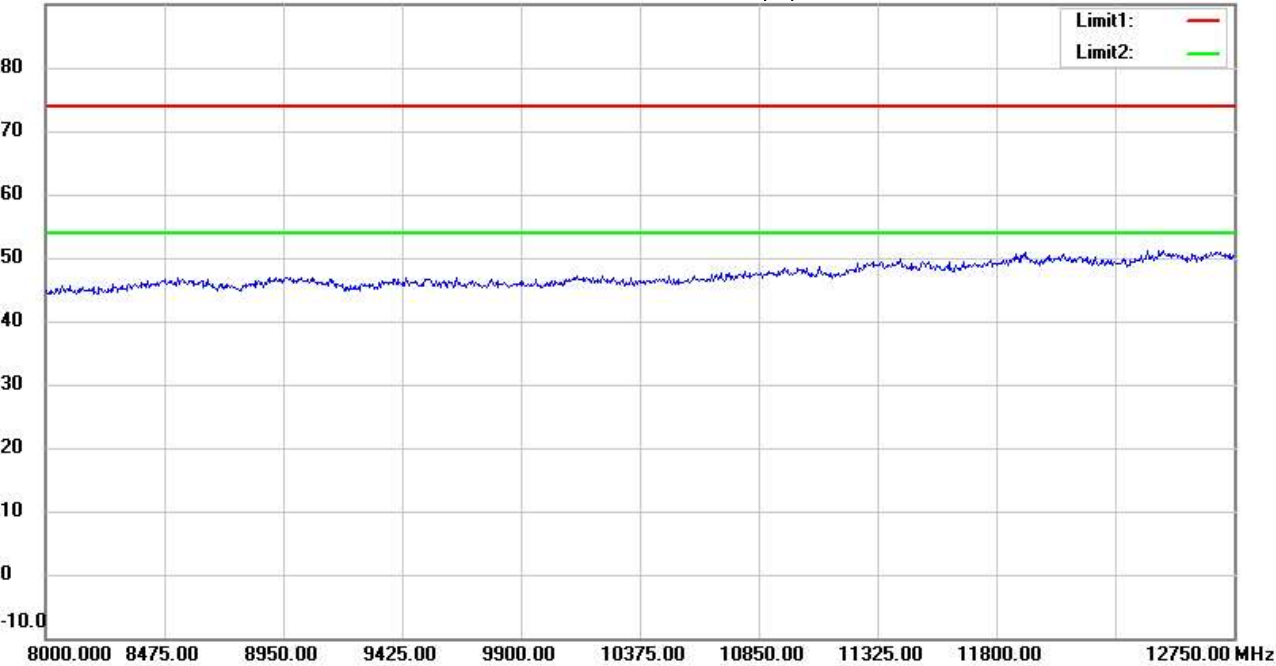
Data :#3

Polarization: Horizontal  
Power : 120 V.a.c.  
Distance: 3m

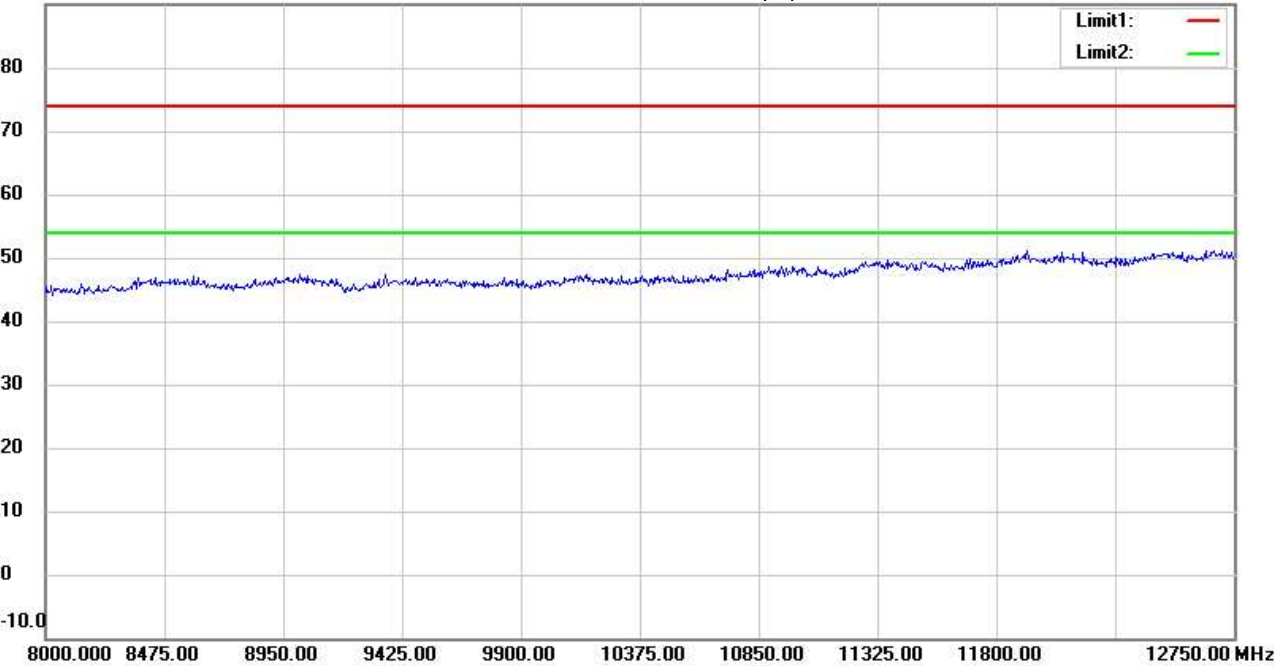
Data :#9

Site : 966A Chamber  
Condition : FCC\_part 15E RE\_Above 1GHz\_PK  
EUT : W6M22409-23739  
M/N:  
Test Mode : TX 802.11a CH229  
Note :

Polarization: Vertical  
Power : 120 V.a.c.  
Distance: 3m

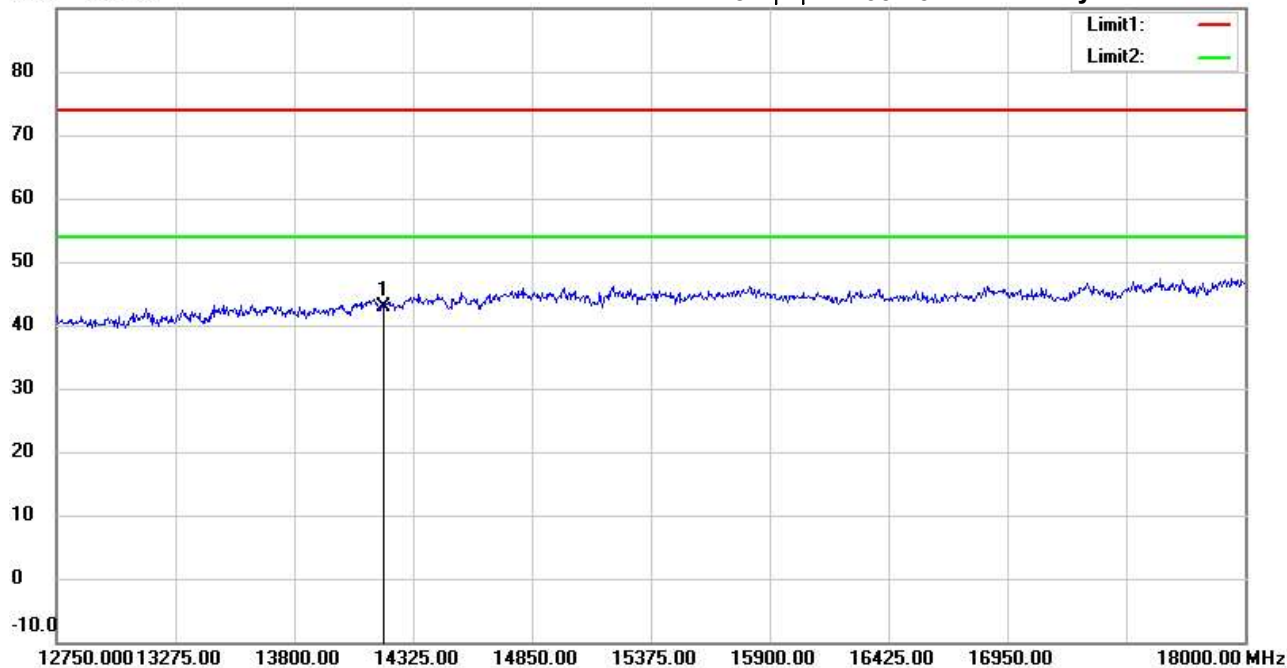
Data : #4

Condition : FCC\_part 15E RE\_Above 1GHz\_PK

Test Mode : TX 802.11a CH229

Polarization: **Horizontal**

| Mk. | Frequency (MHz) | Reading (dBuV) | Detector | Corr. factor (dB/m) | Result (dBuV/m) | Limit (dBuV/m) | Ant.Pos (cm) | Tab.Pos (deg.) | Margin (dB) | Comment |
|---|---|---|---|---|---|---|---|---|---|---|
| * | 14190.000 | 20.93 | peak | 21.94 | 42.87 | 74.00 | 150 | 18 | -31.13 | |

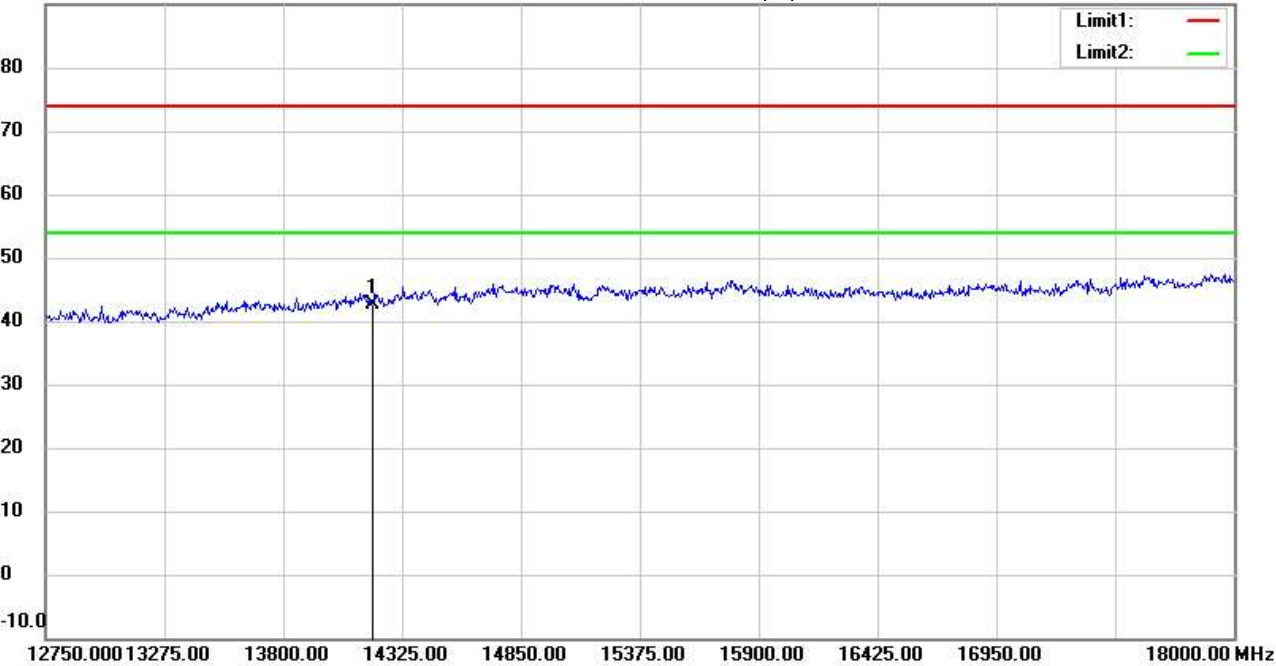
Data :#10

Condition : FCC\_part 15E RE\_Above 1GHz\_PK

Test Mode : TX 802.11a CH229

Polarization: Vertical

| Mk. | Frequency (MHz) | Reading (dBuV) | Detector | Corr. factor (dB/m) | Result (dBuV/m) | Limit (dBuV/m) | Ant.Pos (cm) | Tab.Pos (deg.) | Margin (dB) | Comment |
|---|---|---|---|---|---|---|---|---|---|---|
| * | 14190.000 | 20.70 | peak | 21.94 | 42.64 | 74.00 | 150 | 359 | -31.36 | |

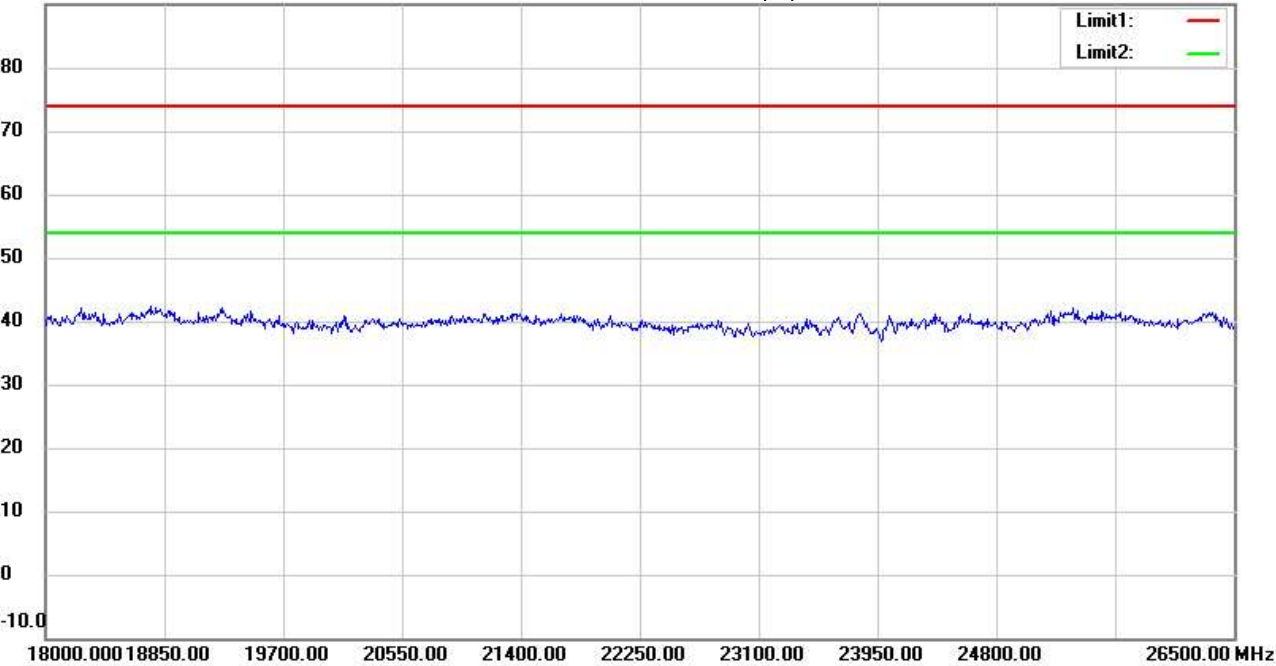
Data :#5

Site : 966A Chamber  
Condition : FCC\_part 15E RE\_Above 1GHz\_PK  
EUT : W6M22409-23739  
M/N:  
Test Mode : TX 802.11a CH229  
Note :

Polarization: *Horizontal*  
Power : 120 Va.c.  
Distance: 3m

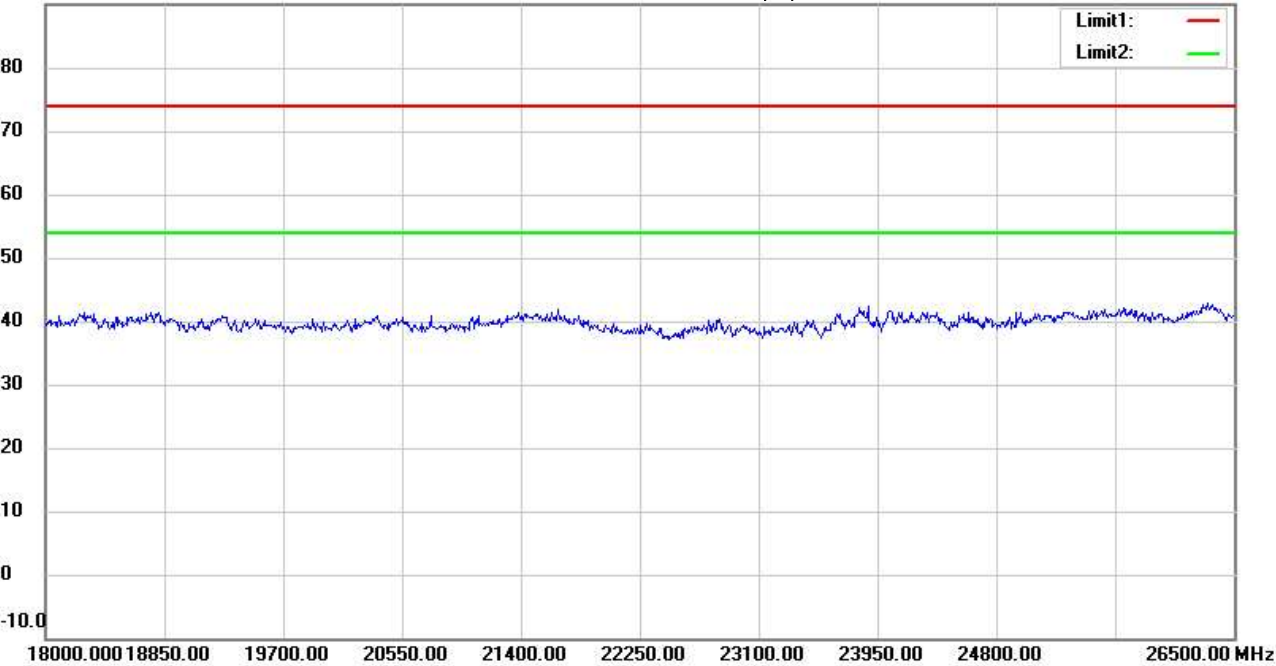
Data :#11

Condition : FCC\_part 15E RE\_Above 1GHz\_PK

Test Mode : TX 802.11a CH229

Polarization: Vertical

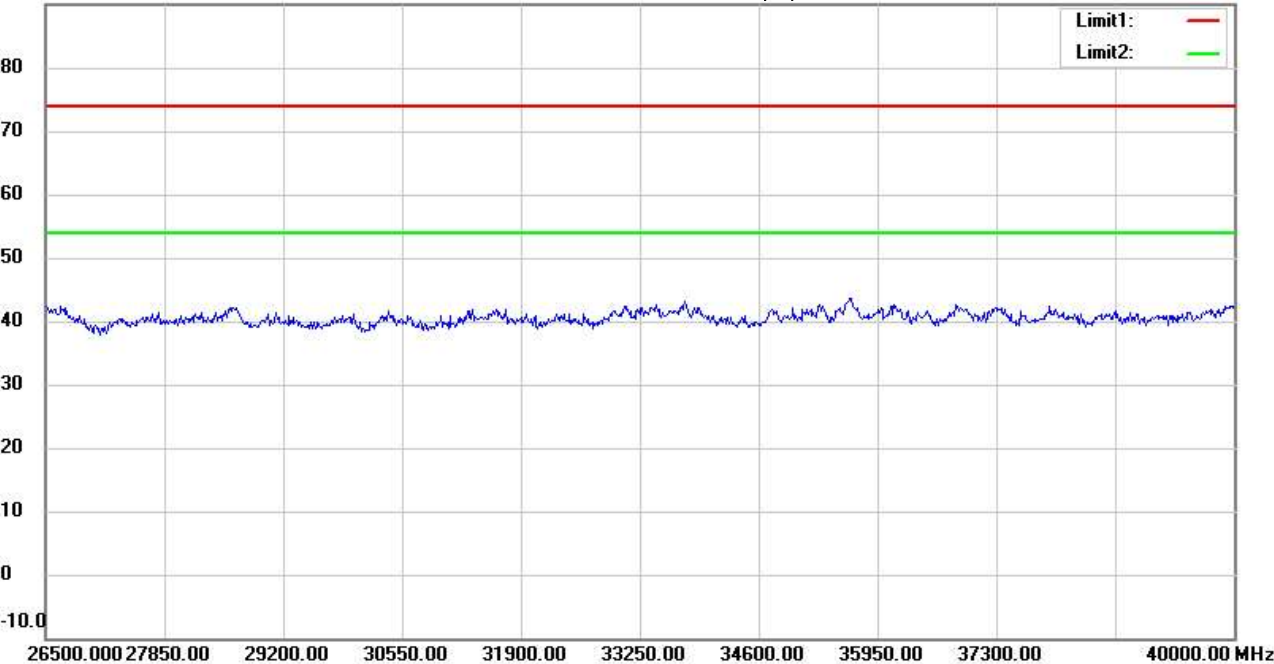
Data :#6

Condition : FCC\_part 15E RE\_Above 1GHz\_PK

Test Mode : TX 802.11a CH229

Polarization: *Horizontal*

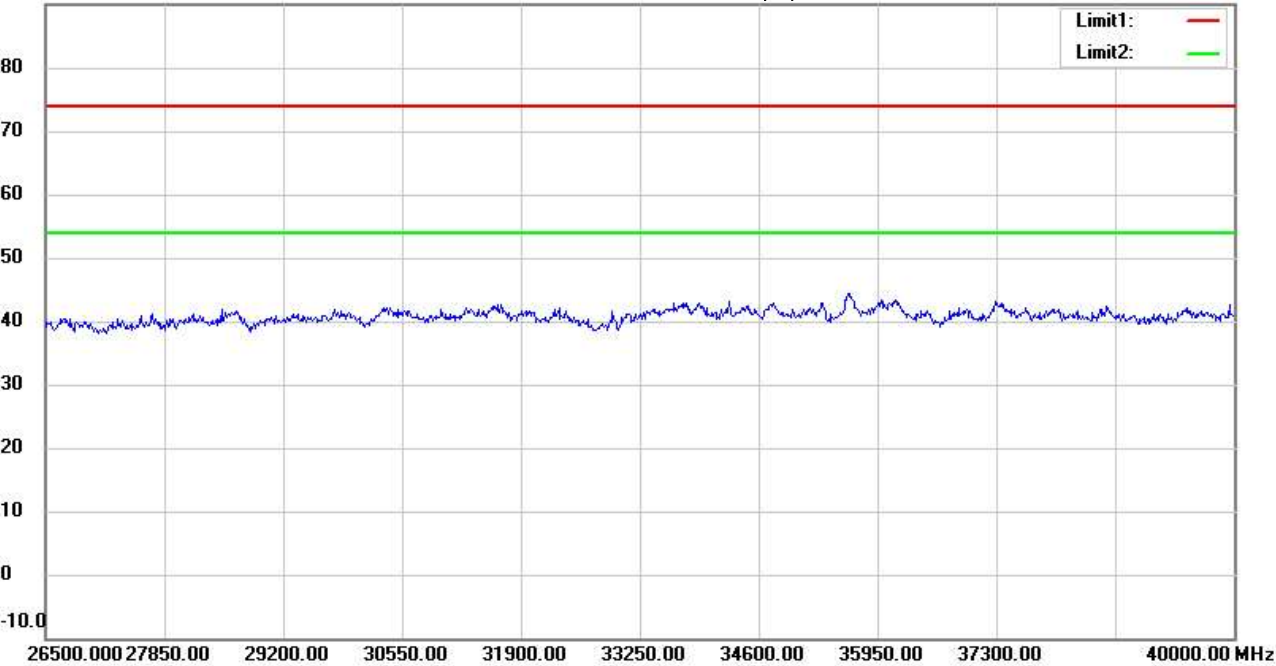
Data :#12

Site : 966A Chamber  
Condition : FCC\_part 15E RE\_Above 1GHz\_PK  
EUT : W6M22409-23739  
M/N:  
Test Mode : TX 802.11a CH229  
Note :

Polarization: Vertical  
Power : 120 Va.c.  
Distance: 3m

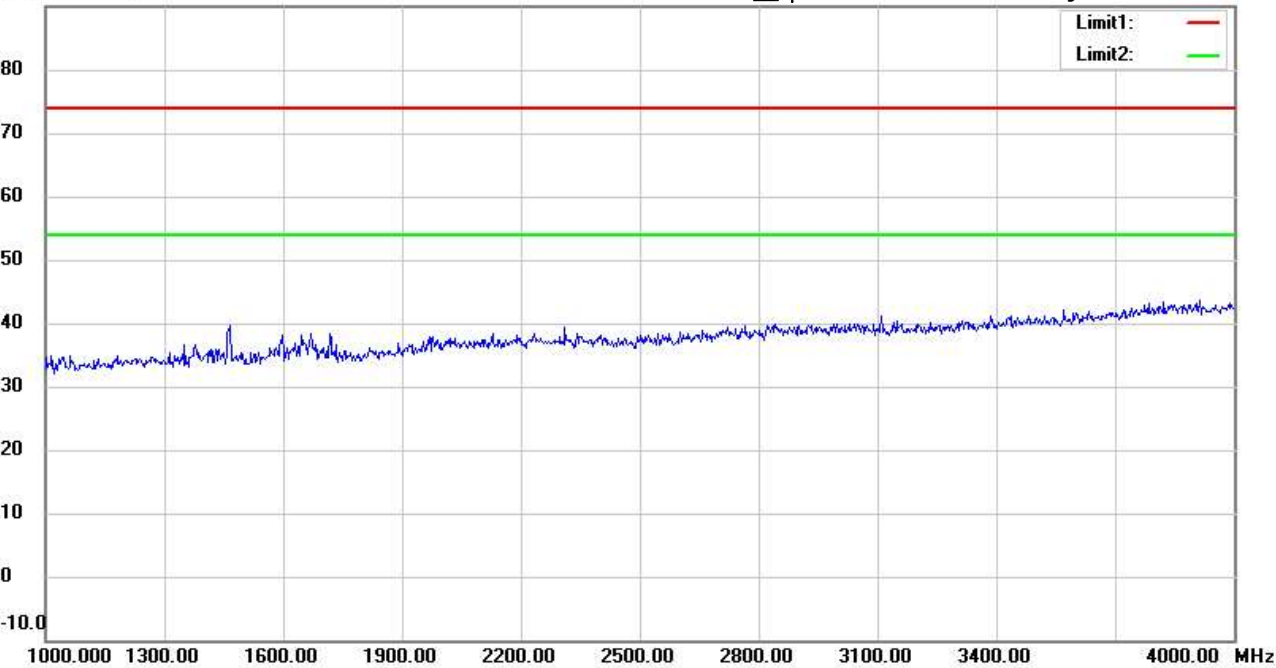
Data :#1

Condition : FCC\_part 15E RE\_Above 1GHz\_PK

Test Mode : TX 802.11ax20 CH189

Polarization: *Horizontal*

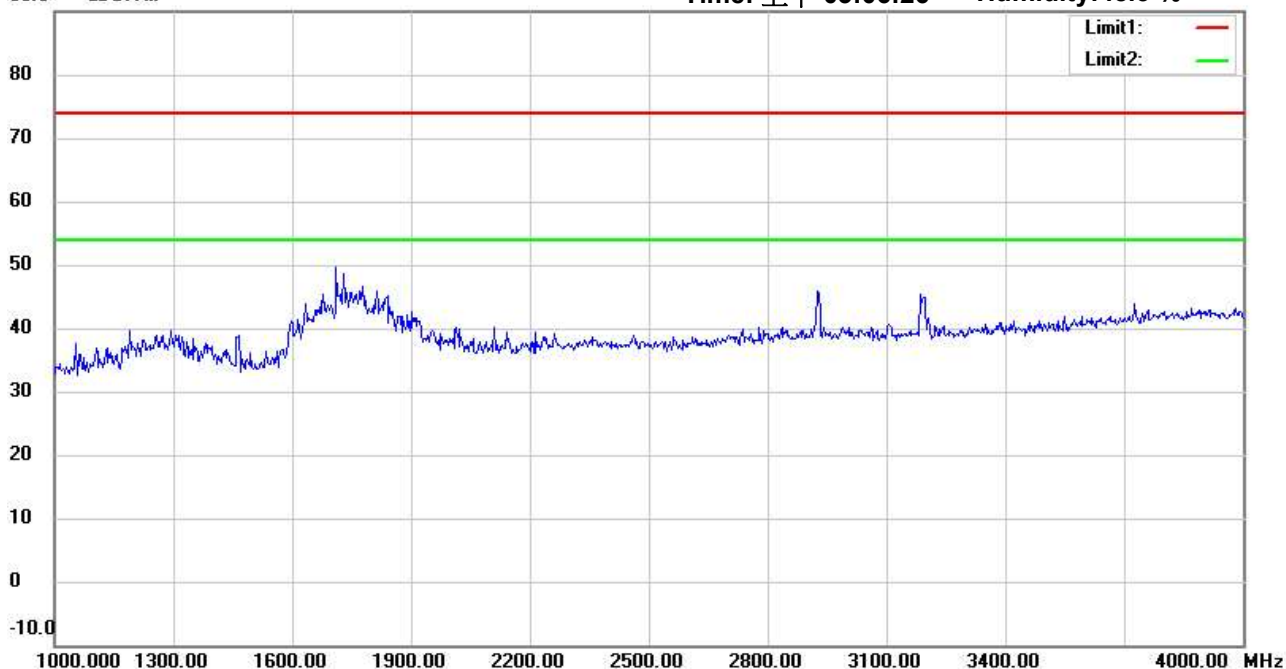
Data : #7

Condition : FCC\_part 15E RE\_Above 1GHz\_PK

Test Mode : TX 802.11ax20 CH189

Polarization: Vertical

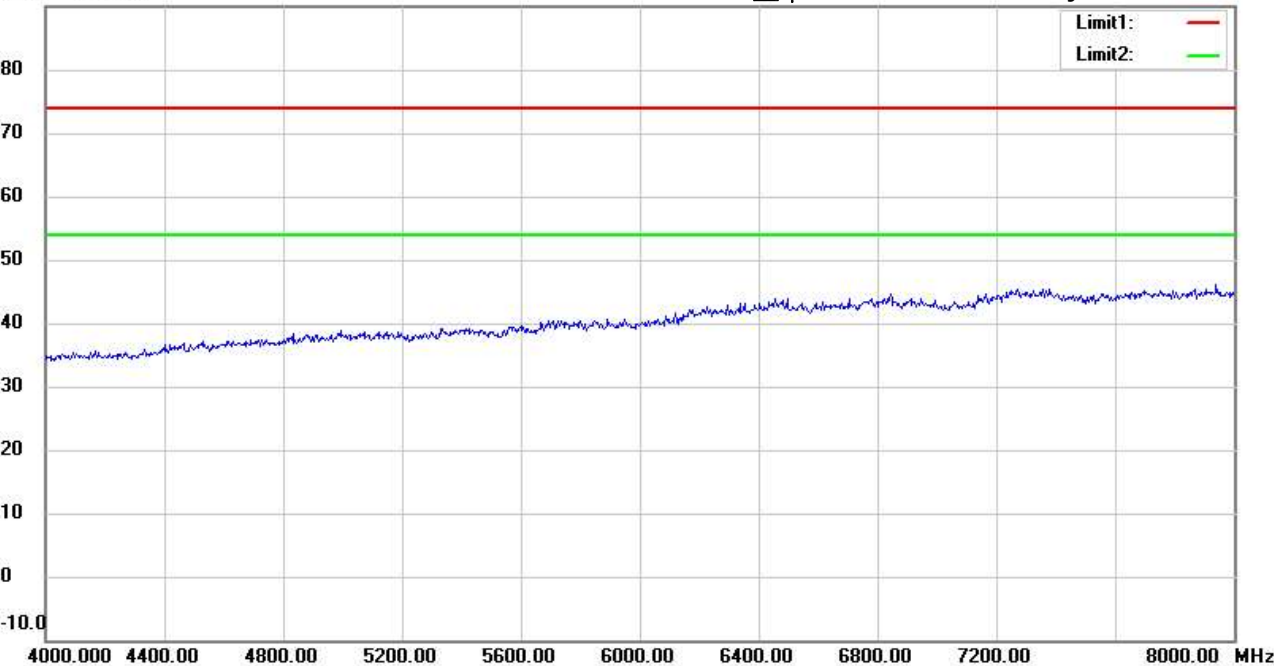
Data :#2

Condition : FCC\_part 15E RE\_Above 1GHz\_PK

Test Mode : TX 802.11ax20 CH189

Polarization: *Horizontal*

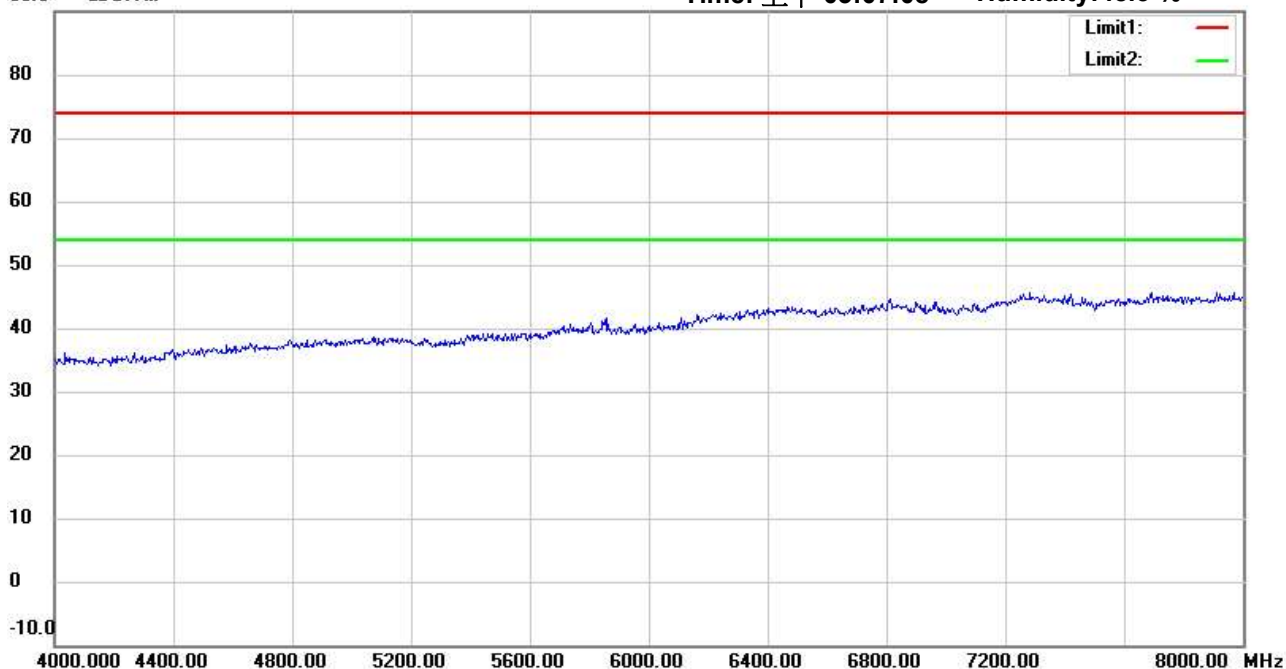
Data : #8

Condition : FCC\_part 15E RE\_Above 1GHz\_PK

Test Mode : TX 802.11ax20 CH189

Polarization: **Vertical**

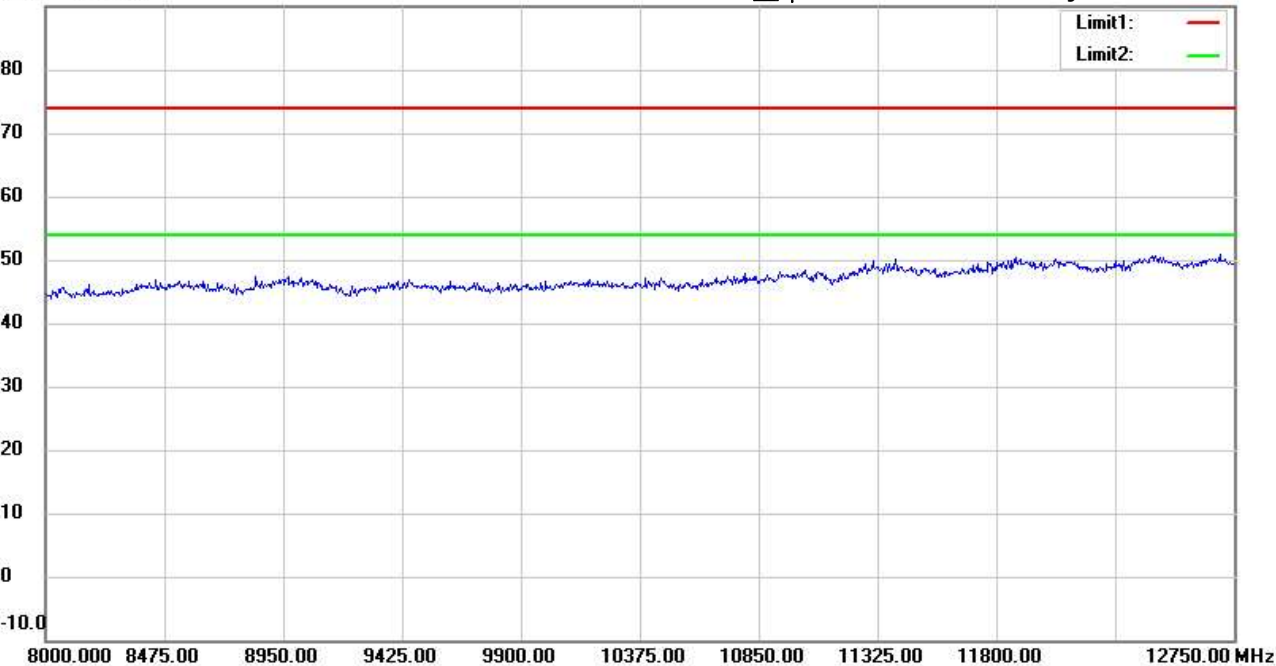
Data :#3

Condition : FCC\_part 15E RE\_Above 1GHz\_PK

Test Mode : TX 802.11ax20 CH189

Polarization: *Horizontal*

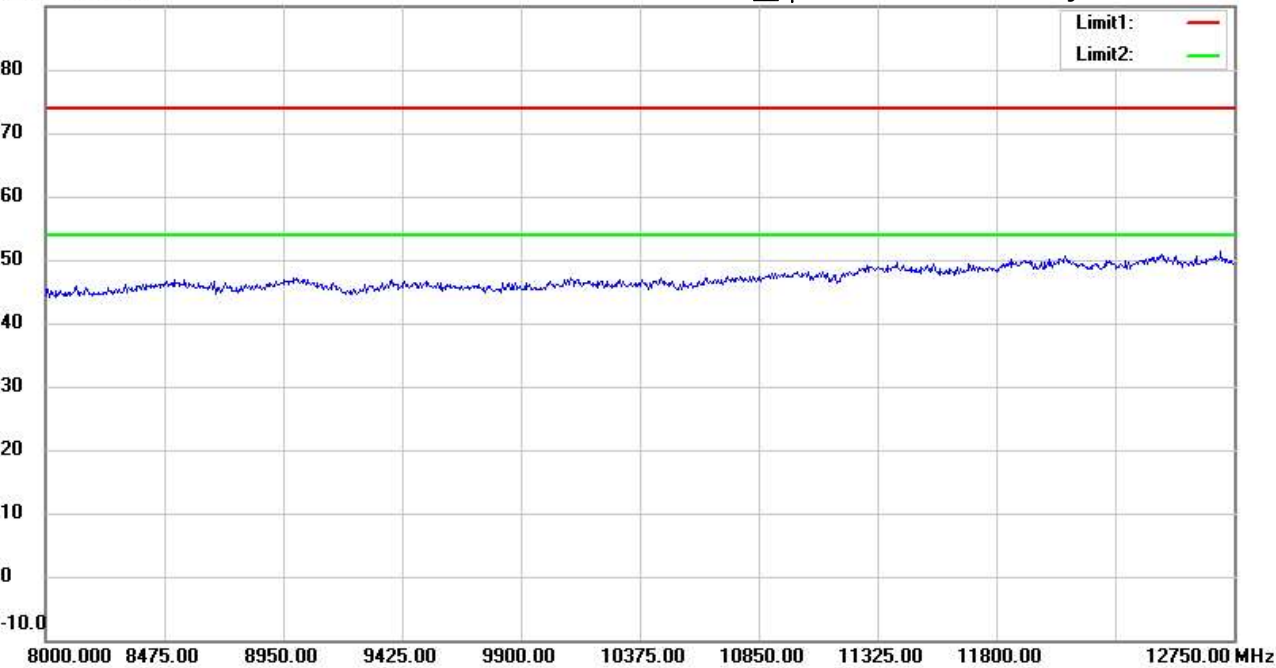
Data :#9

Condition : FCC\_part 15E RE\_Above 1GHz\_PK

Test Mode : TX 802.11ax20 CH189

Polarization: Vertical

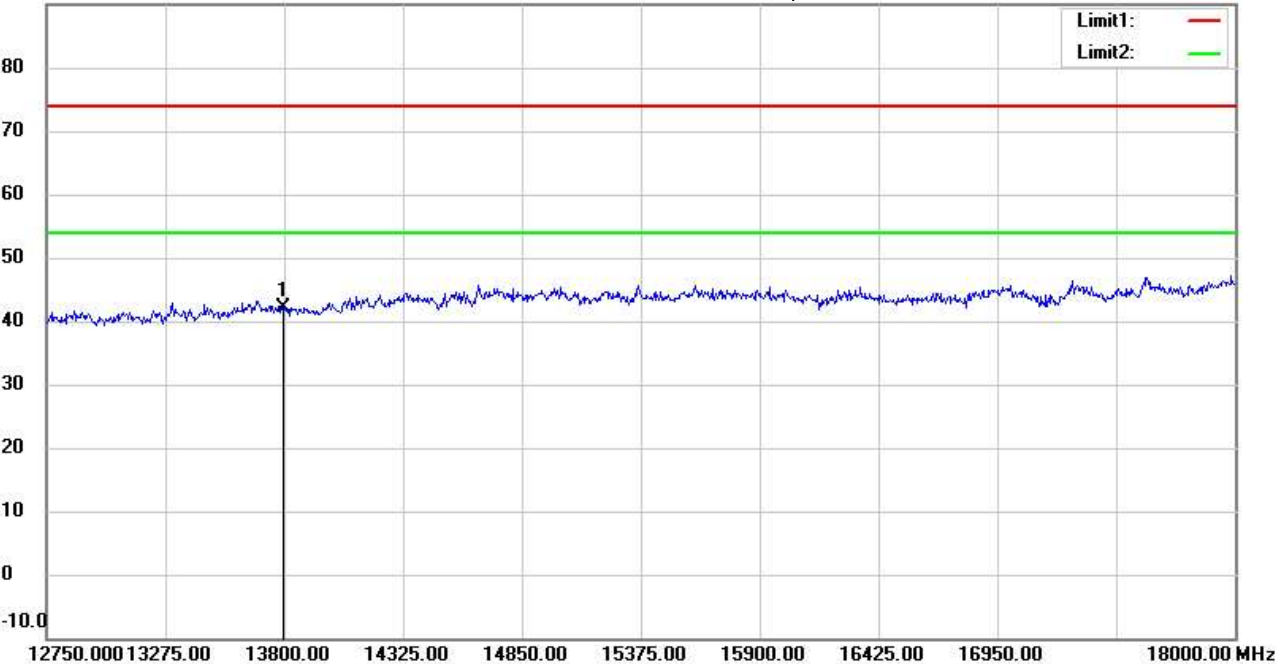
Data :#4

Condition : FCC\_part 15E RE\_Above 1GHz\_PK

Test Mode : TX 802.11ax20 CH189

Polarization: **Horizontal**

| Mk. | Frequency (MHz) | Reading (dBuV) | Detector | Corr. factor (dB/m) | Result (dBuV/m) | Limit (dBuV/m) | Ant.Pos (cm) | Tab.Pos (deg.) | Margin (dB) | Comment |
|---|---|---|---|---|---|---|---|---|---|---|
| * | 13790.000 | 22.44 | peak | 19.59 | 42.03 | 74.00 | 150 | 227 | -31.97 | |

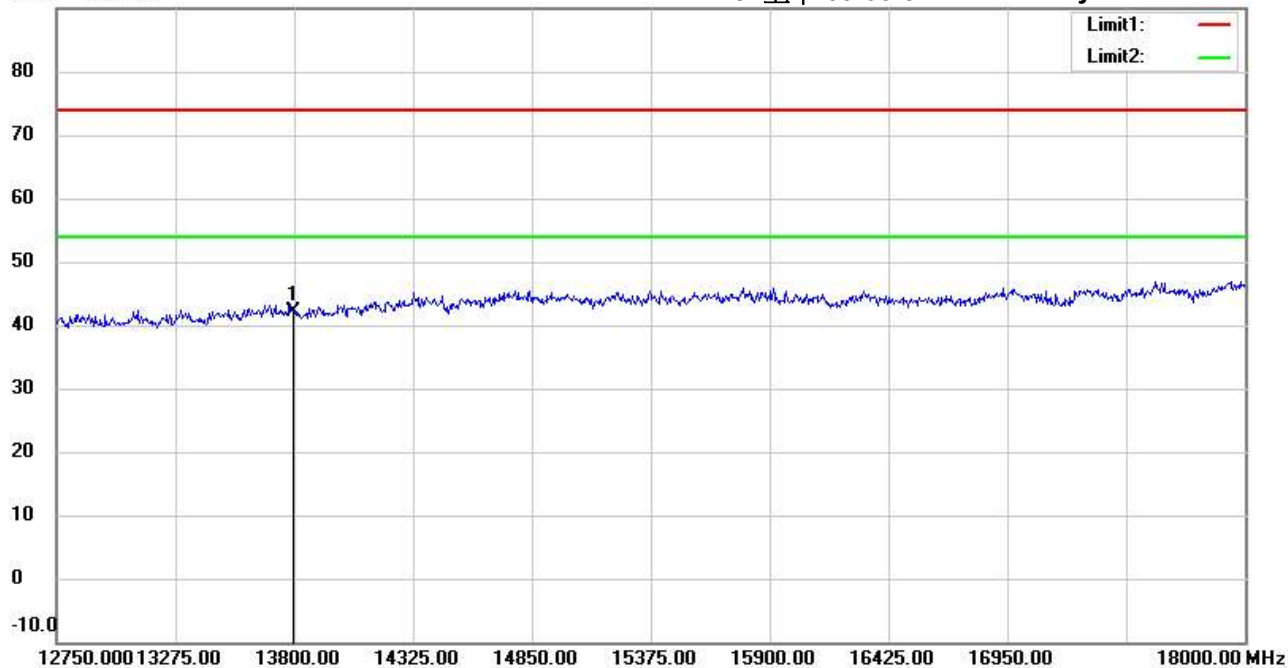
Data : #10

Condition : FCC\_part 15E RE\_Above 1GHz\_PK

Test Mode : TX 802.11ax20 CH189

Polarization: Vertical

| Mk. | Frequency (MHz) | Reading (dBuV) | Detector | Corr. factor (dB/m) | Result (dBuV/m) | Limit (dBuV/m) | Ant.Pos (cm) | Tab.Pos (deg.) | Margin (dB) | Comment |
|---|---|---|---|---|---|---|---|---|---|---|
| * | 13790.000 | 22.58 | peak | 19.59 | 42.17 | 74.00 | 150 | 311 | -31.83 | |

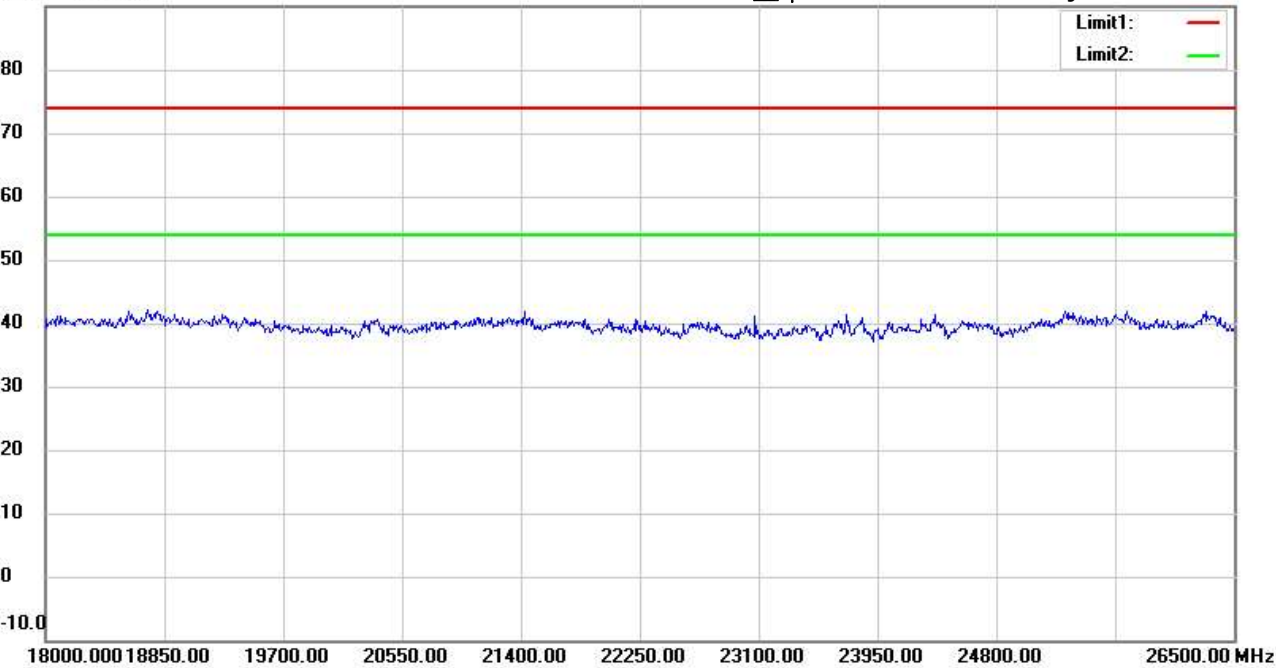
Data :#5

Condition : FCC\_part 15E RE\_Above 1GHz\_PK

Test Mode : TX 802.11ax20 CH189

Polarization: *Horizontal*

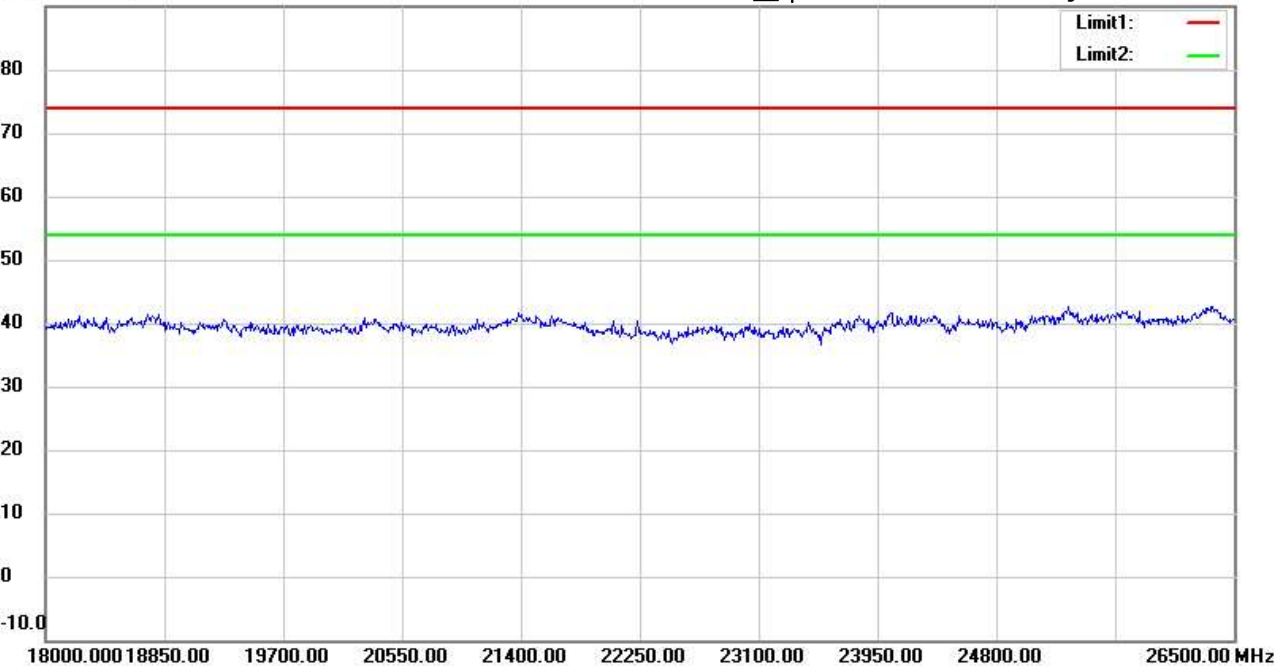
Data :#11

Condition : FCC\_part 15E RE\_Above 1GHz\_PK

Test Mode : TX 802.11ax20 CH189

Polarization: Vertical

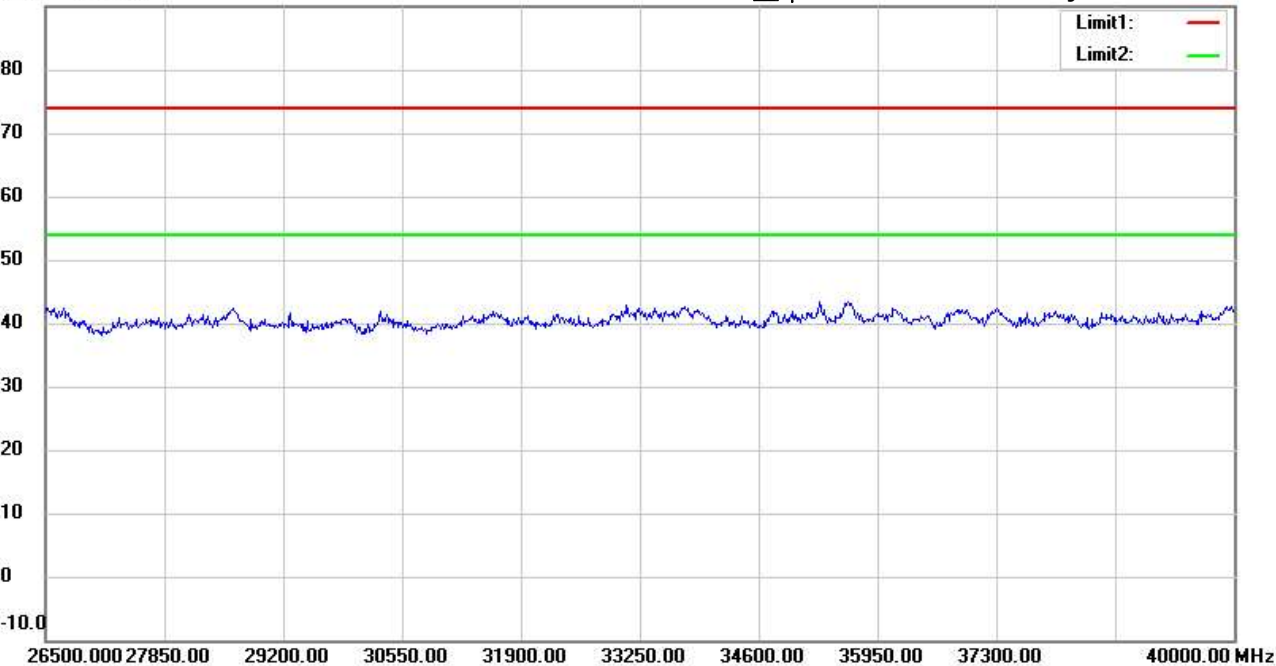
Data :#6

Condition : FCC\_part 15E RE\_Above 1GHz\_PK

Test Mode : TX 802.11ax20 CH189

Polarization: Horizontal

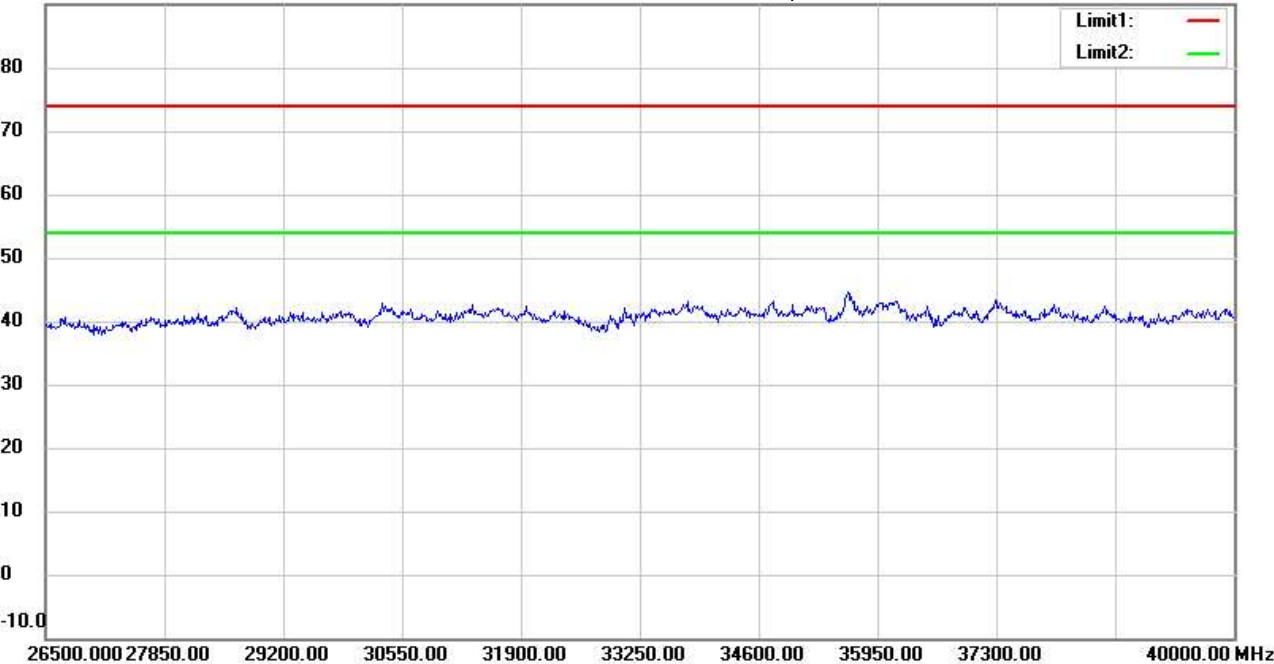
Data :#12

Condition : FCC\_part 15E RE\_Above 1GHz\_PK

Test Mode : TX 802.11ax20 CH189

Polarization: Vertical

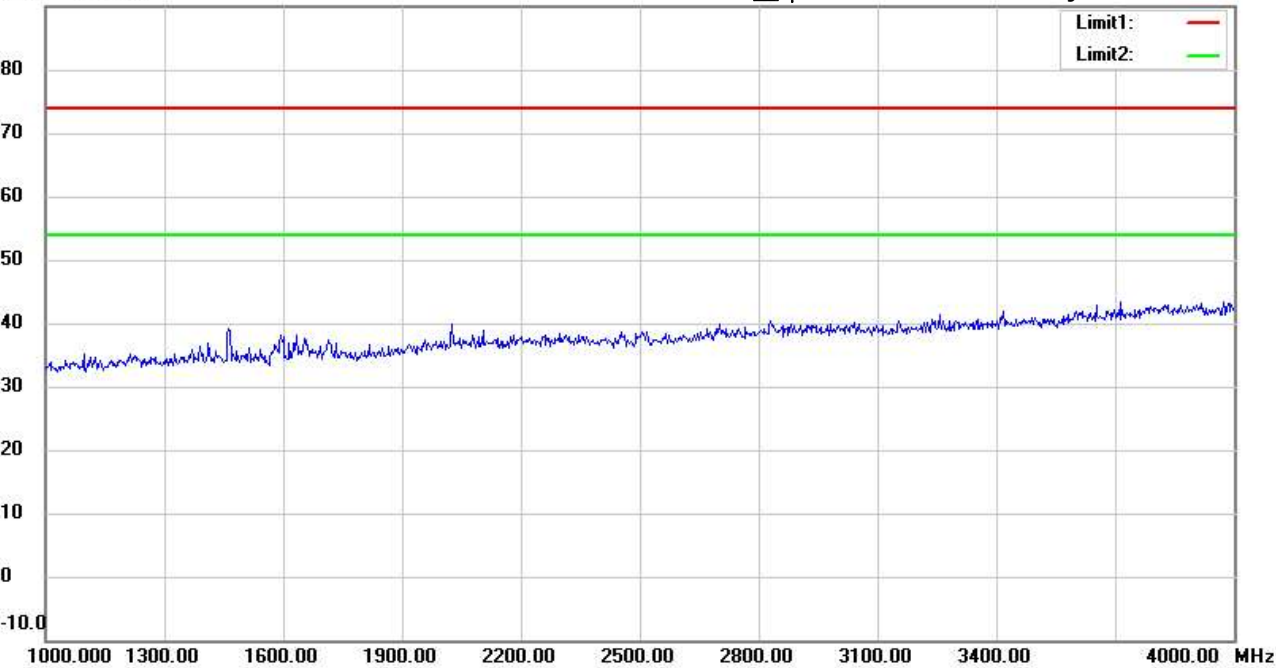
Data :#1

Condition : FCC\_part 15E RE\_Above 1GHz\_PK

Test Mode : TX 802.11ax20 CH209

Polarization: Horizontal

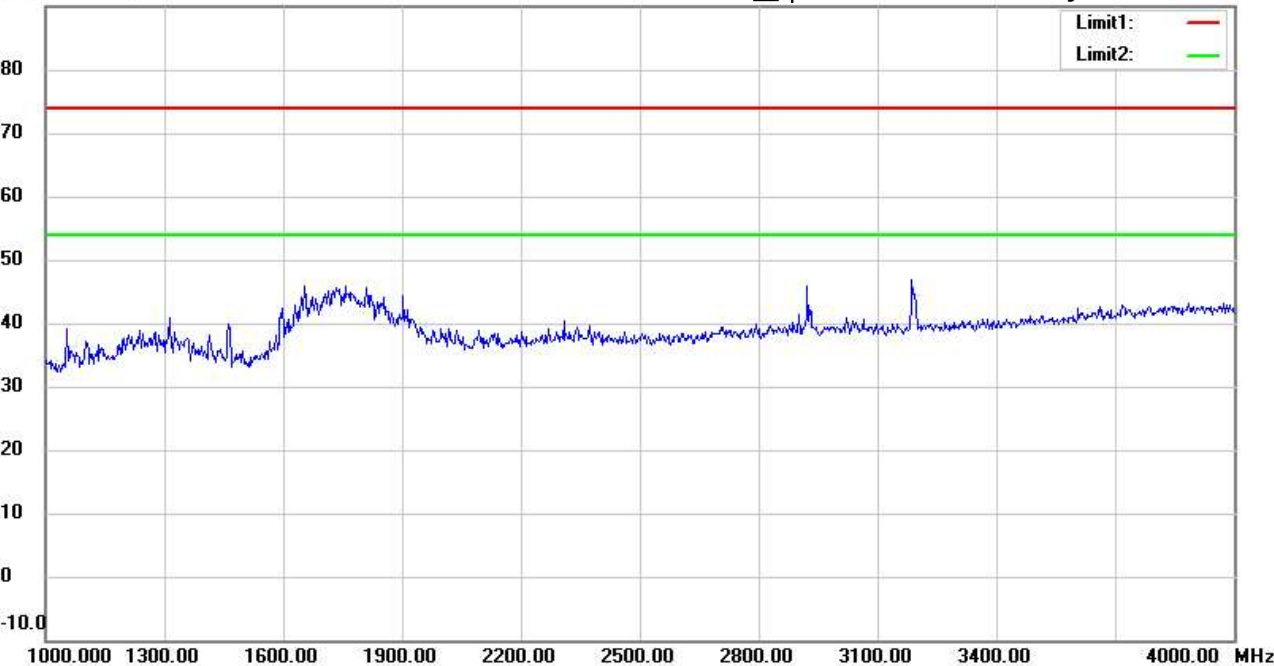
Data :#7

Condition : FCC\_part 15E RE\_Above 1GHz\_PK

Test Mode : TX 802.11ax20 CH209

Polarization: Vertical

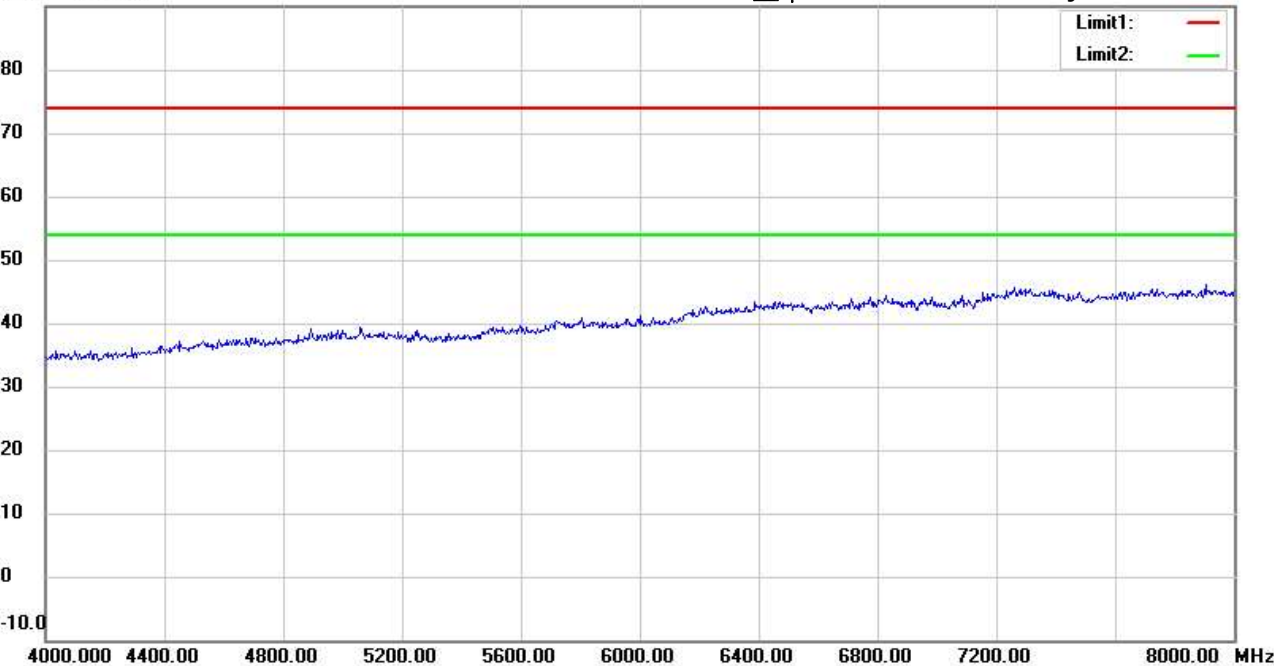
Data :#2

Condition : FCC\_part 15E RE\_Above 1GHz\_PK

Test Mode : TX 802.11ax20 CH209

Polarization: *Horizontal*

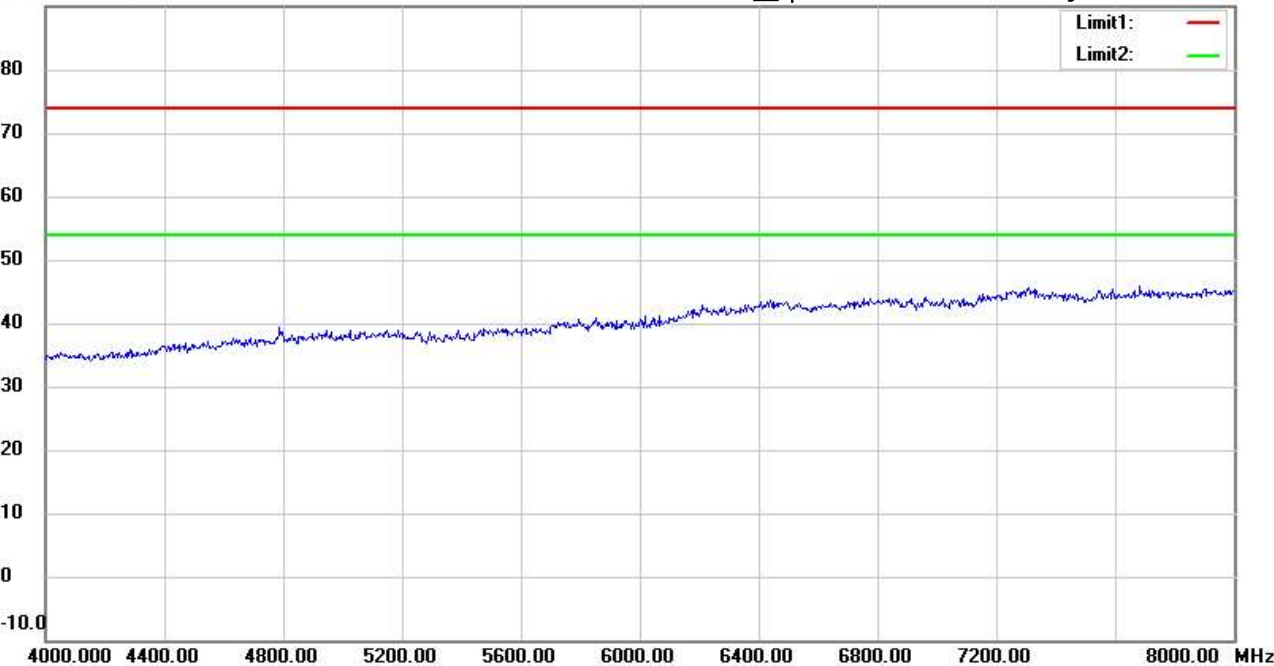
Data :#8

Condition : FCC\_part 15E RE\_Above 1GHz\_PK

Test Mode : TX 802.11ax20 CH209

Polarization: Vertical

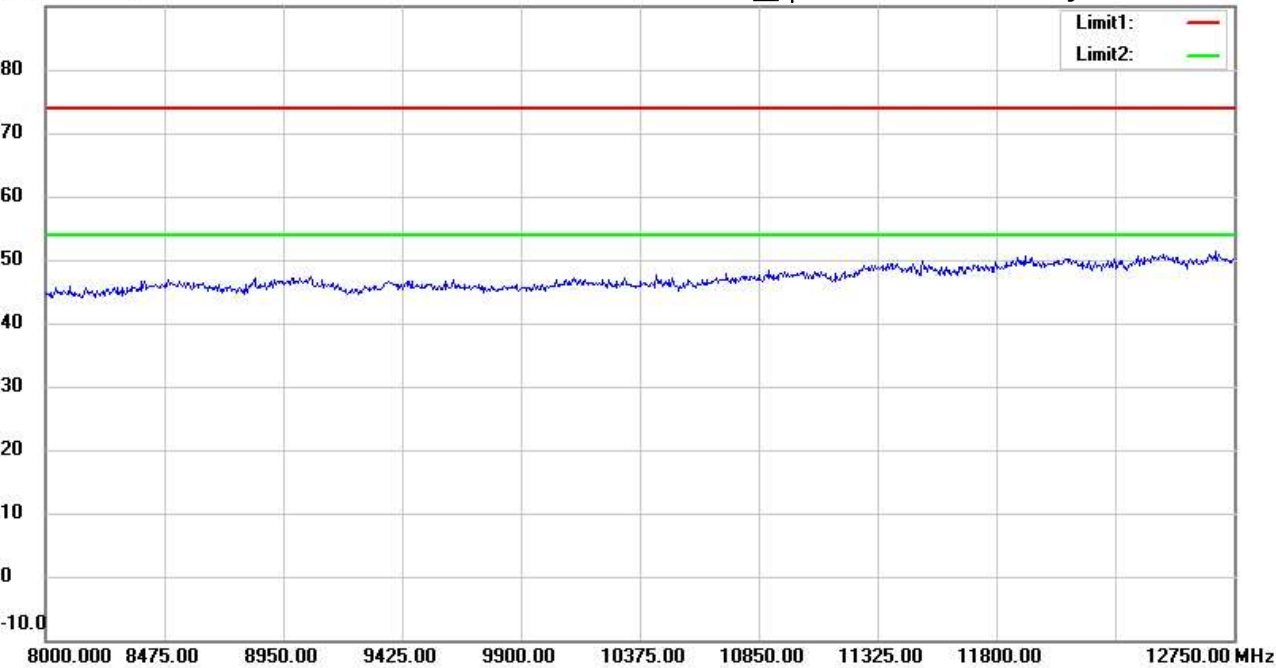
Data :#3

Condition : FCC\_part 15E RE\_Above 1GHz\_PK

Test Mode : TX 802.11ax20 CH209

Polarization: **Horizontal**
