Radiated Emission Measurement

Site : 966A Chamber  
Condition : FCC\_part 15E RE\_Above 1GHz\_PK  
EUT : W6M22409-23739  
M/N:  
Test Mode : TX 802.11a CH229  
Note :

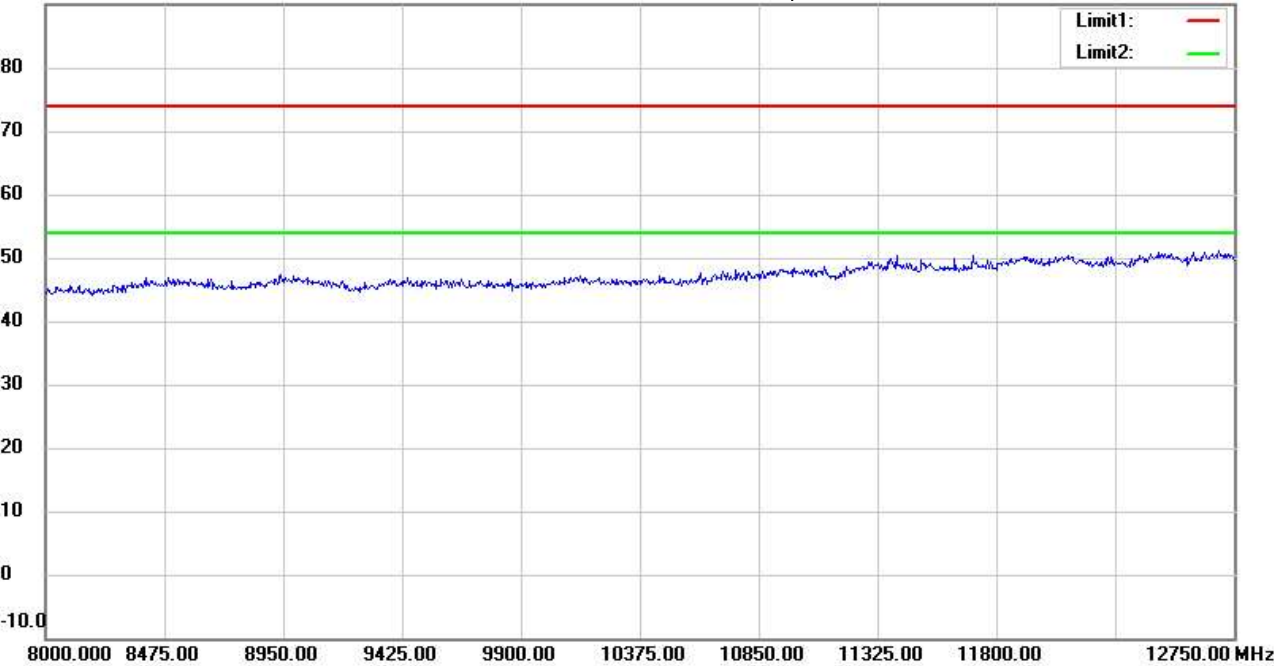
Data :#9

Condition : FCC\_part 15E RE\_Above 1GHz\_PK

Test Mode : TX 802.11ax20 CH209

Polarization: Vertical

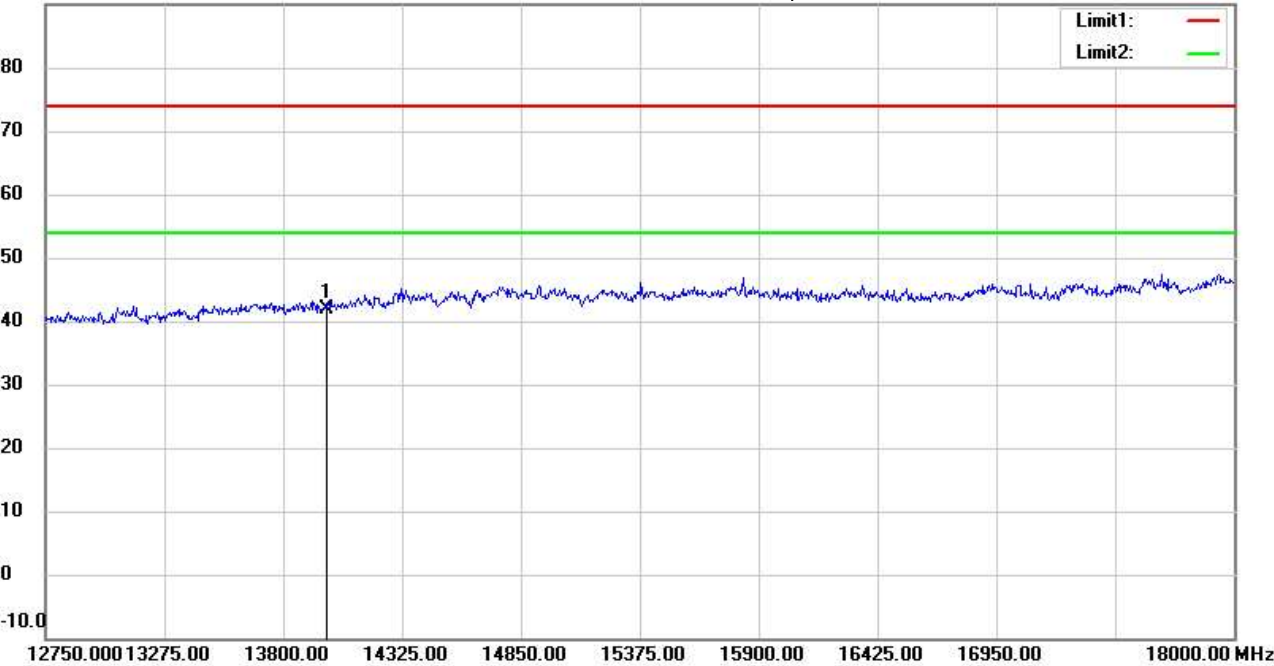
Data :#4

Condition : FCC\_part 15E RE\_Above 1GHz\_PK

Test Mode : TX 802.11ax20 CH209

Polarization: *Horizontal*

| Mk. | Frequency (MHz) | Reading (dBuV) | Detector | Corr. factor (dB/m) | Result (dBuV/m) | Limit (dBuV/m) | Ant.Pos (cm) | Tab.Pos (deg.) | Margin (dB) | Comment |
|---|---|---|---|---|---|---|---|---|---|---|
| * | 13990.000 | 21.04 | peak | 20.93 | 41.97 | 74.00 | 150 | 100 | -32.03 | |
