Radiated Emission Measurement

Condition : FCC\_part 15E RE\_Above 1GHz\_PK

EUT : W6M22409-23739

Test Mode : TX 802.11ax20 CH209

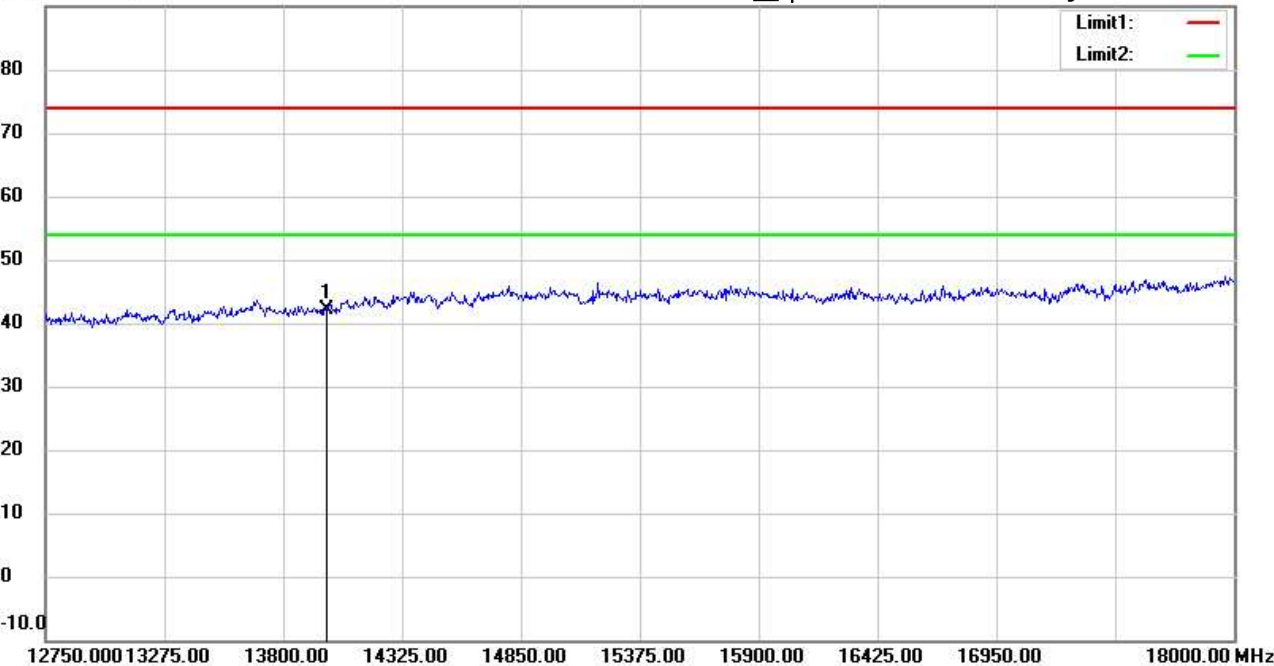
Polarization: Vertical

| Mk. | Frequency (MHz) | Reading (dBuV) | Detector | Corr. factor (dB/m) | Result (dBuV/m) | Limit (dBuV/m) | Ant.Pos (cm) | Tab.Pos (deg.) | Margin (dB) | Comment |
|---|---|---|---|---|---|---|---|---|---|---|
| * | 13990.000 | 21.10 | peak | 20.93 | 42.03 | 74.00 | 150 | 143 | -31.97 | |

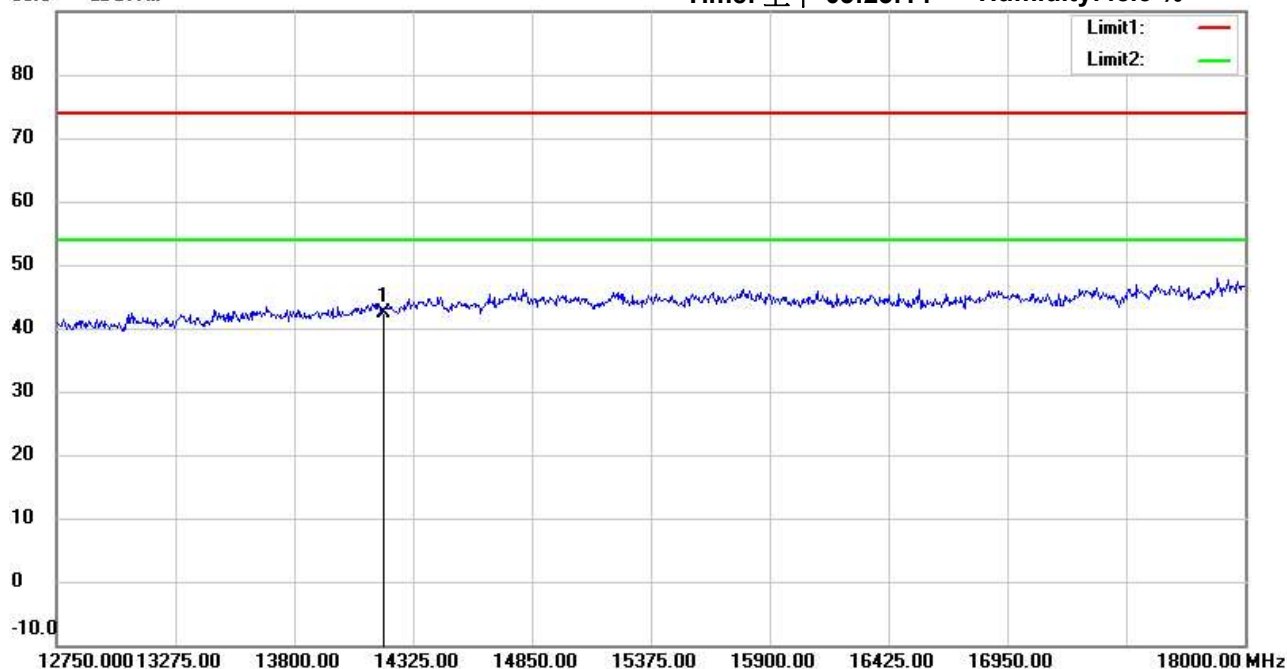
Condition : FCC\_part 15E RE\_Above 1GHz\_PK

Test Mode : TX 802.11ax20 CH229

Polarization: **Horizontal**

| Mk. | Frequency (MHz) | Reading (dBuV) | Detector | Corr. factor (dB/m) | Result (dBuV/m) | Limit (dBuV/m) | Ant.Pos (cm) | Tab.Pos (deg.) | Margin (dB) | Comment |
|---|---|---|---|---|---|---|---|---|---|---|
| * | 14190.000 | 20.38 | peak | 21.94 | 42.32 | 74.00 | 150 | 351 | -31.68 | |

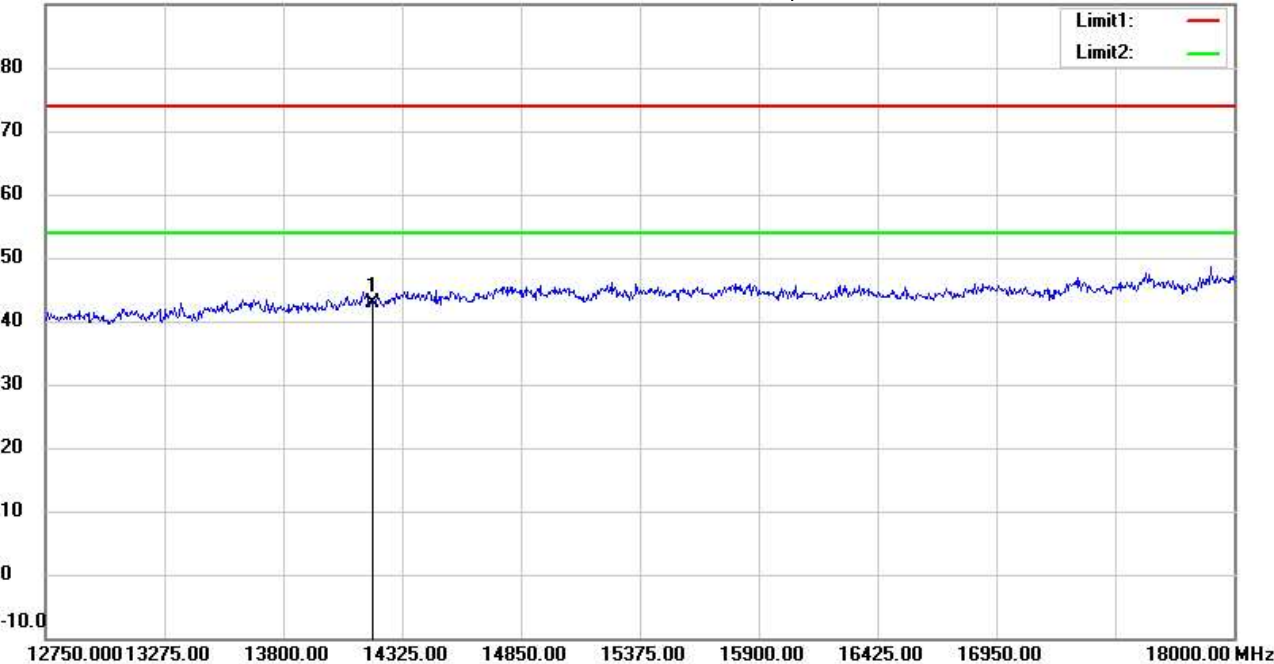
Condition : FCC\_part 15E RE\_Above 1GHz\_PK

Test Mode : TX 802.11ax20 CH229

Polarization: Vertical

| Mk. | Frequency (MHz) | Reading (dBuV) | Detector | Corr. factor (dB/m) | Result (dBuV/m) | Limit (dBuV/m) | Ant.Pos (cm) | Tab.Pos (deg.) | Margin (dB) | Comment |
|---|---|---|---|---|---|---|---|---|---|---|
| * | 14190.000 | 21.02 | peak | 21.94 | 42.96 | 74.00 | 150 | 306 | -31.04 | |

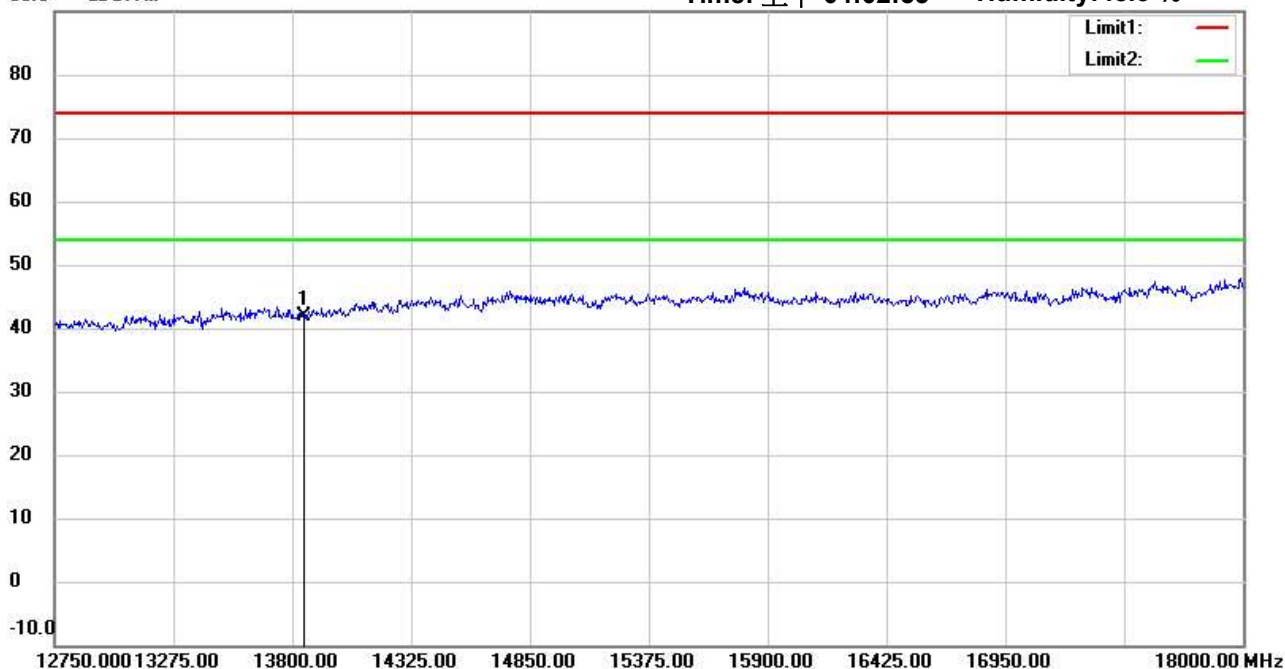
Condition : FCC\_part 15E RE\_Above 1GHz\_PK

Test Mode : TX 802.11ax40 CH195

Polarization: **Horizontal**

| Mk. | Frequency (MHz) | Reading (dBuV) | Detector | Corr. factor (dB/m) | Result (dBuV/m) | Limit (dBuV/m) | Ant.Pos (cm) | Tab.Pos (deg.) | Margin (dB) | Comment |
|---|---|---|---|---|---|---|---|---|---|---|
| * | 13850.000 | 22.00 | peak | 19.84 | 41.84 | 74.00 | 150 | 359 | -32.16 | |

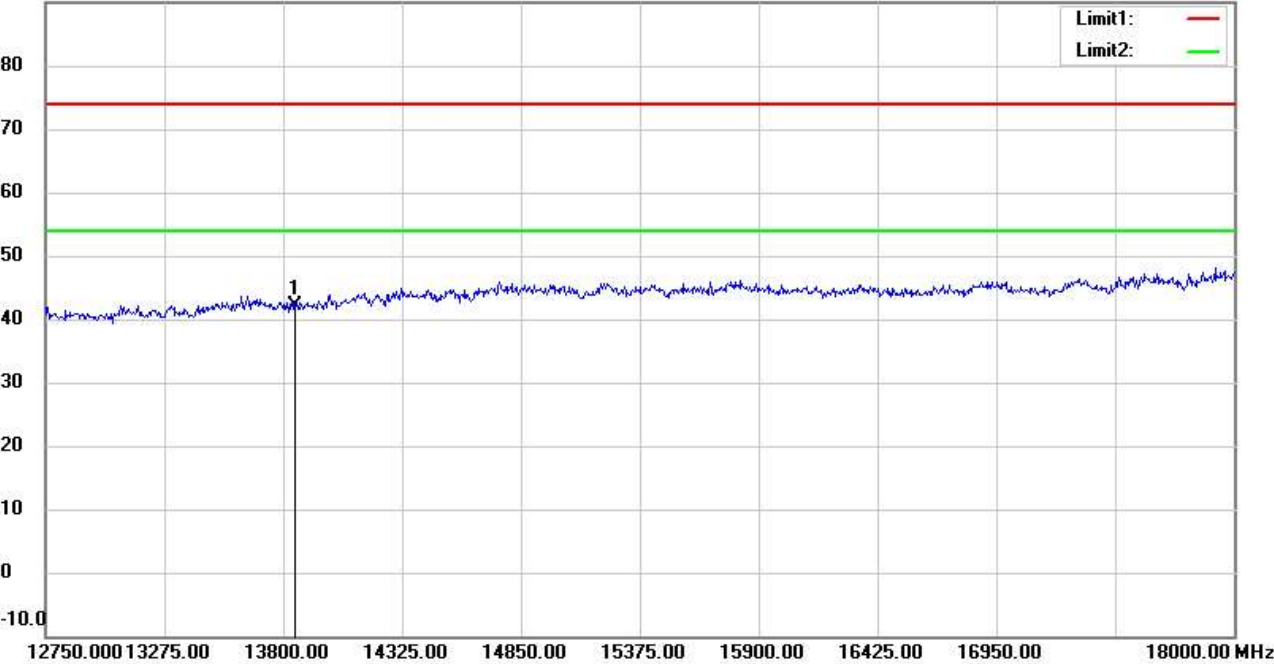
Condition : FCC\_part 15E RE\_Above 1GHz\_PK

Test Mode : TX 802.11ax40 CH195

Polarization: Vertical

| Mk. | Frequency (MHz) | Reading (dBuV) | Detector | Corr. factor (dB/m) | Result (dBuV/m) | Limit (dBuV/m) | Ant.Pos (cm) | Tab.Pos (deg.) | Margin (dB) | Comment |
|---|---|---|---|---|---|---|---|---|---|---|
| * | 13850.000 | 22.38 | peak | 19.84 | 42.22 | 74.00 | 150 | 268 | -31.78 | |
