Radiated Emission Measurement

Condition : FCC\_part 15E RE\_Above 1GHz\_PK

EUT : W6M22409-23739

Test Mode : TX 802.11ax40 CH195

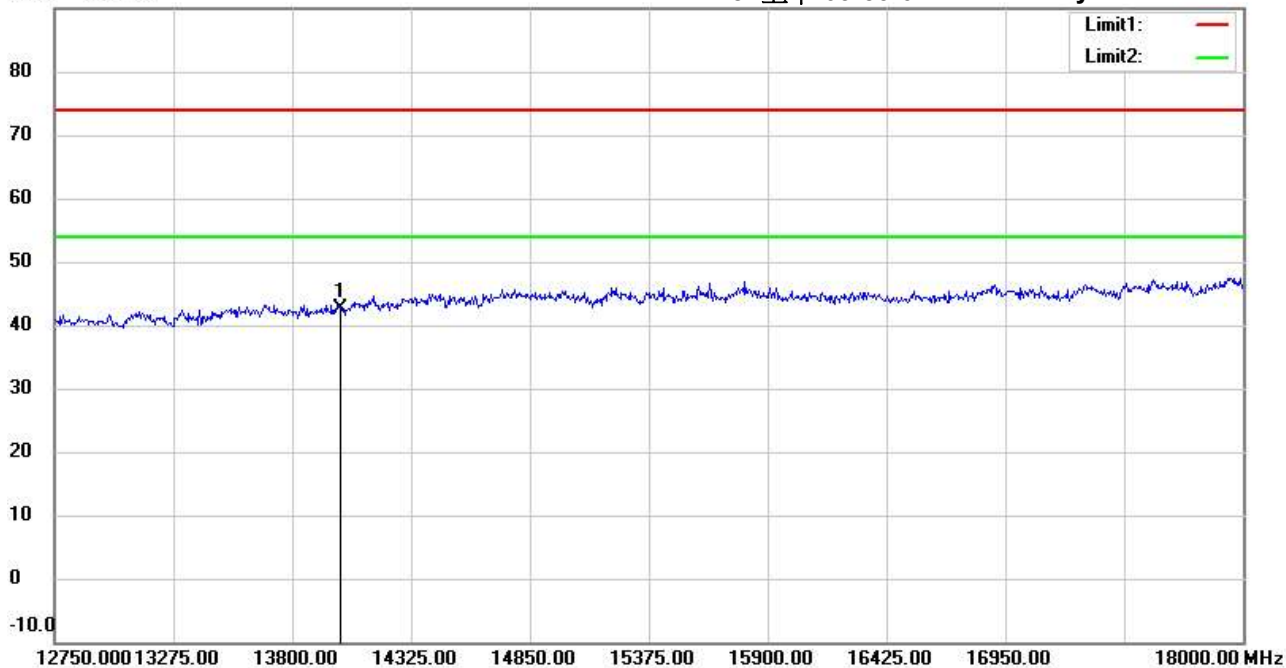
Data : #4

Test Mode : TX 802.11ax40 CH211

Polarization: **Horizontal**

| Mk. | Frequency (MHz) | Reading (dBuV) | Detector | Corr. factor (dB/m) | Result (dBuV/m) | Limit (dBuV/m) | Ant.Pos (cm) | Tab.Pos (deg.) | Margin (dB) | Comment |
|---|---|---|---|---|---|---|---|---|---|---|
| * | 14010.000 | 21.62 | peak | 21.03 | 42.65 | 74.00 | 150 | 16 | -31.35 | |

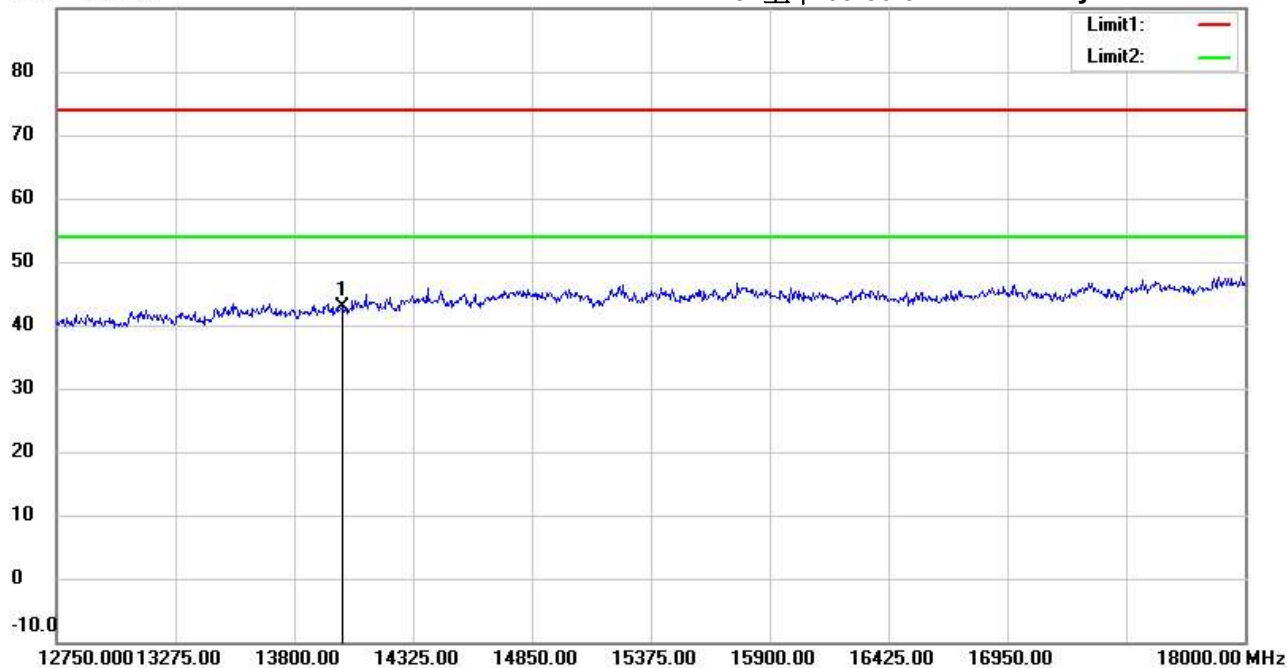
Data : #10

Test Mode : TX 802.11ax40 CH211

Polarization: Vertical

| Mk. | Frequency (MHz) | Reading (dBuV) | Detector | Corr. factor (dB/m) | Result (dBuV/m) | Limit (dBuV/m) | Ant.Pos (cm) | Tab.Pos (deg.) | Margin (dB) | Comment |
|---|---|---|---|---|---|---|---|---|---|---|
| * | 14010.000 | 21.94 | peak | 21.03 | 42.97 | 74.00 | 150 | 307 | -31.03 | |

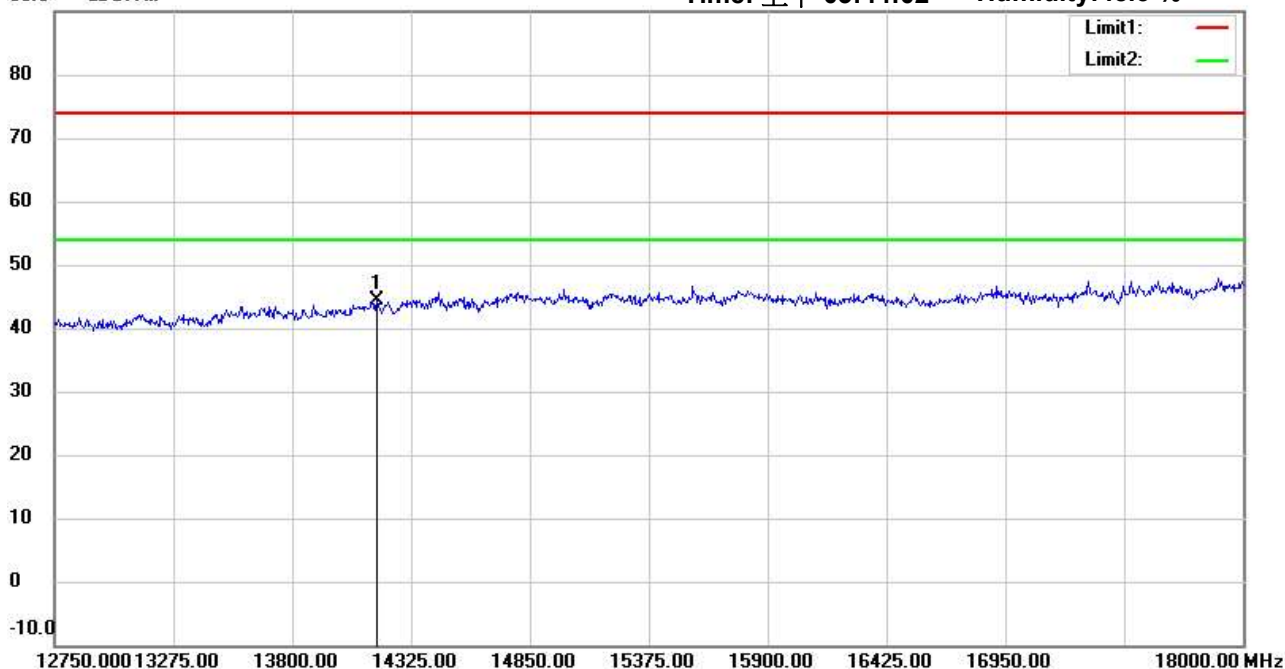
Data : #4

Test Mode : TX 802.11ax40 CH227

Polarization: **Horizontal**

| Mk. | Frequency (MHz) | Reading (dBuV) | Detector | Corr. factor (dB/m) | Result (dBuV/m) | Limit (dBuV/m) | Ant.Pos (cm) | Tab.Pos (deg.) | Margin (dB) | Comment |
|---|---|---|---|---|---|---|---|---|---|---|
| * | 14170.000 | 22.71 | peak | 21.75 | 44.46 | 74.00 | 150 | 16 | -29.54 | |

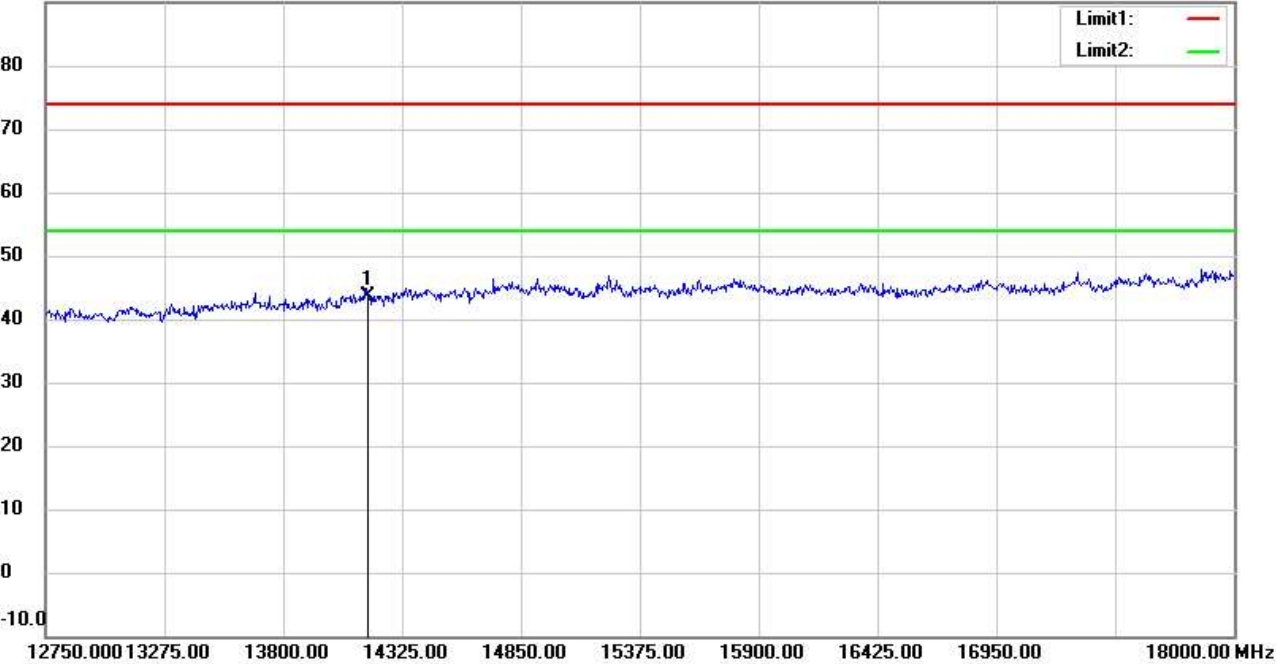
Data :#10

Test Mode : TX 802.11ax40 CH227

Polarization: Vertical

| Mk. | Frequency (MHz) | Reading (dBuV) | Detector | Corr. factor (dB/m) | Result (dBuV/m) | Limit (dBuV/m) | Ant.Pos (cm) | Tab.Pos (deg.) | Margin (dB) | Comment |
|---|---|---|---|---|---|---|---|---|---|---|
| * | 14170.000 | 21.88 | peak | 21.75 | 43.63 | 74.00 | 150 | 223 | -30.37 | |
