Radiated Emission Measurement

Condition : FCC\_part 15E RE\_Above 1GHz\_PK

EUT : W6M22409-23739

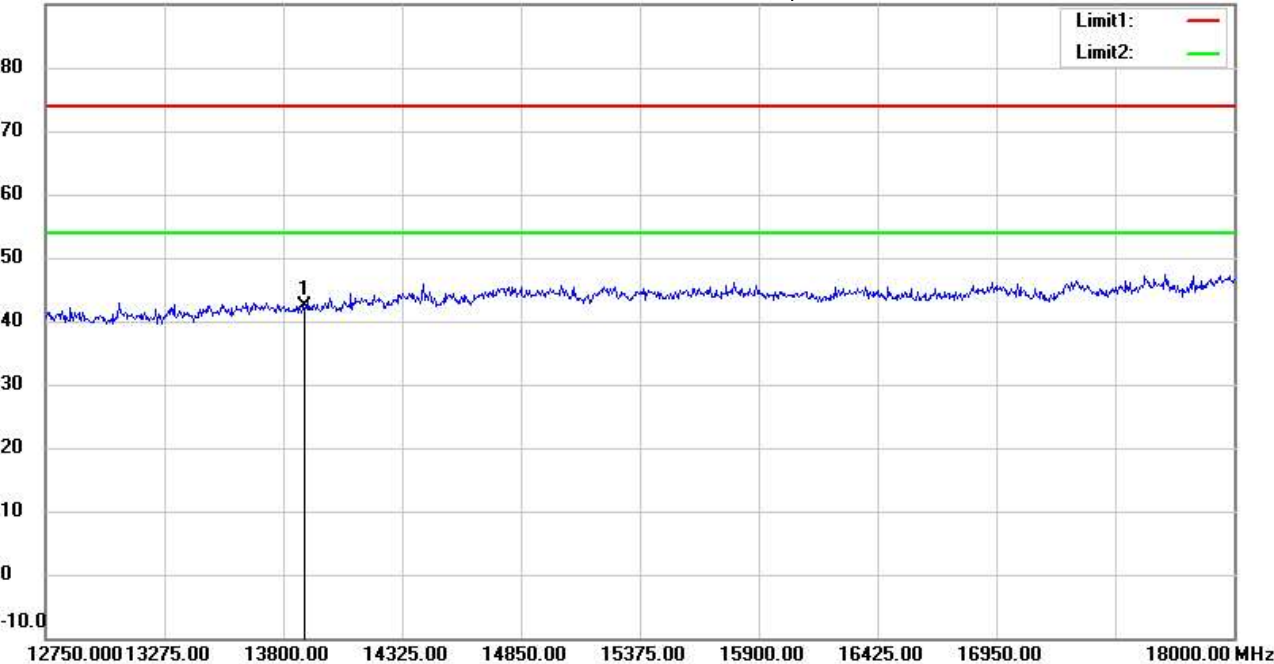
Data :#4

Test Mode : TX 802.11ax80 CH199

Polarization: **Horizontal**

| Mk. | Frequency (MHz) | Reading (dBuV) | Detector | Corr. factor (dB/m) | Result (dBuV/m) | Limit (dBuV/m) | Ant.Pos (cm) | Tab.Pos (deg.) | Margin (dB) | Comment |
|---|---|---|---|---|---|---|---|---|---|---|
| * | 13890.000 | 22.22 | peak | 20.09 | 42.31 | 74.00 | 150 | 266 | -31.69 | |

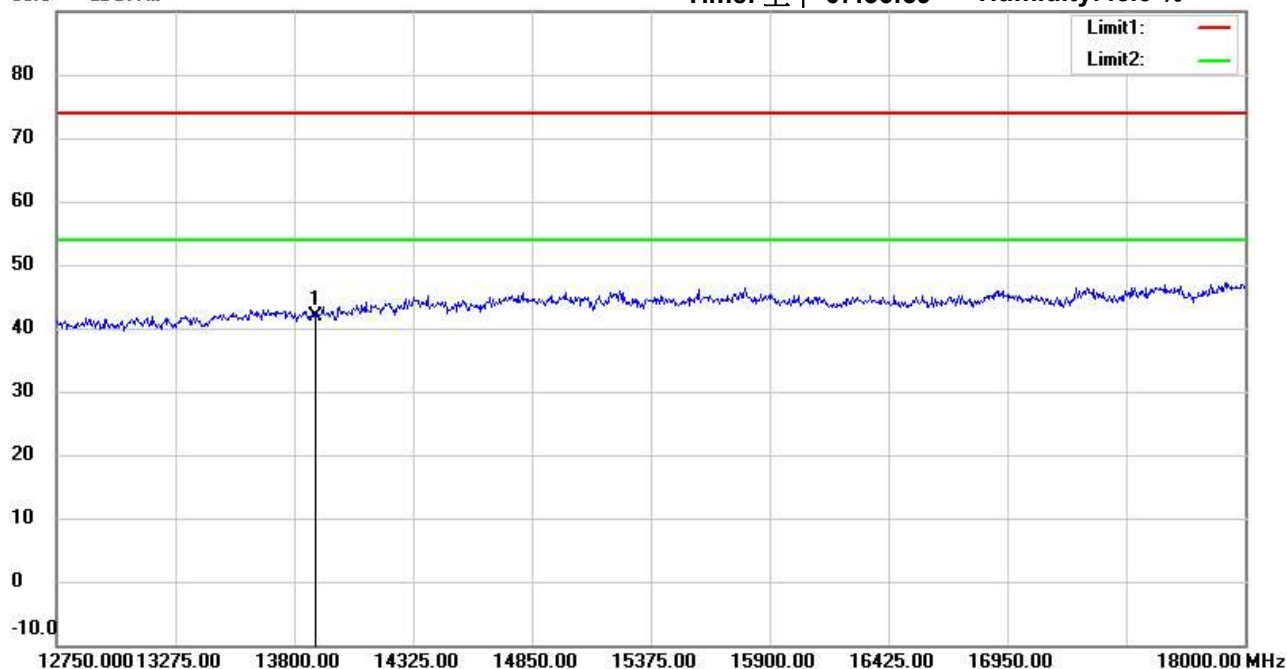
Data : #10

Test Mode : TX 802.11ax80 CH199

Polarization: Vertical

| Mk. | Frequency (MHz) | Reading (dBuV) | Detector | Corr. factor (dB/m) | Result (dBuV/m) | Limit (dBuV/m) | Ant.Pos (cm) | Tab.Pos (deg.) | Margin (dB) | Comment |
|---|---|---|---|---|---|---|---|---|---|---|
| * | 13890.000 | 21.81 | peak | 20.09 | 41.90 | 74.00 | 150 | 186 | -32.10 | |

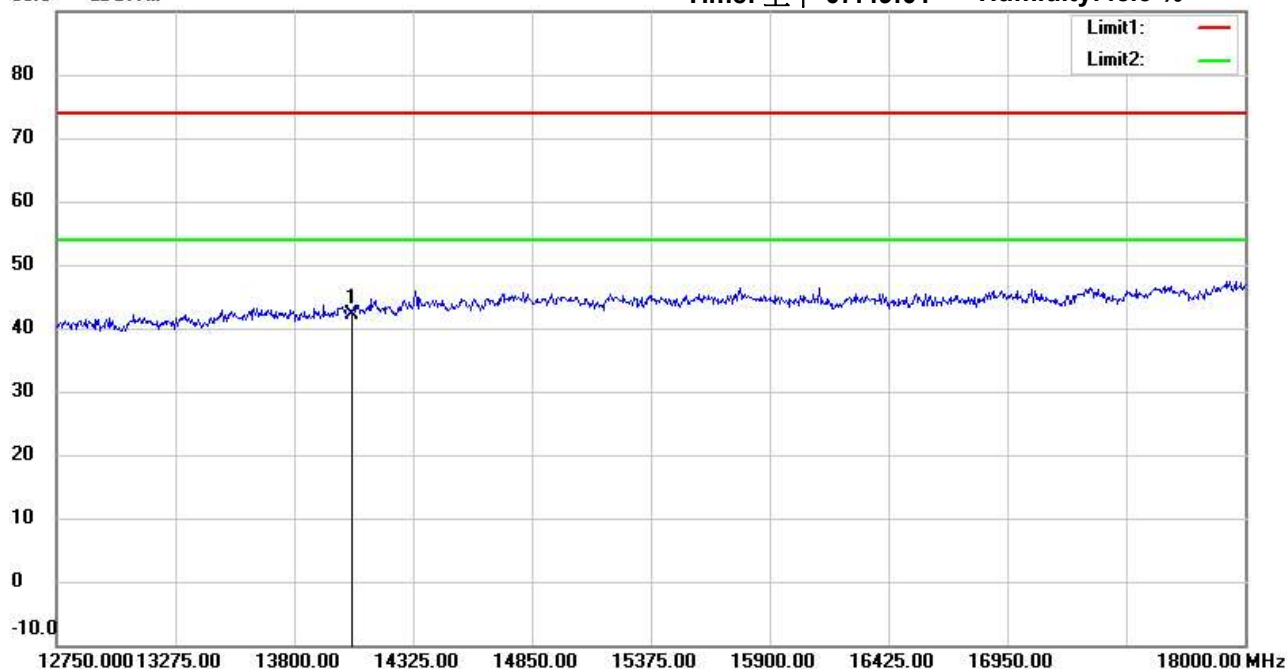
Data : #10

Test Mode : TX 802.11ax80 CH215

Polarization: Vertical

| Mk. | Frequency (MHz) | Reading (dBuV) | Detector | Corr. factor (dB/m) | Result (dBuV/m) | Limit (dBuV/m) | Ant.Pos (cm) | Tab.Pos (deg.) | Margin (dB) | Comment |
|---|---|---|---|---|---|---|---|---|---|---|
| * | 14050.000 | 20.99 | peak | 21.05 | 42.04 | 74.00 | 150 | 271 | -31.96 | |
