Report No.: 9810735

Scan Settings (1 Range)

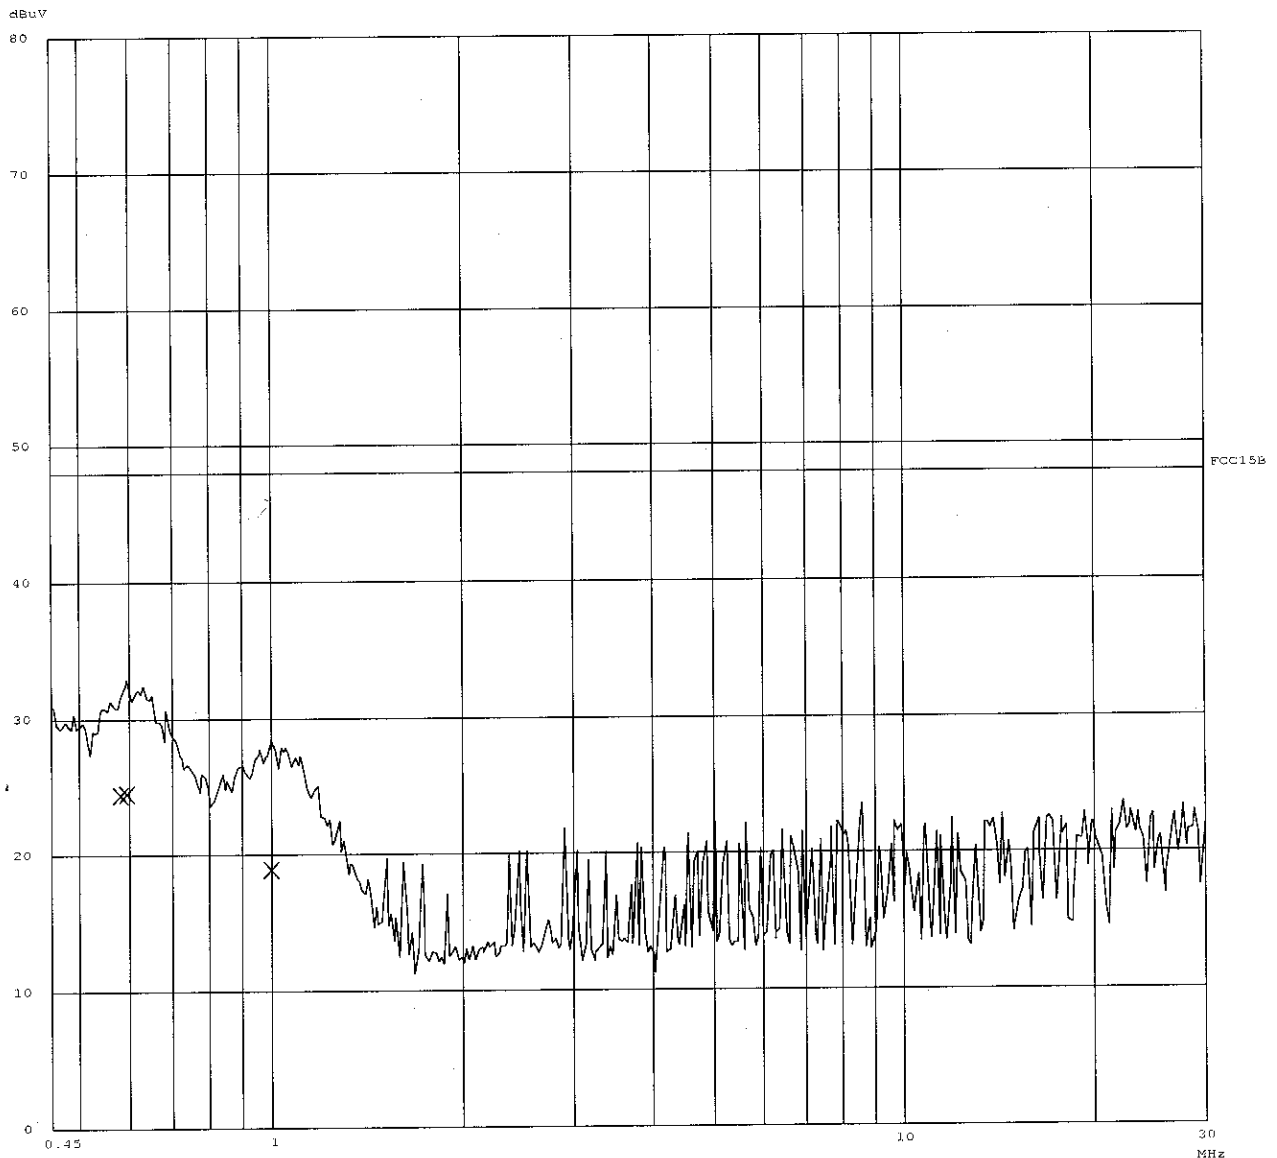
| Frequencies | | | Receiver Settings | | | | | |
| Start | Stop | Step | IF BW | Detector | M-Time | Atten | Preamp | OpRge |
| 450k | 30M | 5k | 10K | PK | 20ms | AUTO | LN OFF | 60dB |

Final Measurement: X QP

| Transducer No. | Start | Stop | Name |
| 3 | 9k | 30M | EI078 |

Final Measurement Results:

| Frequency<br>MHz | QP Level<br>dBuV | QP Limit<br>dBuV |
| 0.58000 | 24.3 | 48.0 |
| 0.59500 | 24.4 | 48.0 |
| 1.00000 | 18.9 | 48.0 |
