Appendix C. Co-location

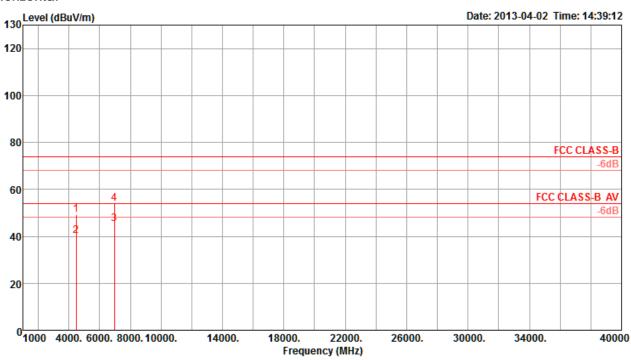
1. Results of Radiated Emissions for Co-located

Horizontal
