ALIGNMENT AND ADJUSTMENT

ADJUSTMENT PROCEDURE

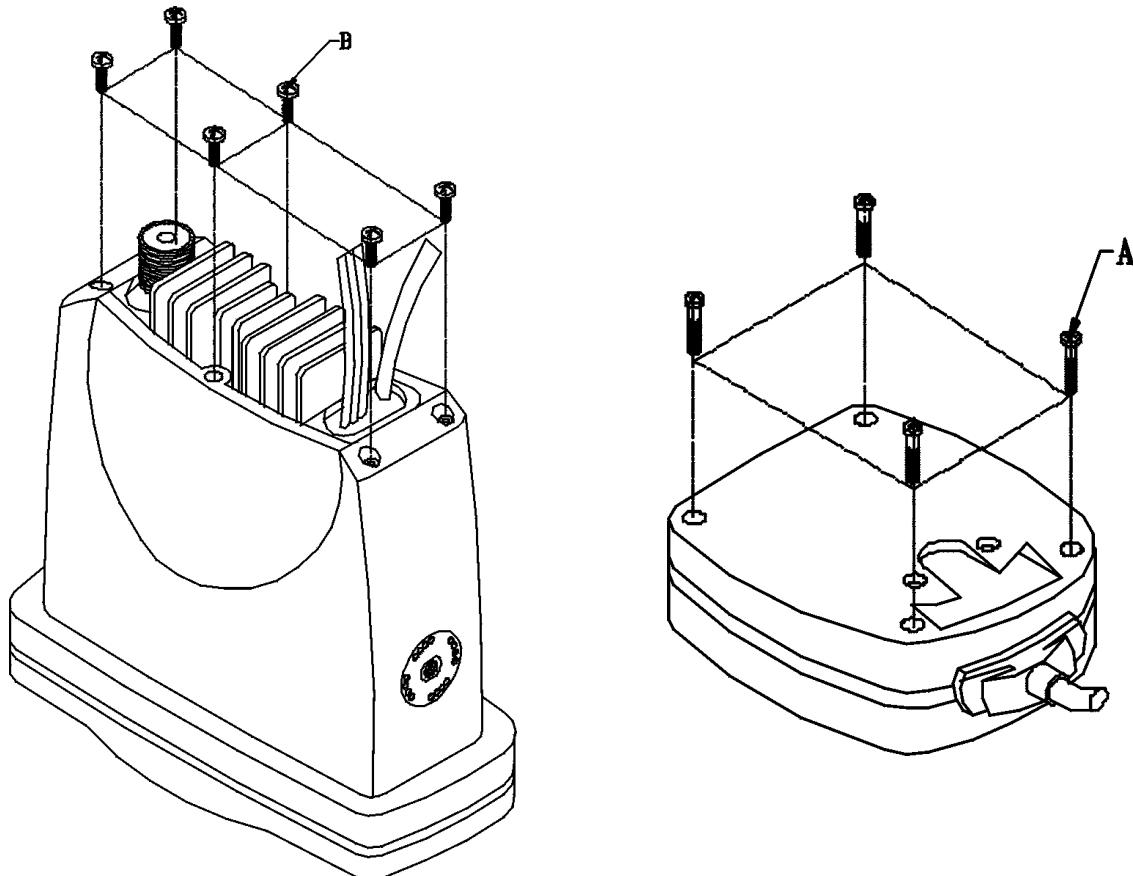
To remove the front and rear panels from the main chassis:

1. Rotate the POWER knob fully counter-clockwise and disconnect the power supply.
2. Remove the six screws from the bottom of the base station.
3. Remove the four screws from the bottom of the handset.
