Photo Report

GSM gateway aGATE GSM 32 VoIP

Report Reference: MDE_Teles_1001_FCC_Photo

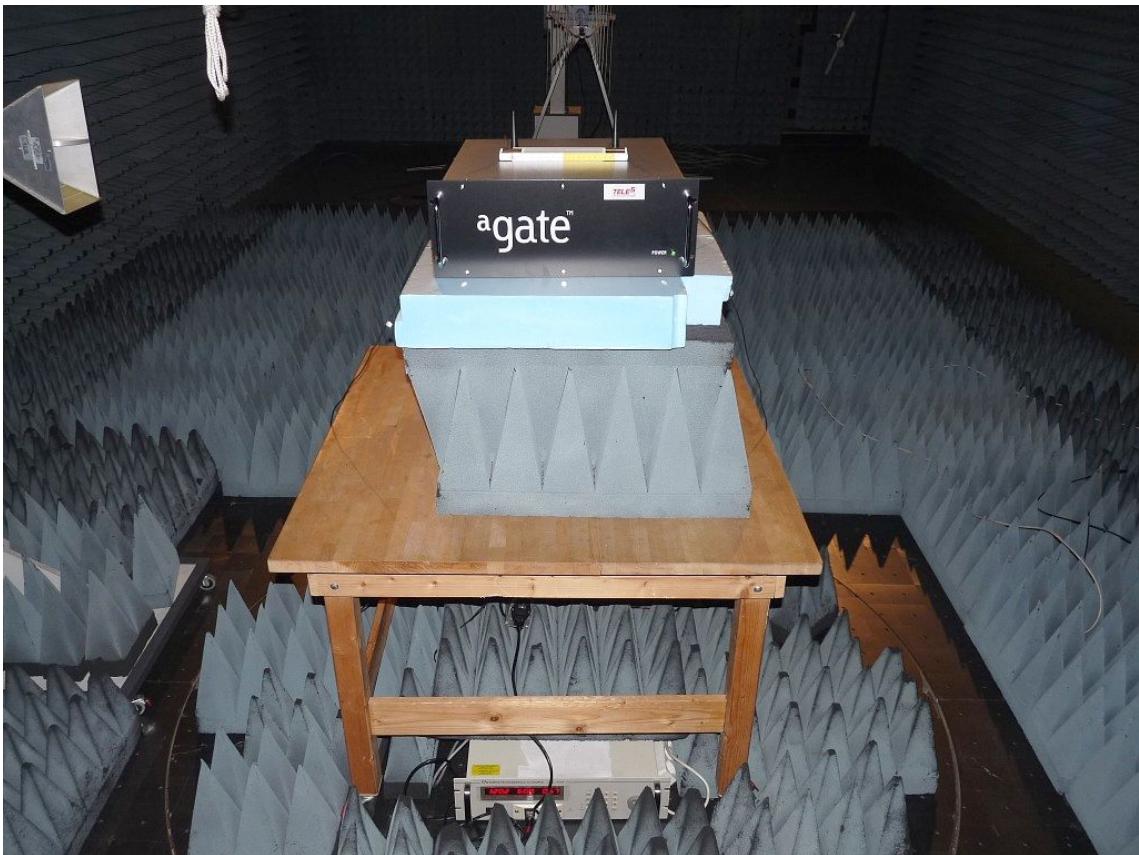
Photo 1: Setup for radiated tests

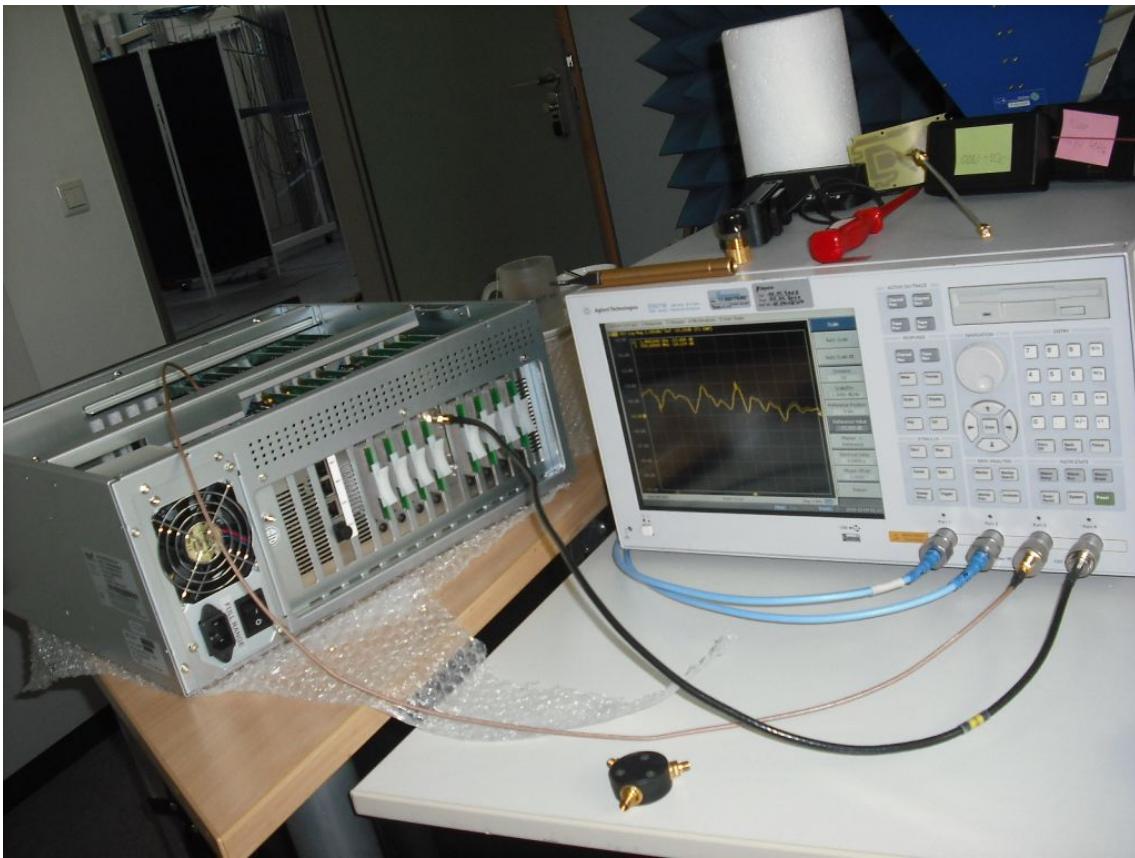
Photo 2: Setup for measurement of the combiner's attenuation

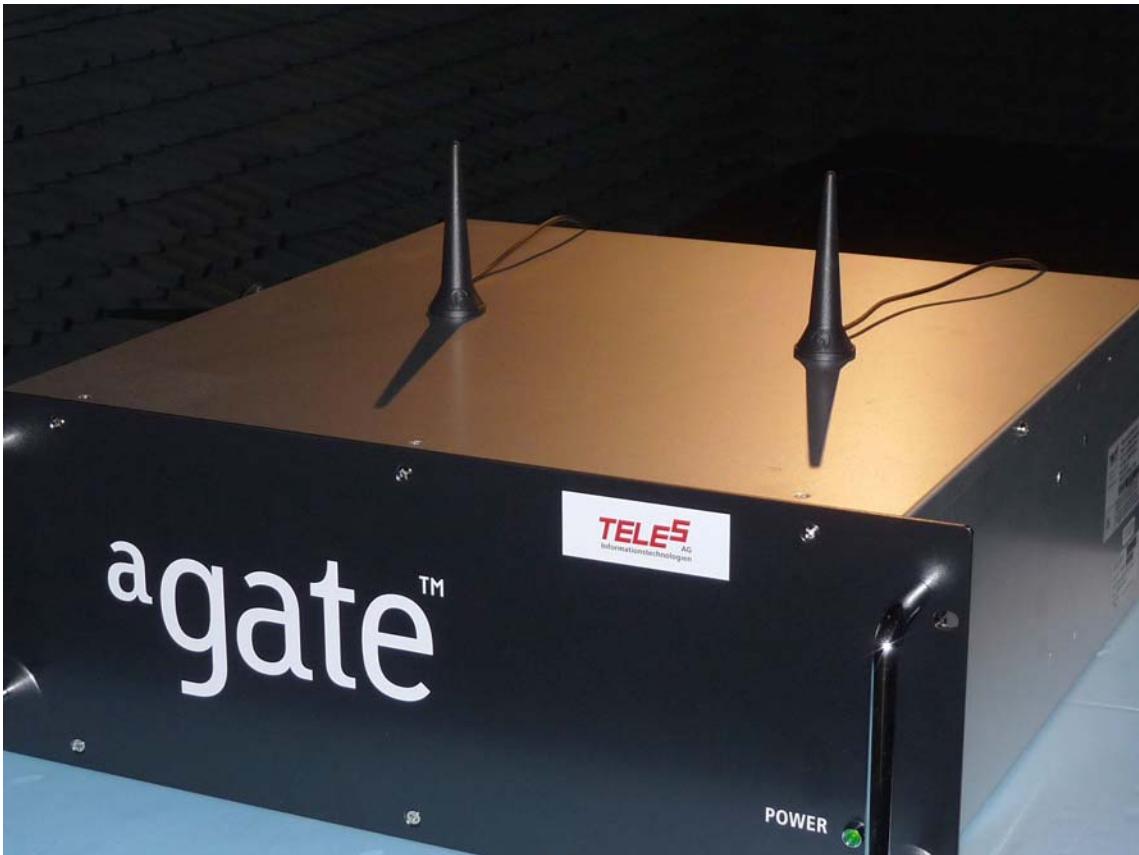
Photo 3: Assembly of both antennas on top of the housing

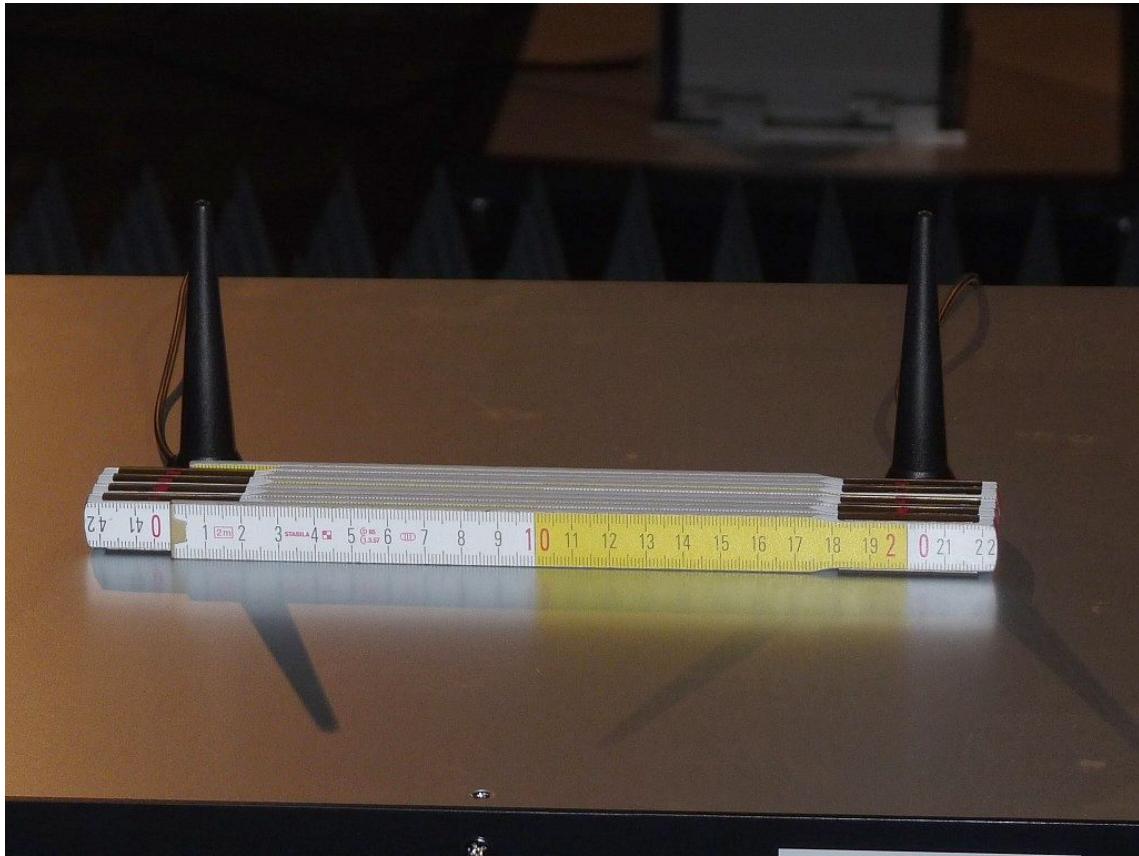
Photo 4: Distance between both antennas is 0.2 m
