# Antenna Report

**F231414E5**

**Level Probing Radar**

**FMR10B**

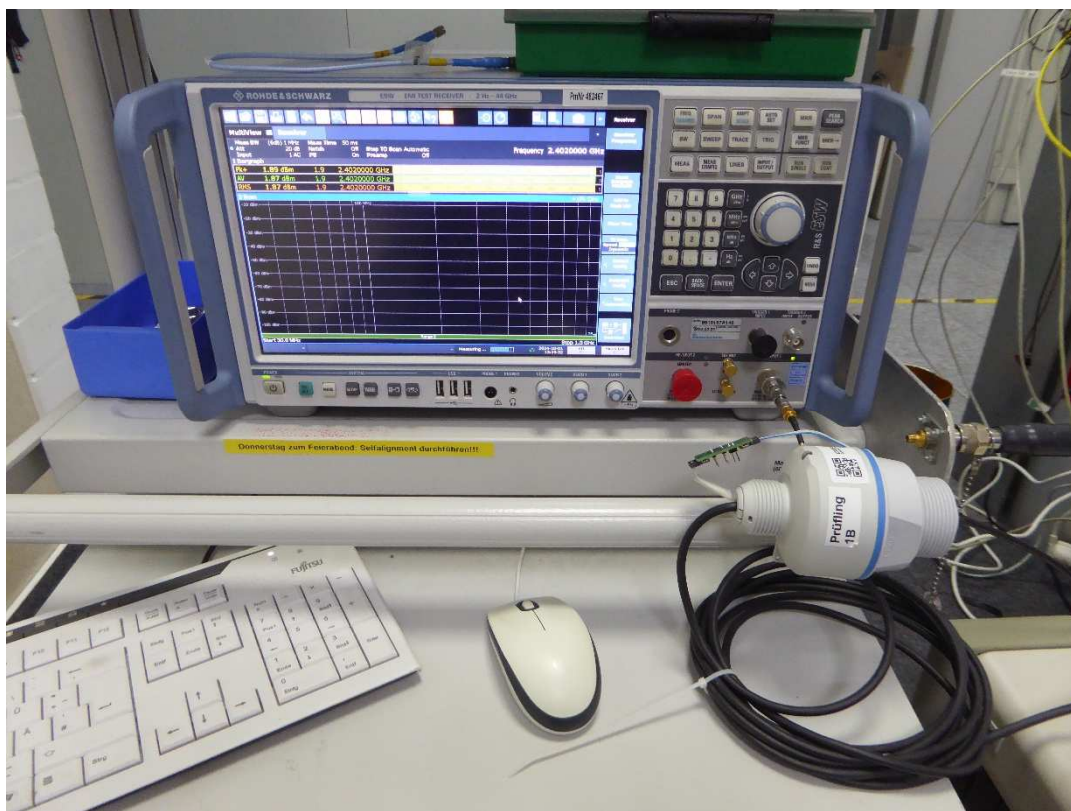
Conducted measurements were done with a modified sample as provided by the applicant.

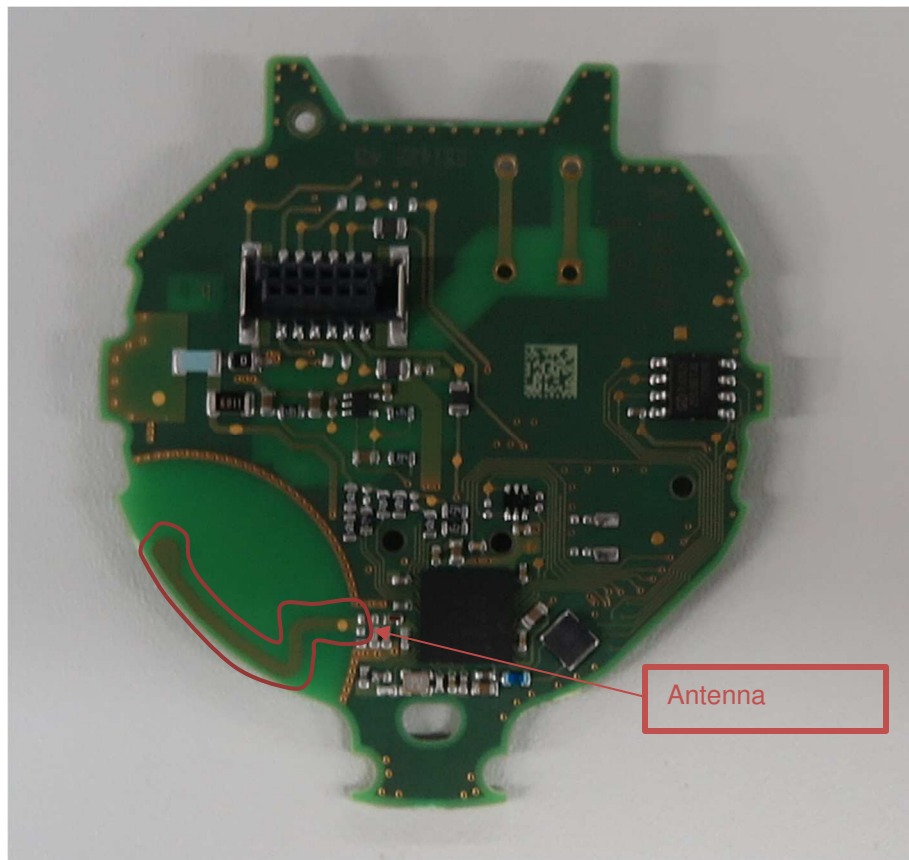
EUT PCB (PCB side with antenna trace)

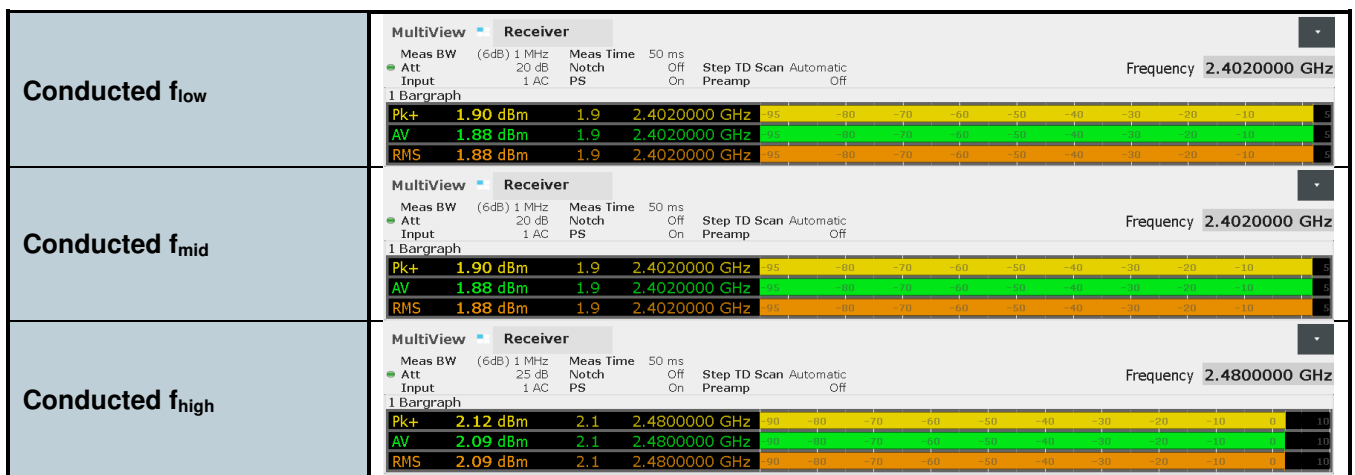
Test equipment (please refer to chapter 7 for details)

1 - 12

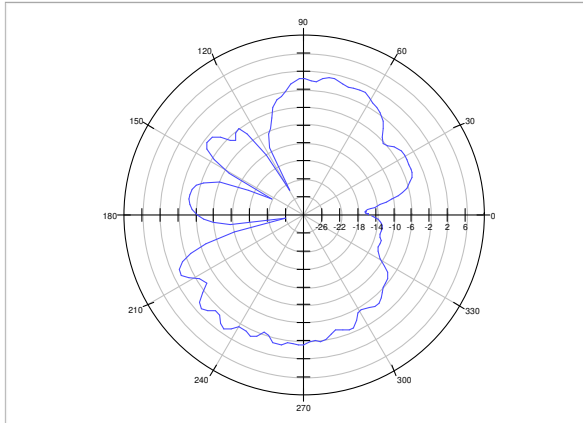
$f_{mid}$ , horizontal, pos. 2

Azimuth Chart: 90deg, Horizontal

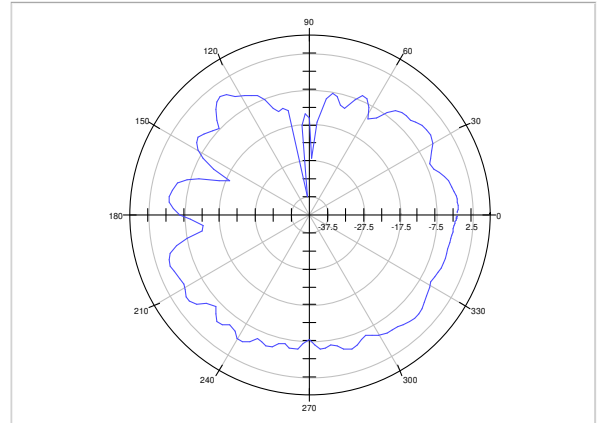
$f_{mid}$ , vertical, pos. 2

Azimuth Chart: 90deg, Vertical

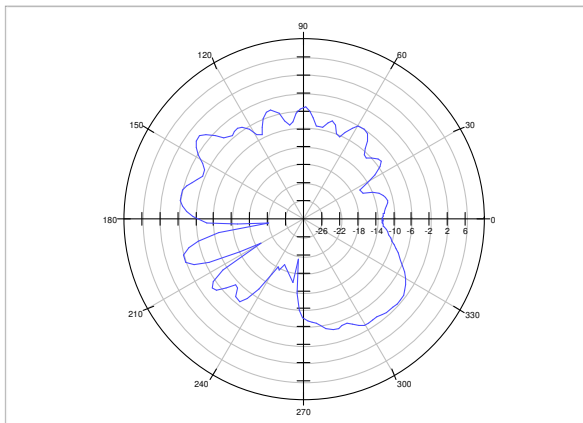
$f_{mid}$ , horizontal, pos. 3

Azimuth Chart: 0deg, Horizontal

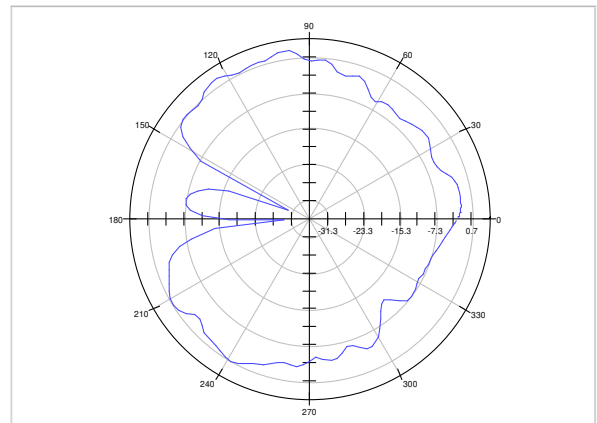
$f_{mid}$ , vertical, pos. 3

Azimuth Chart: 0deg, Vertical
