## Setup photos for HAC RF Emissions Test Report

| Test report no.: | Salo_HAC_0925_06 | Date of report: | 2009-07-10 |
| Tested devices: | RM-51 (Hearing aid mode active) | | |
| Testing has been carried out in accordance with: | <b>ANSI C63.19-2007</b><br>American National Standard for Methods of Measurement of Compatibility between Wireless Communications Devices and Hearing Aids | | |

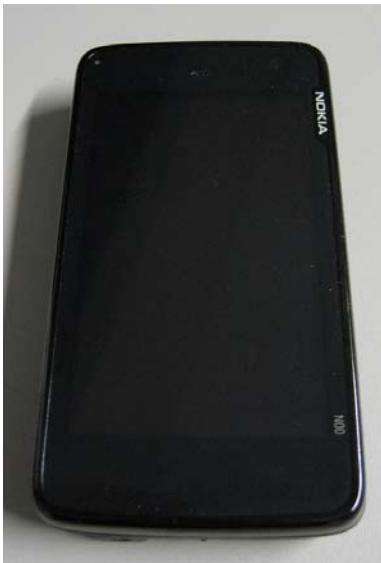
Slide closed

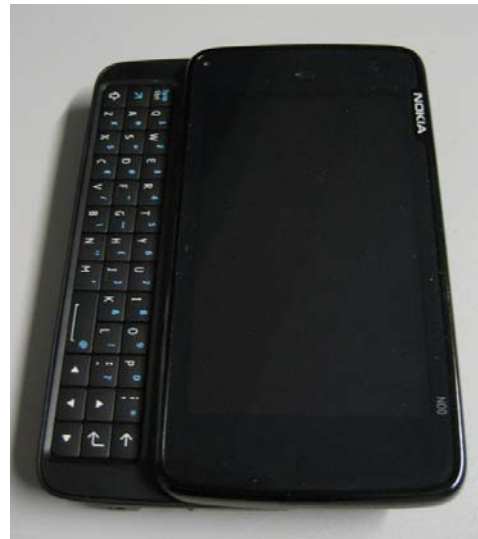
Slide open

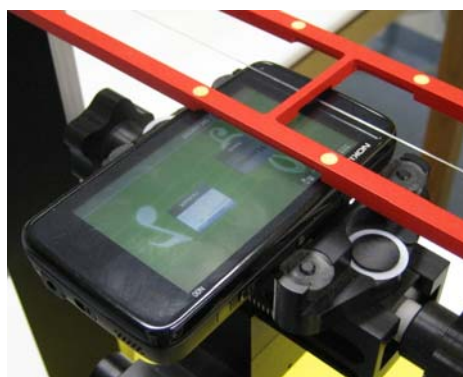
The device was positioned such that Device Reference plane was touching the bottom of the Test Arch. The scan is centered at the acoustic output by aligning the acoustic output with the intersection of the Test Arch's middle bar and dielectric wire.

Photo of the device positioned under Test Arch
