Description of Changes

on
FZV Transmitter, FCC ID LX8FZVS
of
Bayerische Motoren Werke AG

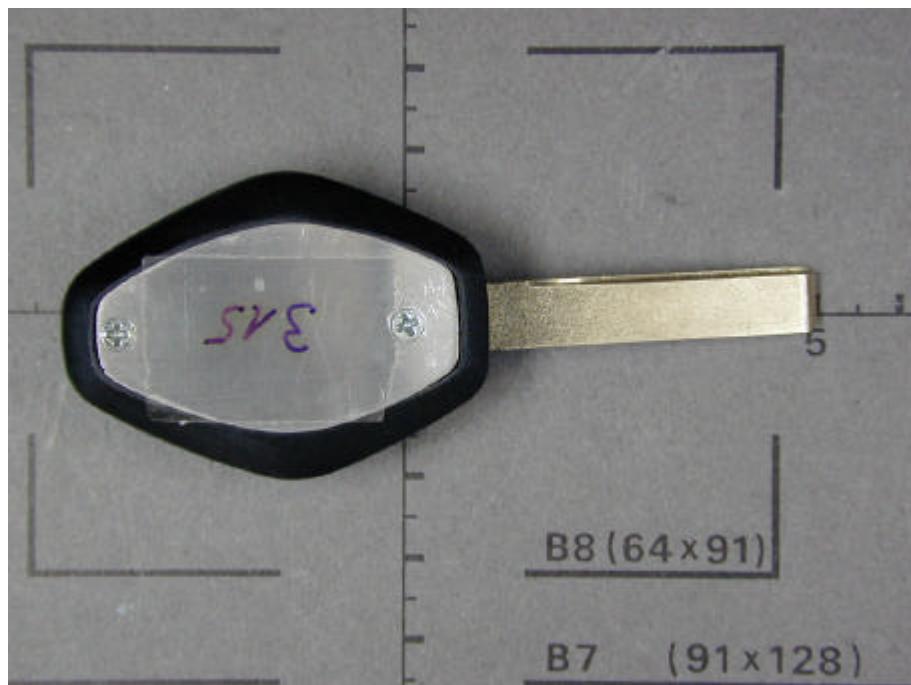
For design reasons a metal plate was affixed to the cabinet of the transmitter. Although the plate does not have electrical contact to the TX circuit, there is a potential effect on TX power and spurious emissions due to close proximity to the TX antenna structure on the PCB.
