### 9.3 LOCATION NÜRNBERG

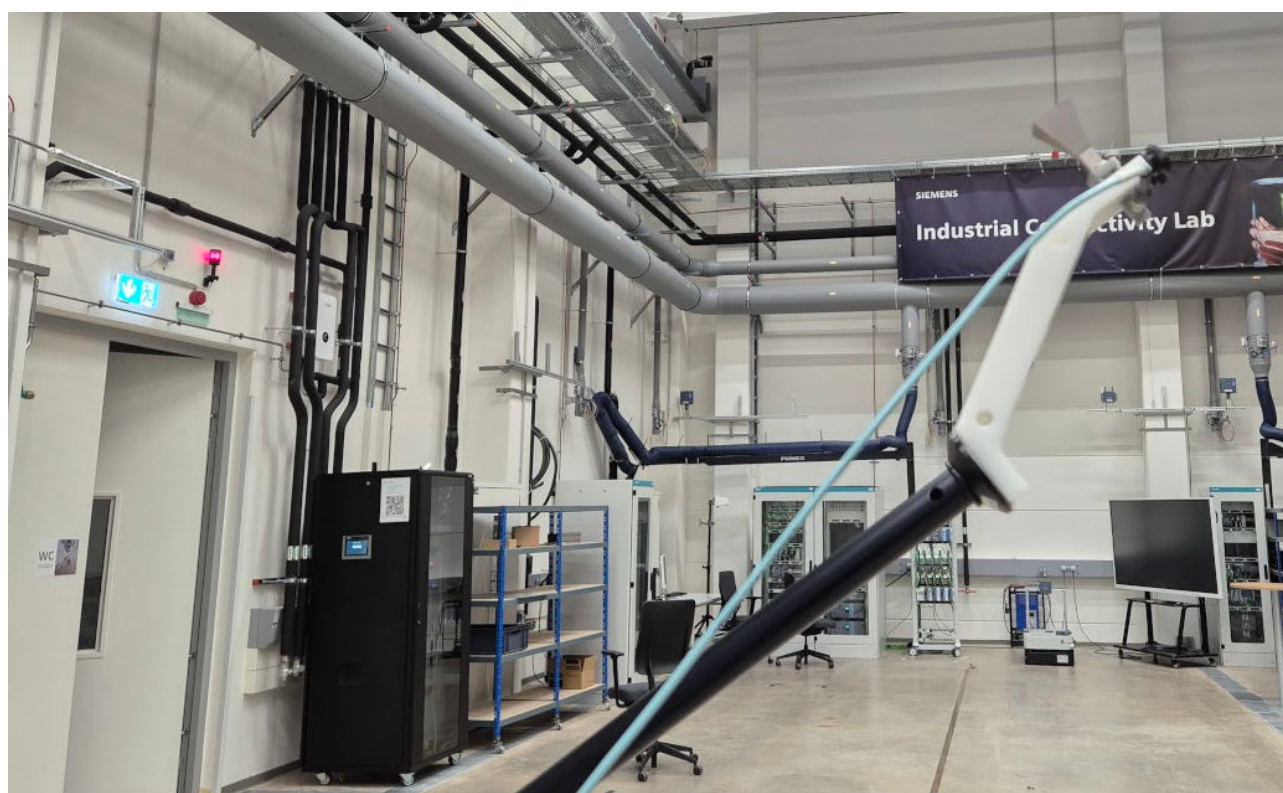
Photo 6: Standard gain horn 26.5 GHz – 40.0 GHz on trolley

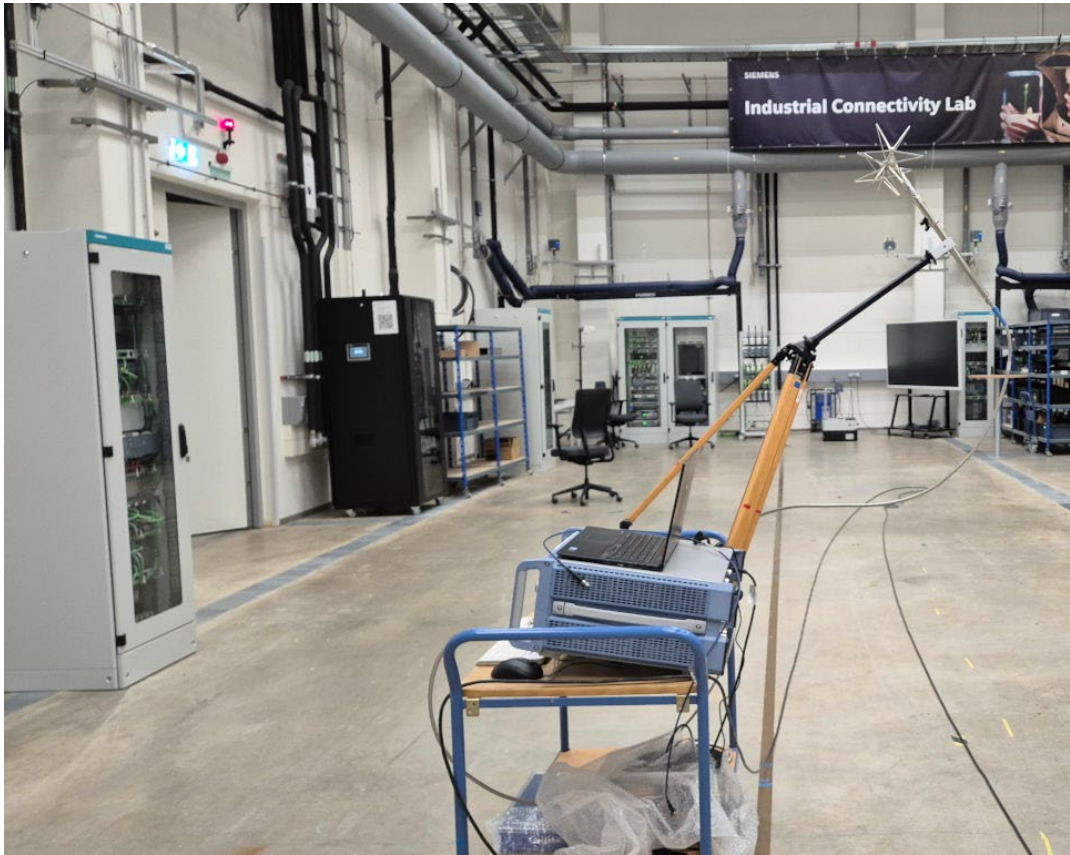
Photo 6: VUBA 9117 biconical dipole antenna 30.0 MHz – 1.0 GHz on trolley

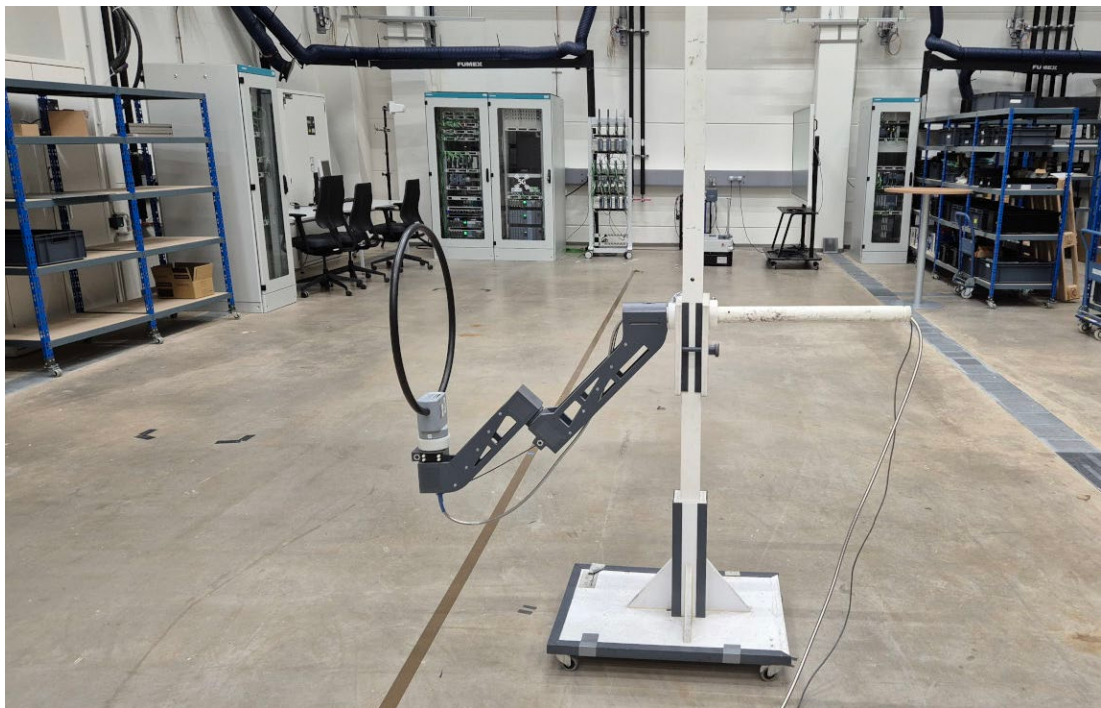
Photo 7: HFH2-Z2 magnetic field antenna 9.0 kHz – 30 MHz

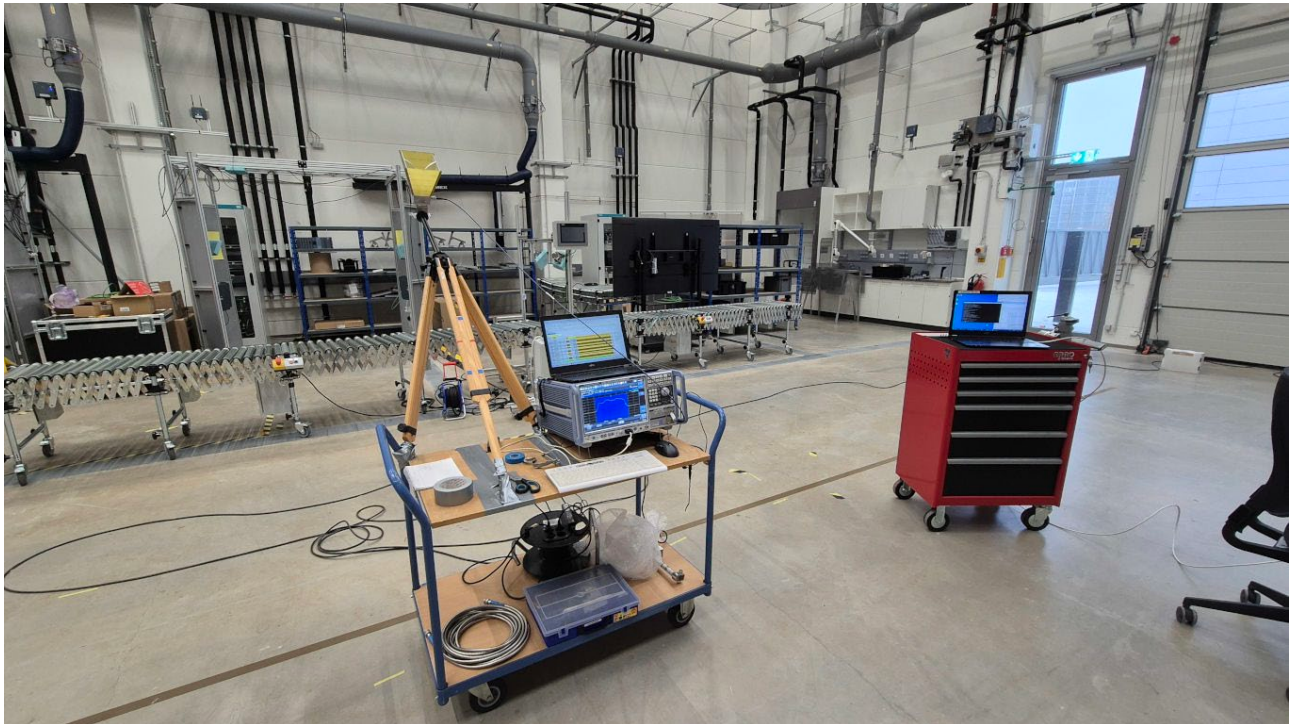
Photo 8: HF906 horn antenna, 1 GHz – 18 GHz, on trolley

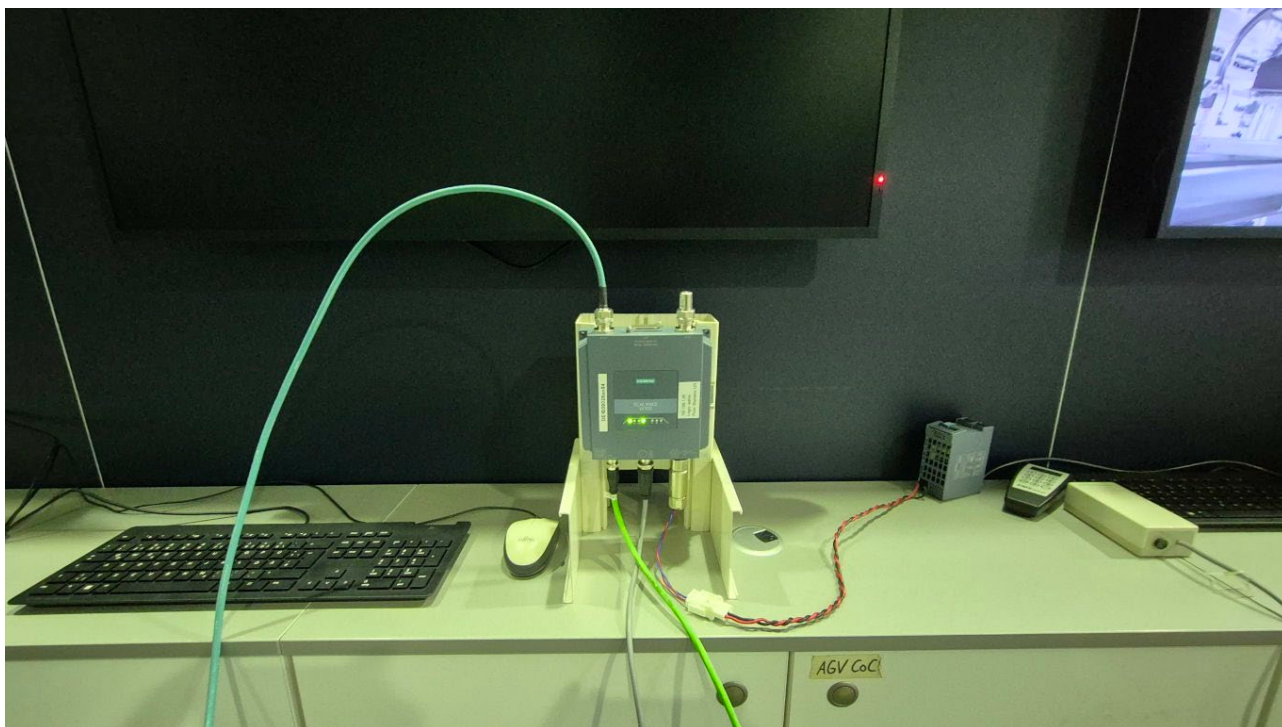
Photo 1: Installation of EUT with connection to RCoax cable

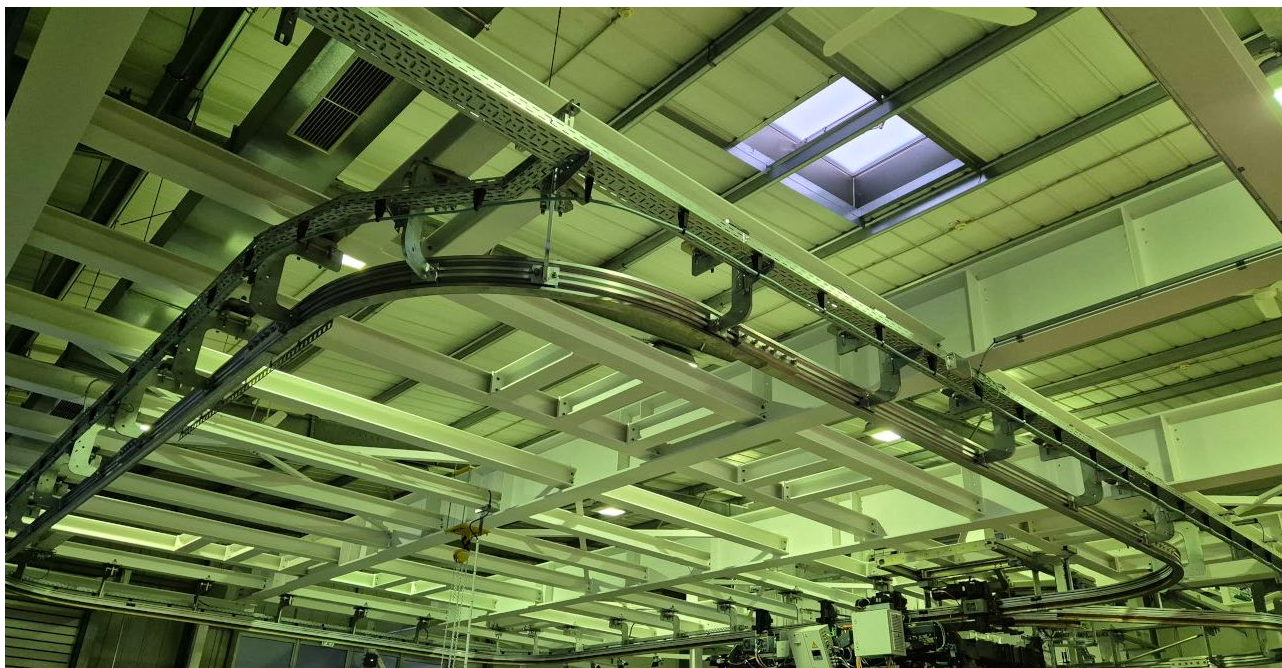
Photo 2: Installation of RCoax cable in the test location

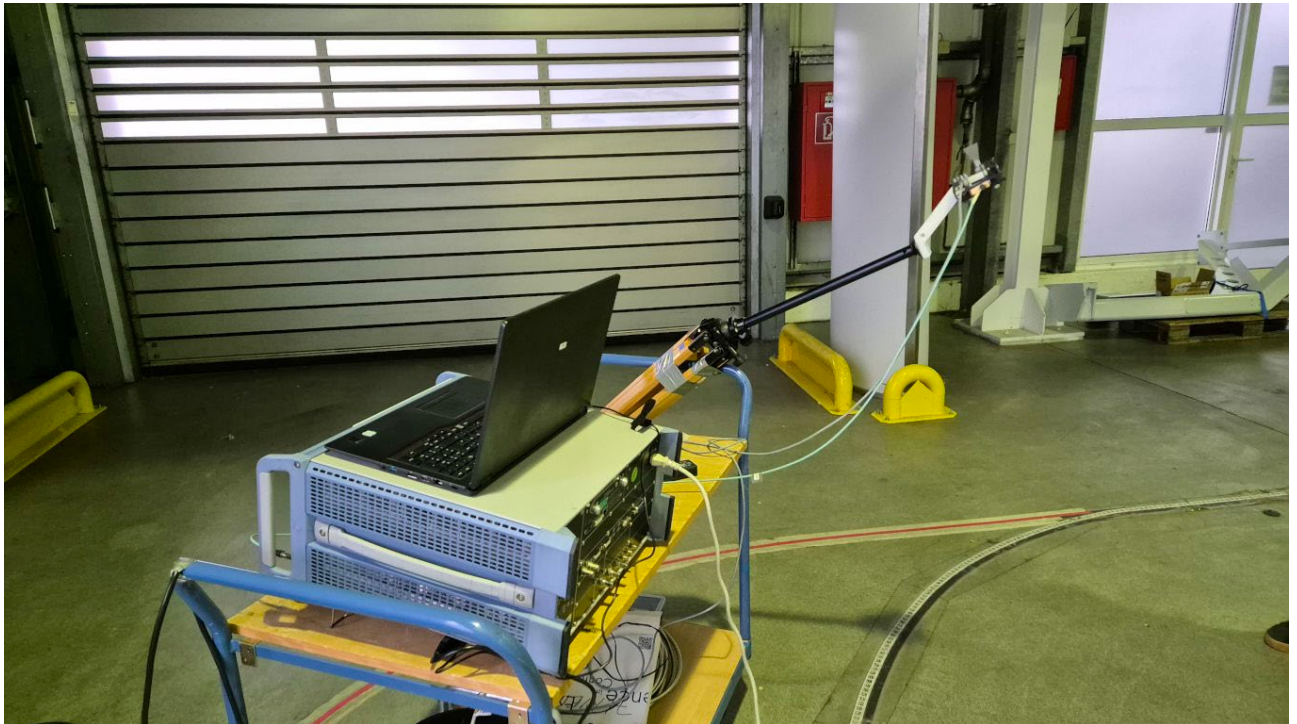
Photo 3: Measurement equipment on trolley

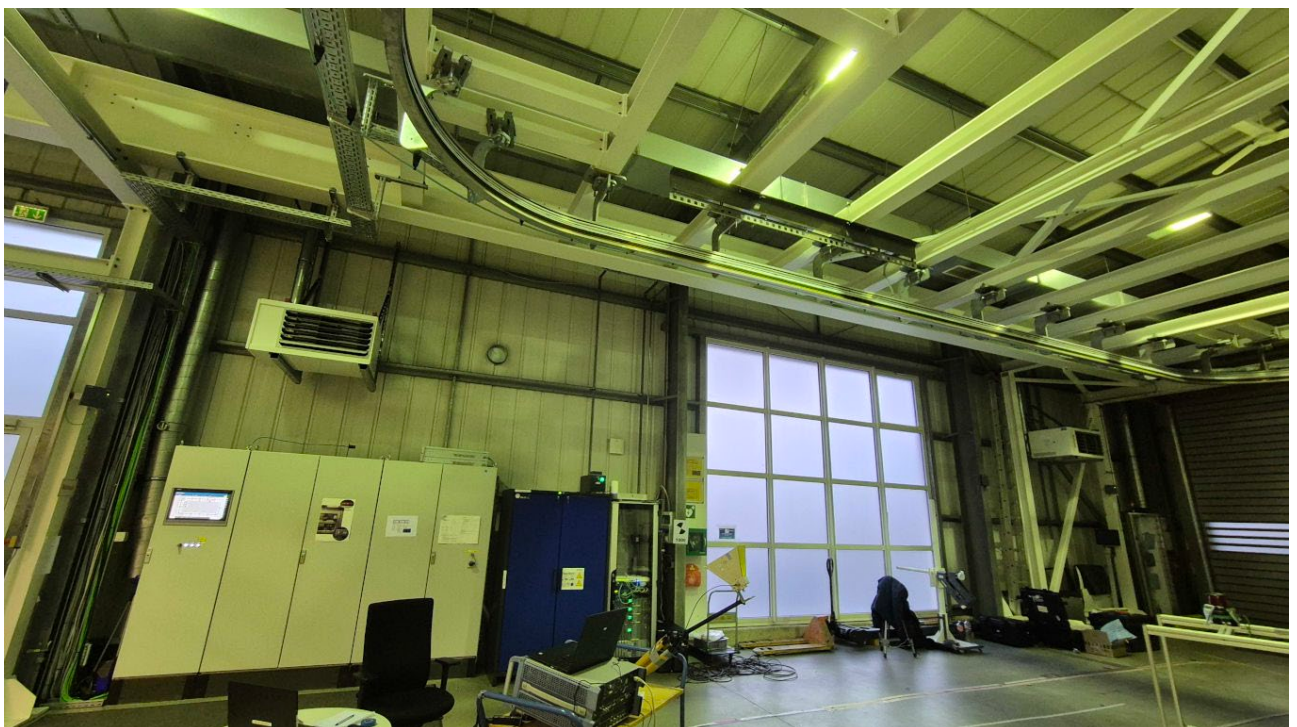
Photo 4: Test location overview

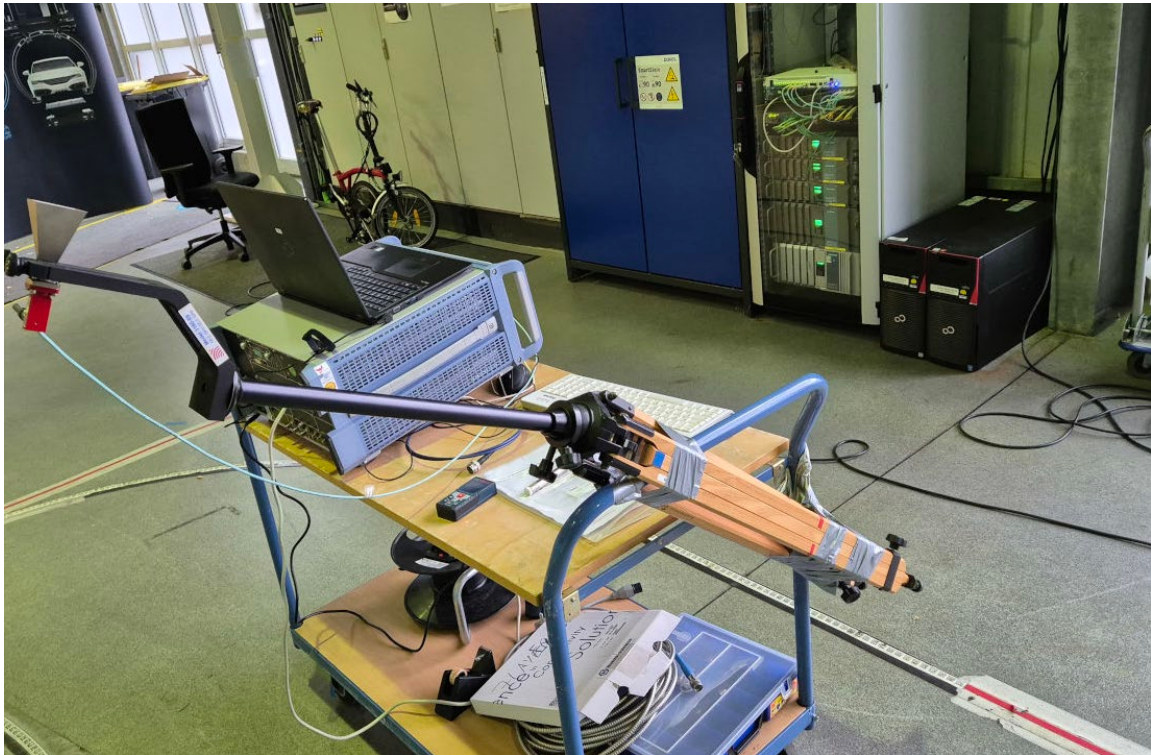
Photo 5: Standard gain horn 18 GHz – 26.5 GHz on trolley

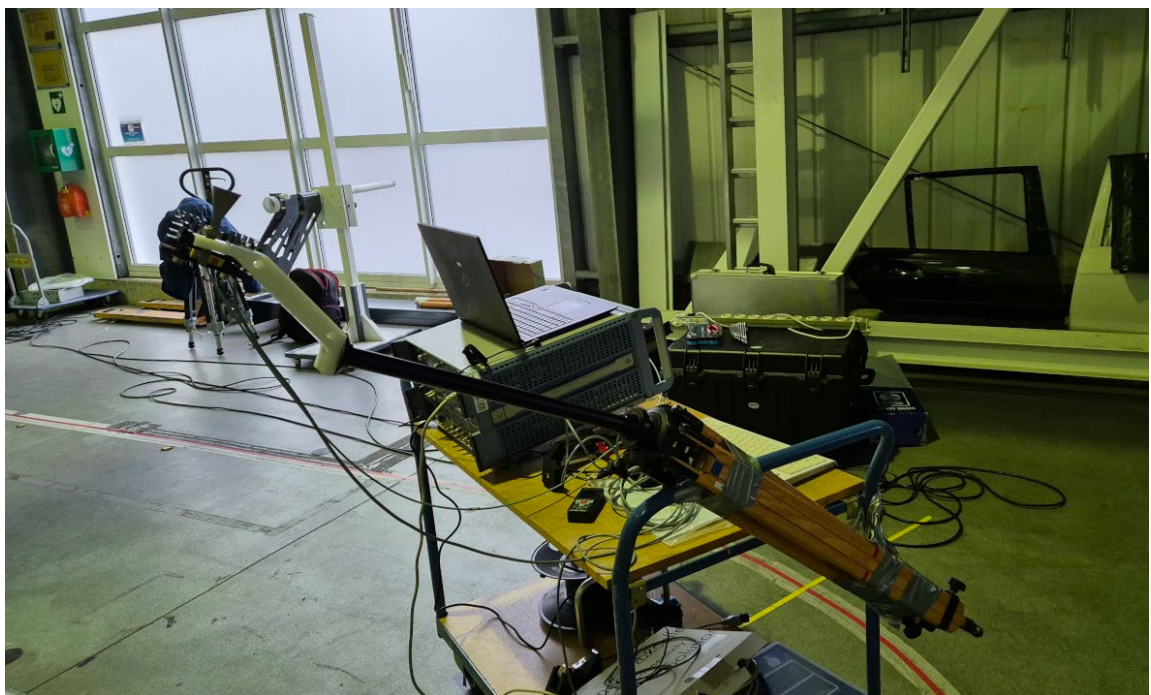
Photo 6: Standard gain horn 26.5 GHz – 40.0 GHz on trolley

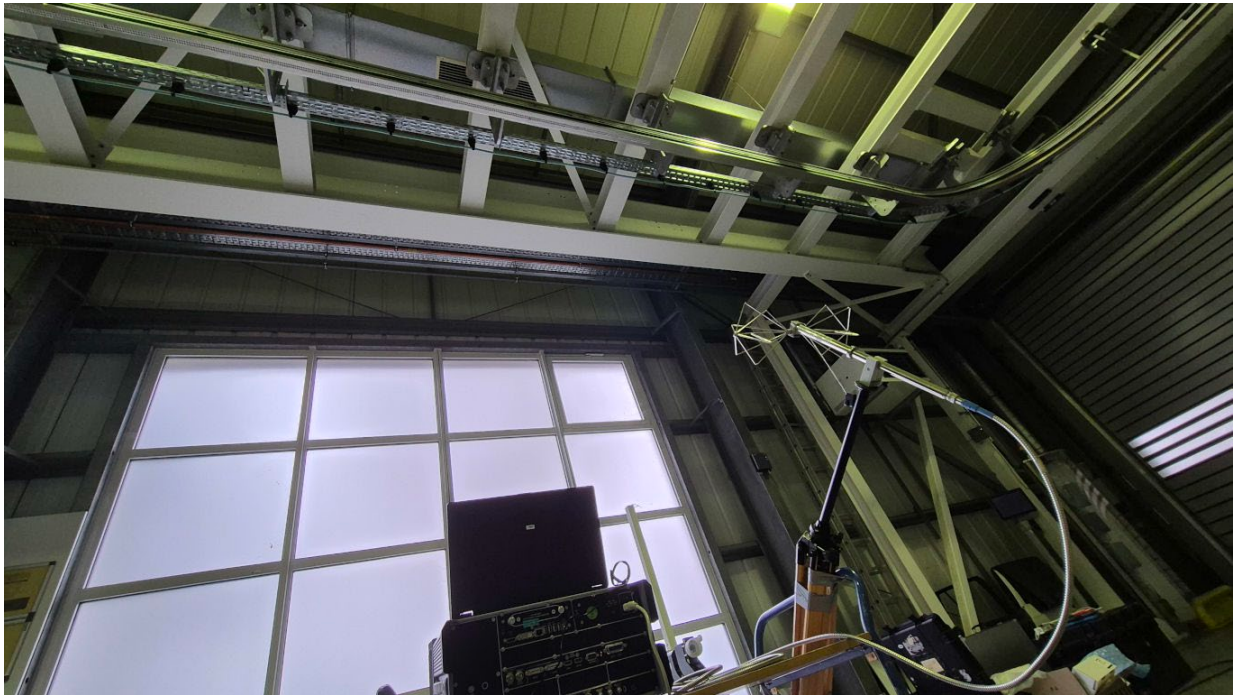
Photo 6: VUBA 9117 biconical dipole antenna 30.0 MHz – 1.0 GHz on trolley

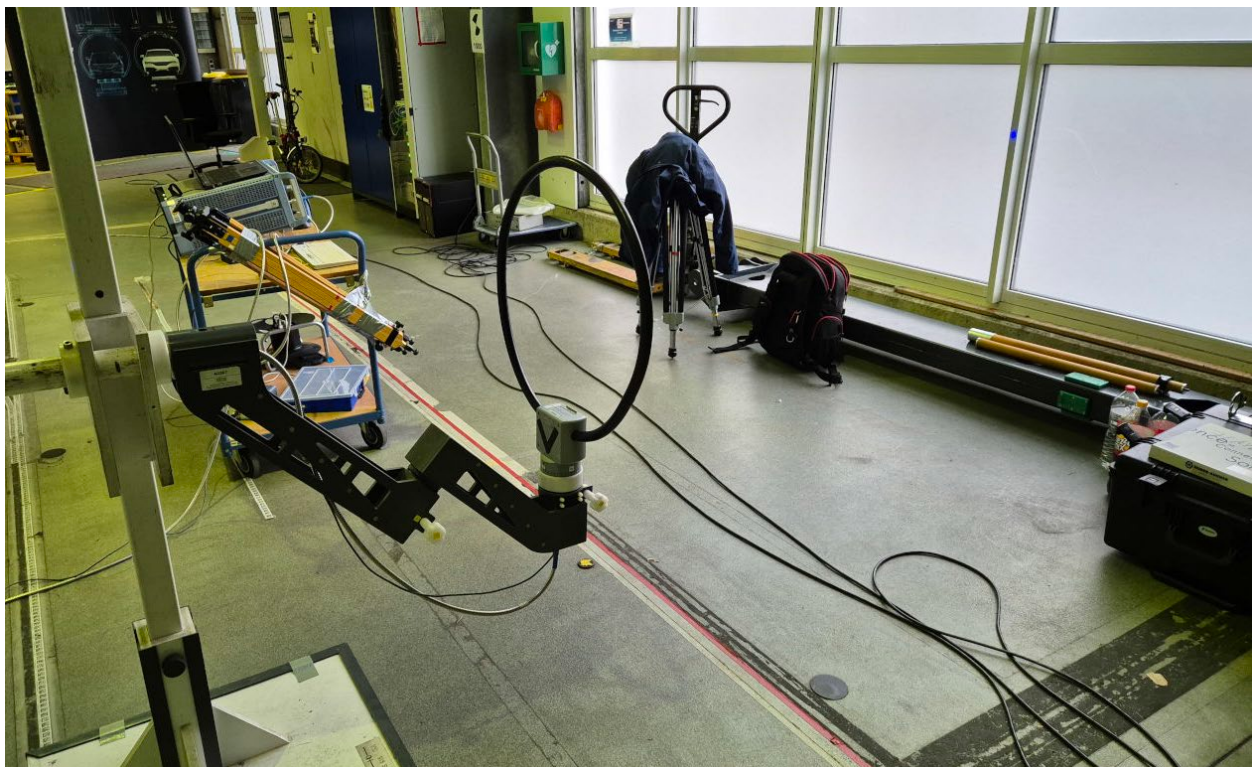
Photo 7: HFH2-Z2 magnetic field antenna 9.0 kHz – 30 MHz

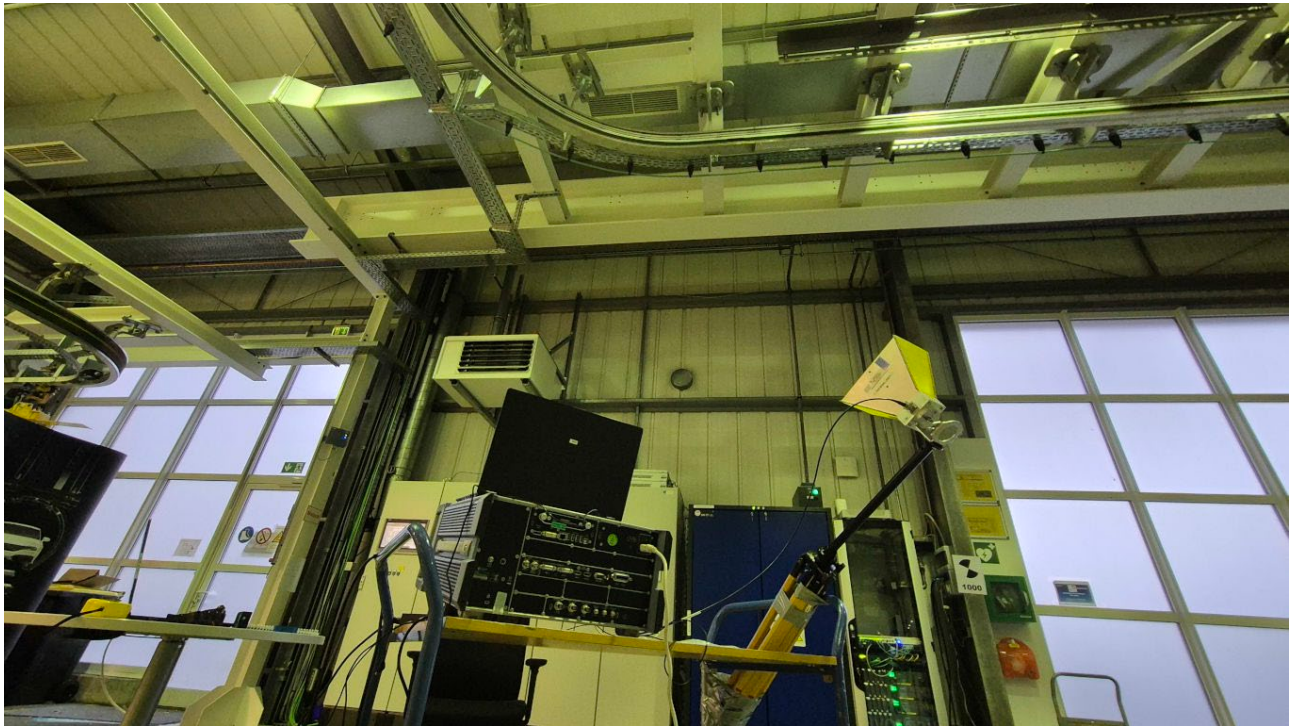
Photo 8: HF906 horn antenna, 1 GHz – 18 GHz, on trolley
