### **APPENDIX 3: Photographs of test setup**

#### **Radiated emission** **(Below 1GHz)**

**Radiated emission**  
**(Above 1GHz)**

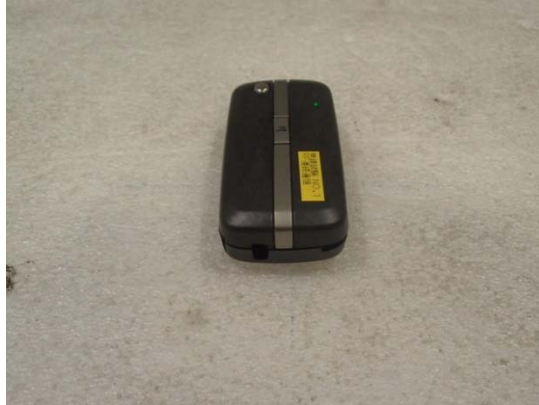
**X-axis**

**Worst case position**

**Below 1 GHz (Horizontal: X-axis / Vertical: Y-axis)**

**Above 1 GHz (Horizontal: X-axis / Vertical: Y-axis)**

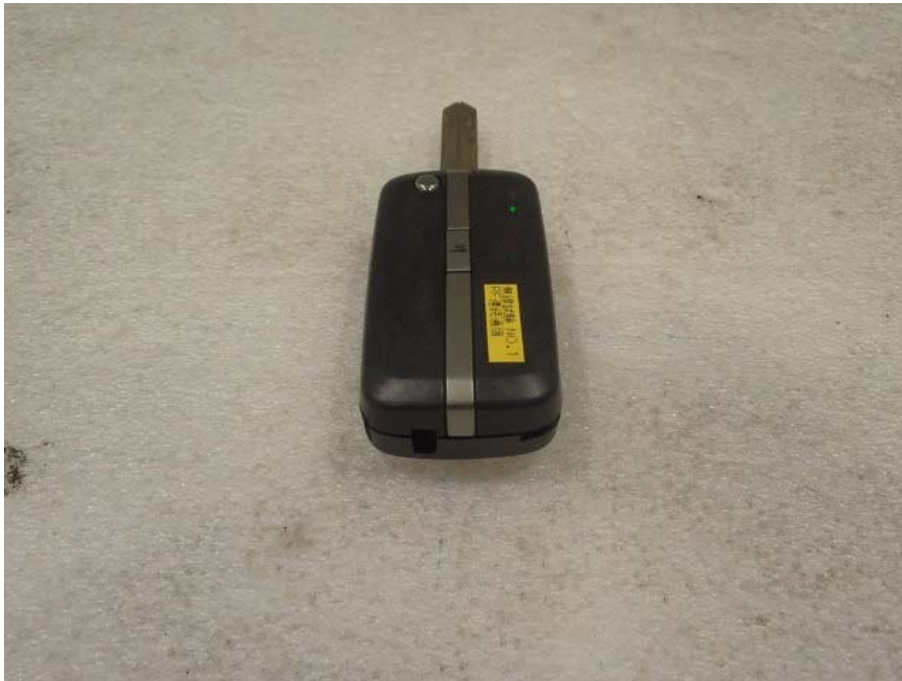
**Worst case position**

**Mechanical Key (folded out)**

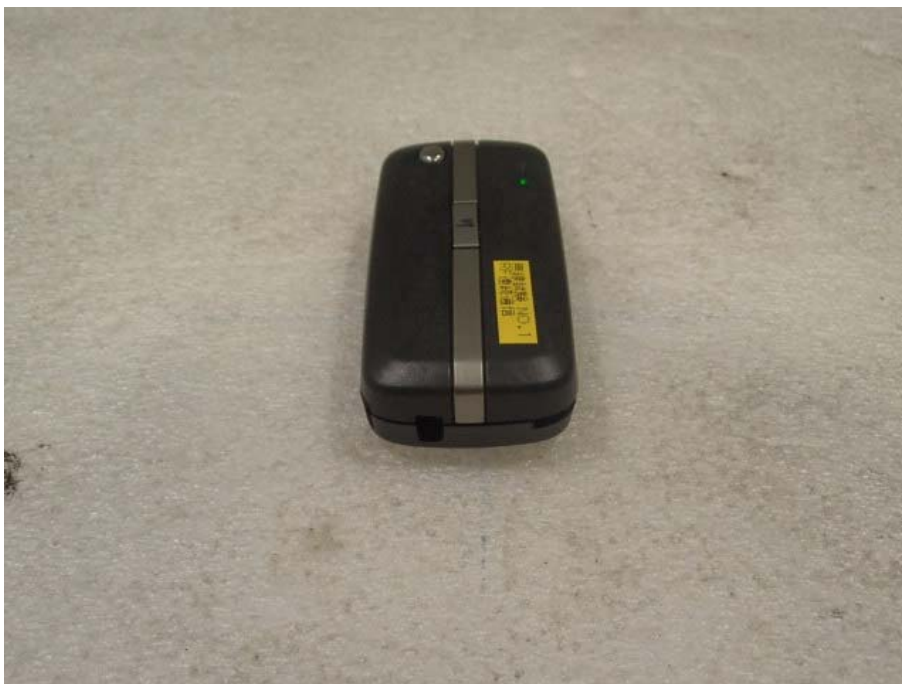
**Mechanical Key (folded in) Worst**
