Report No.: 9808666

Scan Settings (1 Range)

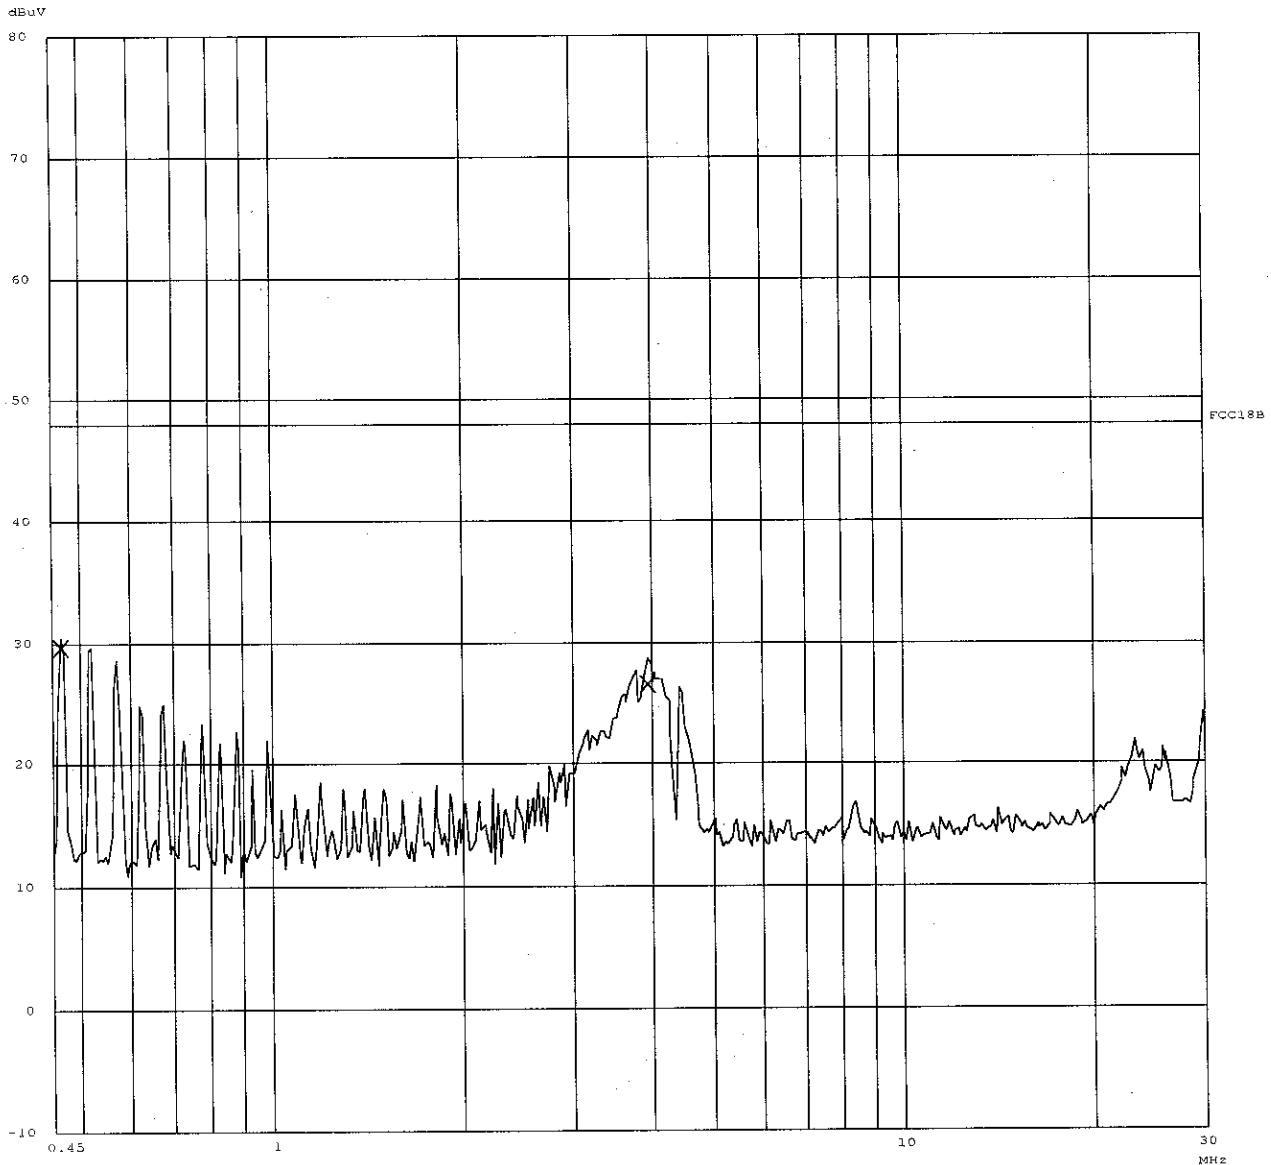
| Frequencies | | | Receiver Settings | | | | |
| Start | Stop | Step | IF BW | Detector | M-Time | Atten | Preamp OpRge |
| 450k | 30M | 5k | 10k | PK | 20ms | AUTO | LN OFF 60dB |

Final Measurement: X QP

Meas Time: 1 s  
Subranges: 16  
Acc Margin: 20dB

Final Measurement Results:

| Frequency<br>MHz | QP Level<br>dBuV | QP Limit<br>dBuV |
| 0.46500 | 29.6 | 48.0 |
| 3.94000 | 26.5 | 48.0 |
