Report No.: 9808277

Scan Settings (1 Range)

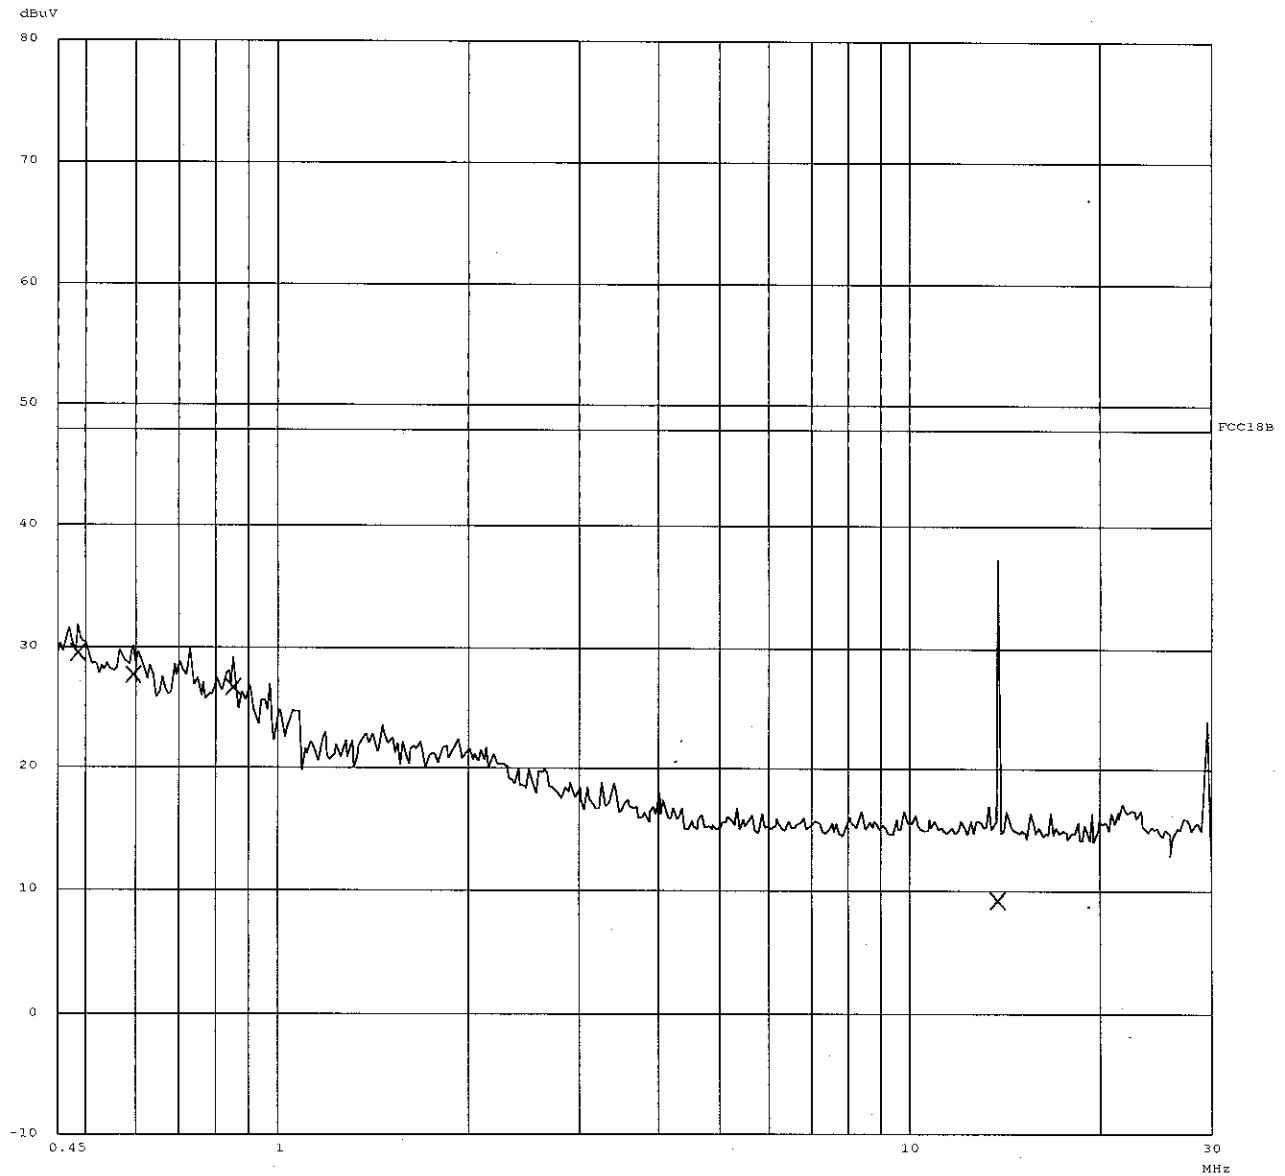
PAGE 1

| Start | Stop | Step | IF BW | Detector | M-Time | Atten | Preamp | OpRge |
|---|---|---|---|---|---|---|---|---|
| 450k | 30M | 5k | 10k | PK | 20ms | AUTO | LN OFF | 60dB |

Final Measurement: x QP

Acc Margin: 20dB

Final Measurement Results:

| Frequency<br>MHz | QP Level<br>dBuV | QP Limit<br>dBuV |
|---|---|---|
| 0.48500 | 29.5 | 48.0 |
| 0.59500 | 27.7 | 48.0 |
| 0.85500 | 26.6 | 48.0 |
| 13.82000 | 9.2 | 48.0 |
