FCC SAR Test Report

<Photographs of EUT>

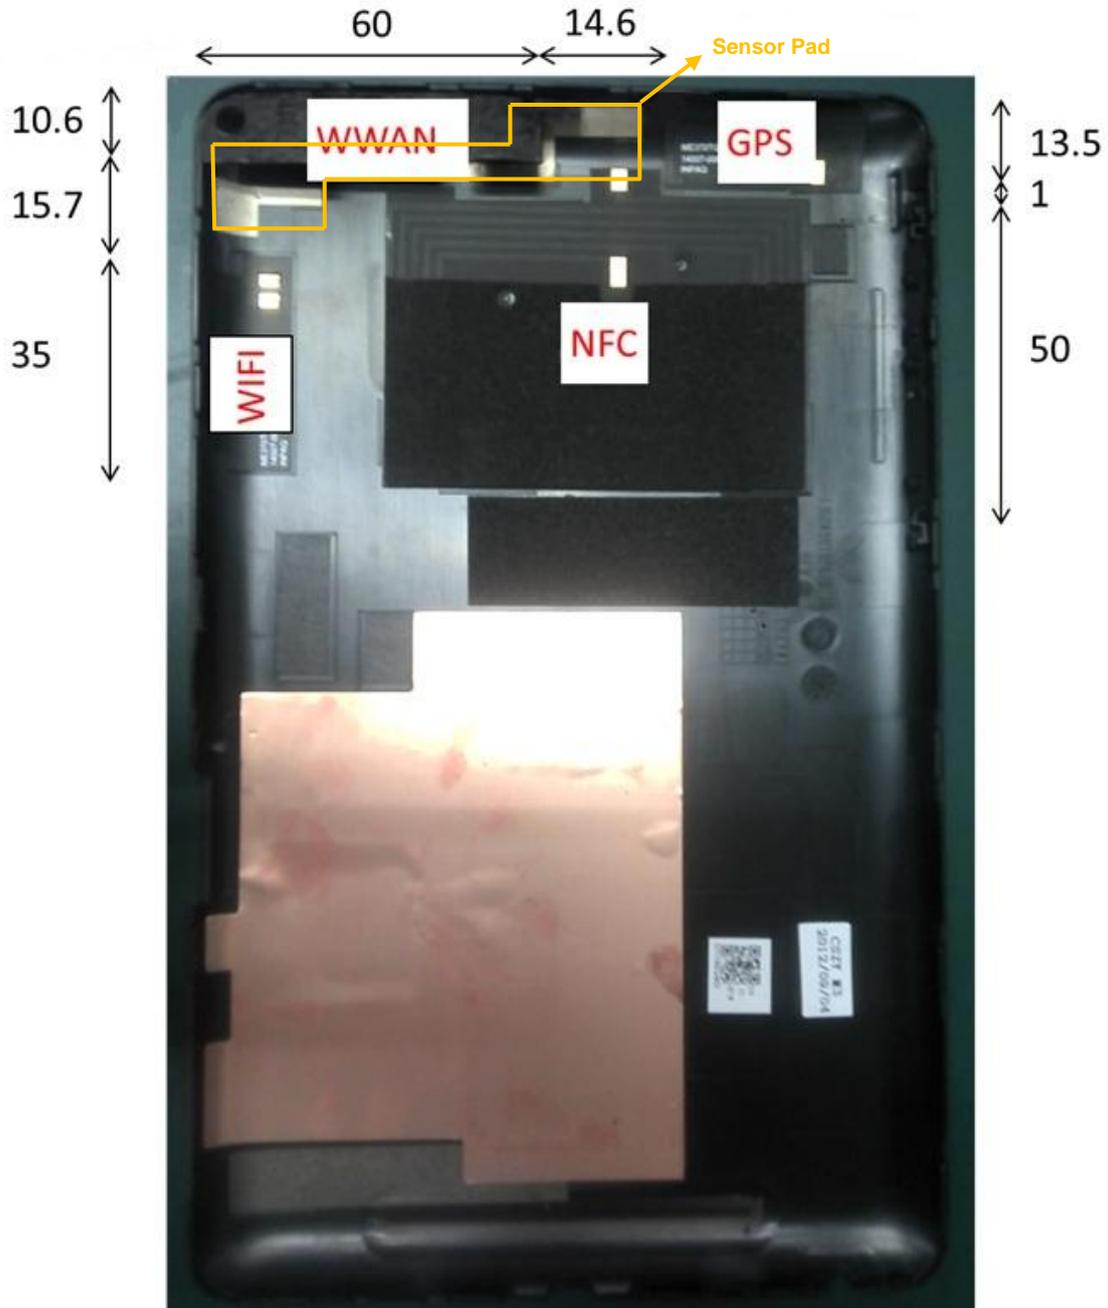
<Proximity Sensing Path Location>

Note: Since the technical document related to the design of proximity sensor and power reduction is confidential, the detail is described in the separate document, not in this SAR report, and please refers to the PBA document of “The Proximity Sensor Technical Description” and “PBA Document for Power Reduction”.

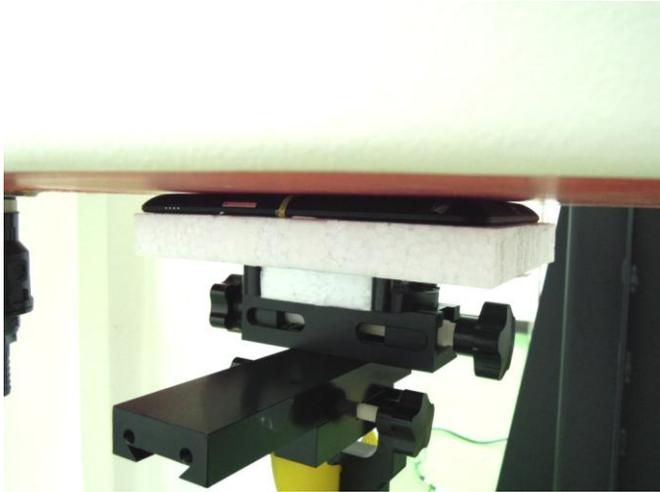
Rear Face of EUT with 0 cm Gap

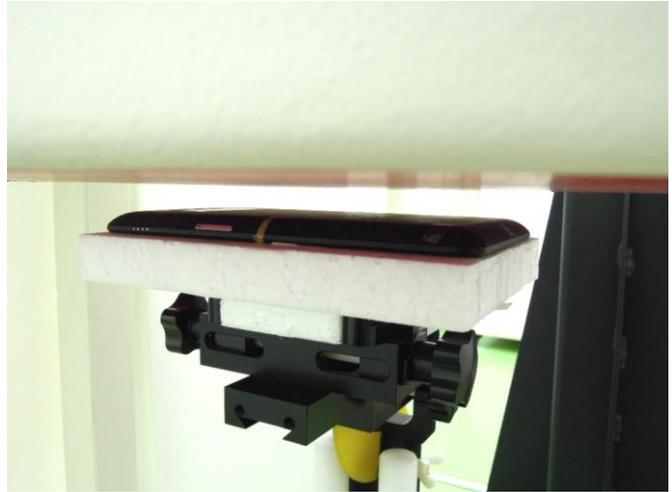
Rear Face of EUT with 1.4 cm Gap

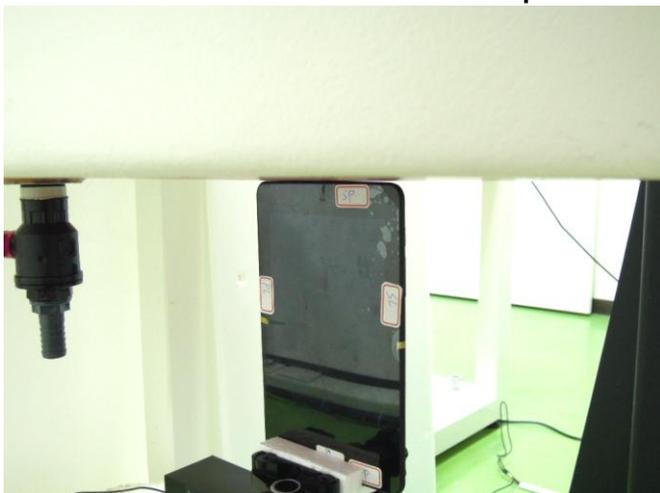
Secondary Portrait with 0 cm Gap

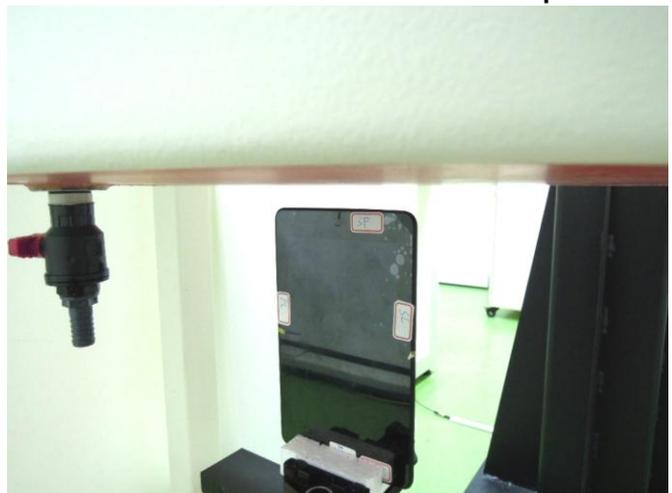
Secondary Portrait with 1.4 cm Gap

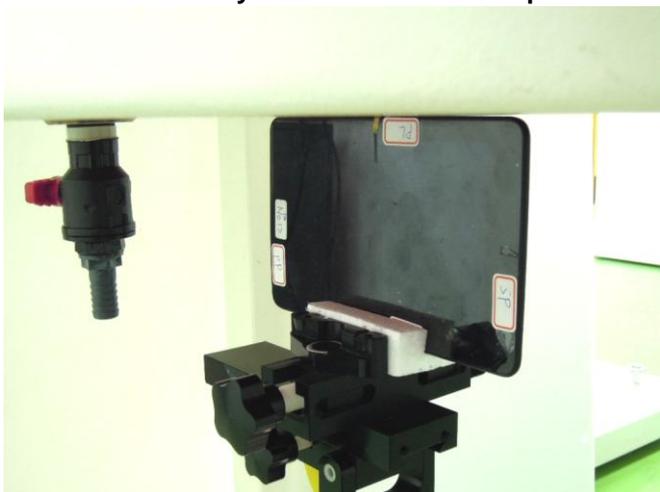
Primary Landscape with 0 cm Gap

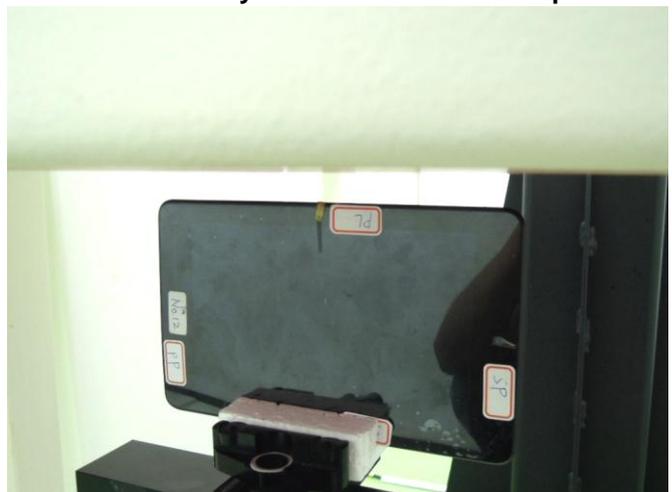
Primary Landscape with 1.4 cm Gap

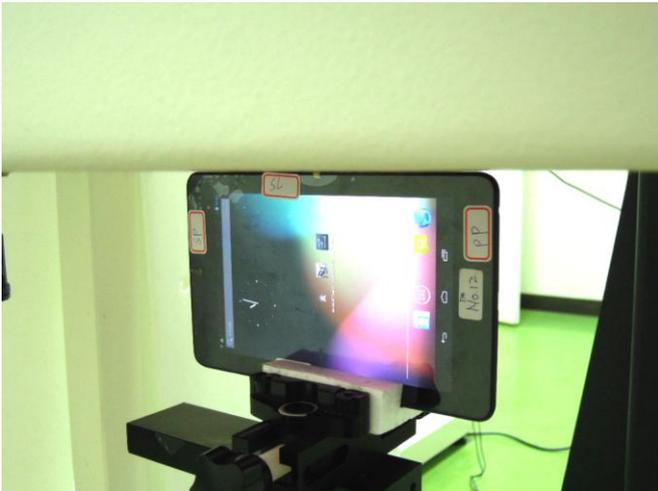
Secondary Landscape with 0 cm Gap

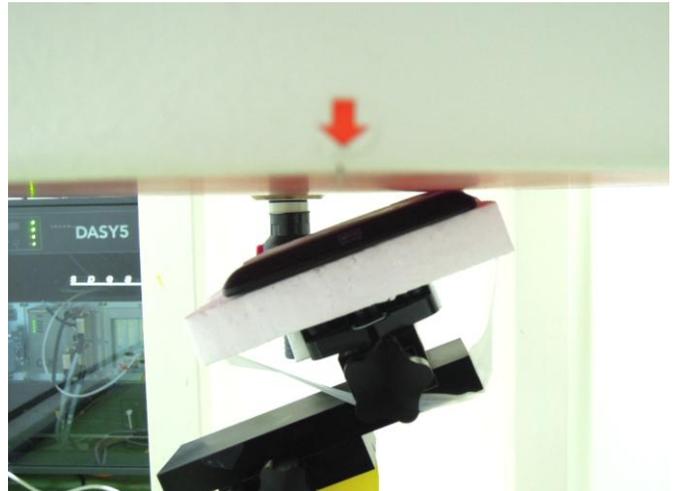
**Rear Face of EUT with 0 cm Gap
(Top Edge/Right Rear Corner at 19 degree)**

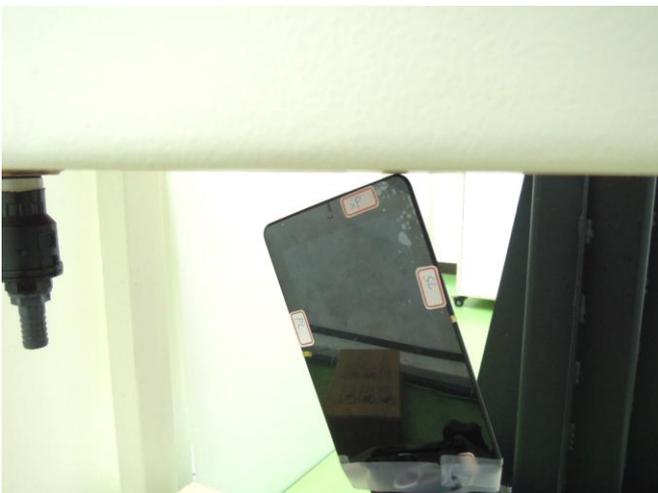
**Secondary Portrait with 0 cm Gap
(Top Edge/Right Corner at 19 degree)**

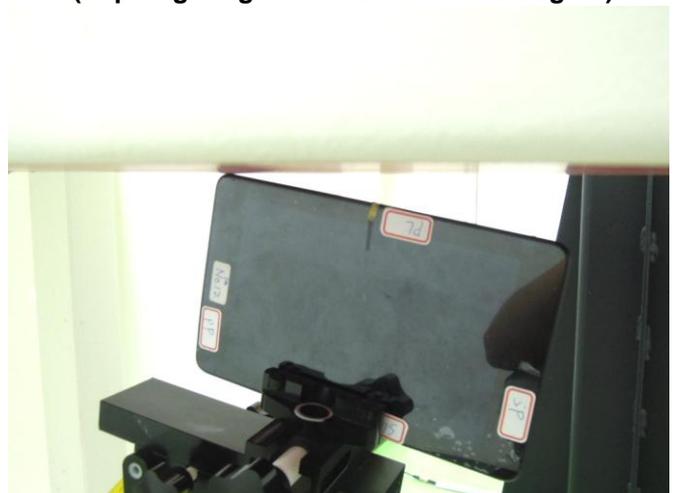
**Primary Landscape with 0 cm Gap
(Top Edge/Left Corner at 7 degree)**
