### **APPENDIX 3: Photographs of Test Setup**

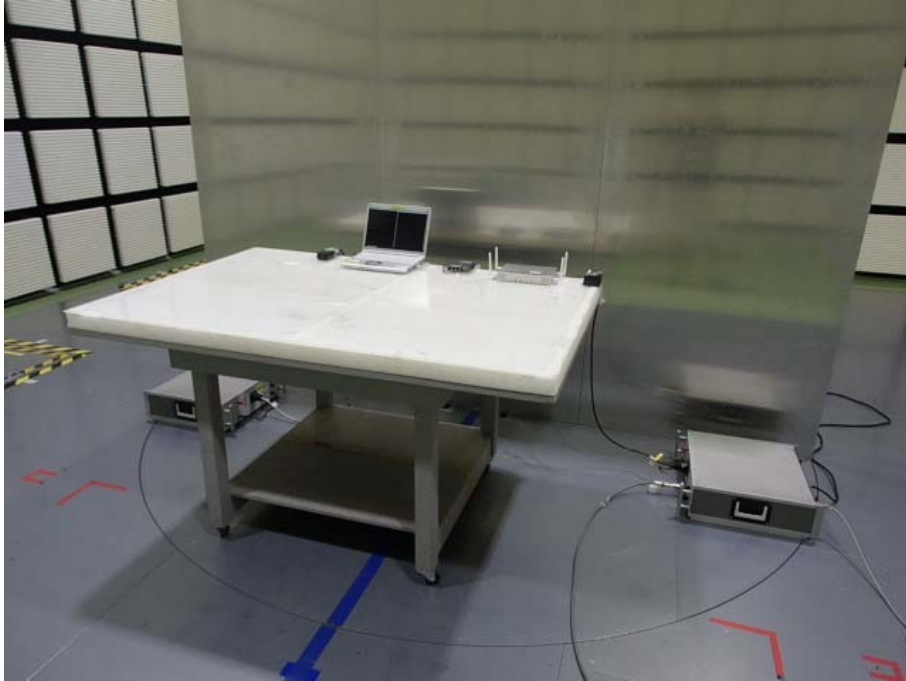
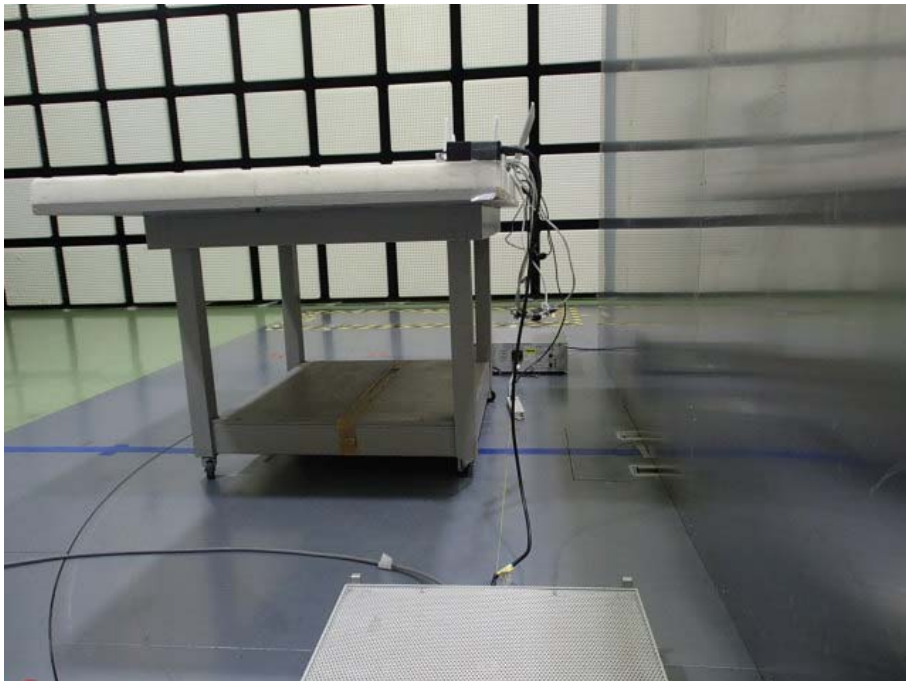
#### **Conducted Emission**

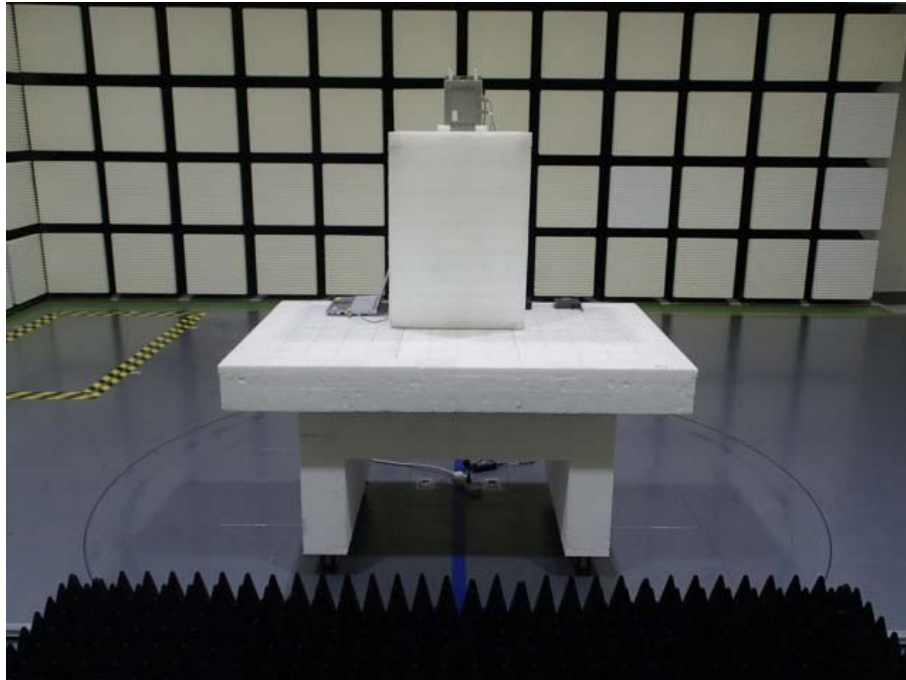
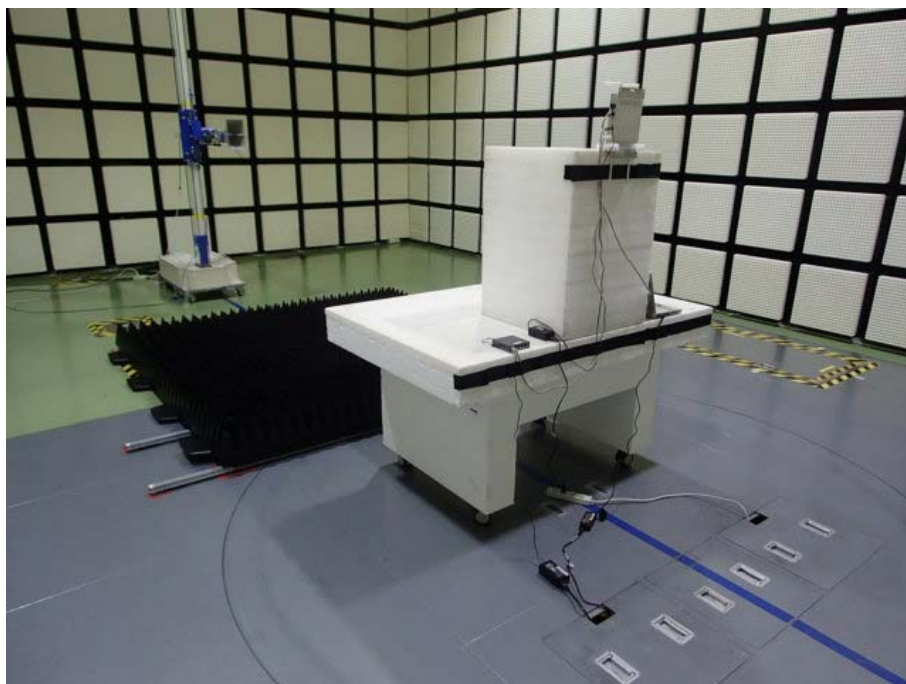
### Radiated Spurious Emission

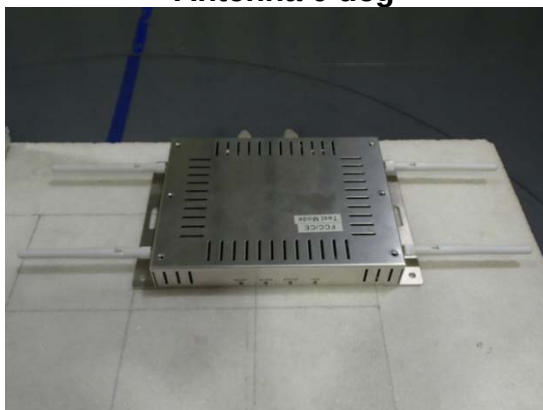
**EUT X-axis  
Antenna 0 deg**

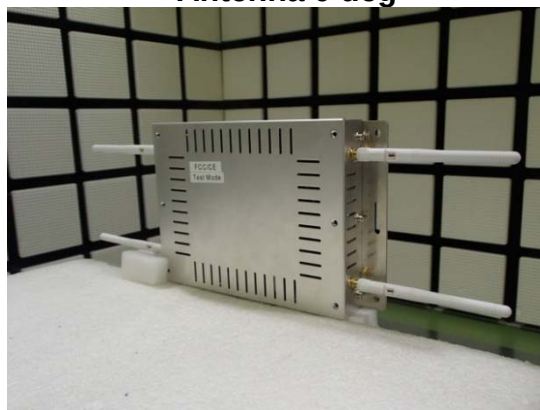
**EUT Y-axis  
Antenna 0 deg**

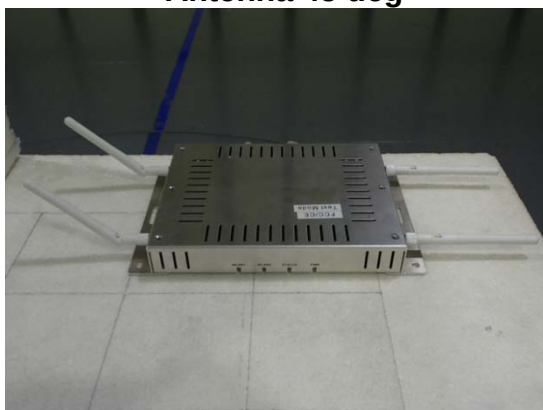
**EUT X-axis  
Antenna 45 deg**

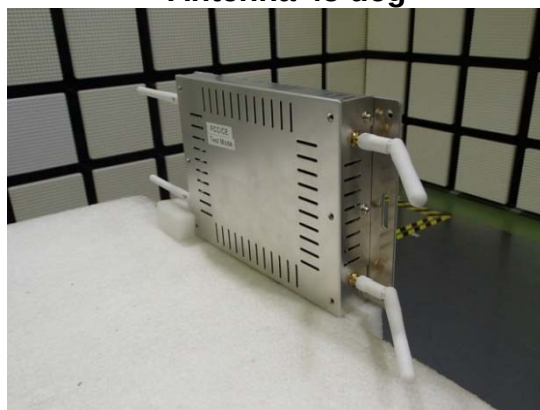
**EUT Y-axis  
Antenna 45 deg**

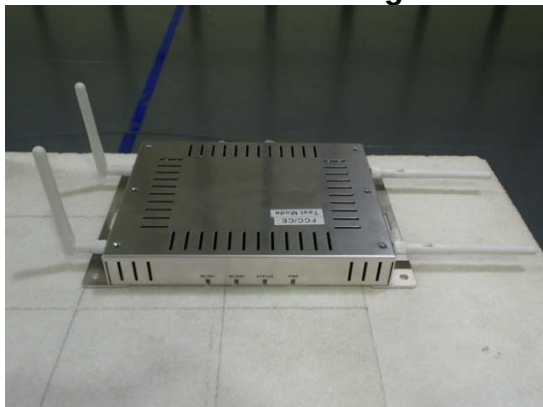
**EUT X-axis  
Antenna 90 deg**

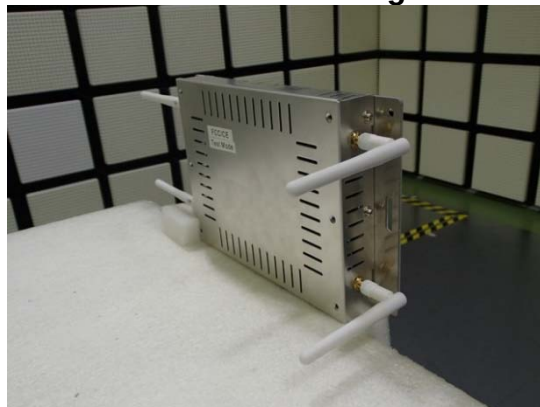
**EUT Y-axis  
Antenna 90 deg**

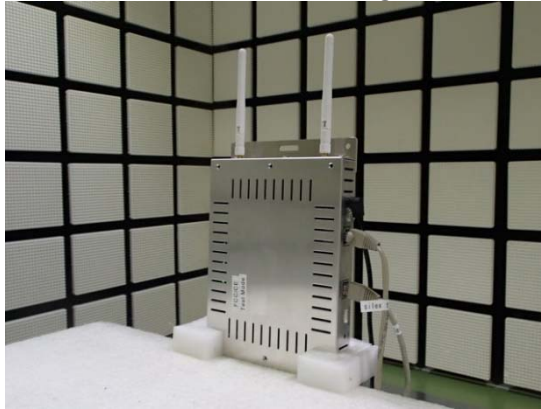
**Worst Case Position**

**EUT Z-axis  
Antenna 0 deg**

| Test Range | Horizontal | Vertical |
|---|---|---|
| Below 1 GHz | EUT Z-axis<br>Antenna 0 deg | EUT Z-axis<br>Antenna 0 deg |
| Above 1 GHz | EUT Z-axis<br>Antenna 90 deg | EUT Z-axis<br>Antenna 0 deg |

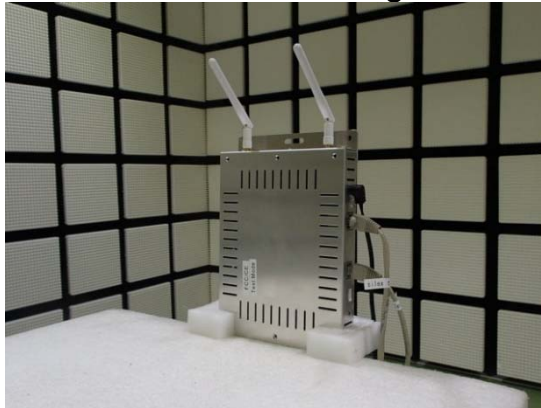
**EUT Z-axis  
Antenna 45 deg**

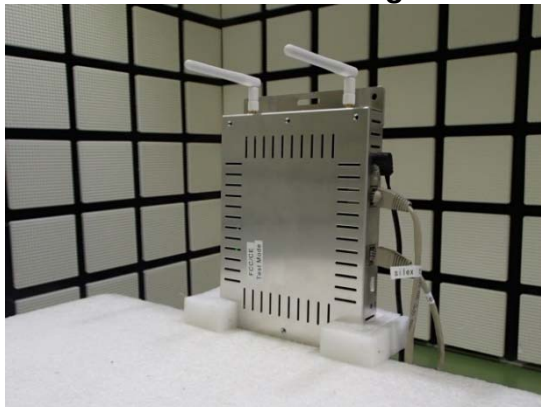
**EUT Z-axis  
Antenna 90 deg**

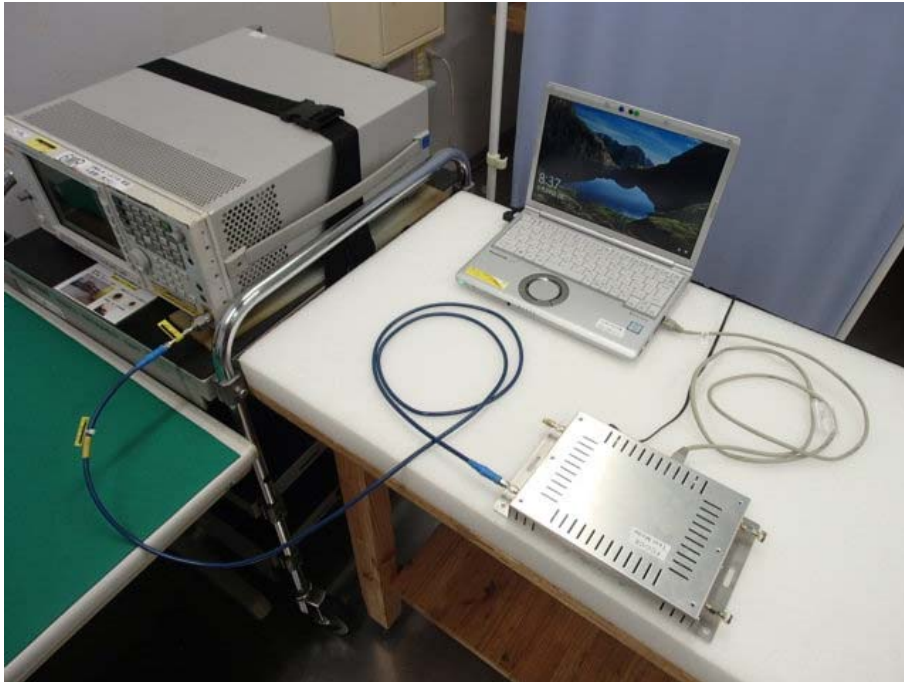
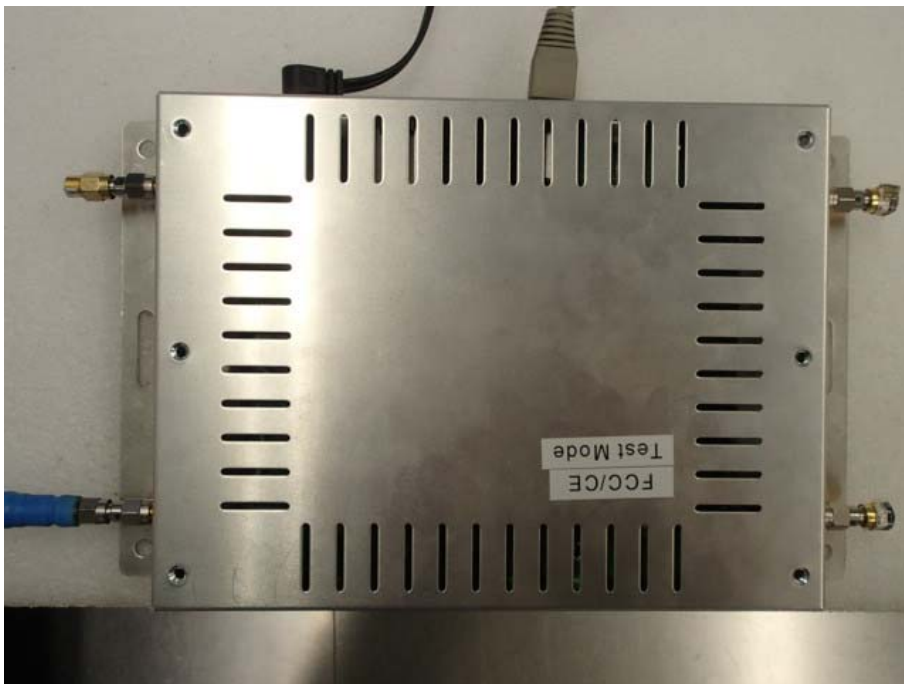
### Antenna Terminal Conducted Tests
