### **APPENDIX 3: Photographs of test setup**

#### **Radiated Spurious Emission**

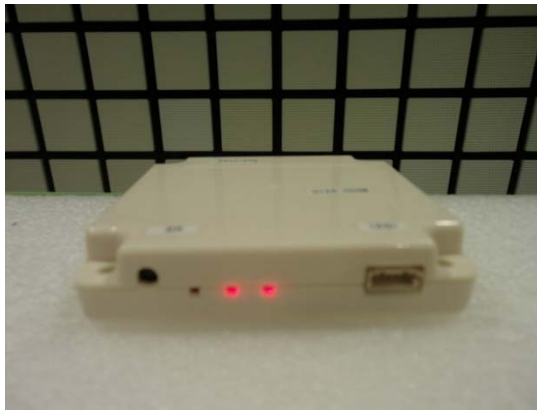
**X-axis**

#### Module

| Frequency Range | Horizontal | Vertical |
| Below 1 GHz | X-axis | X-axis |
| Above 1 GHz | Y-axis | Y-axis |
| Spurious (6 GHz) | Y-axis | X-axis |
| Spurious (13 GHz) | Z-axis | Y-axis |

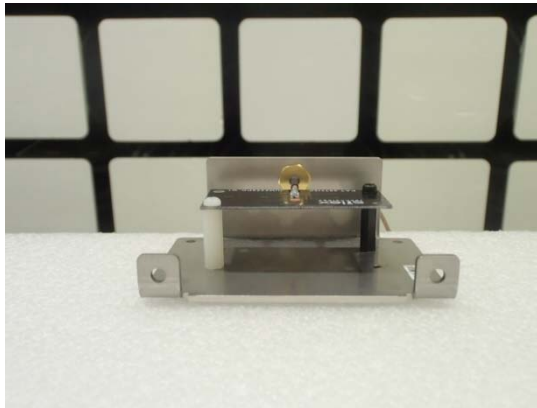
**X-axis**

### Antenna

| Frequency Range | Horizontal | Vertical |
| Below 1 GHz | X-axis | X-axis |
| Above 1 GHz | X-axis | Z-axis |
| Spurious (6 GHz) | Y-axis | Z-axis |
| Spurious (13 GHz) | Z-axis | Z-axis |

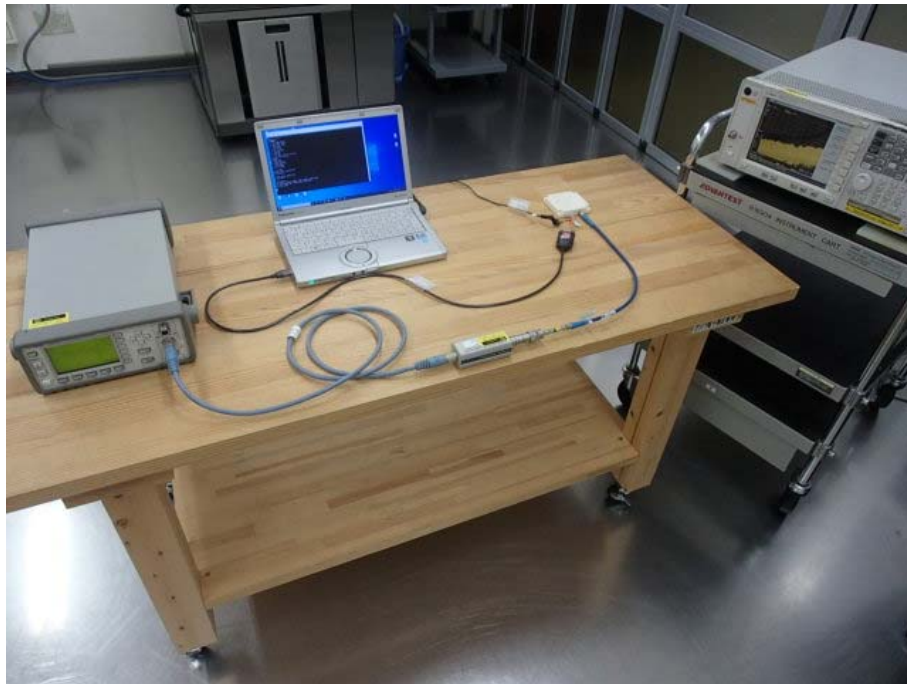
**Photo 1**

### Antenna Terminal Conducted Tests
