FCC ID: NDX-WALKBY

## 5 TEST CONDITIONS AND RESULTS

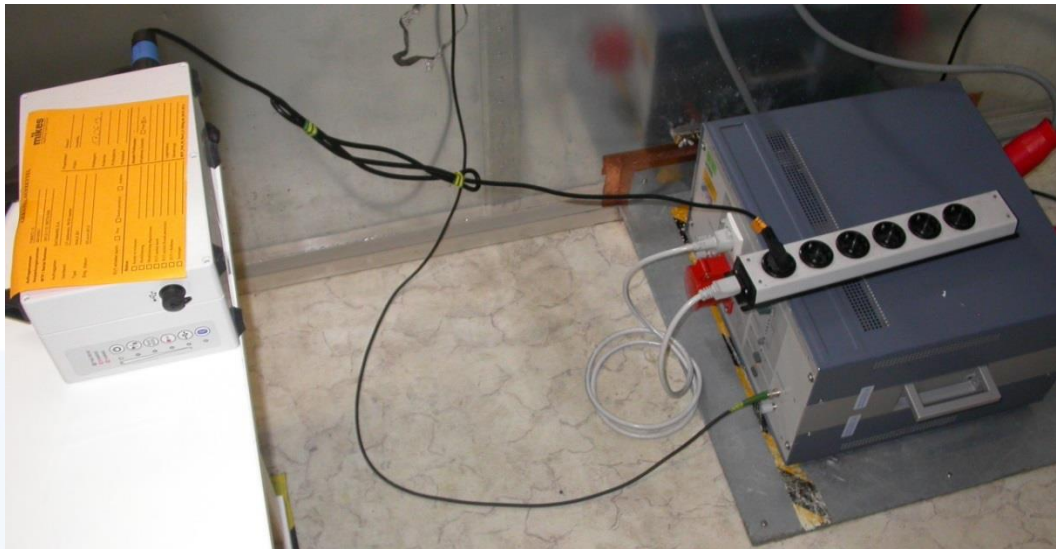
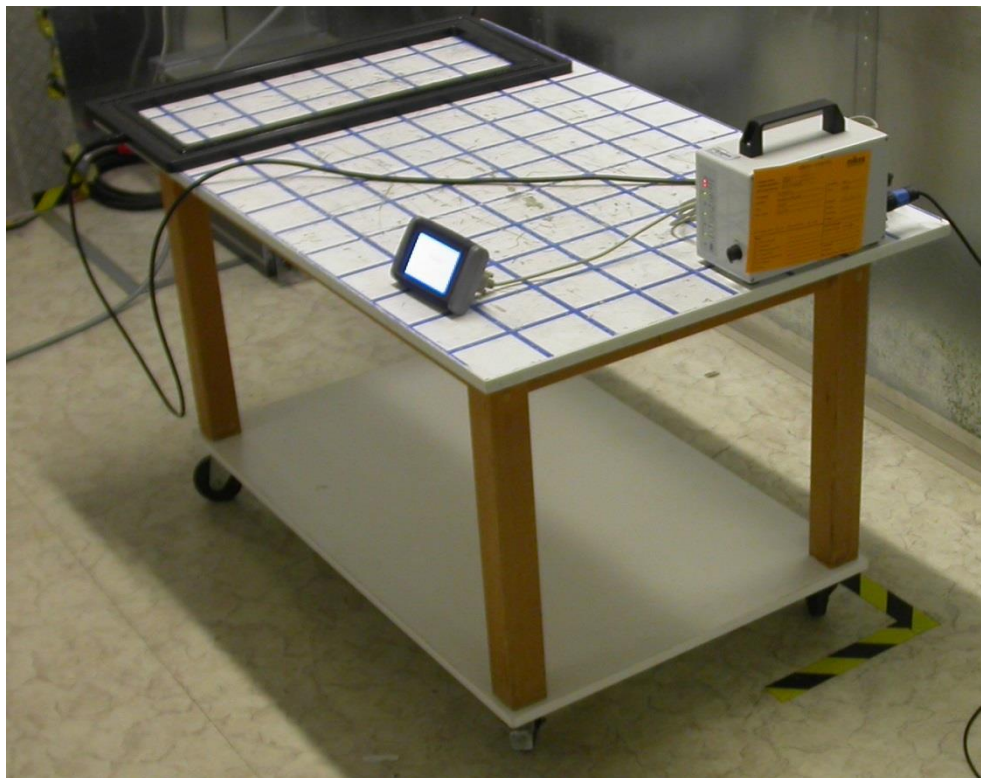
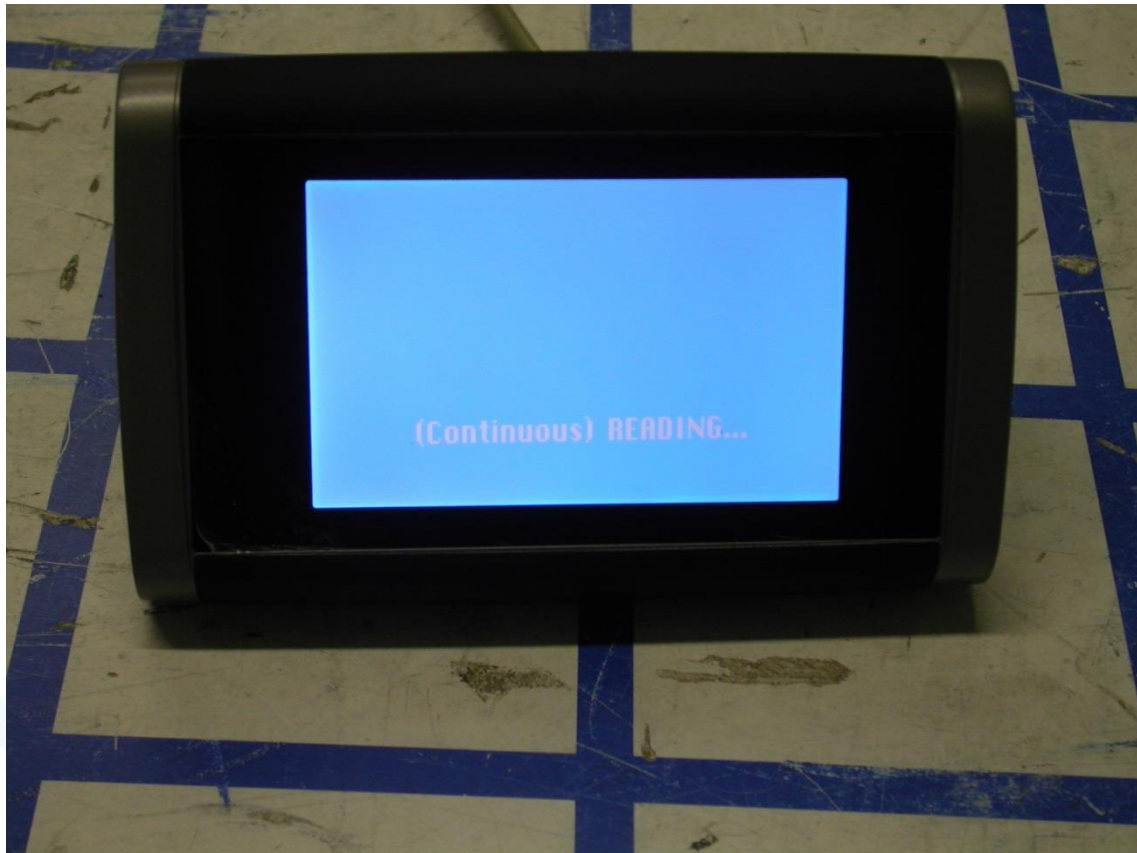
#### 5.1.2 Photo documentation of the test set-up

### 5.1 Conducted emissions

Test location:                Shielded Room S2

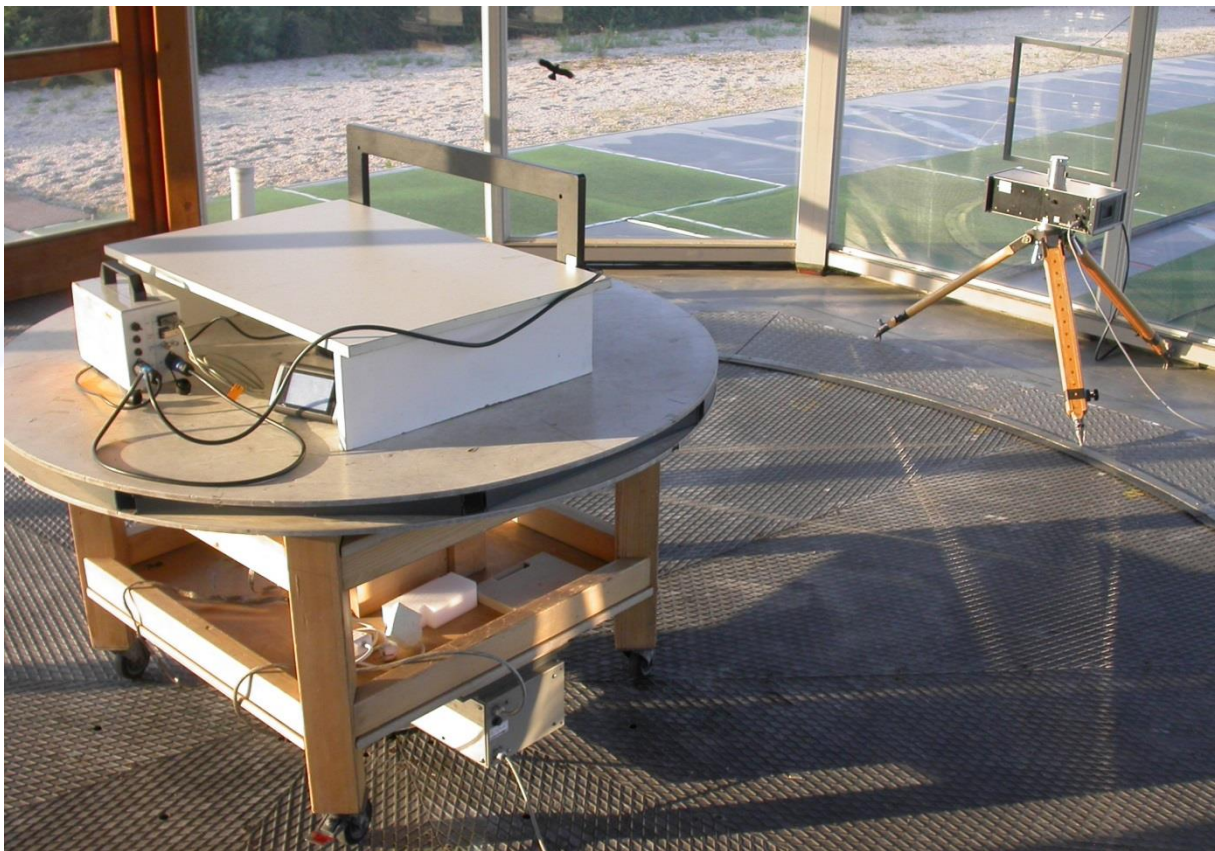
### 5.2.2 Photo documentation of the test set-up

## 5.2 Field strength of the fundamental wave

Test location: OATS1

Test distance: 3 metres

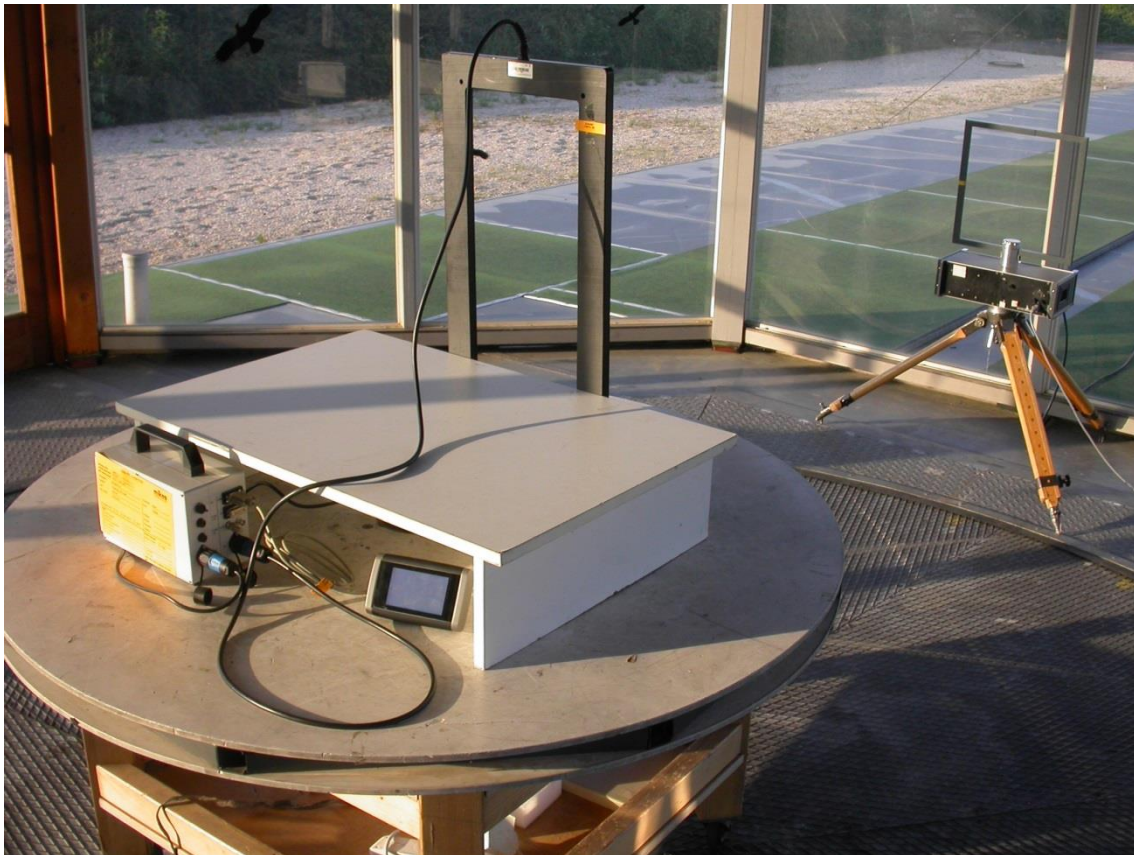
**5.3.2 Photo documentation of the test set-up**

**FCC ID: NDX-WALKBY****5.3 Spurious emissions (magnetic field) 9 kHz – 30 MHz**

Test location: OATS1

Test distance: 3 metres

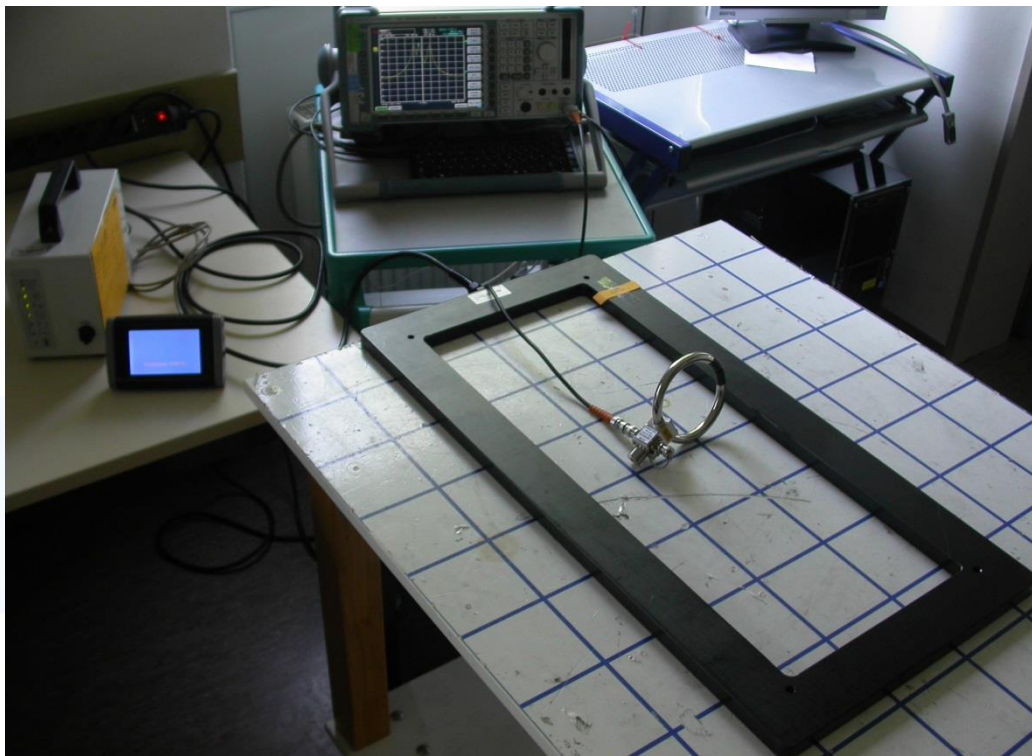
### 5.4.2 Photo documentation of the test set-up

## 5.4 Emission Bandwidth

Test location: AREA4

| Fundamental<br>[kHz]<br>See Plot 1 | 20dB<br>Bandwidth<br>F1 | 20dB<br>Bandwidth<br>F2 | Measured<br>Bandwidth<br>[kHz] |
| 134.20 | 133.66 | 134.72 | 1.06 |
