### **APPENDIX 3: Photographs of test setup**

#### **Radiated Emission**

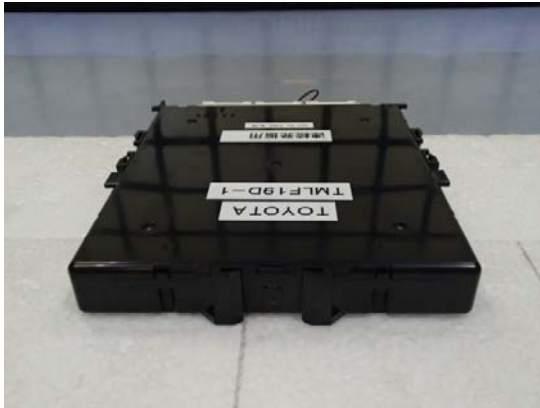
**X-axis**

ECU  
Below 30 MHz: X-axis  
Above 30 MHz (Horizontal: X / Vertical: X)

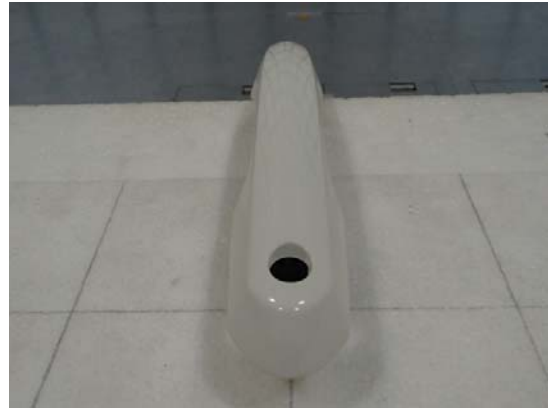
**X-axis**

Outside Antenna  
Below 30 MHz: X-axis  
Above 30 MHz (Horizontal: X / Vertical: X)

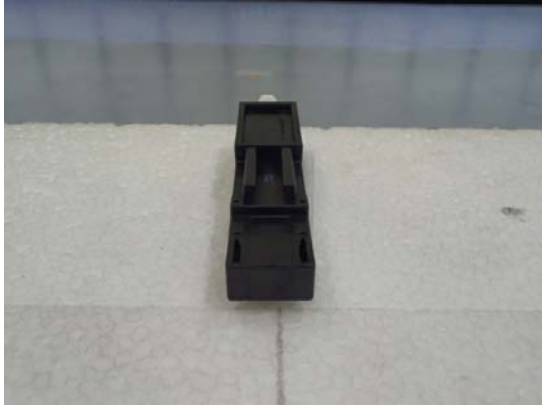
Inside Antenna  
Below 30 MHz: X-axis  
Above 30 MHz (Horizontal: X / Vertical: X)  
**X-axis**

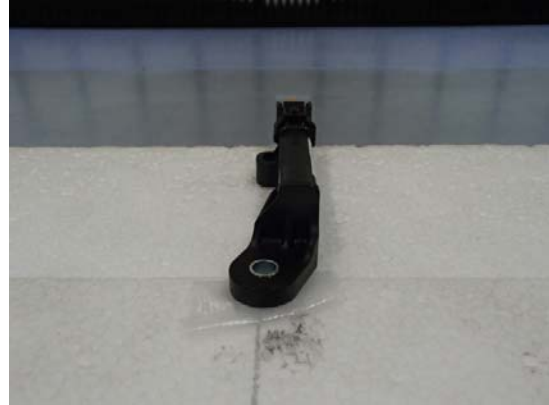
Rear Antenna  
Below 30 MHz: X-axis  
Above 30 MHz (Horizontal: X / Vertical: X)  
**X-axis**
