### **APPENDIX 3: Photographs of test setup**

#### **Radiated Emission**

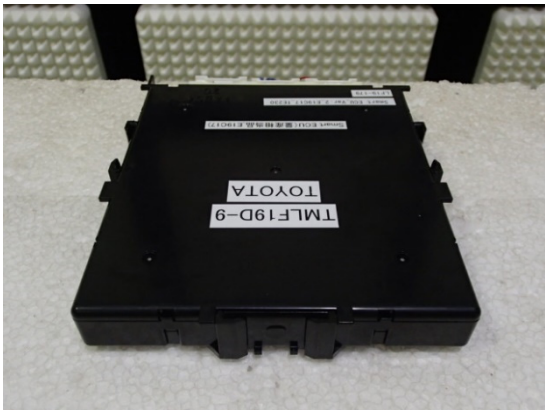
**X-axis**

**ECU**  
Below 30 MHz  
X-axis  
Above 30 MHz  
Horizontal: X-axis / Vertical: X-axis

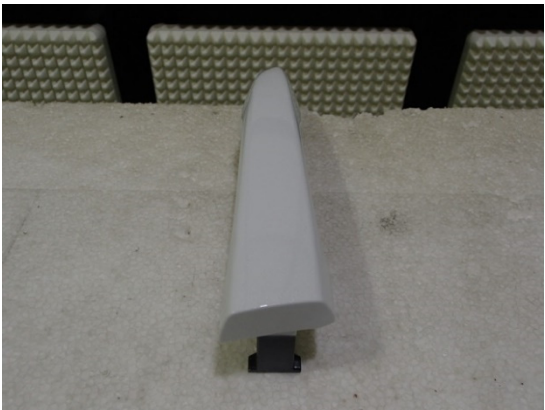
**X-axis**

**Outside Antenna**  
Below 30 MHz  
X-axis  
Above 30 MHz  
Horizontal: X-axis / Vertical: X-axis

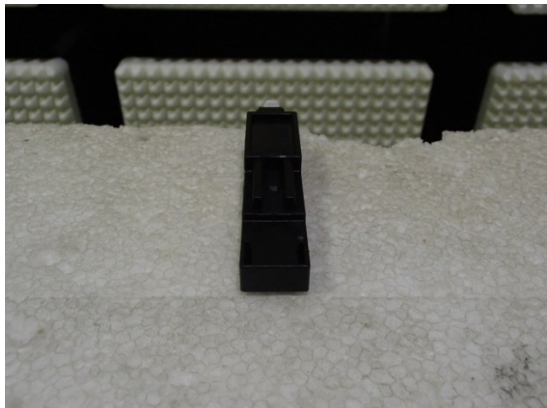
**Inside Antenna**

**Below 30 MHz**

**X-axis**

**Above 30 MHz**

**Horizontal: X-axis / Vertical: X-axis**

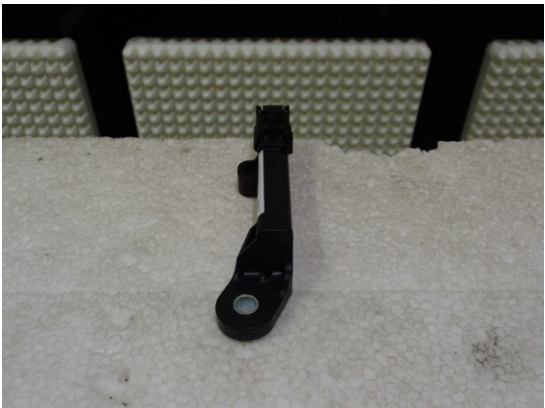
**Rear Antenna**

**Below 30 MHz**

**X-axis**

**Above 30 MHz**

**Horizontal: X-axis / Vertical: X-axis**

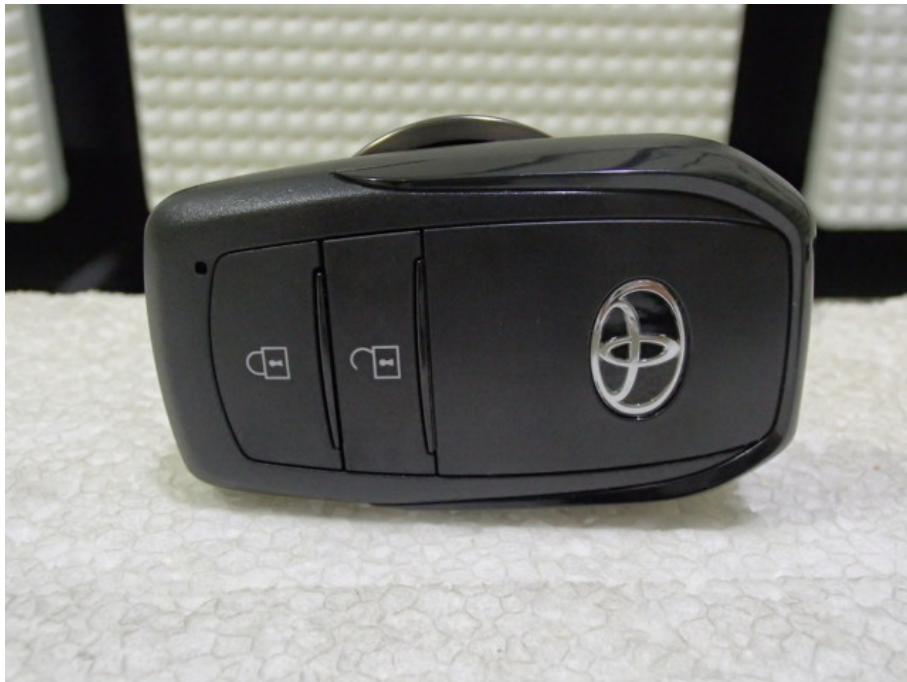
**With transponder key attached**
