13.PHOTOGRAPHS

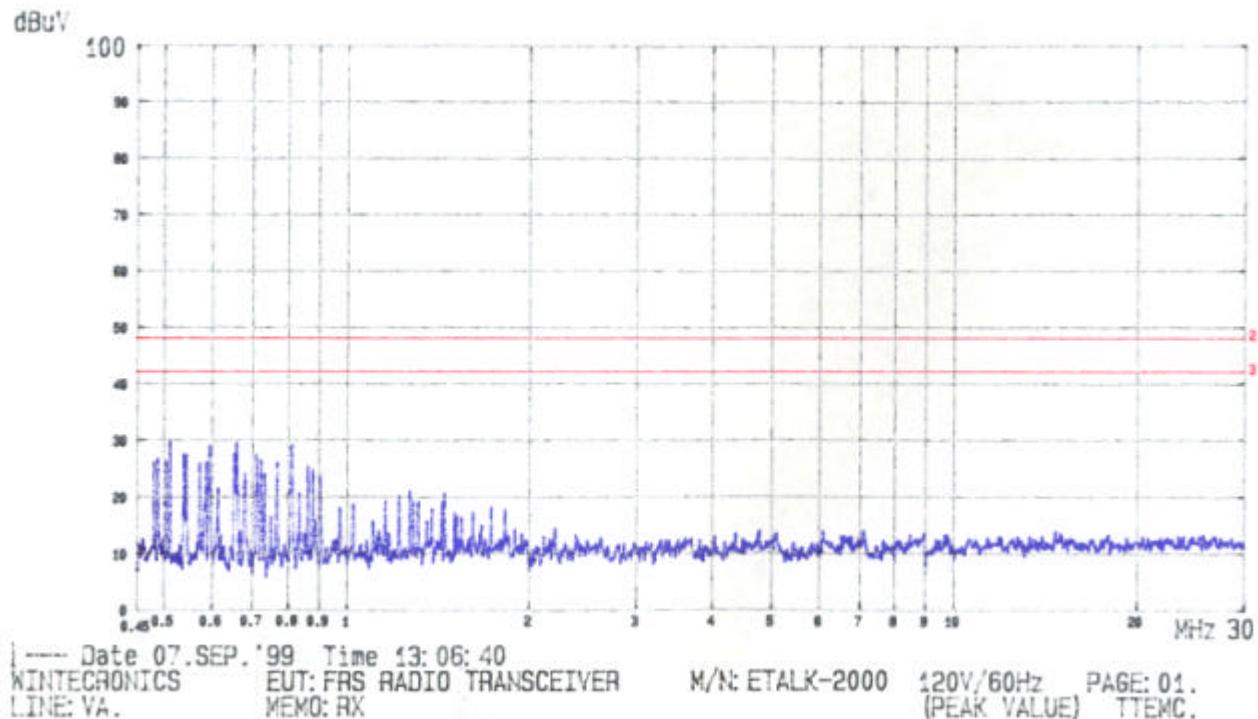
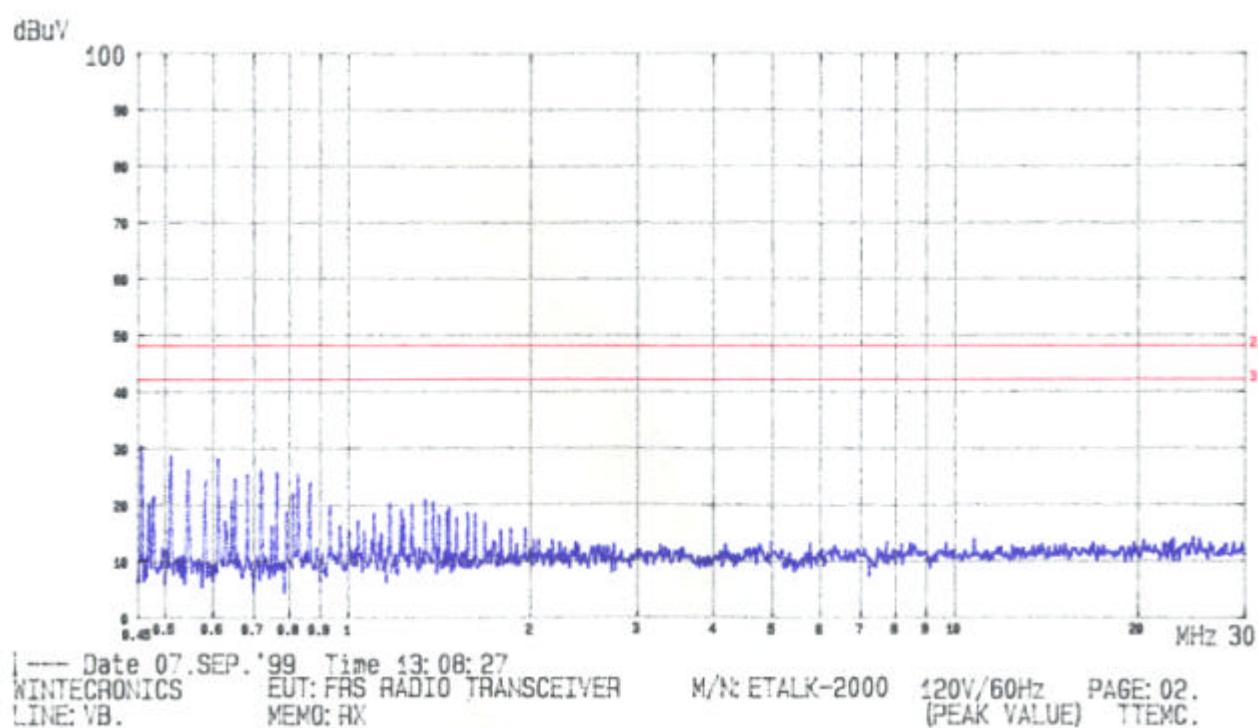
(Conducted Test Data)

Test Mode: Channel 1, Receiver / Receiving Mode
