Report No.: 9808478

Scan Settings (1 Range)

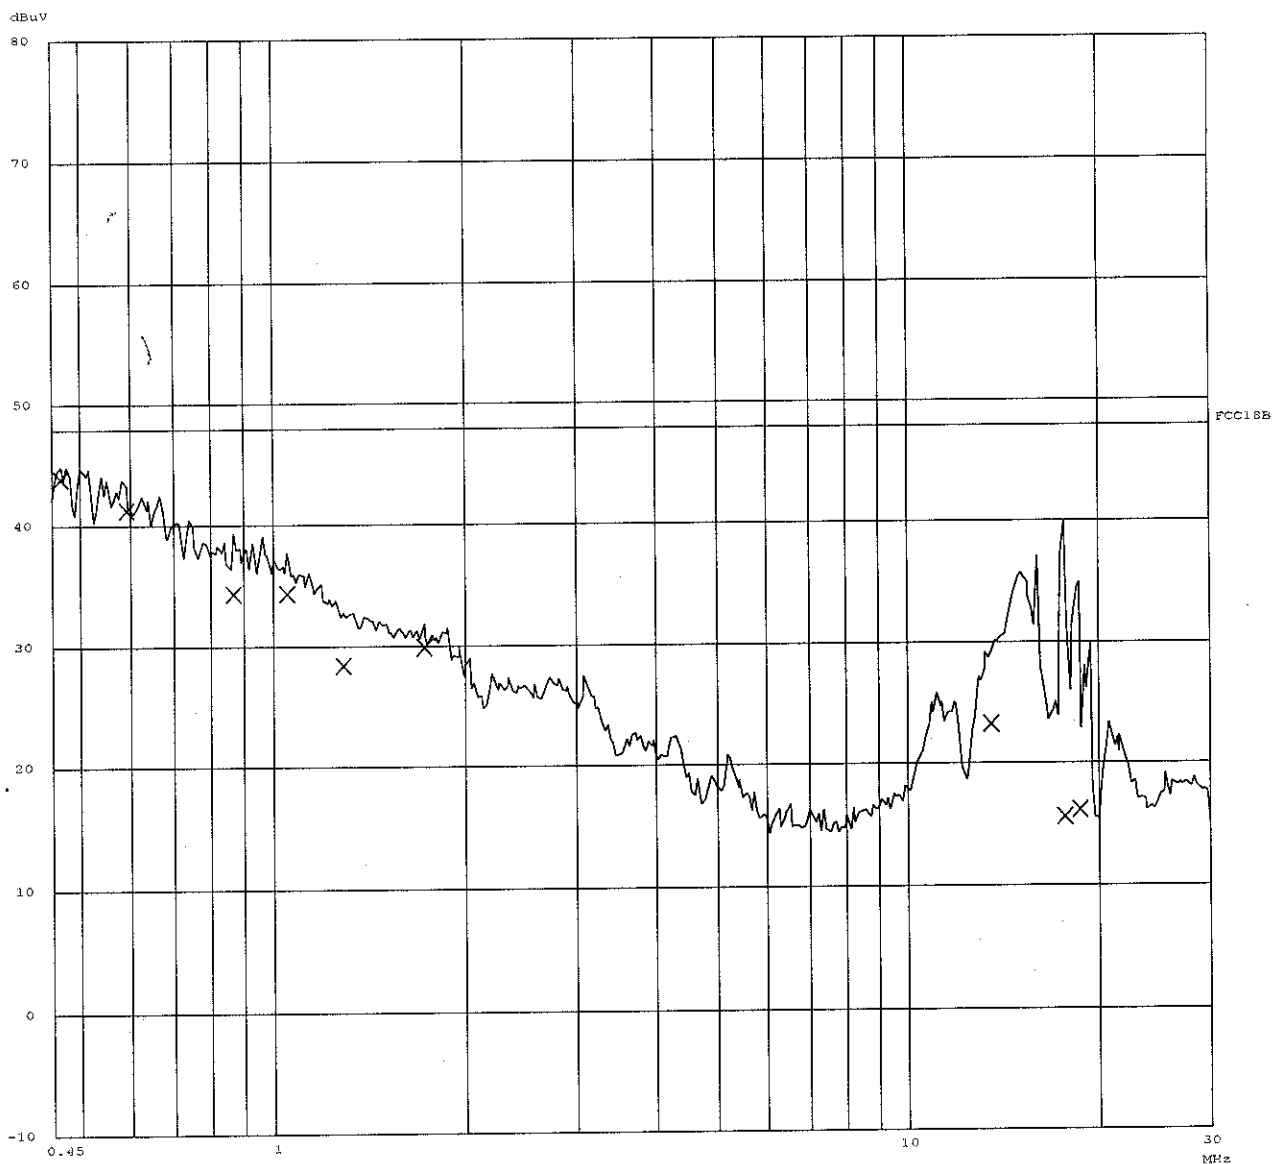
| Frequencies | | | Receiver Settings | | | | | |
| Start | Stop | Step | IF BW | Detector | M-Time | Atten | Preamp | OpRge |
| 450k | 30M | 5k | 10k | PK | 20ms | AUTO | LN OFF | 60dB |

Final Measurement: H QP

Meas Time: 1 s  
Subranges: 18  
Acc Margin: 20dB

Final Measurement Results:

| Frequency<br>MHz | QP Level<br>dBuV | QP Limit<br>dBuV |
| 0.46500 | 43.8 | 48.0 |
| 0.59000 | 41.2 | 48.0 |
| 0.87000 | 34.3 | 48.0 |
