Report No.: 9800841

Scan Settings (1 Range)

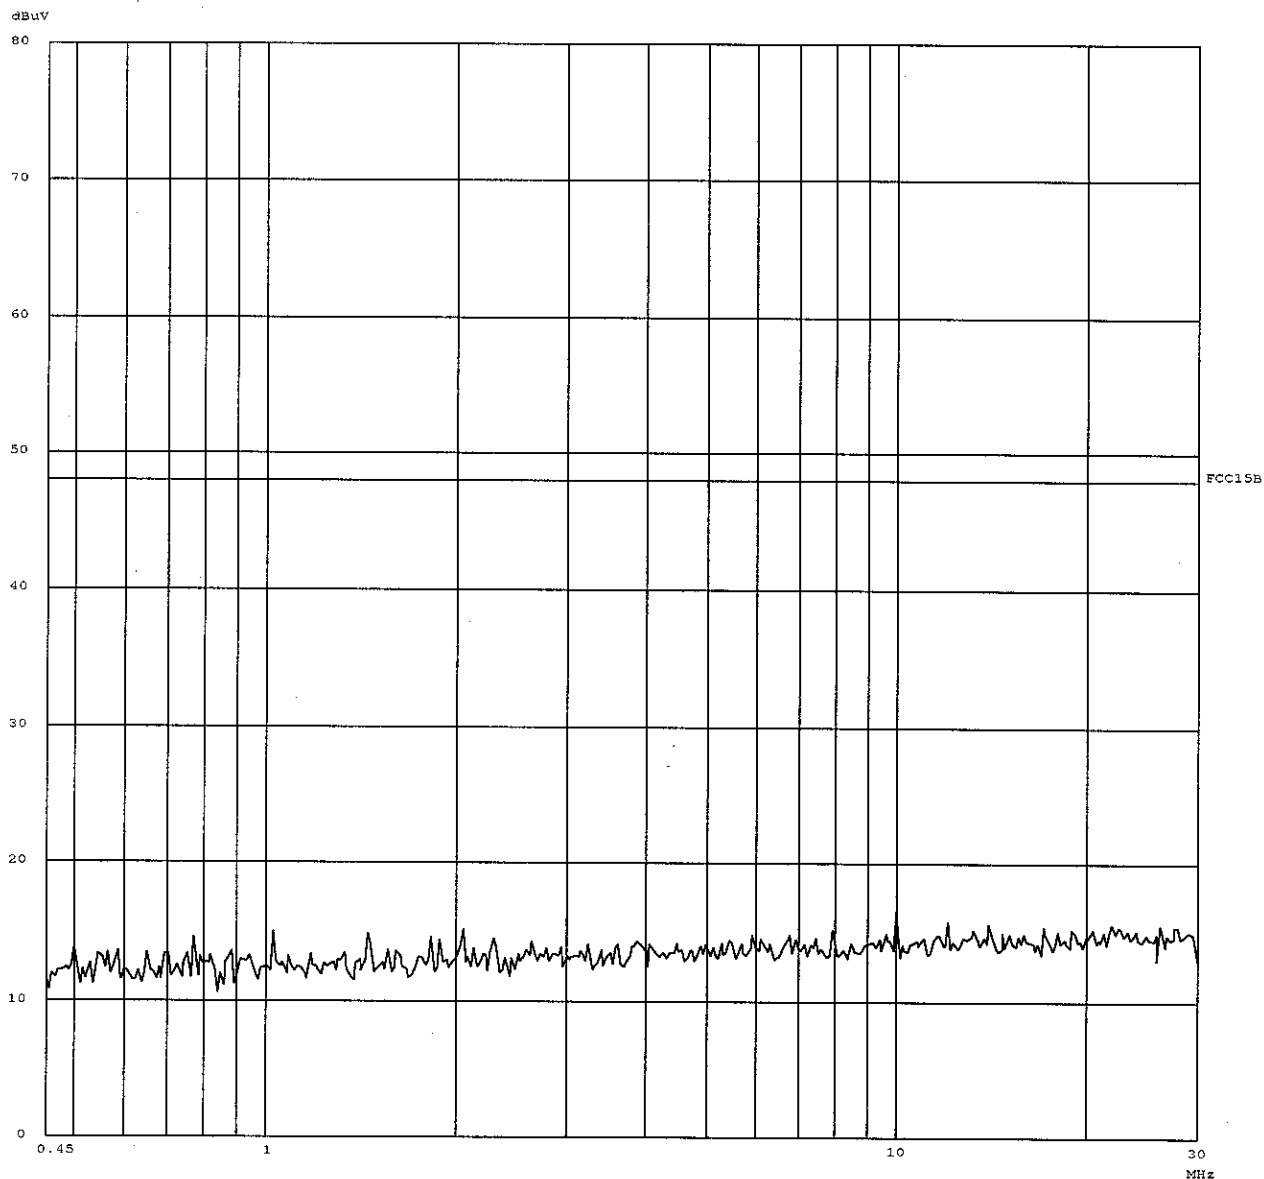
----- Frequencies ----- Receiver Settings -----

| Start | Stop | Step | IF BW | Detector | M-Time | Atten | Preamp | OpRge |
| 450k | 30M | 5k | 10k | PK | 20ms | AUTO | LN OFF | 60dB |

Final Measurement: x QP

| Transducer No. | Start | Stop | Name |
| 3 | 9k | 30M | EI078 |

Meas Time: 1 s

Subranges: 16

Acc Margin: 20dB
