# FCC SAR Test Report

## <Photographs of EUT>

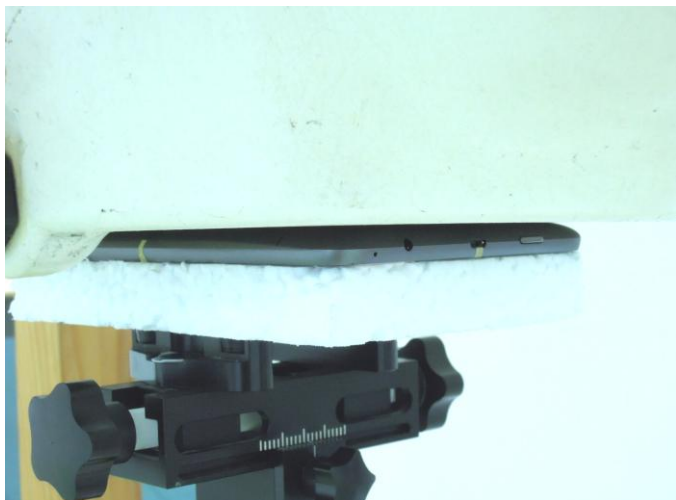
**Rear Face of EUT with 0 cm Gap**

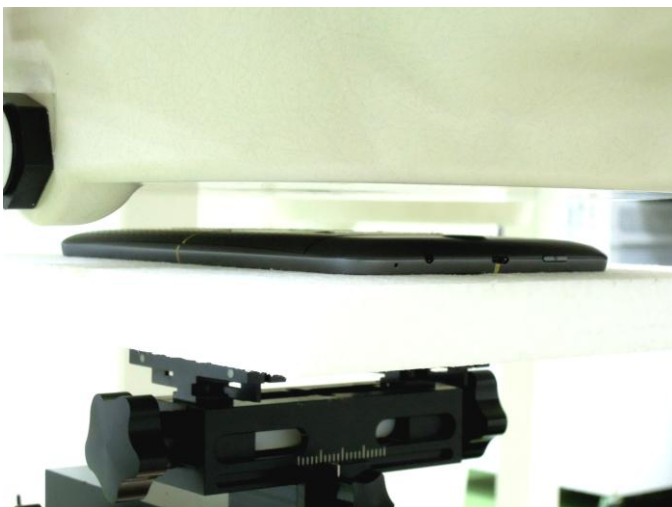
**Rear Face of EUT with 1.5 cm Gap**

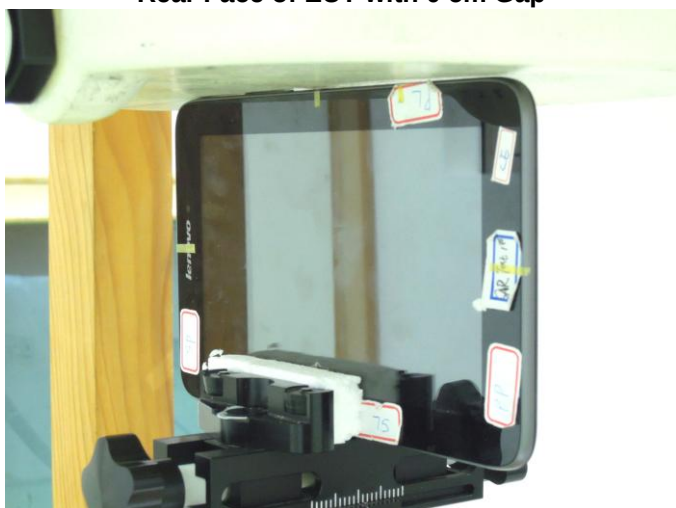
**Primary Landscape with 0 cm Gap**

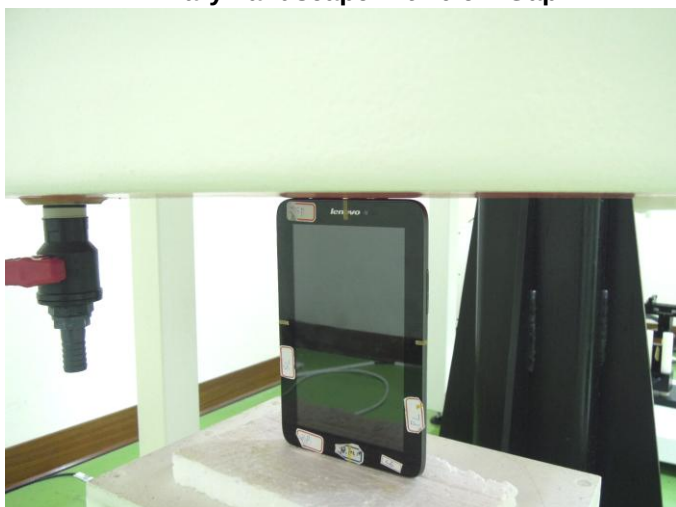
**Secondary Portrait with 0 cm Gap**

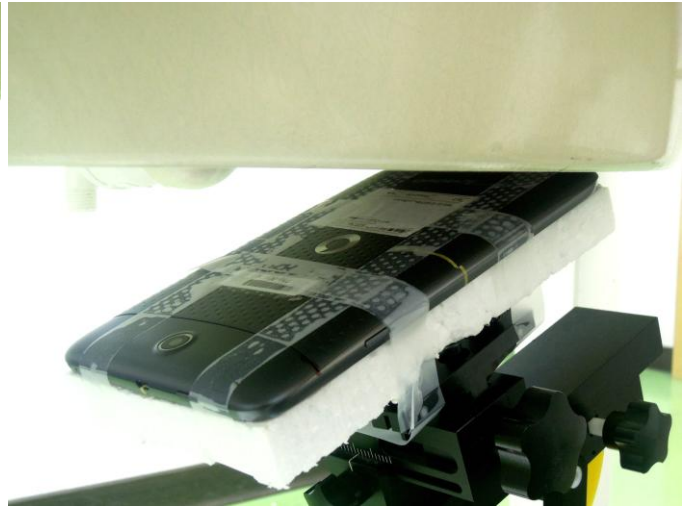
**Rear Face with 0 cm Gap  
(Top Edge/Right Rear Corner at 20 degree)**

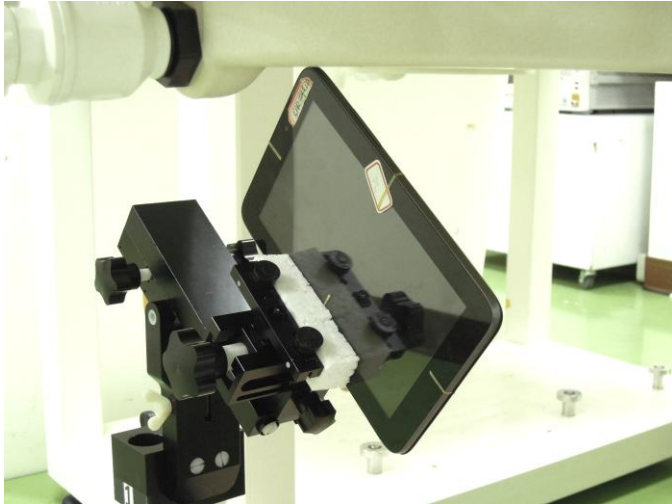
**Primary Landscape with 0 cm Gap  
(Top Edge/Left Corner at 35 degree)**

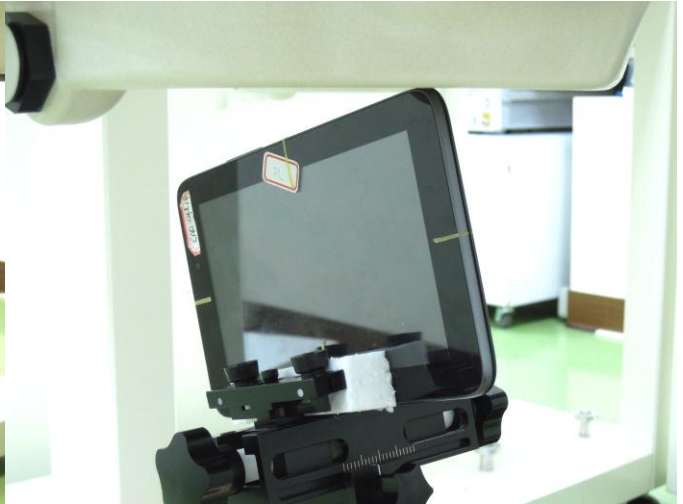
**Primary Landscape with 0 cm Gap  
(Top Edge/Right Corner at 15 degree)**
