Report No.: 9810658

Scan Settings (1 Range)

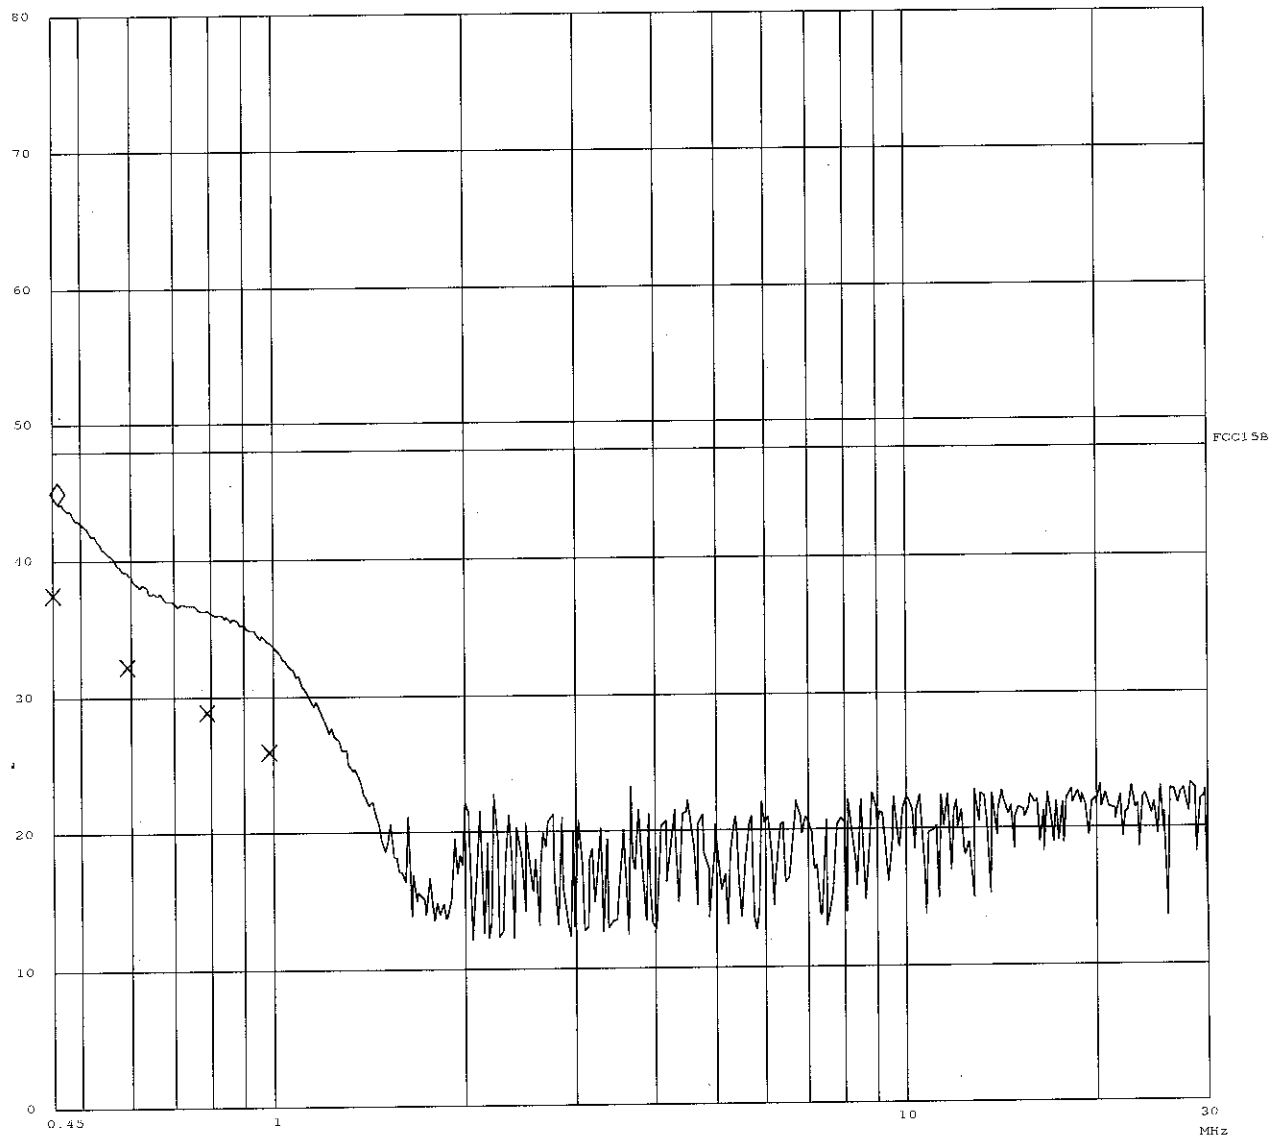
| Frequencies | | | Receiver Settings | | | | | |
| Start | Stop | Step | IF BW | Detector | M-Time | Atten | Preamp | OpRge |
| 450k | 30M | 5k | 10k | PK | 20ms | AUTO | LN OFF | 60dB |

Final Measurement: x QP

Meas Time: 1 s  
Subranges: 16  
Acc Margin: 20dB

dBuV  $\diamond$  Mkr : 460.00 kHz 44.1 dBuV

Final Measurement Results:

| Frequency<br>MHz | QP Level<br>dBuV | QP Limit<br>dBuV |
| 0.45000 | 37.5 | 48.0 |
| 0.59000 | 32.2 | 48.0 |
| 0.79000 | 28.8 | 48.0 |
| 0.99000 | 25.9 | 48.0 |
