### **APPENDIX 3: Photographs of test setup**

#### **Radiated Emission**

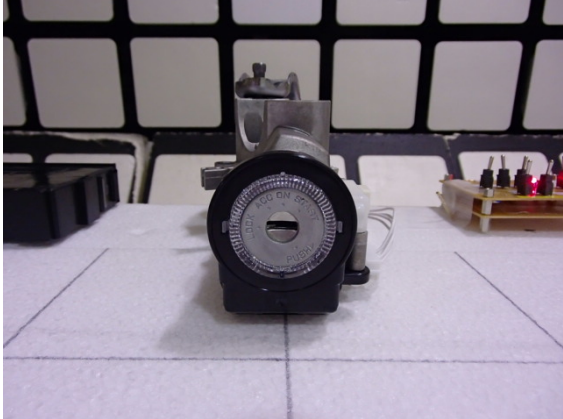
#### Immobilizer

Below 30MHz: X  
Above 30MHz: Horizontal Z, Vertical Z  
X-axis

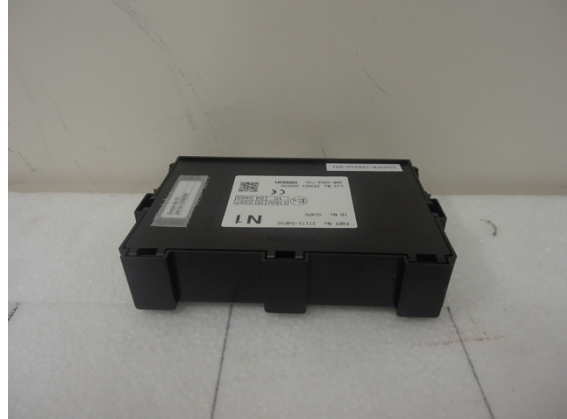
#### ECU

Below 30MHz: X  
Above 30MHz: Horizontal X, Vertical X  
X-axis

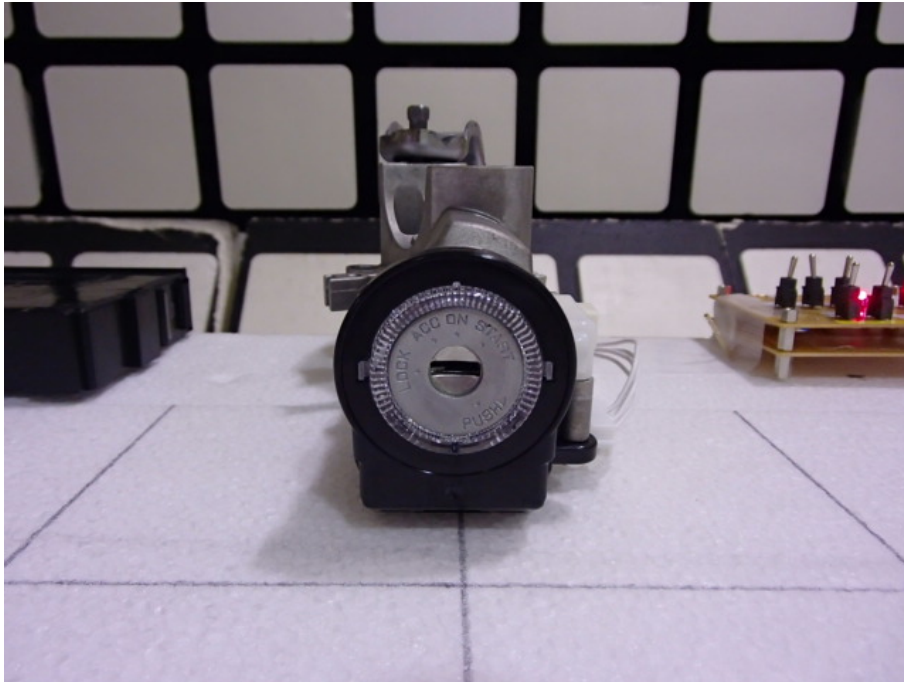
**Worst case position**

**Mechanical Key (Not Inserted) Worst**

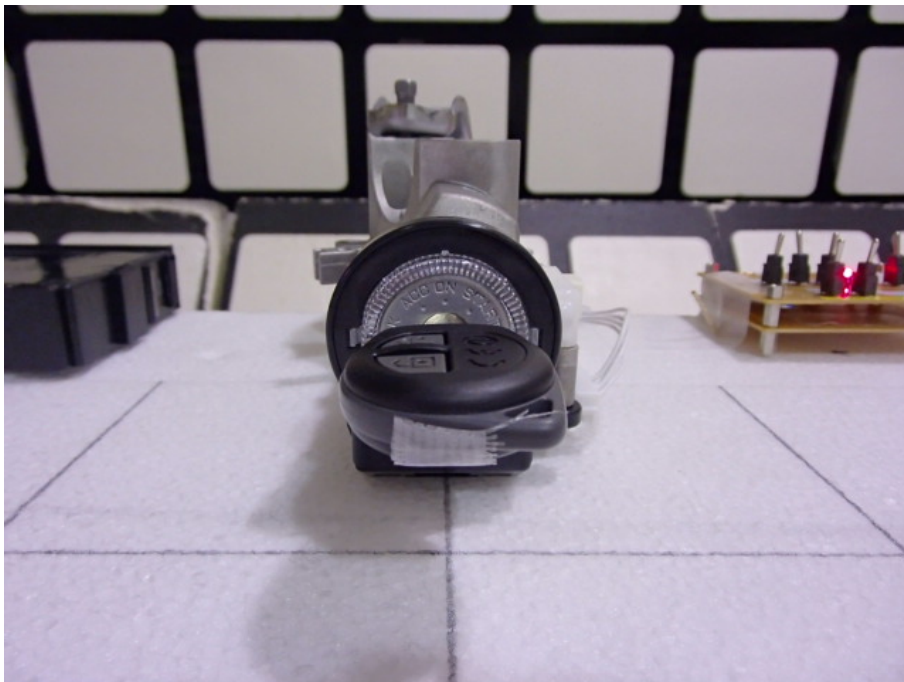
**Mechanical Key (Inserted)**
