**Prüfbericht-Nr: 18062201.f01**  
**Test report No: 18062201.f01**

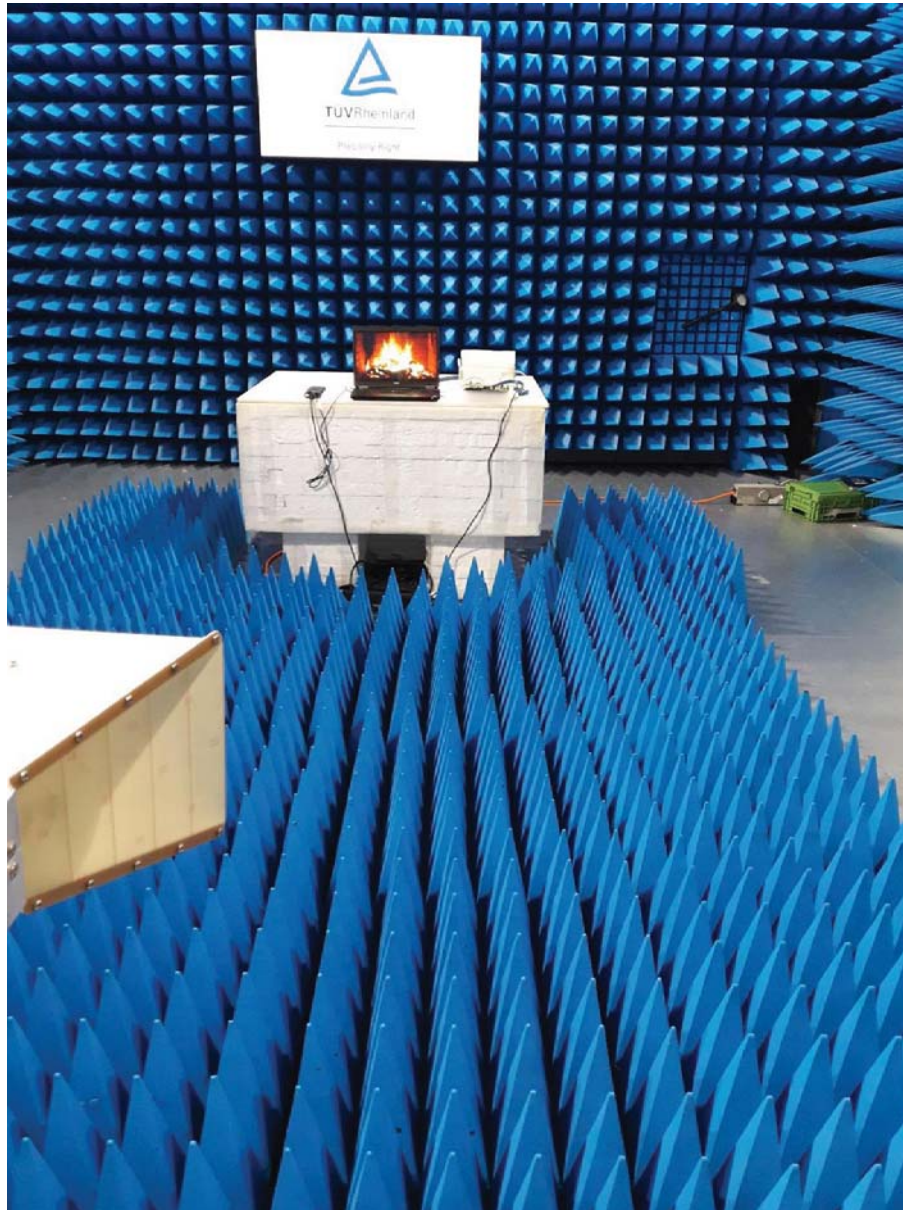
### 3.2.3 Photograph test setup 1- 6 GHz

*Photo 2: Photograph radiated emissions 1 – 6 GHz*

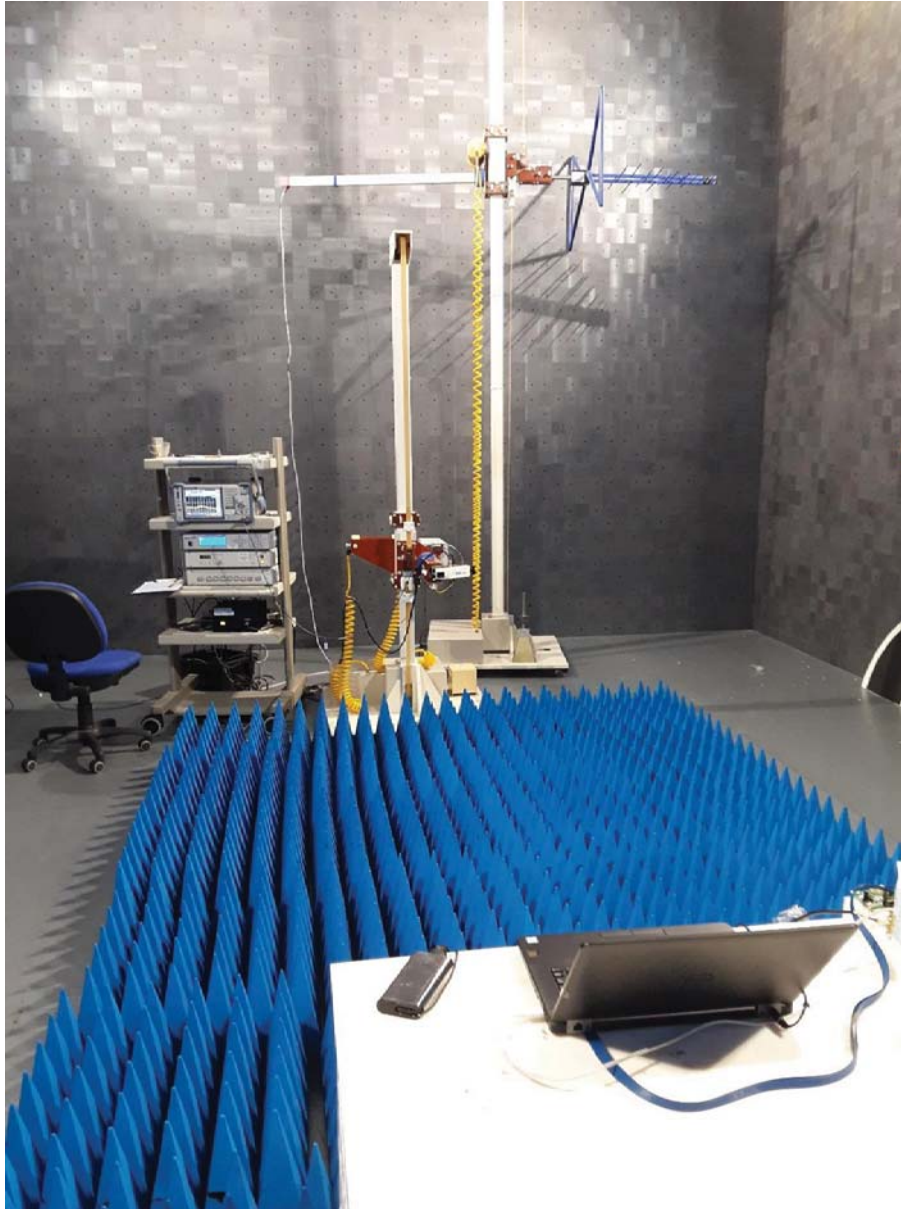
### 3.2.5 test setup 18-25 GHz

*Photo 4: Photograph radiated emissions 6 – 18 GHz (Applying another Gainhorn in the range 18-25 GHz)*

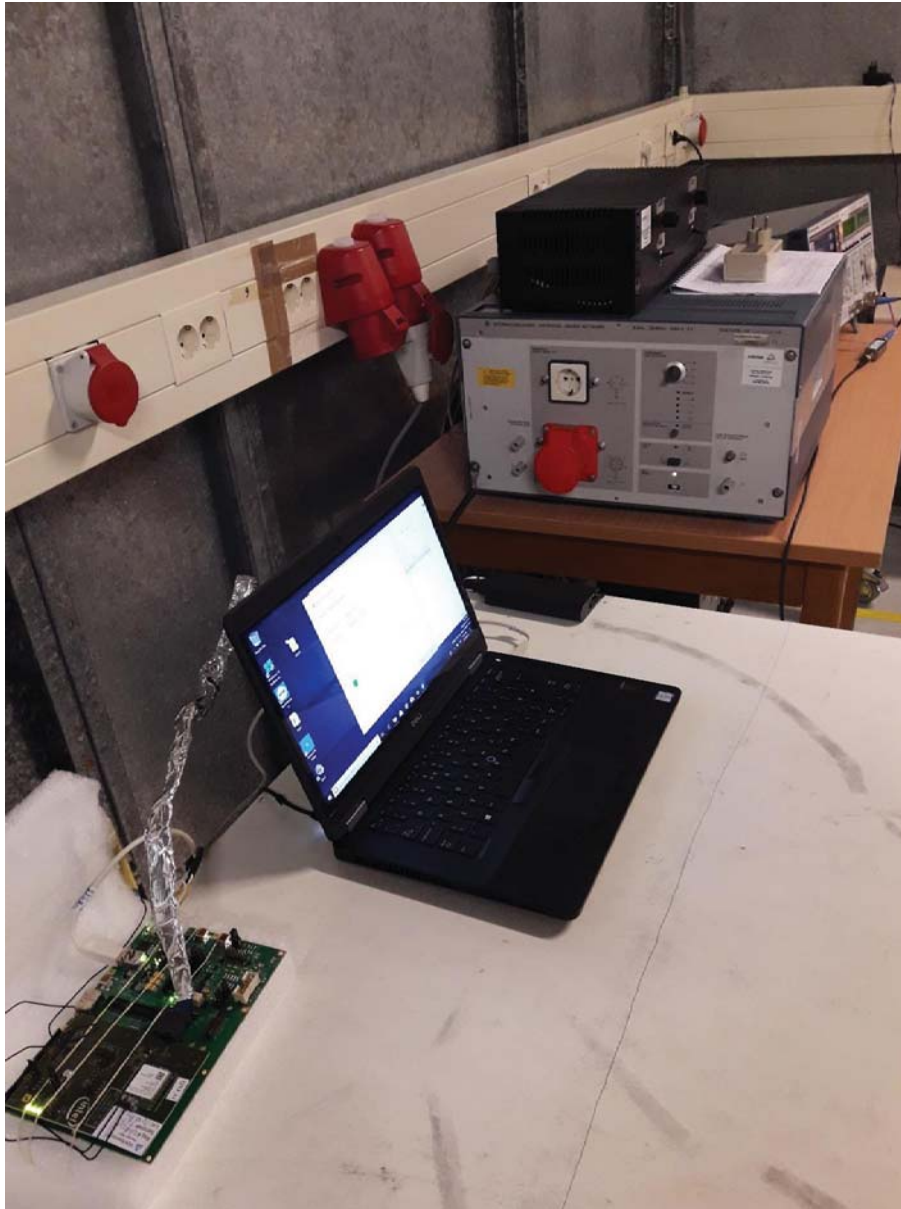
### 3.3.6.3 Photograph test setup

Photo 5: Photograph conducted emissions 0.15-30 MHz
