## **Annex D**

### **Conducted Spurious Emissions**

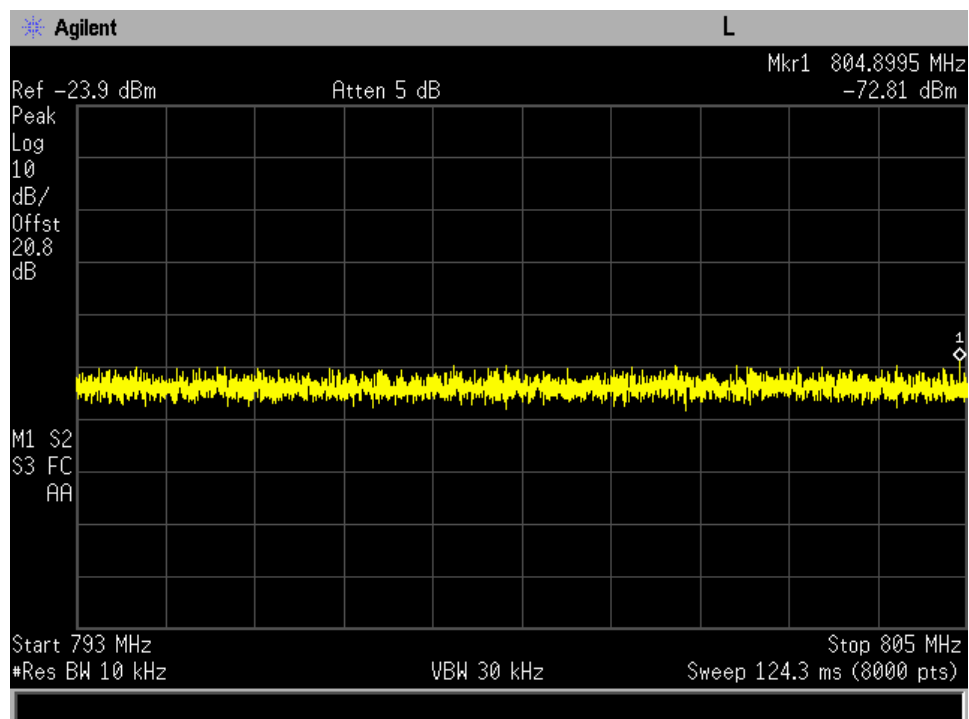
Conducted Spurious\_Downlink\_746 - 757 MHz\_ extra test 793 - 805
