Annex K

Conducted Spurious Emissions With Modem Transmitting

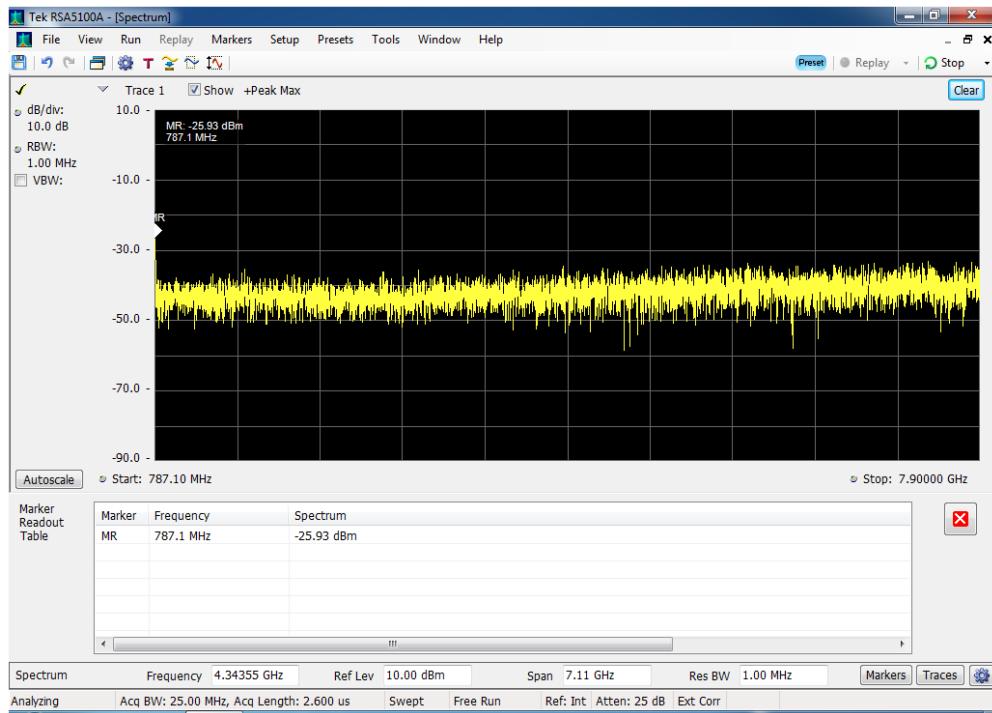
Conducted Spurious with modem TX on_UL_B13_776 - 787 MHz_Upper_S2 to Dedicated Donor Port 3

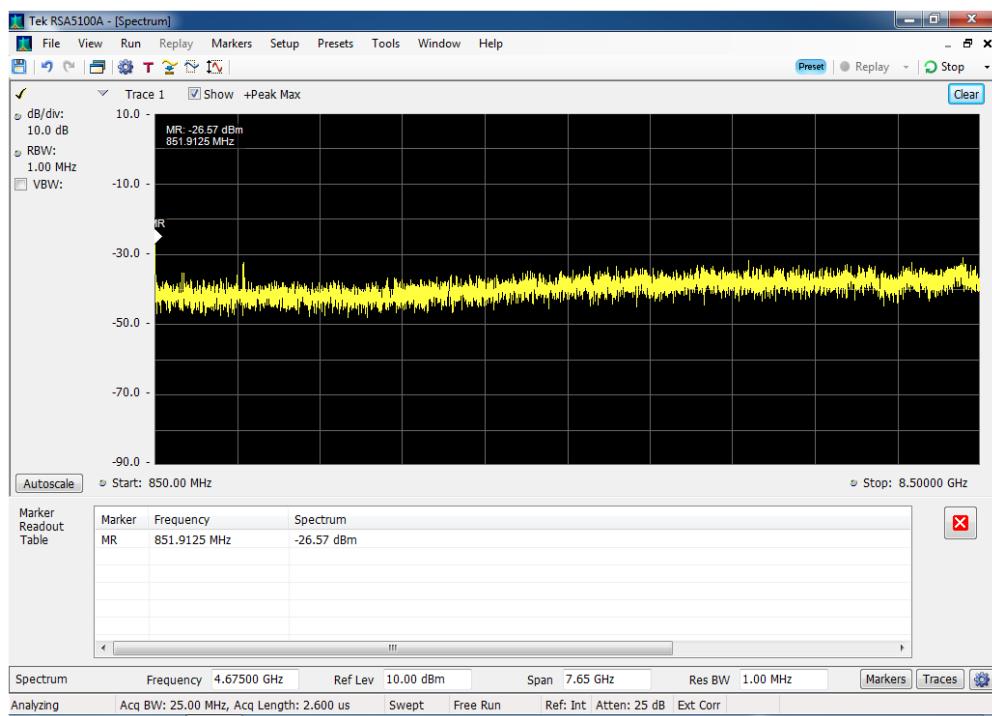
Conducted Spurious with modem TX on_UL_B5_824 - 849 MHz_Upper_S3 to Dedicated Donor Port 2
