Order Number: 11139405 Report Number: R11139405B-E2V3 Page 15 of 27

FCC ID: PY7-PM0943

Client Name: Sony Mobile Communications Inc. Issued: 2016-04-26

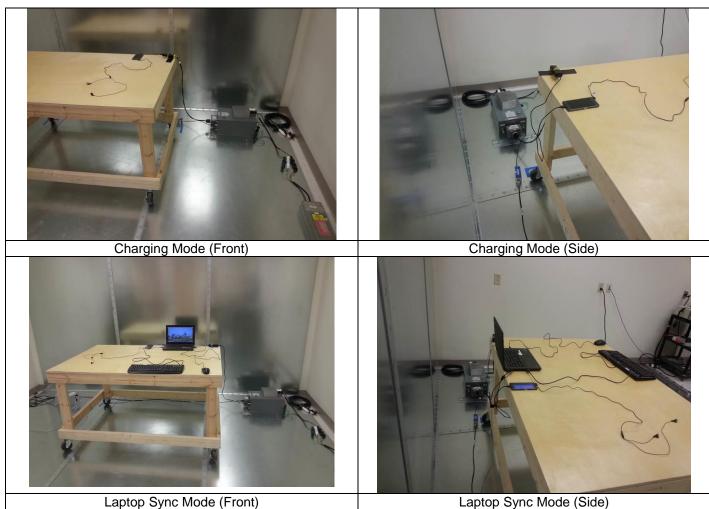
Figure 1 Test Setup for Conducted Emissions

Note: Laptop Ethernet was plugged into facility wall jack that was connected to facility switch, running ping session.

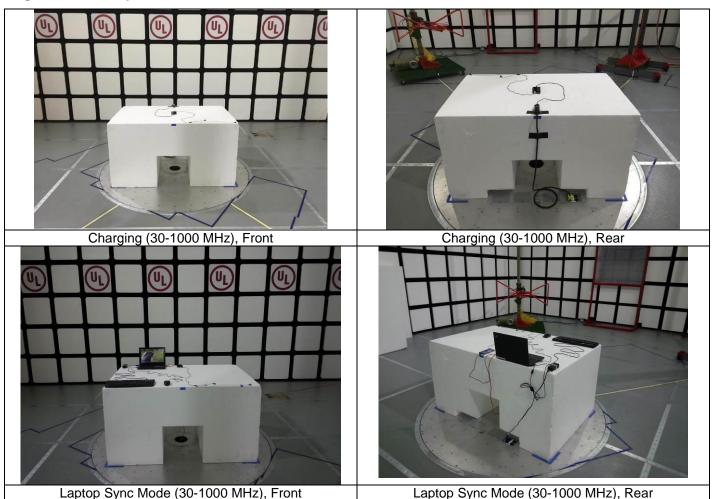
Figure 4 Test setup for Radiated Emissions < 1GHz

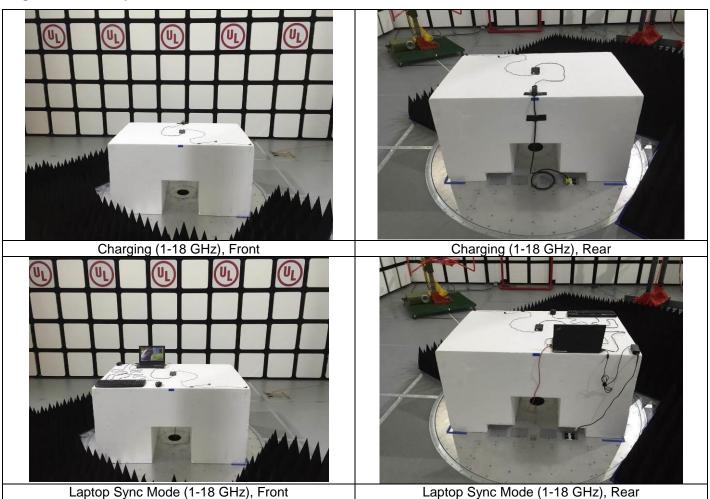
Figure 5 Test setup for Radiated Emissions > 1GHz
