Test Setup Photographs

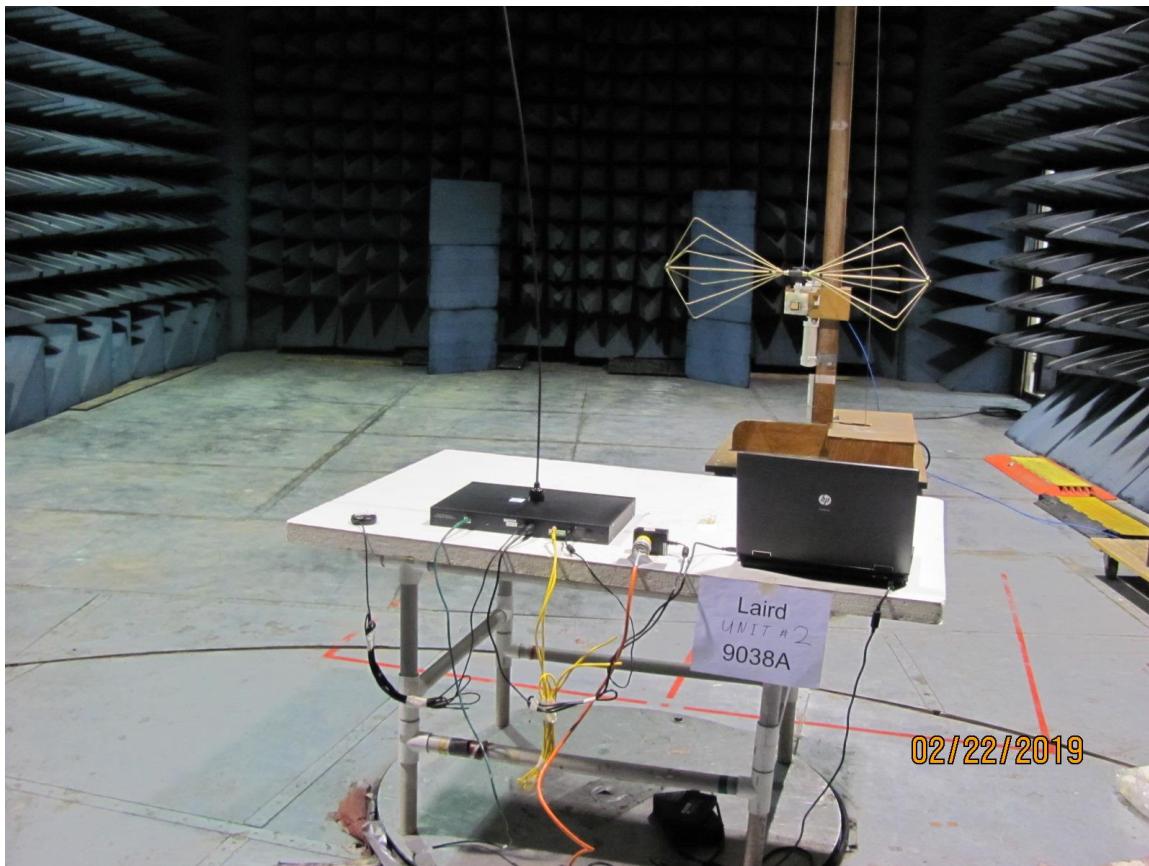
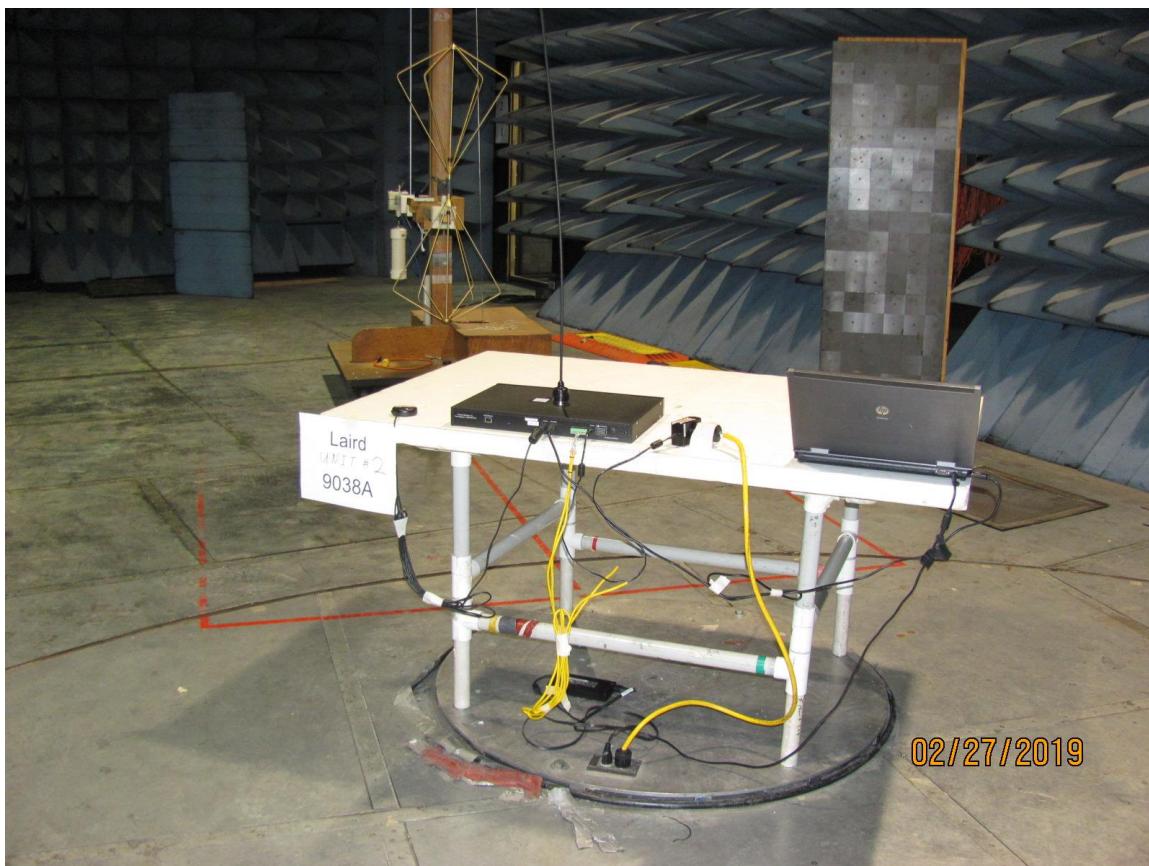
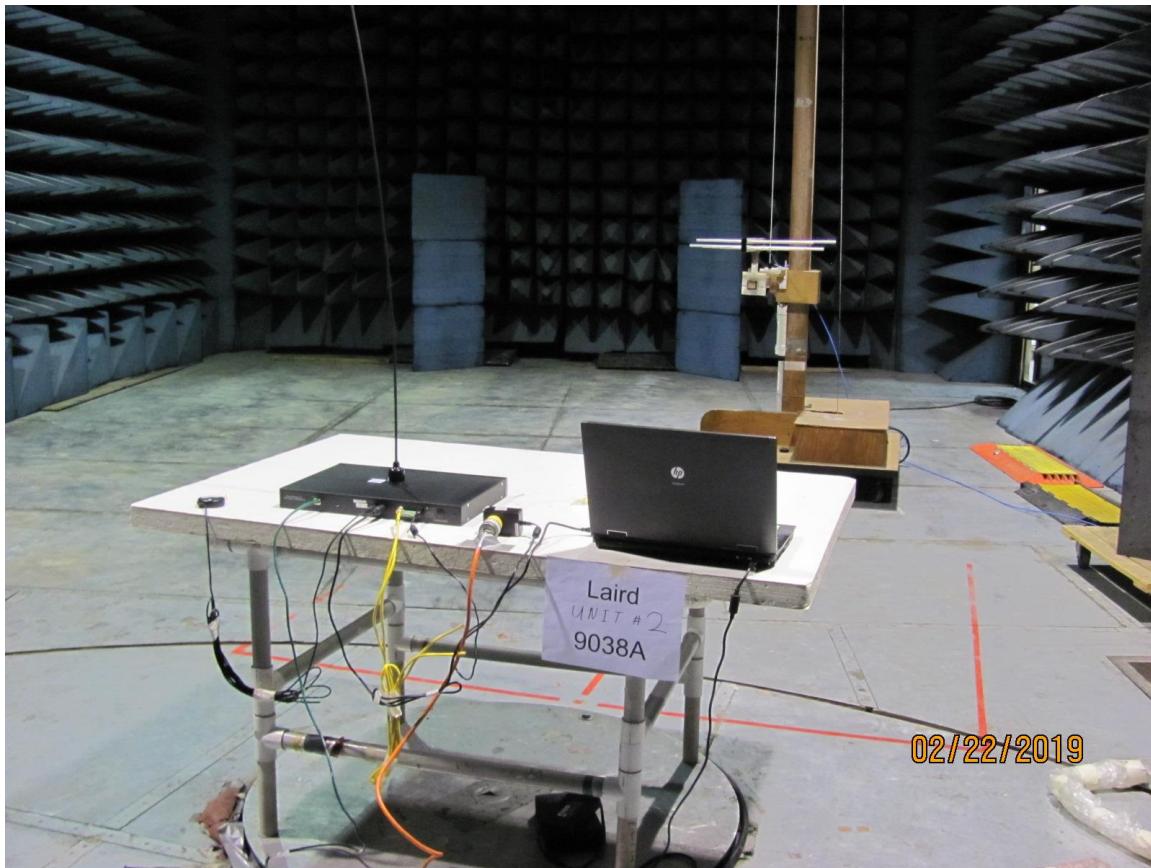
Photograph of Radiated Emissions Test Setup

The transmit mode was tested with a load in place of the monopole antenna with no low pass filter. The load was installed inside the the case of the transmitter.

Receive mode was tested with the monopole antenna installed as normal, with no Low pass filter.
